NGAARUAWAAHIA AND TAUPIRI CPTED ASSESSMENT

Prepared for Waikato City Council

by Beca Ltd (Beca)

28 June 2023

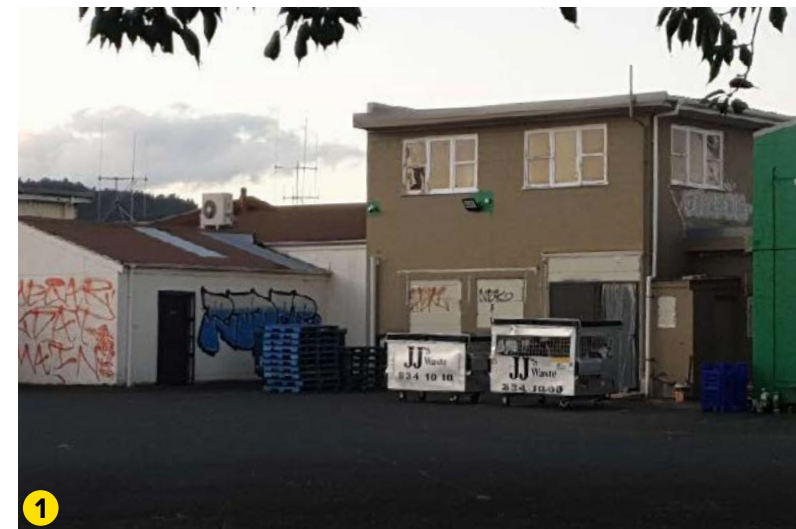
ISSUE	LOCATION & PHOTOGRAPH REFERENCE	BEST PRACTICE RESPONSE	PRIORITY
<p>Natural ladders</p> <p>There are natural ladders behind Great South Road - owners to evaluate if this is an issue for access onto rooves etc. The bins can also be a place for people to hide behind at night.</p>

<p>This is an example where rubbish locations are placed in a well-lit location and away from potential climbing opportunities.</p>

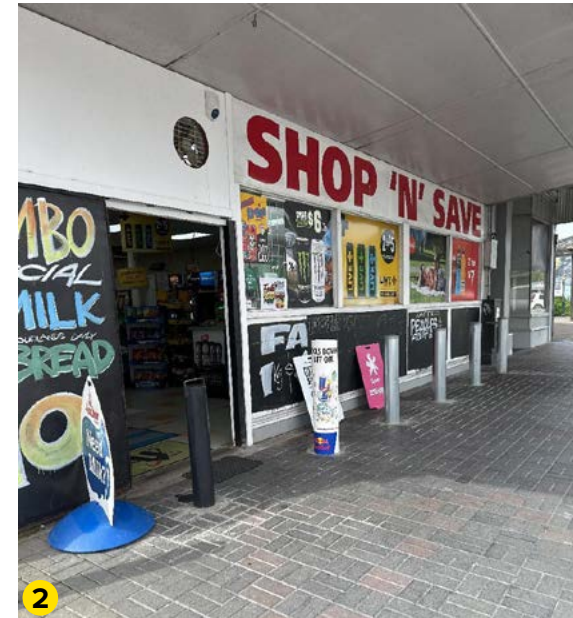
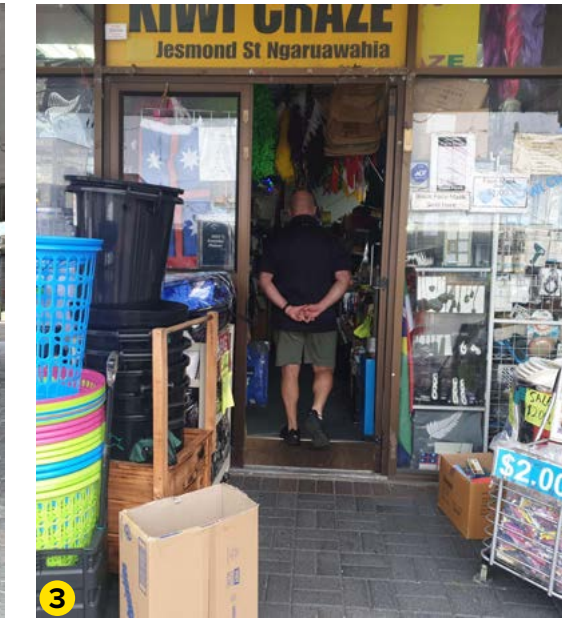
<p>Precedent Image: Hurstmere, Takapuna Auckland</p>	<p>EXTREMELY HIGH</p>
<p>Passive surveillance</p> <p>Shops have posters and screens obstructing views on Jesmond St.</p>

<p>Removal of posters to open sightlines into the shops and provide eyes onto the street.</p> <p>Any roller doors on Great South Rd – suggest could paint in consistent design</p>

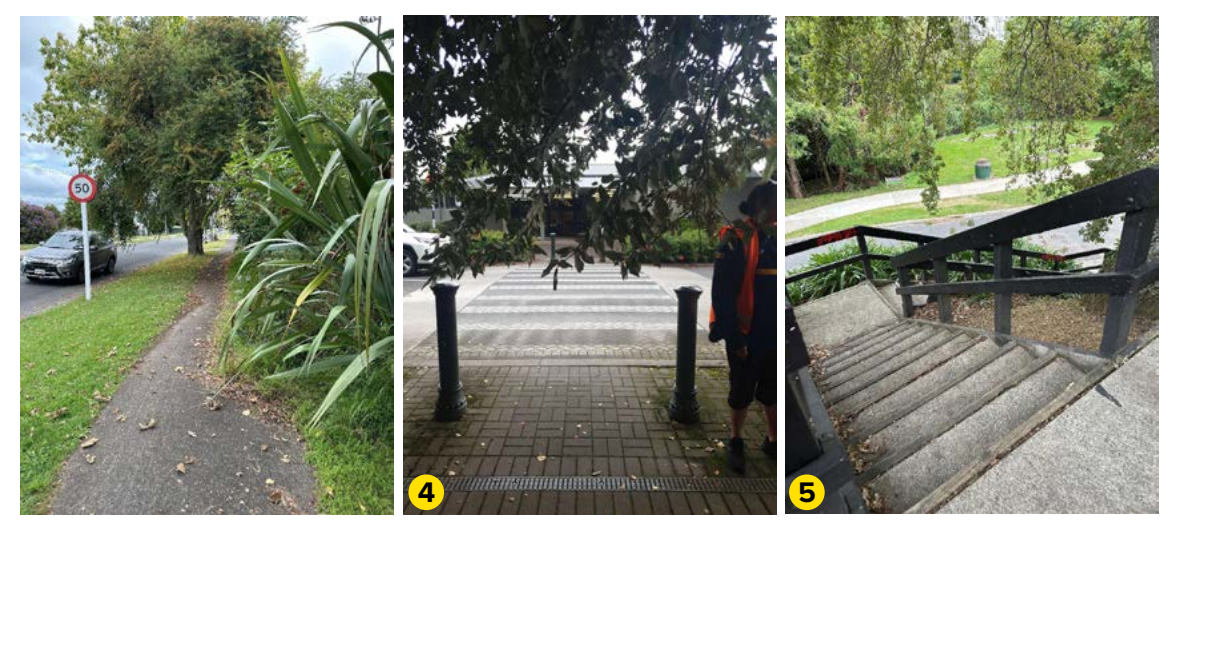
ISSUE	LOCATION & PHOTOGRAPH REFERENCE	BEST PRACTICE RESPONSE	PRIORITY
<p>Clear sight lines (vegetation)</p> <p>There are areas where vegetation is overgrown with incursion onto the footpath or there is a low canopy obstructing sightlines.</p> <p>i.e. Paterson Park, stairs that connect the bridge and cycleway. All areas where this is identified are at the end of this section.</p>

<p>Trees (in all areas) should be canopy-lifted, allowing sight lines to be maintained. Trimming of trees surrounding to open sight lines.</p> <p>CPTED best practice stipulates a vegetative clearance between 0.6m to 2.5m (refer diagram below).</p> <p>Trim lower limbs of trees to provide a clear trunk and improve visual connection.</p>

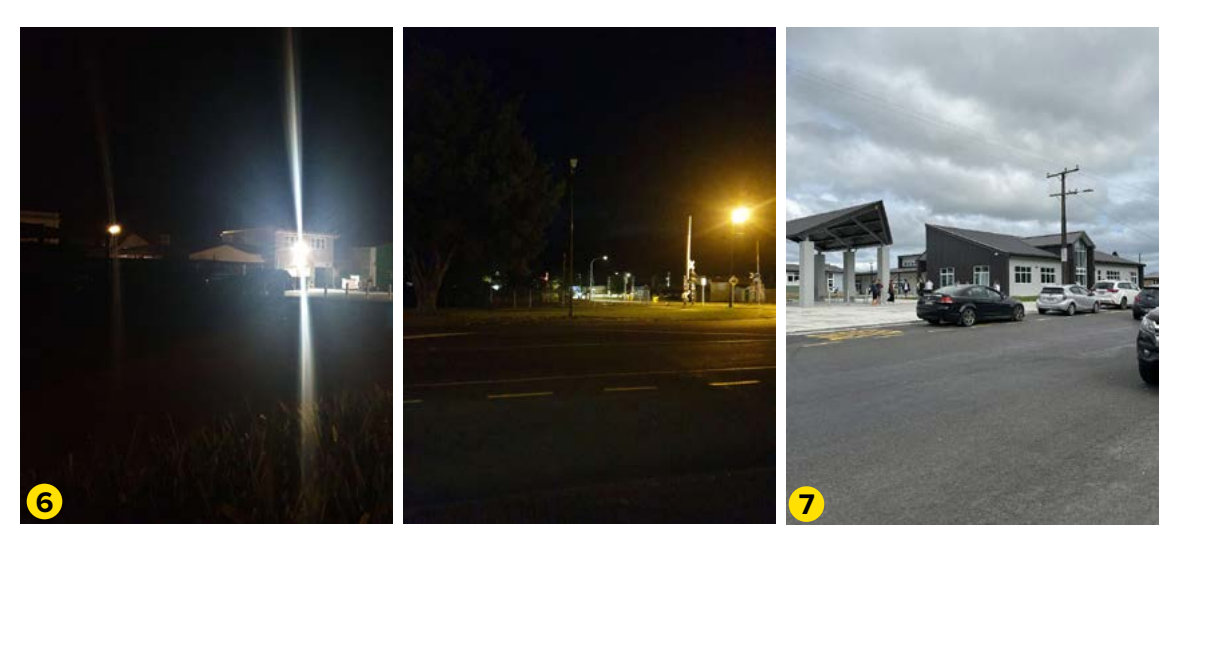
<p>EXTREMELY HIGH</p>
<p>Lighting</p> <p>The space between the buildings along Great South Road has dark unlit areas which leads to a varying pedestrian experience (well lit to no lighting in the gaps). Pedestrian paths alongside the rail line on Great South Road are well lit but obscured by the tree canopy with resulting patchy lighting.</p> <p>Along the rail line and in front of Ngaaruwaahia High School there is no lighting.</p>

<p>Conduct a review of the lighting (on the night of the walkover lights were being replaced) and an arborist review to determine where trees are blocking lighting at ground level.</p> <p>Along the canopies of Great South Road and Jesmond Road shops lighting is effective with no obstruction.</p>

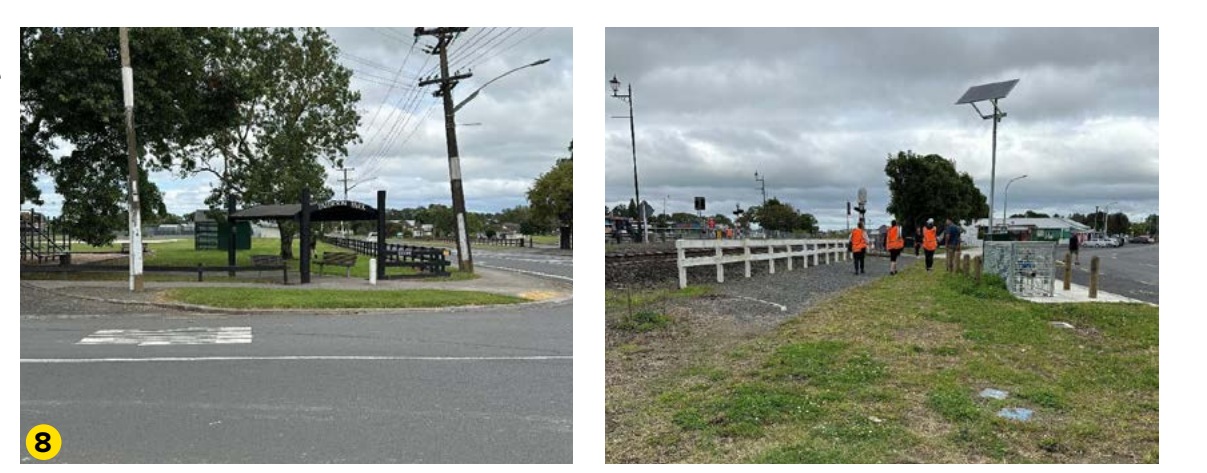
<p>Legibility through wayfinding</p> <p>Lack of signage to connect the town centre to Te Awa Cycle Trail, along the Waikato River edge, bridge and to the Hakarimata Ranges walkway.</p>

<p>Consider a suite of signage that would assist pedestrians in identifying natural amenities, attractions and navigating around the town centre, i.e., consistent signage directing people to toilets, schools, library, and other public facilities. Ensure signage is clear and appropriately placed.</p>

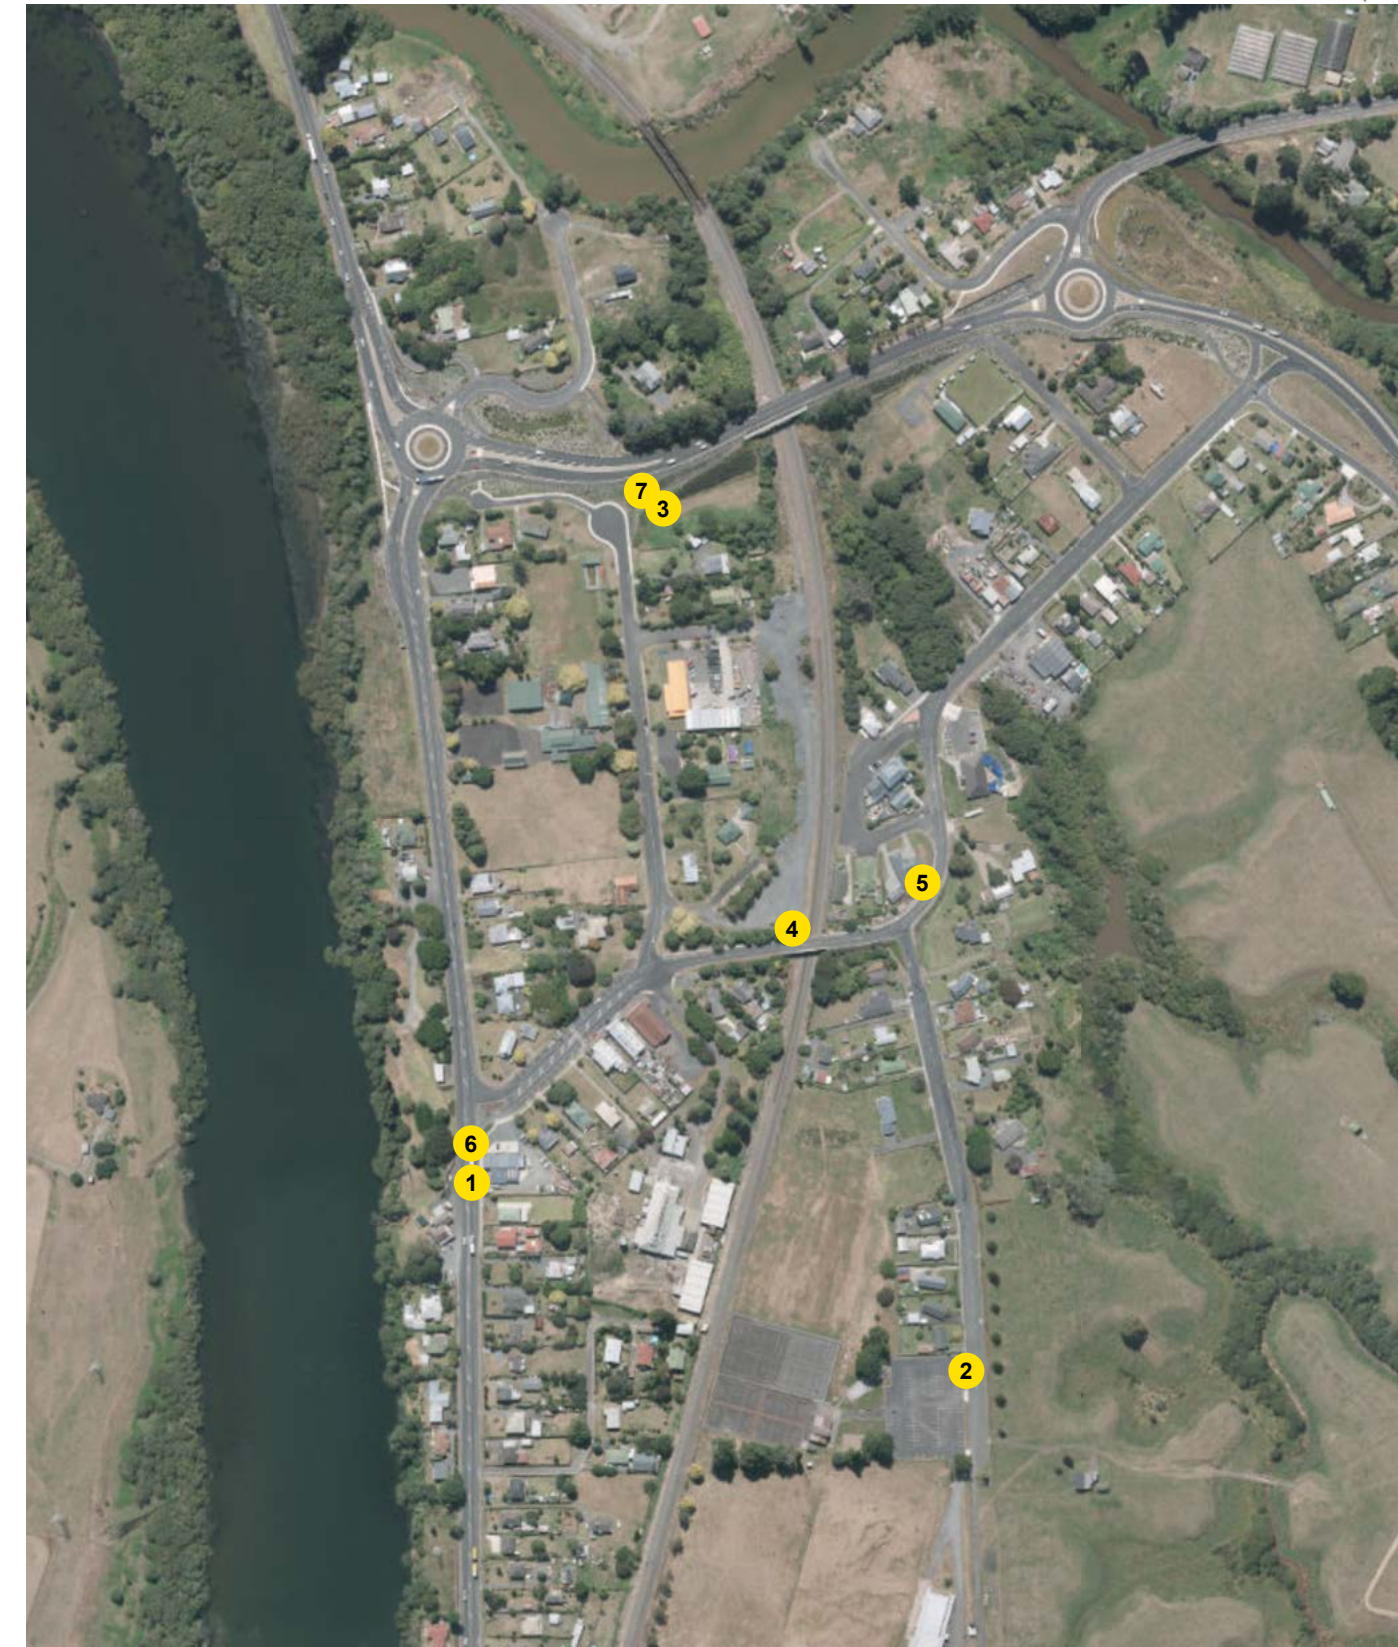
Figure 13. Mapping of CPTED issues - Taupiri

ISSUE	LOCATION & PHOTOGRAPH REFERENCE	BEST PRACTICE RESPONSE	PRIORITY
a. Concealment opportunities Areas of possible entrapment including blind corners) should be avoided to improve the sense of safety and reduce opportunity for crime that is unobserved.		Increase lighting, consider gating areas where there is deep recess if this is an area where there is a level of heightened risk. Receiving wider feedback from users is important to establish whether change is warranted.	● HIGH/ BEST PRACTICE

e. Lighting The underpass under Gordonton Road and the Rugby Field carpark are not sufficiently illuminated after dark.		Install more pedestrian scale lighting and provide a wider localised area for the Rugby field parking.	● EXTREMELY HIGH

f. Legibility through wayfinding Wayfinding with area severed by roads and no easy pedestrian access to each quarter - there is a need to discuss the lack of access to recreational and community facilities with several people wanting to age in place and use mobility scooters.		Increase signage and pedestrian amenity to assist the community to safely access natural amenities, bus stops attractions and navigating around the neighborhood, i.e., consistent signage directing people to schools, community facilities, and other public facilities. Ensure signage is clear and appropriately placed.	● HIGH/ BEST PRACTICE

l. Graffiti Large number of graffiti dotted around the town i.e Marae, bridge, transformer boxes. The presence of graffiti contributes to a lower level of perceived safety.		Address the issue using one of the following methods: <ul style="list-style-type: none"> - Plant dense foliage at the base to restrict access to blank walls. - Paint the wall using one of the precinct's theme colours from the agreed palette. - Consider commissioning a mural artist to paint a mural. - Identify through the community if the taggers are from the wider area and reach out through the Police, community for effective ways to lower incidences. 	● EXTREMELY HIGH

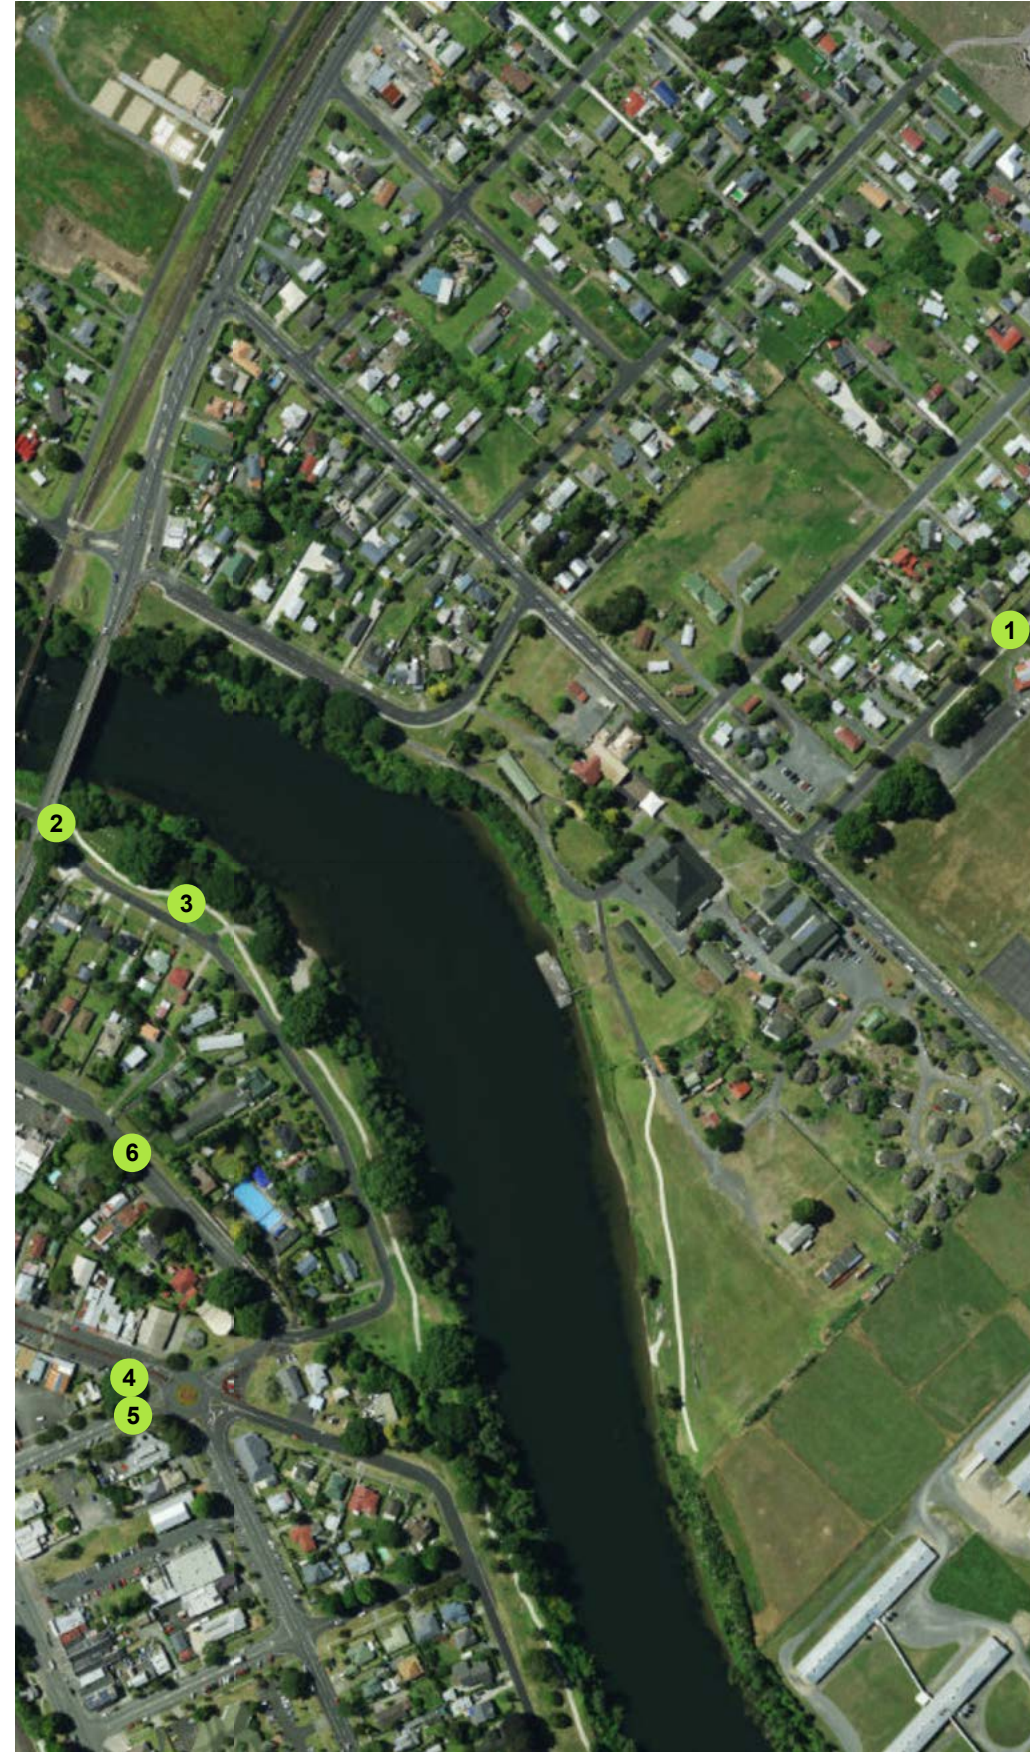
Figure 17. Mapping of overgrown vegetation - Ngaaruawaahia

A number of areas have overgrown vegetation that encroaches on footpaths around residential streets and high pedestrian movement areas. In Ngaaruawaahia the staircase at the bridge, and pedestrian crossing in front of Work and Income are two locations. In Taupiri, this was seen at the underpass at Murphy Lane and entry to the bridge leading to the urupa.

It is recommended to trim vegetation over footpaths and tree canopies as well as that which obscures lighting. This should be included in the maintenance regime to ensure views are not impeded and maximise passive surveillance and safety. Prioritisation should be at higher pedestrian movement areas - The Point, riverside, bridge, Jesmond Street, Great South Road, Market Street, High School, and Turangawaewae Marae.
