## Port Waikato Landslide Assessments

**Prepared for**  
Waikato District Council

**Prepared by**  
Tonkin & Taylor Ltd

**Date**  
June 2023

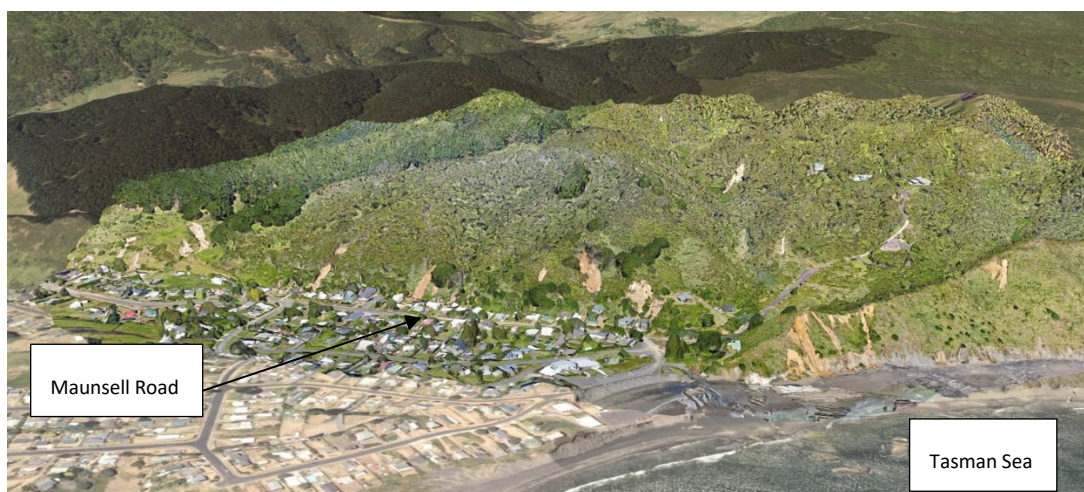
Figure 2.2: Aerial photograph looking south-east towards Maunsell Road.

The above photographs indicate that there are several relatively shallow landslides along the escarpment slopes above the subject properties. In general, these landslides appear to be isolated events rather than being indicative of a larger global landslide.

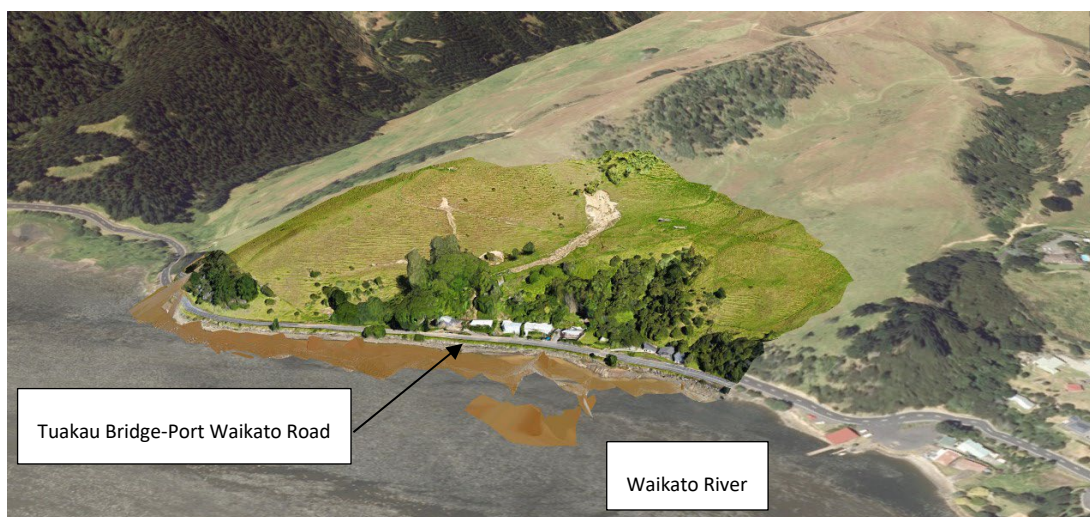
Figure 2.3: Aerial photograph looking south towards land damage on and above properties.

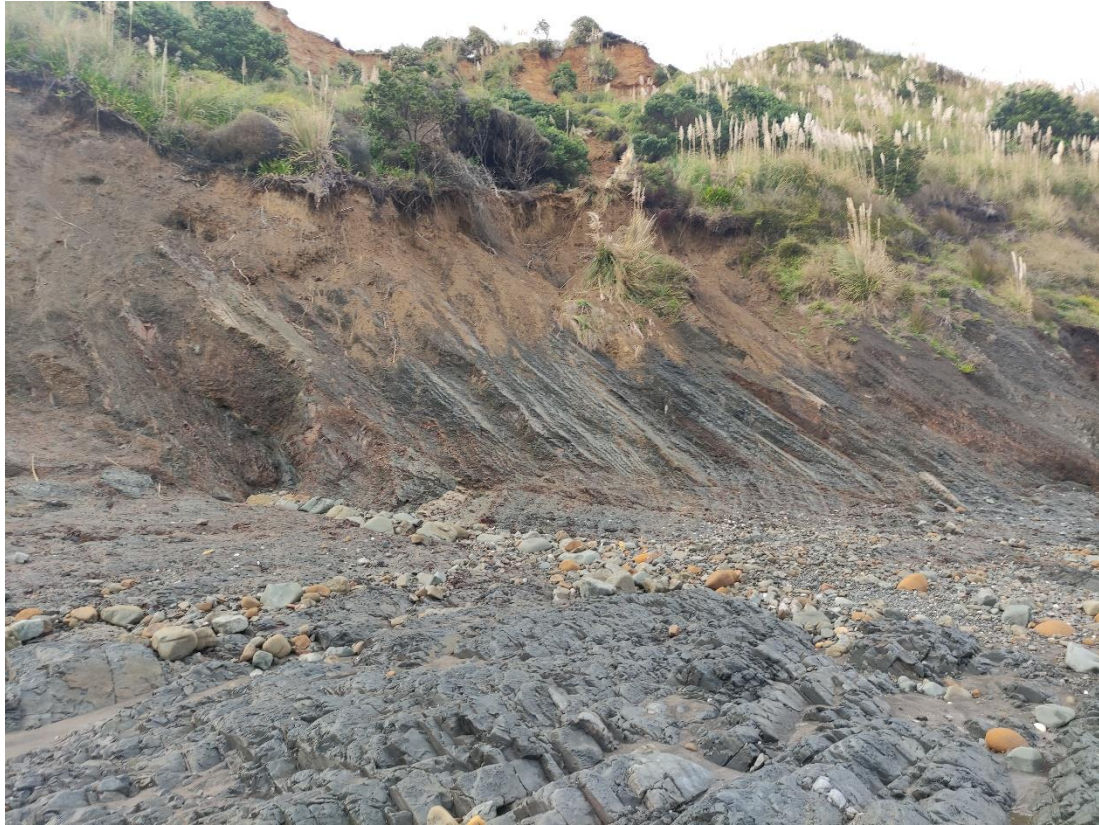
*Photograph 1: Dipping mudstone / sandstone beds view from beach*

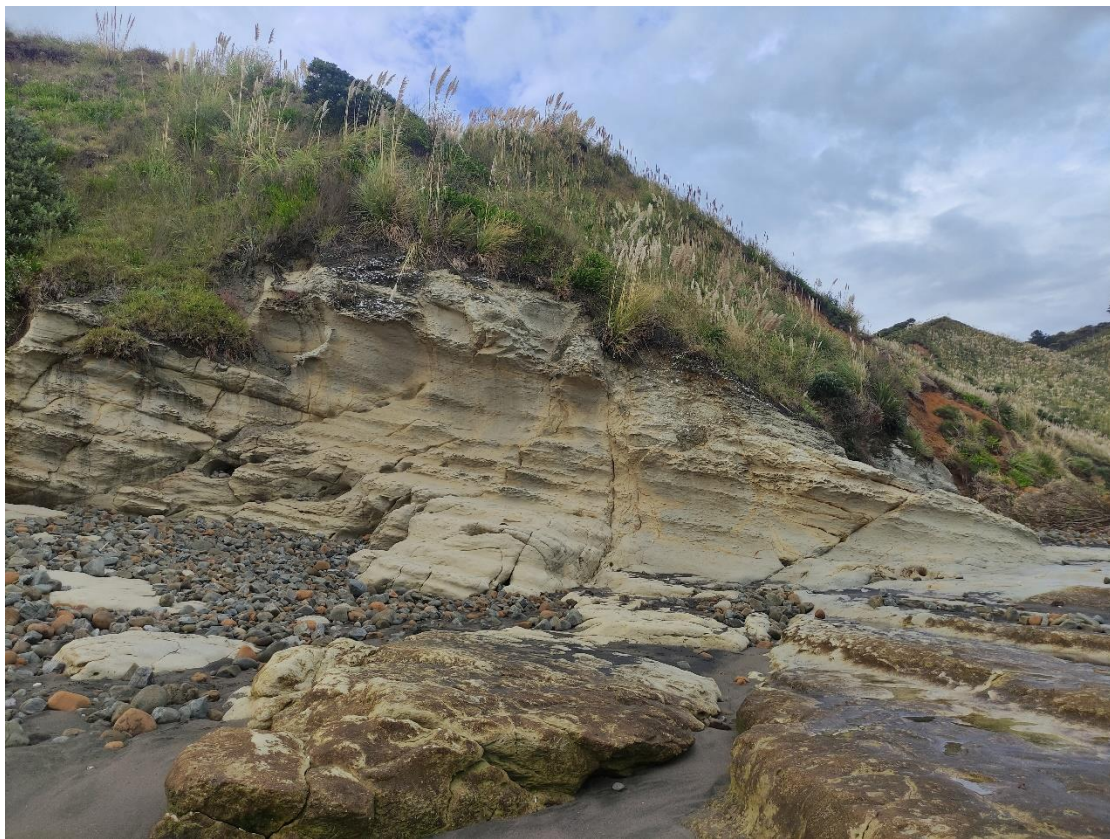
*Photograph 2: Dipping sandstone beds view from beach*

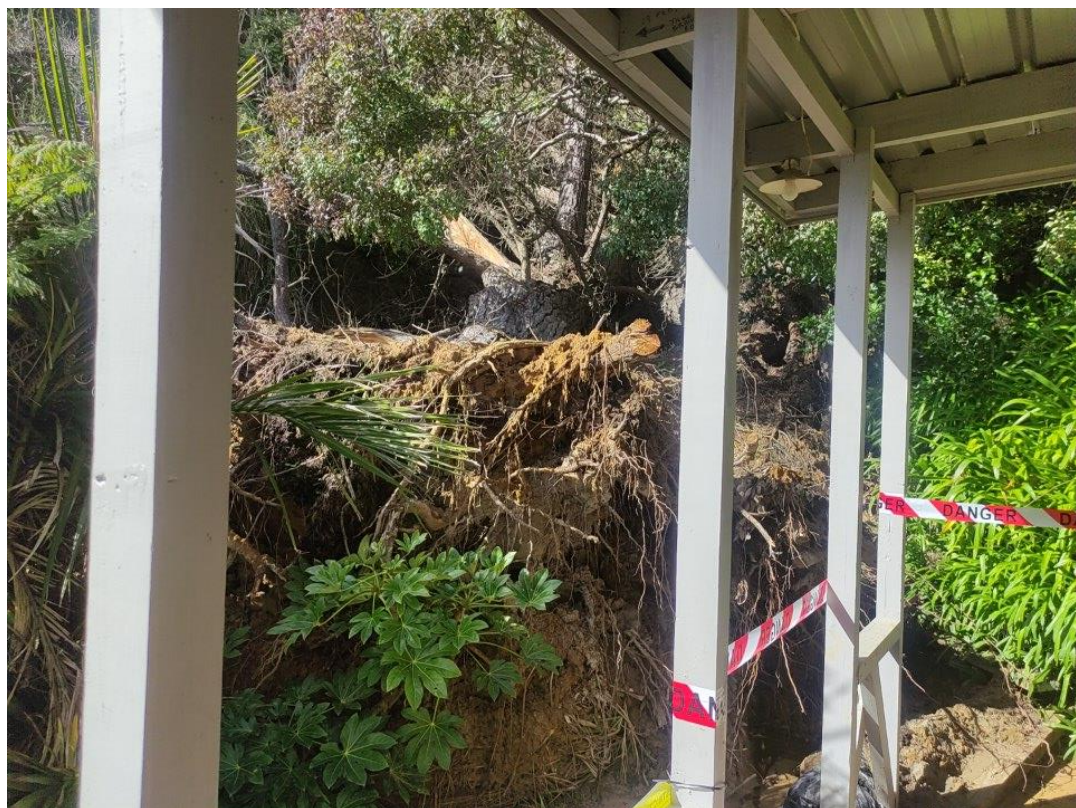
Photograph 6: Debris accumulation

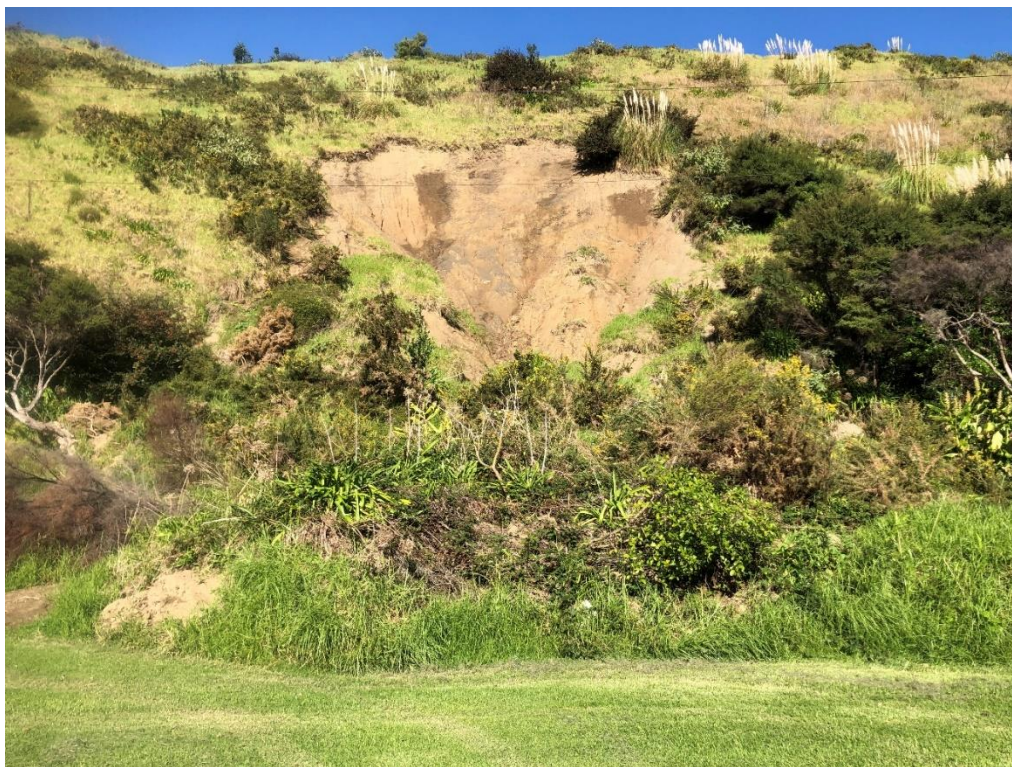
- Landslide 19 (115b Maunsell Road) was one of the larger failures observed, with a 22 m wide headscarp located on a 40-degree slope approximately 16 m from the crest (overall slope height of around 60 m). The height of the landslide headscarp is estimated to be approximately 20 m. Debris run out for this was in the region of 12 m to 14 m from the toe of the natural escarpment slope.

Photograph 12: [REDACTED] Large Landslide 19

For the Holiday Park site (115B Maunsell Road), it is recommended that location of any structures and tent sites give due consideration to the instability risk of the slope. This may include implementing a suitable offset from the slope toe.

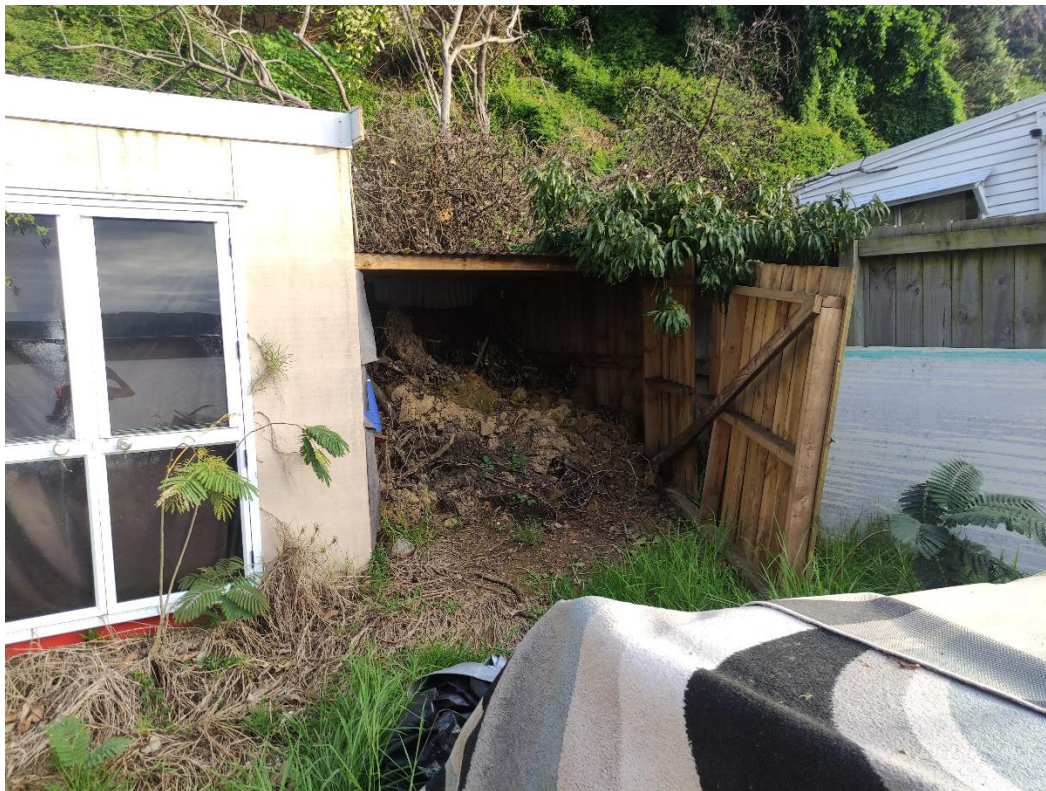
Photograph 14: Damage to shed / car port [REDACTED]
