Date of Inspection:	Time:	Zone / Area:	Weather:	Person Contacted During Visit:
29.06.20	19:30		Overcast	Shawn McLean

### General Observations

The Fill 3 site is proposed to be drained and filled in due course, after the granting of consents and when Fill 2 is completed.

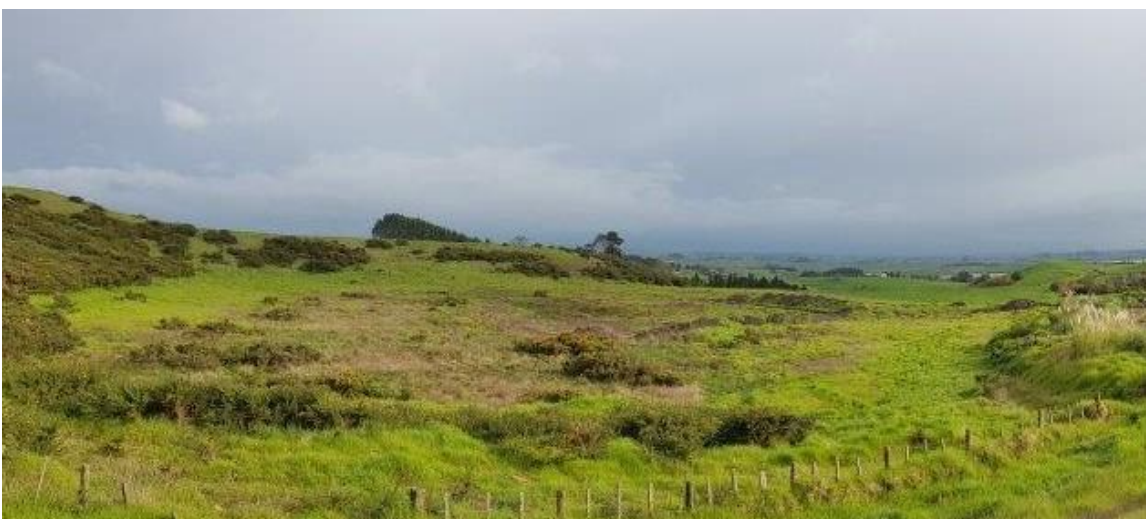
Figure 1: Fill 3 gully.

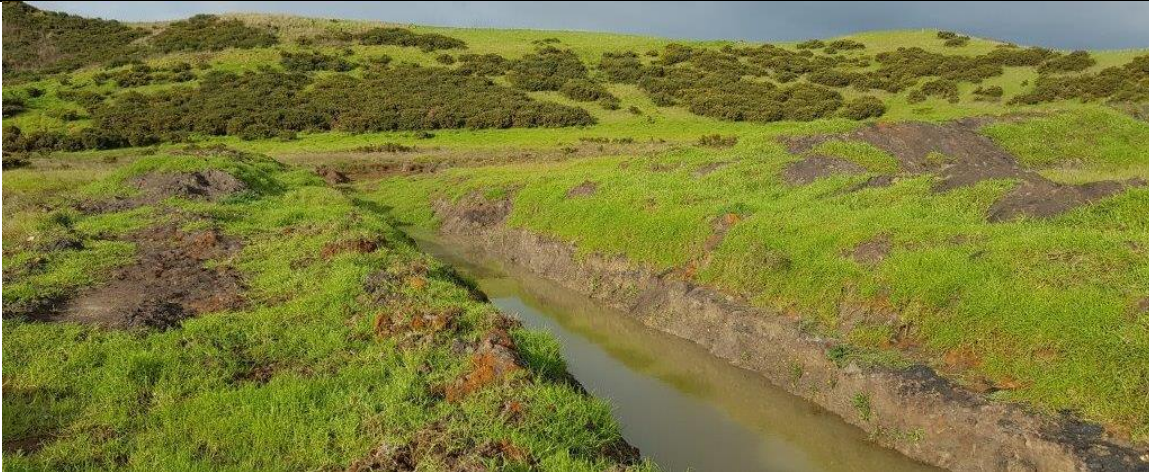
Figure 2: Main channel from pond. Seed and mulch stockpiles. Install rock check dams and hydroseed batters.

1. Install a series of rock check dams along the drain channels at nominal 15m spacing. The purpose of the check dams is to ensure flow velocities remain slow but allow water to pass through the dams to keep the water level low.
2. Open up and rock line the eastern end of the channel and line it down to the existing permanent vegetation to ensure that discharges from the channel do not cause scouring.
3. Seed and mulch all exposed areas (except the channel sides).
4. Hydroseed channel sides.

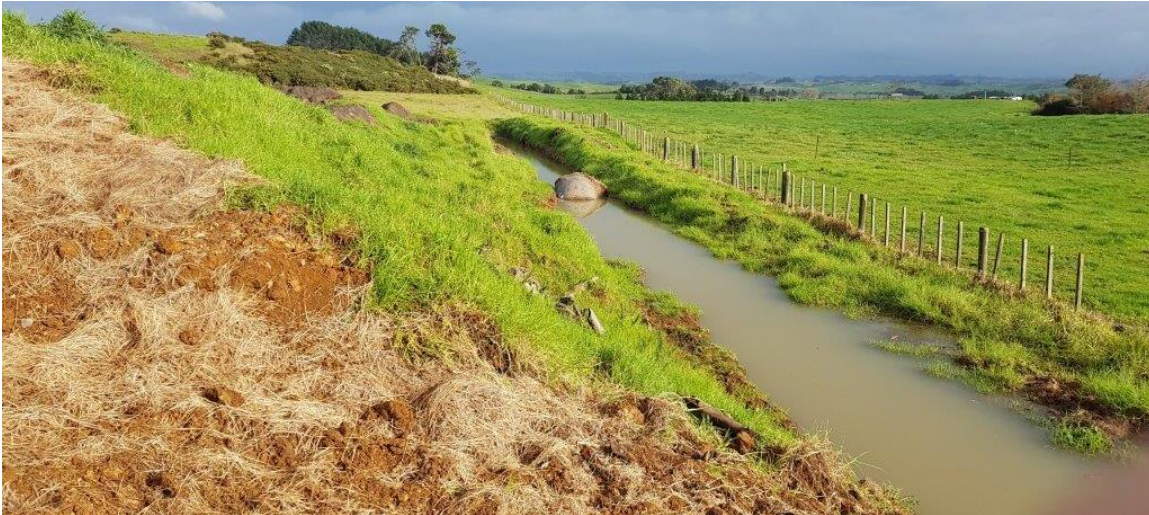
Figure 3: Channel along northern boundary – ponded water spilling across boundary at lower-right of picture. Remove bale and install a series of rock check dams to link to the rock lined channel (see below).

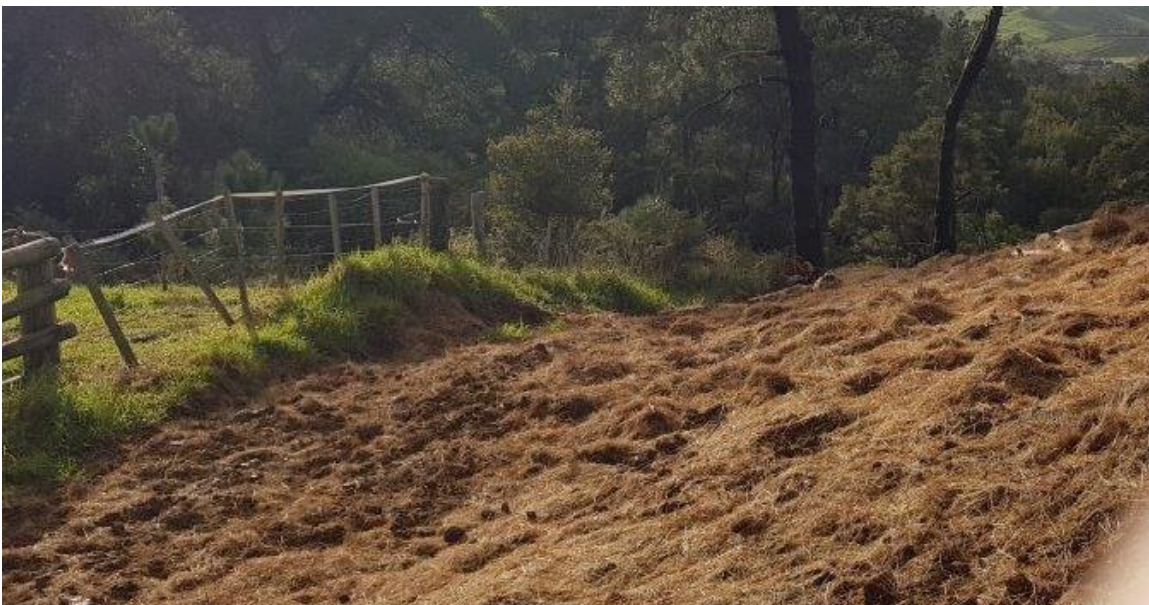
Figure 4: Outlet to east presently blocked with fill and mulched. Install rock lined channel to ensure runoff discharges to a stabilised outfall.

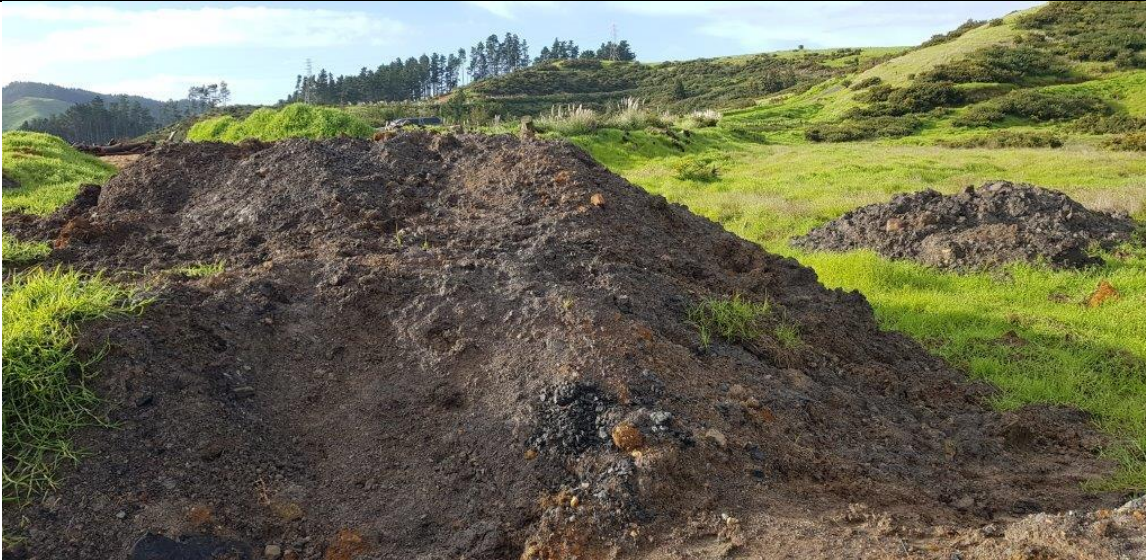
Figure 5: Various exposed stockpiles. Seed and mulch.
