# **PRELIMINARY SITE INVESTIGATION HUNTLY EAST MINE AND FARM**

**PREPARED FOR:  
KIMIHIA LAKES  
COMMUNITY CHARITABLE  
TRUST**

**SEPTEMBER 2020**

**Contaminated Site Investigation**

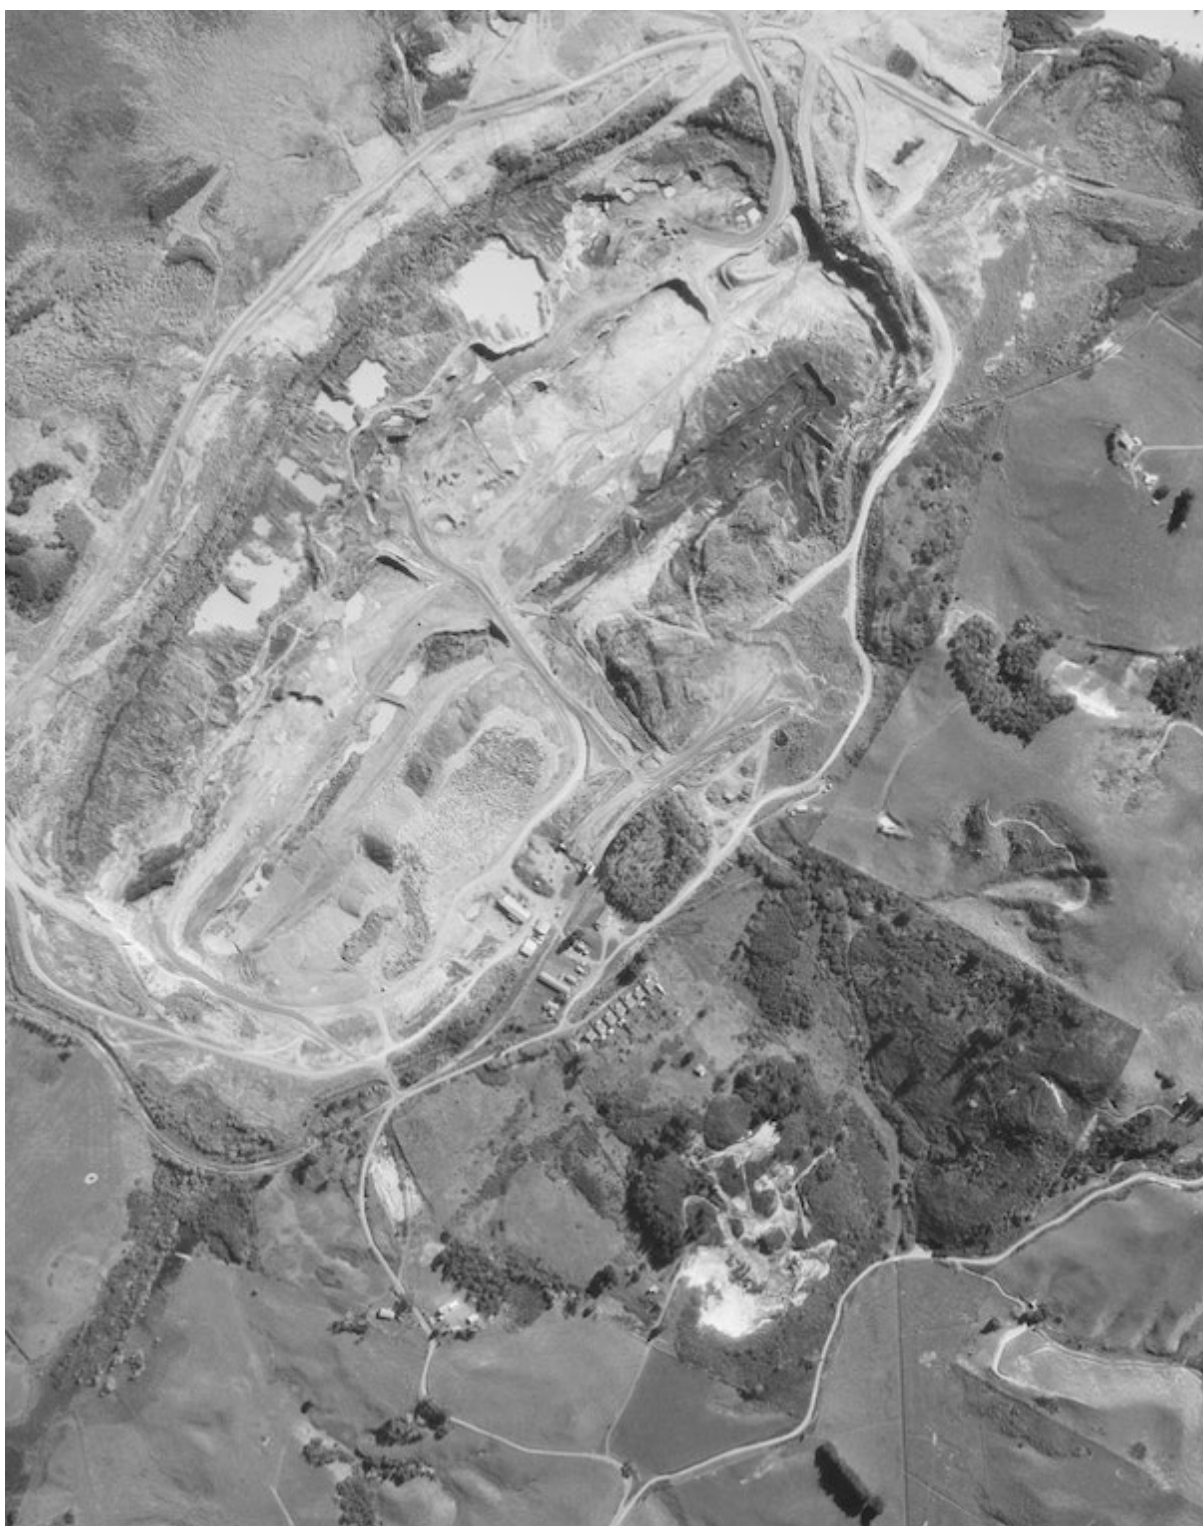
3.1.2.3 The 1966 reproduction (SK03) shows similar conditions to the 1963 reproduction. A strip of vegetation is present in the west and north of the pit.

- 3.1.3.3 The 1966 reproduction (SK03) shows similar conditions to the 1963 reproduction. The grove of trees in the central north has increased in size. A small pond is visible in the south west adjacent to both boundaries.

- 3.1.4.3 The 1966 reproduction (SK03) shows similar conditions to the 1963 reproduction. The grove of trees in the central north has increased in size. The northern and eastern boundaries appear to be fenced.

- 3.1.5.3 The 1966 reproduction (SK03) shows similar conditions to the 1963 reproduction.
- 3.1.5.4 The 1967 reproduction (SK04) shows similar conditions to the 1966 reproductions except the majority of buildings in the north to the east of the central road, have been removed.

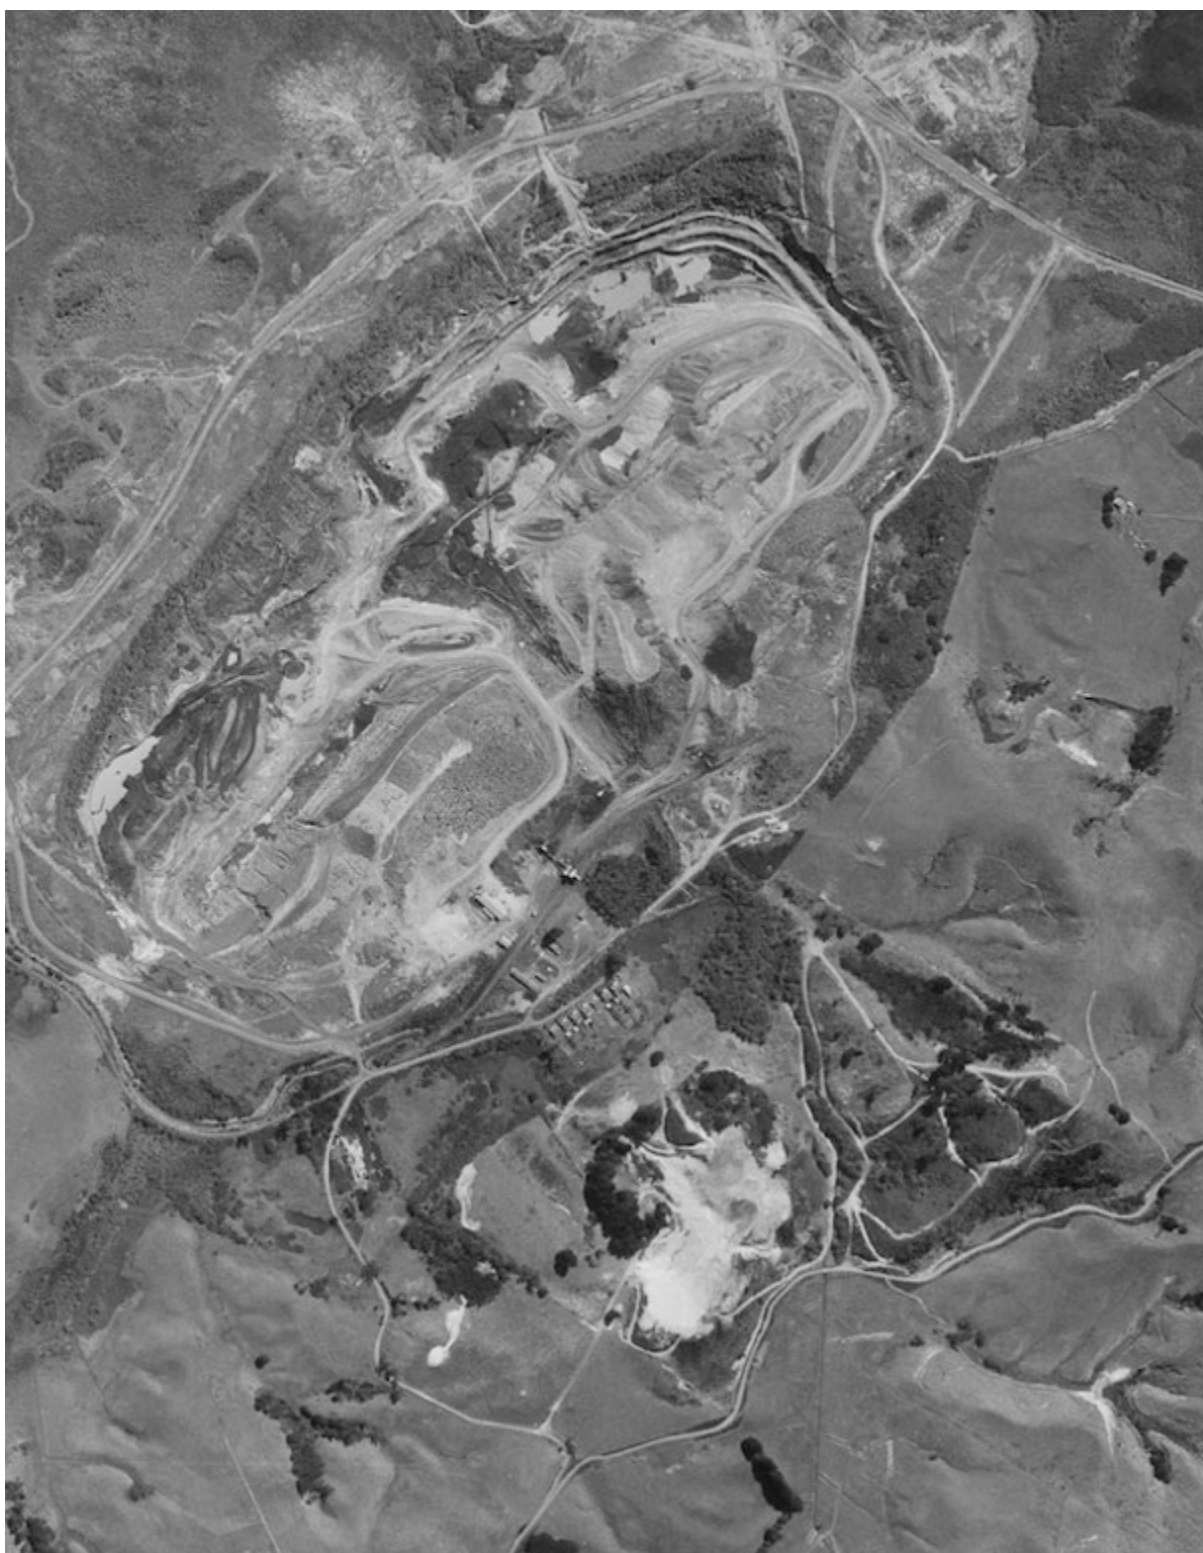
3.1.2.5 The 1973 reproduction (SK05) shows similar conditions to the 1969 reproduction. A small amount of water ponding is visible in the pit in the south and north. The strip of vegetation to the west and north of the pit appears to have increased in size.

- 3.1.5.5 The 1974 reproduction (SK05) shows similar conditions to the 1967 reproduction. All buildings and structures are no longer present. The excavation area has increased in size.

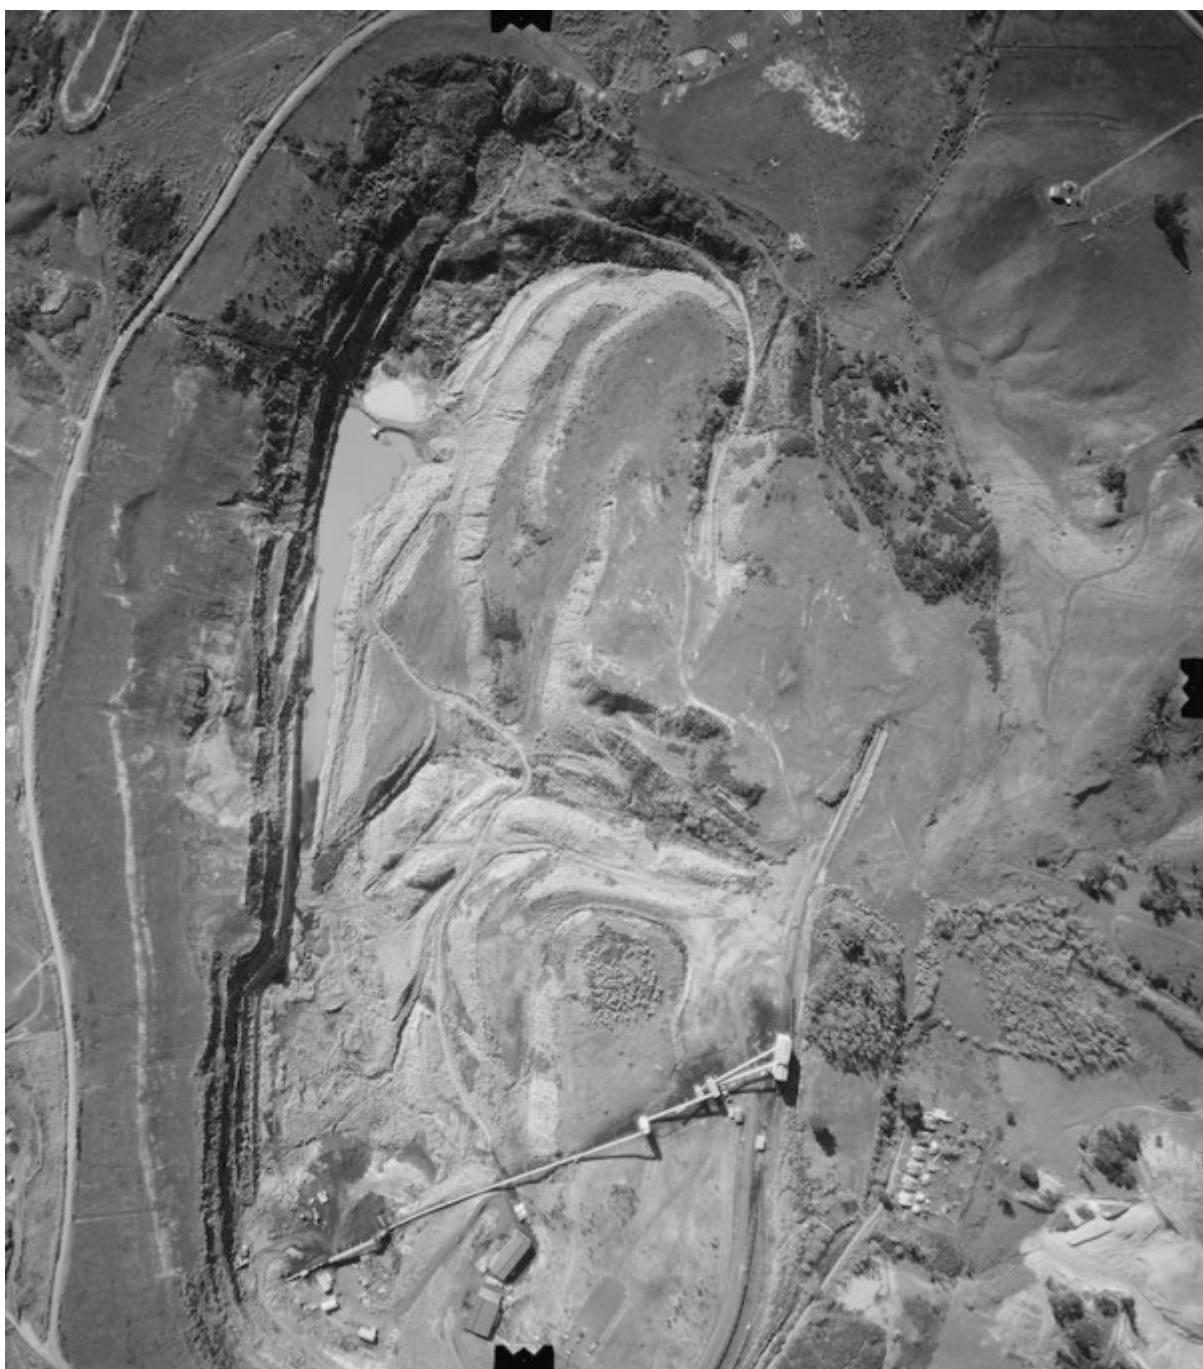
- 3.1.3.7 The 1984 reproduction (SK07) only shows the central and northern parts of the site, which documents similar condition to the 1979 reproduction. The road terminates at the eastern end of the village. Pastoral land is now present in the north. The circular object to the south of the village is clearly visible.

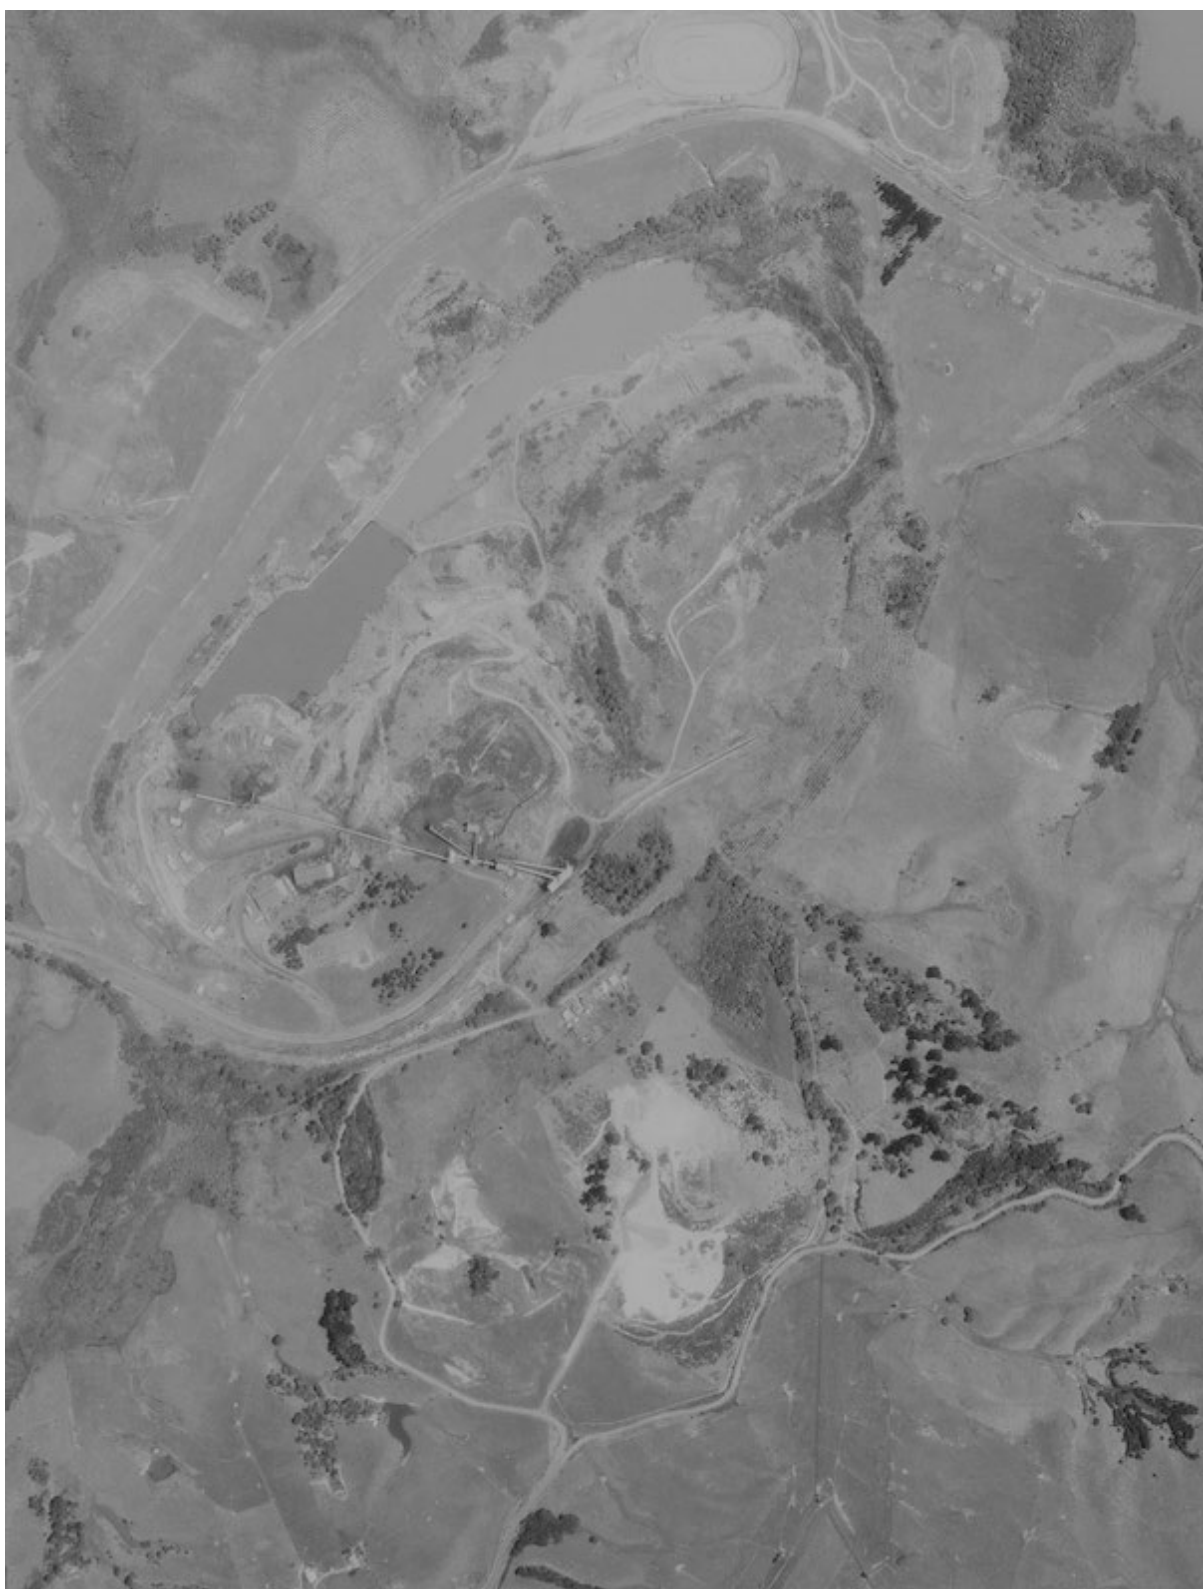
3.1.2.8 The 1991 reproduction (SK08) shows similar conditions to the 1984 reproduction. Water ponding is present over the entire floor of the pit commencing to the north of the working pit. A small area of excavation is present in the northeast.

- 3.1.3.8 The 1991 reproduction (SK08) shows similar conditions to the 1979 and 1988 reproduction. The central north and northern parts of the site are now planted with rows of trees. The central west and west is pastoral land except for the land around watercourses which, is heavily vegetated.

- 3.1.5.6 The 1979 reproduction (SK06) shows similar conditions to the 1974 reproduction.
- 3.1.5.7 The 1991 reproduction (SK08) shows the site as predominately pastoral. Pockets of trees are present in the centre both sides of the road. Excavations in the centre and northeast. Vegetation is present around the excavations in the northeast. Bush is present in the west around the pond. No structures are present.

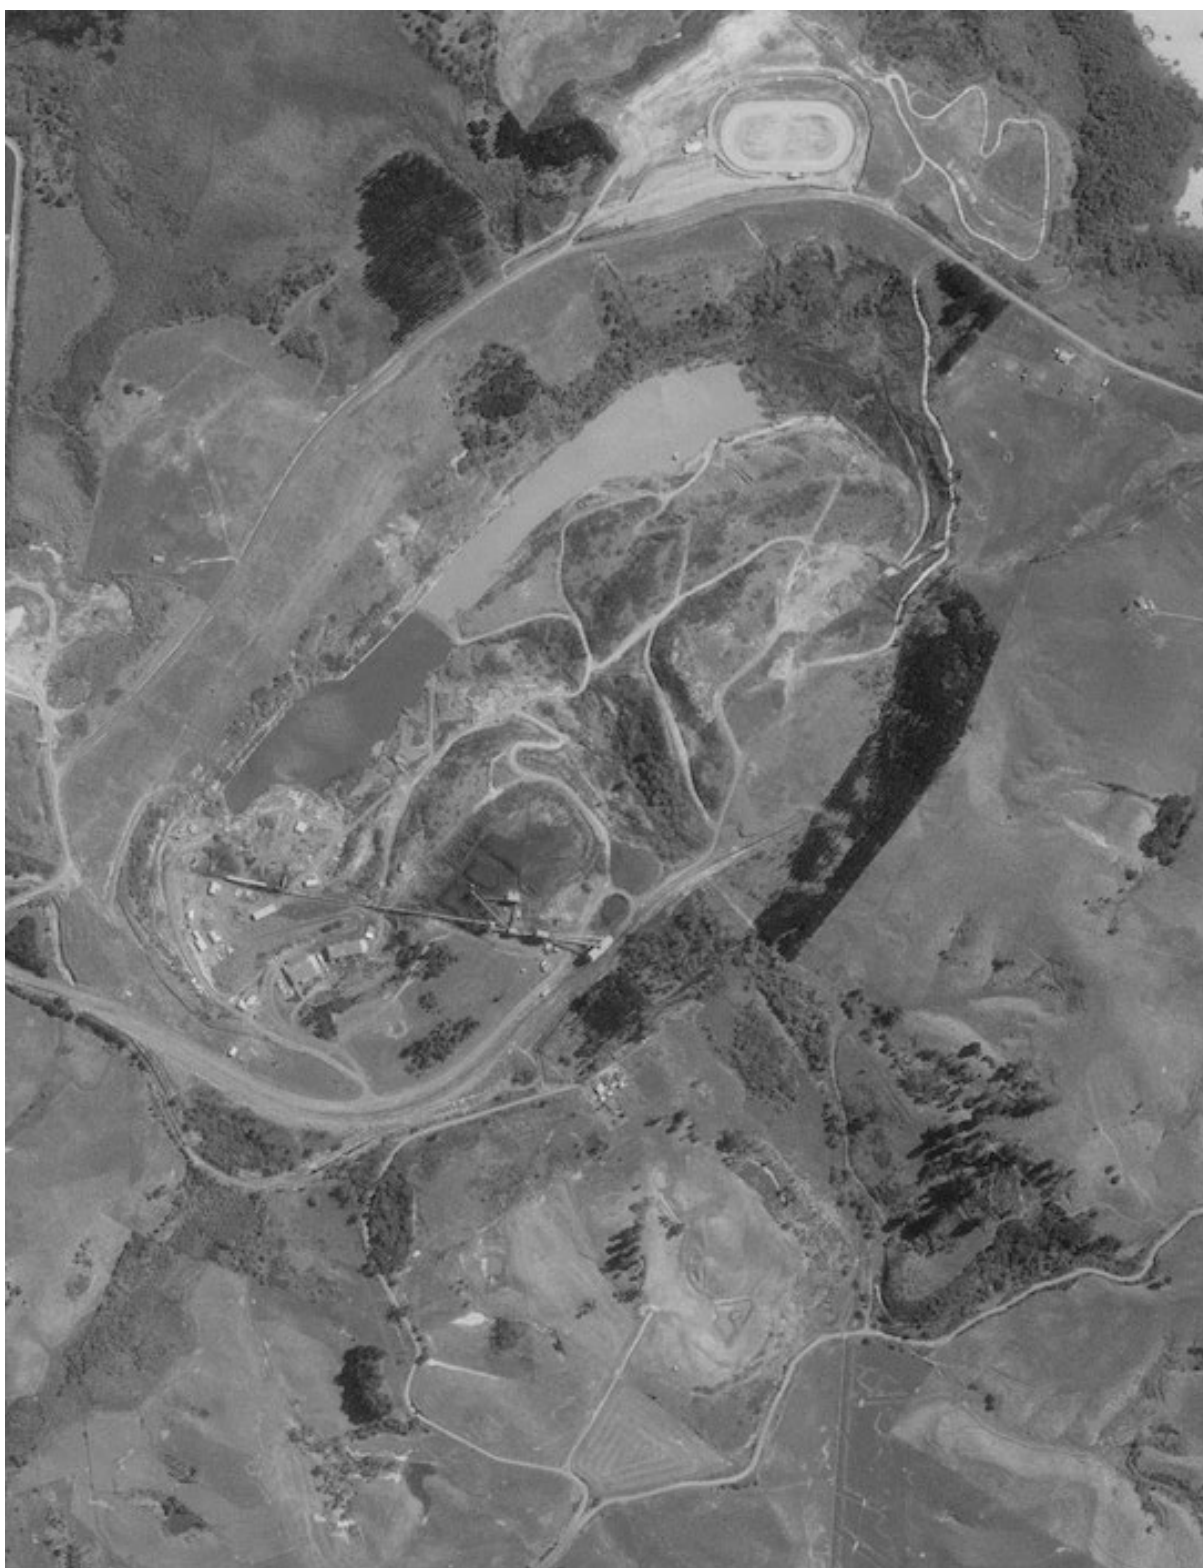
- 3.1.2.9 The 1995 reproduction (SK09) shows similar conditions to the 1984 reproduction. Water ponding is present over the entire floor of the pit. The number of structures visible in the working pit around the conveyor has increased.

- 3.1.4.9 The 1995 reproduction (SK09) shows similar conditions to the 1991 reproduction. The excavations in the south is now pastoral and the structure has been removed.

- 3.1.5.8 The 1995 reproduction (SK09) shows similar conditions to the 1991 reproduction. The excavation areas in the centre and southeast are now pastoral or in the process of becoming pastoral.

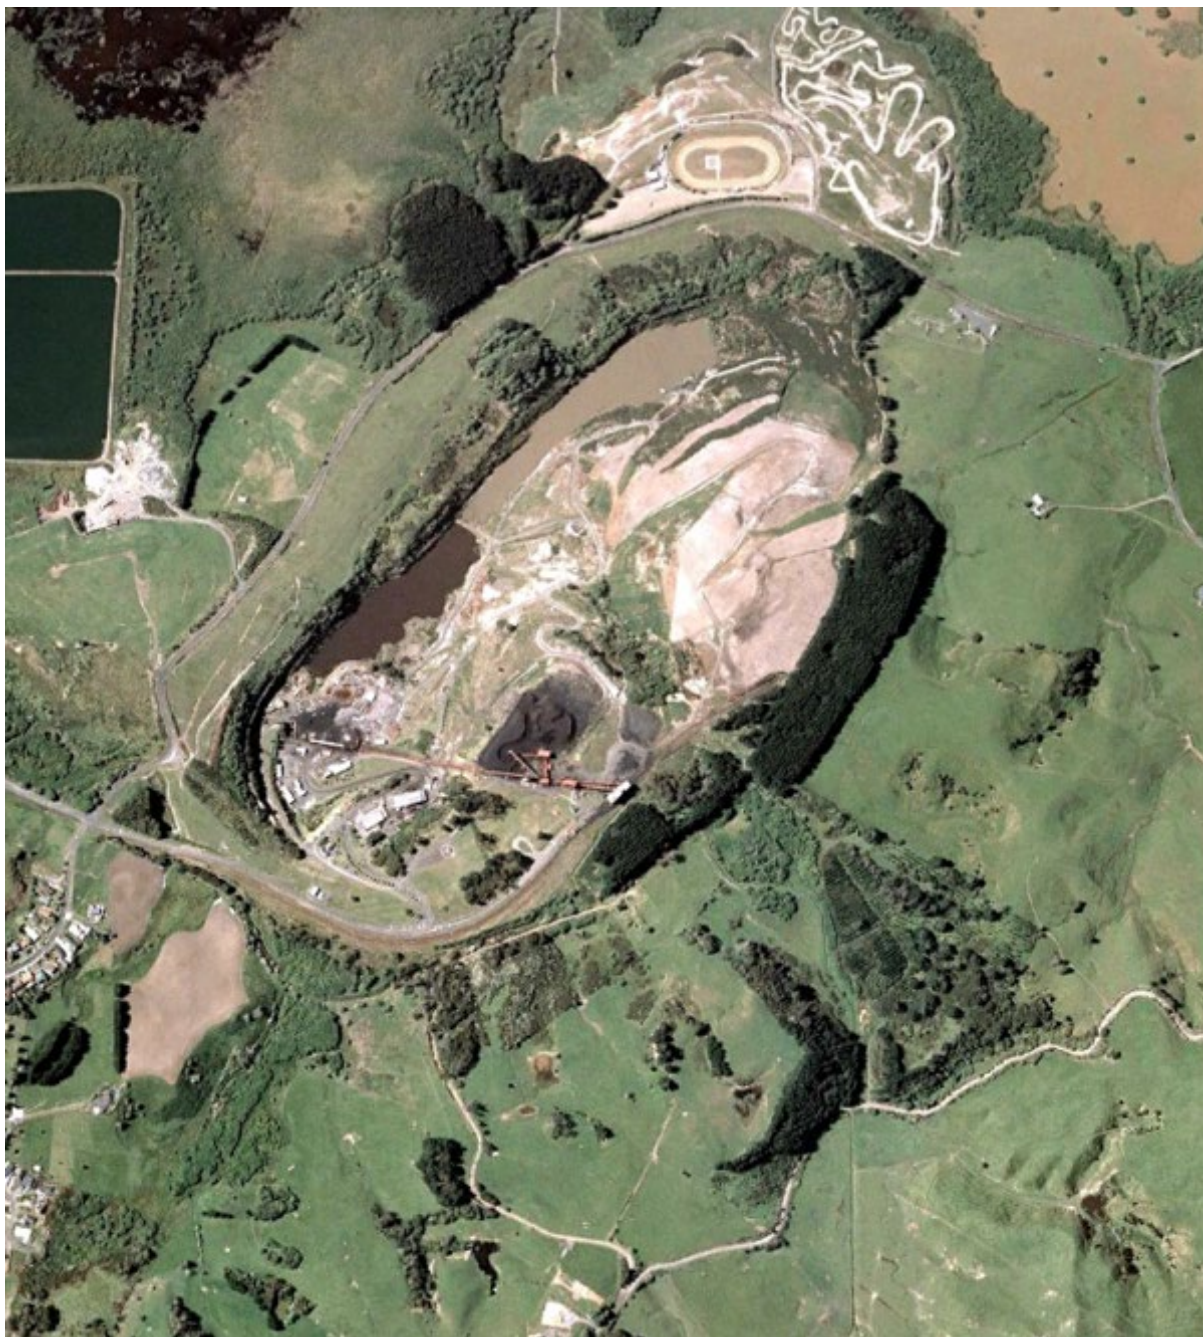
- 3.1.2.10 The 2008 reproduction (SK10) shows similar conditions to the 1984 reproduction. Coal is clearly visible at the bottom of the pit around the conveyor and at the top of the pit around the conveyor.

- 3.1.4.10 The 2008 reproduction (SK10) shows similar conditions to the 1995 reproduction. The amount of vegetation in the centre and central south has increased in area and density.

- 3.1.5.9 The 2008 reproduction (SK10) shows similar conditions to the 1995 reproduction.

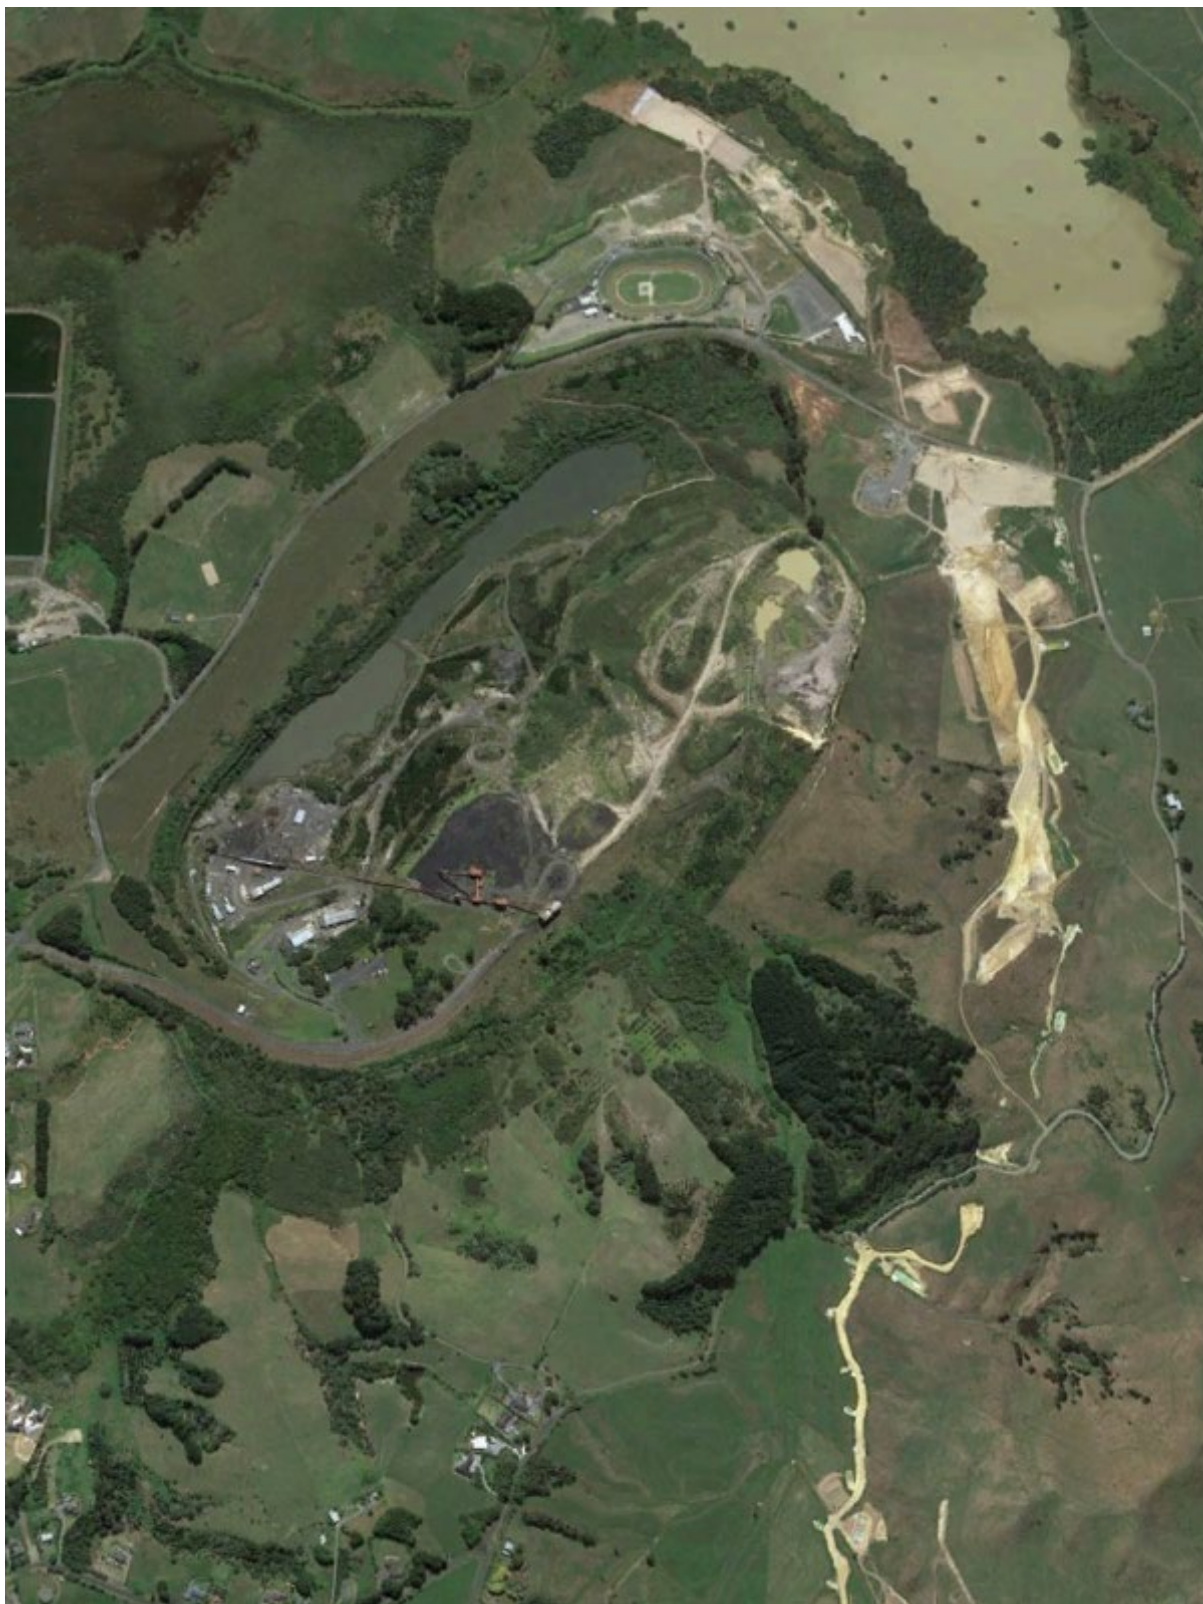
- 3.1.2.11 The 2016 reproduction (SK11) shows similar conditions to the 2004 reproduction. Water ponding is also visible in the northeast.
- 3.1.2.12 The 2019 reproduction (SK12) shows all buildings removed from the site except for a building in the central east. However, all the concrete pads associated with the buildings and other mining activities remain. The railway line in the south and east of the site has also been removed. Coal remains are still visible in the east of the site. The water level in the pit has risen and in the smaller pit in the northeast. The amount of vegetation around the pit in the west, north and east has increased. Bare land is present in the east and north east. The amount of vegetation to the south of the road in the south has also increased.

- 3.1.3.11 The 2016 reproduction (SK11) shows the conveyor in the north has been removed with only the concrete pad and railway line remaining. The reminder of the site documents similar conditions to the 2008 reproduction.

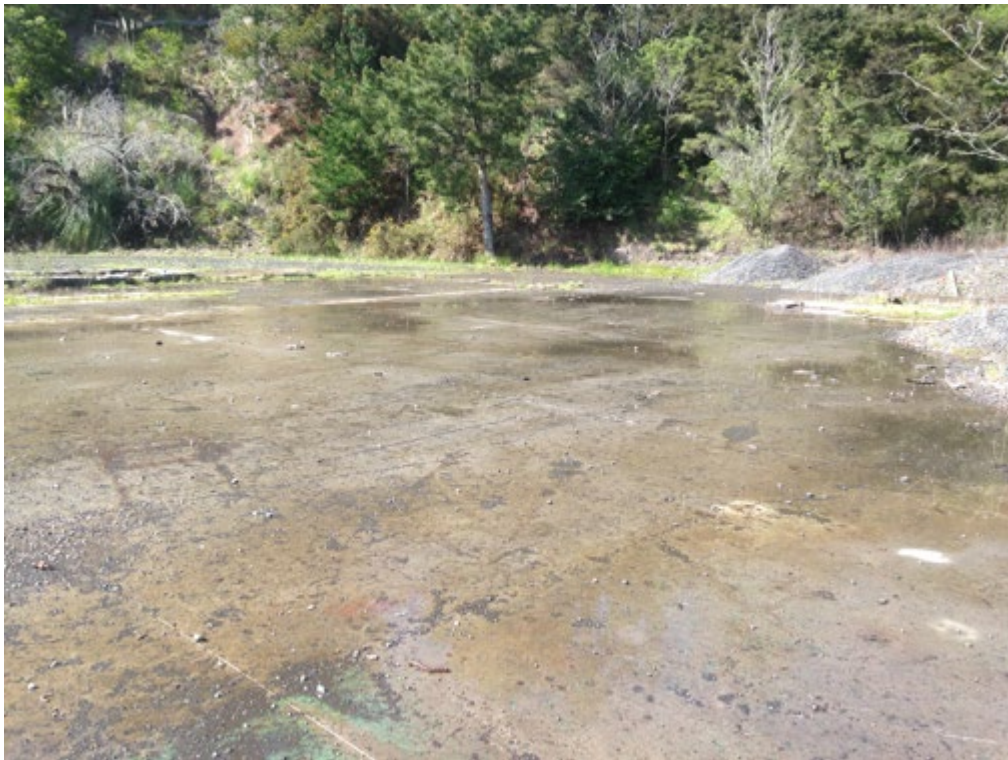
**EX PIT WORKSHOP PAD**

6.1.2.1 The majority of the concrete floor of the SENZ Workshop was covered with broken up concrete. What was visible was marginally cracked and damaged with minimal staining observed. No evidence of the refuelling facility was visible. There was no physical evidence of the older Kimihia Open Pit workshops or potential refuelling facilities on the flat land in the central east.

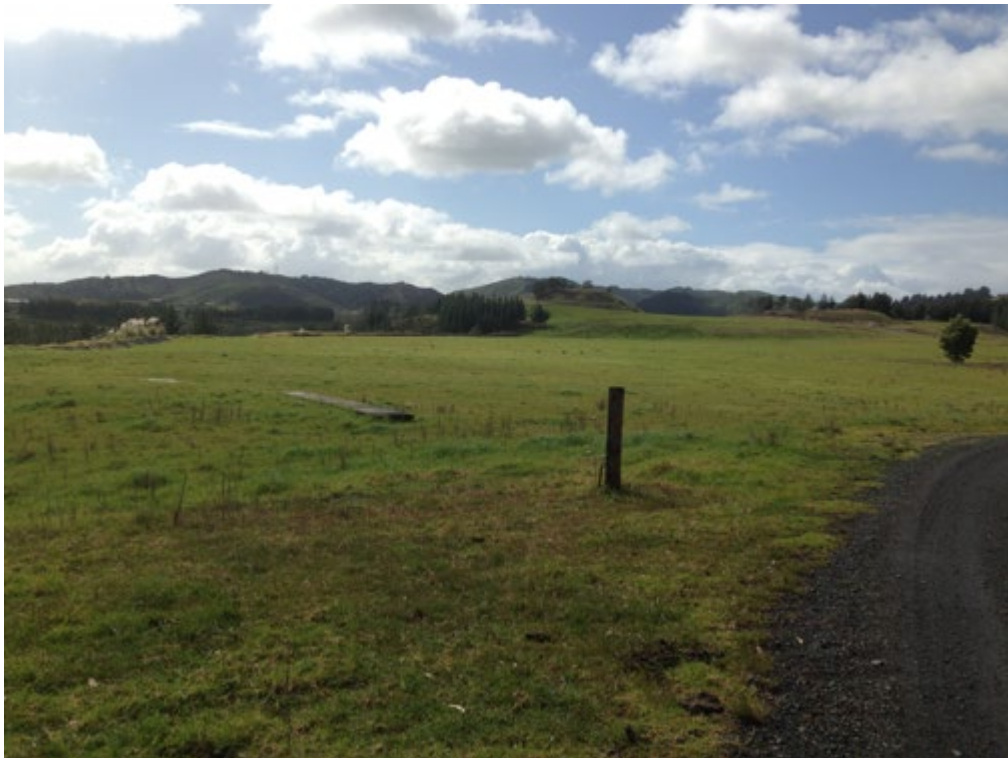
**FLAT LAND ON RIM – EX COAL YARD**

6.1.2.2 There was no obvious evidence that the flat land in the central east had been used to store coal. Only small bits of coal were present on the ground. The concrete pad with railway line for the historical coal loading area was marginally cracked and damaged with no significant staining noted. This area was being used as a service area and storage area for the development of the site. No hazardous substances were noted.

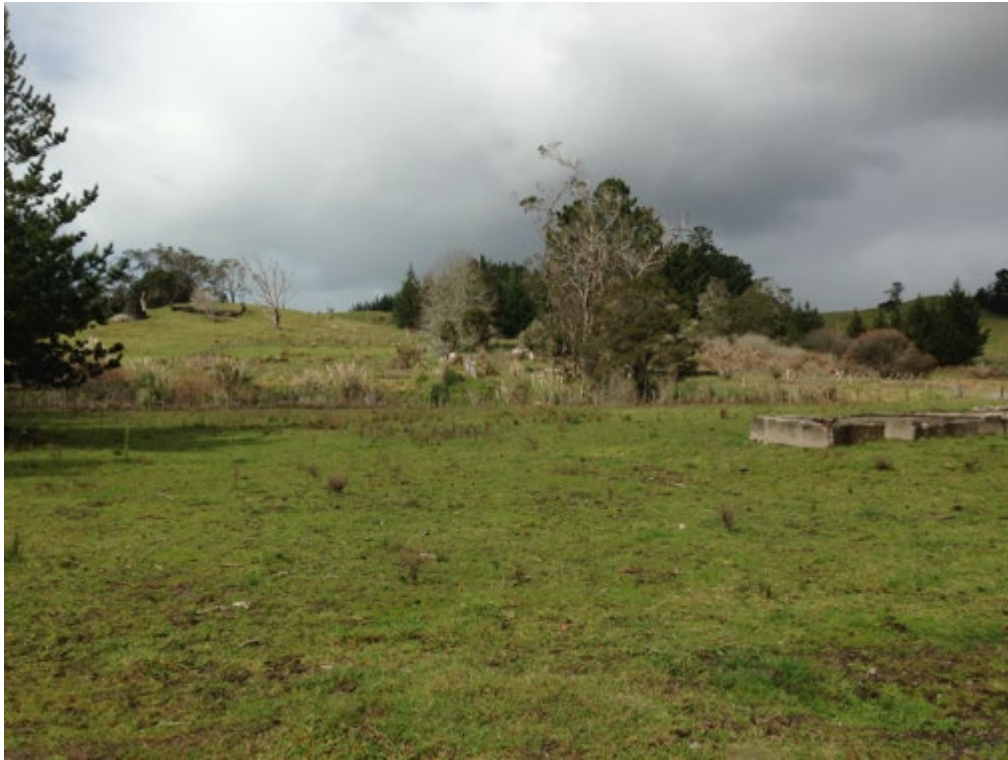
**LOCATION OF HISTORIC VILLAGE**

6.1.2.2 No straining was noted on any of the villages structural remains including the circular object, no asbestos like material was noted on any of these remains and no hummocky land was present to suggest landfilling.

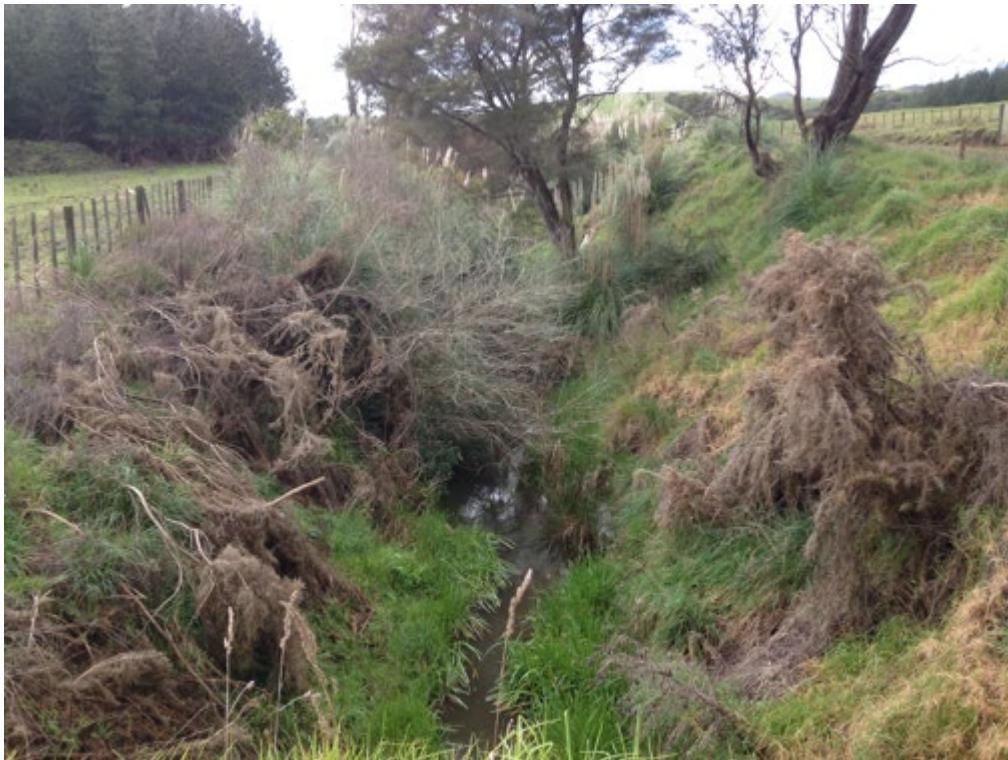
**ON SITE DRAIN**

6.1.2.1. No waste/rubbish was noted in any of the drains or wetlands at this site.
