**Report on hazards following  
mine closure, Huntly East**

**October 2018**

**for  
Waikato District Council**

**Project 1003**

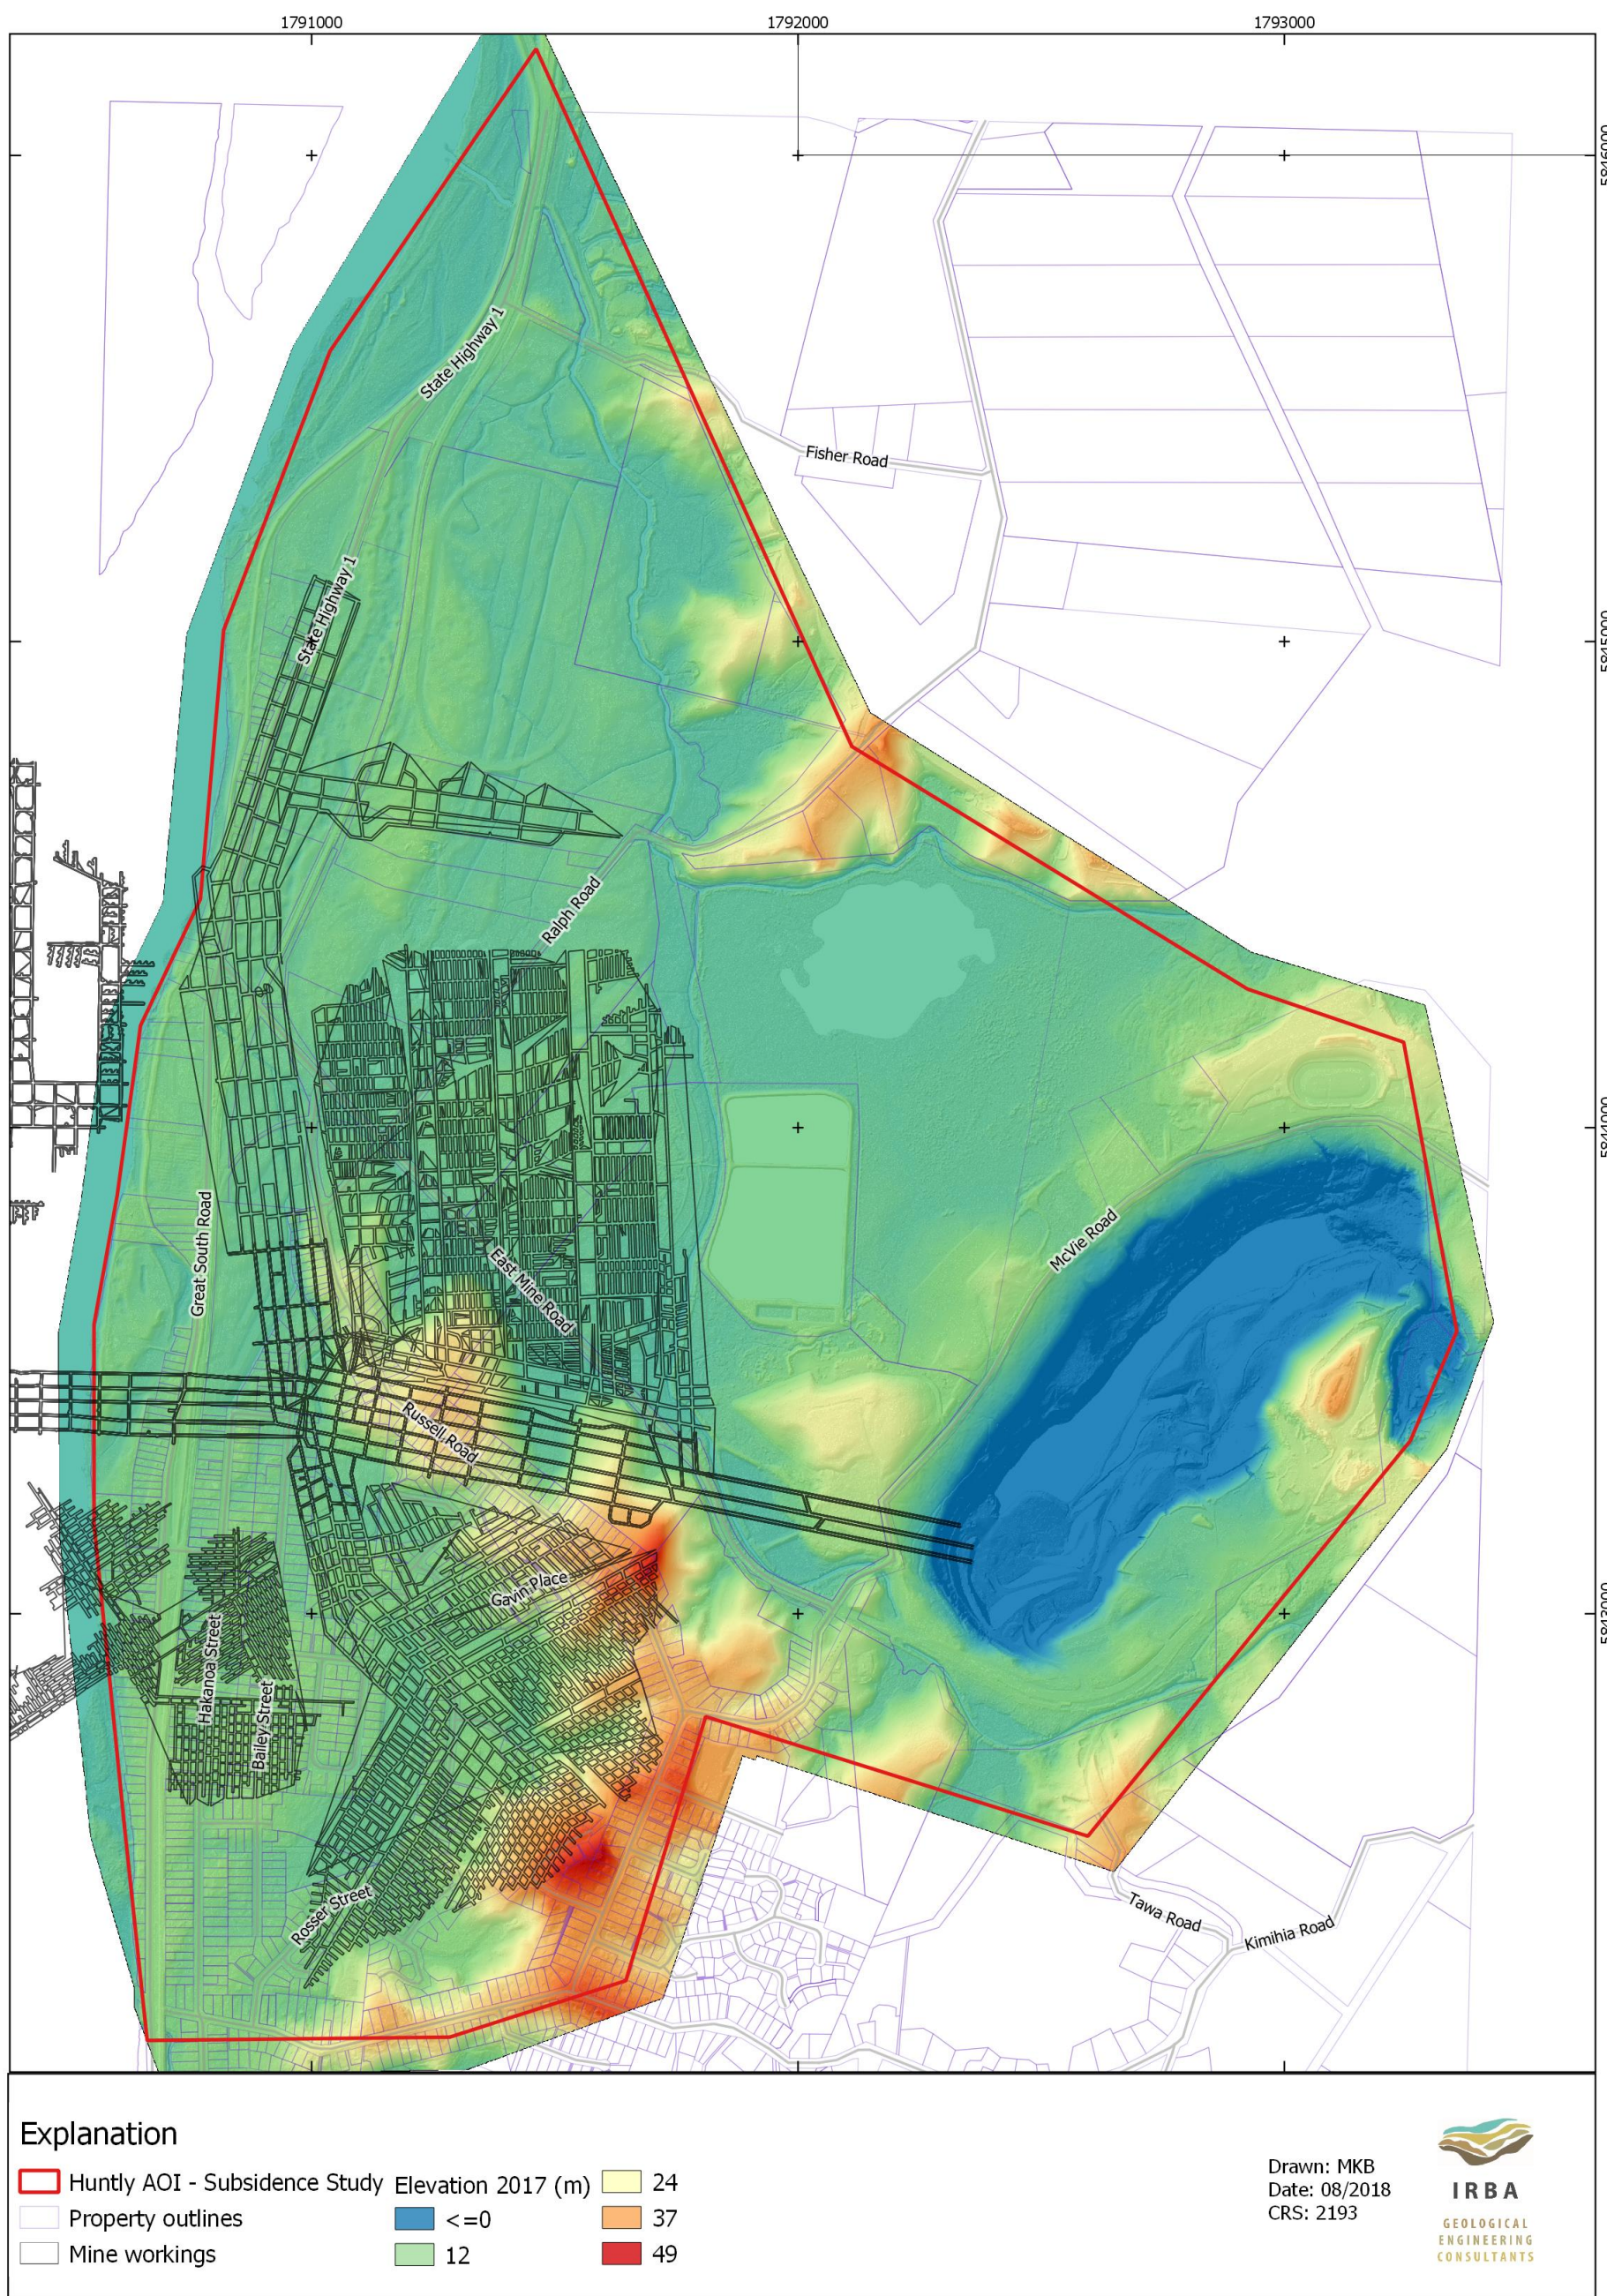
Figure 2 Topography and mine workings

The entrance to Huntly East underground coal mine was established in the highwall of the Kimihia open cast mine by State Coal Mines in 1977. The three main access drives for men and materials, ventilation and conveyor were driven in a westerly direction. Initial extraction of coal was to the south, then to the north of these tunnels. Later, mine development continued to the west and north of the Waikato River (Figure 2).

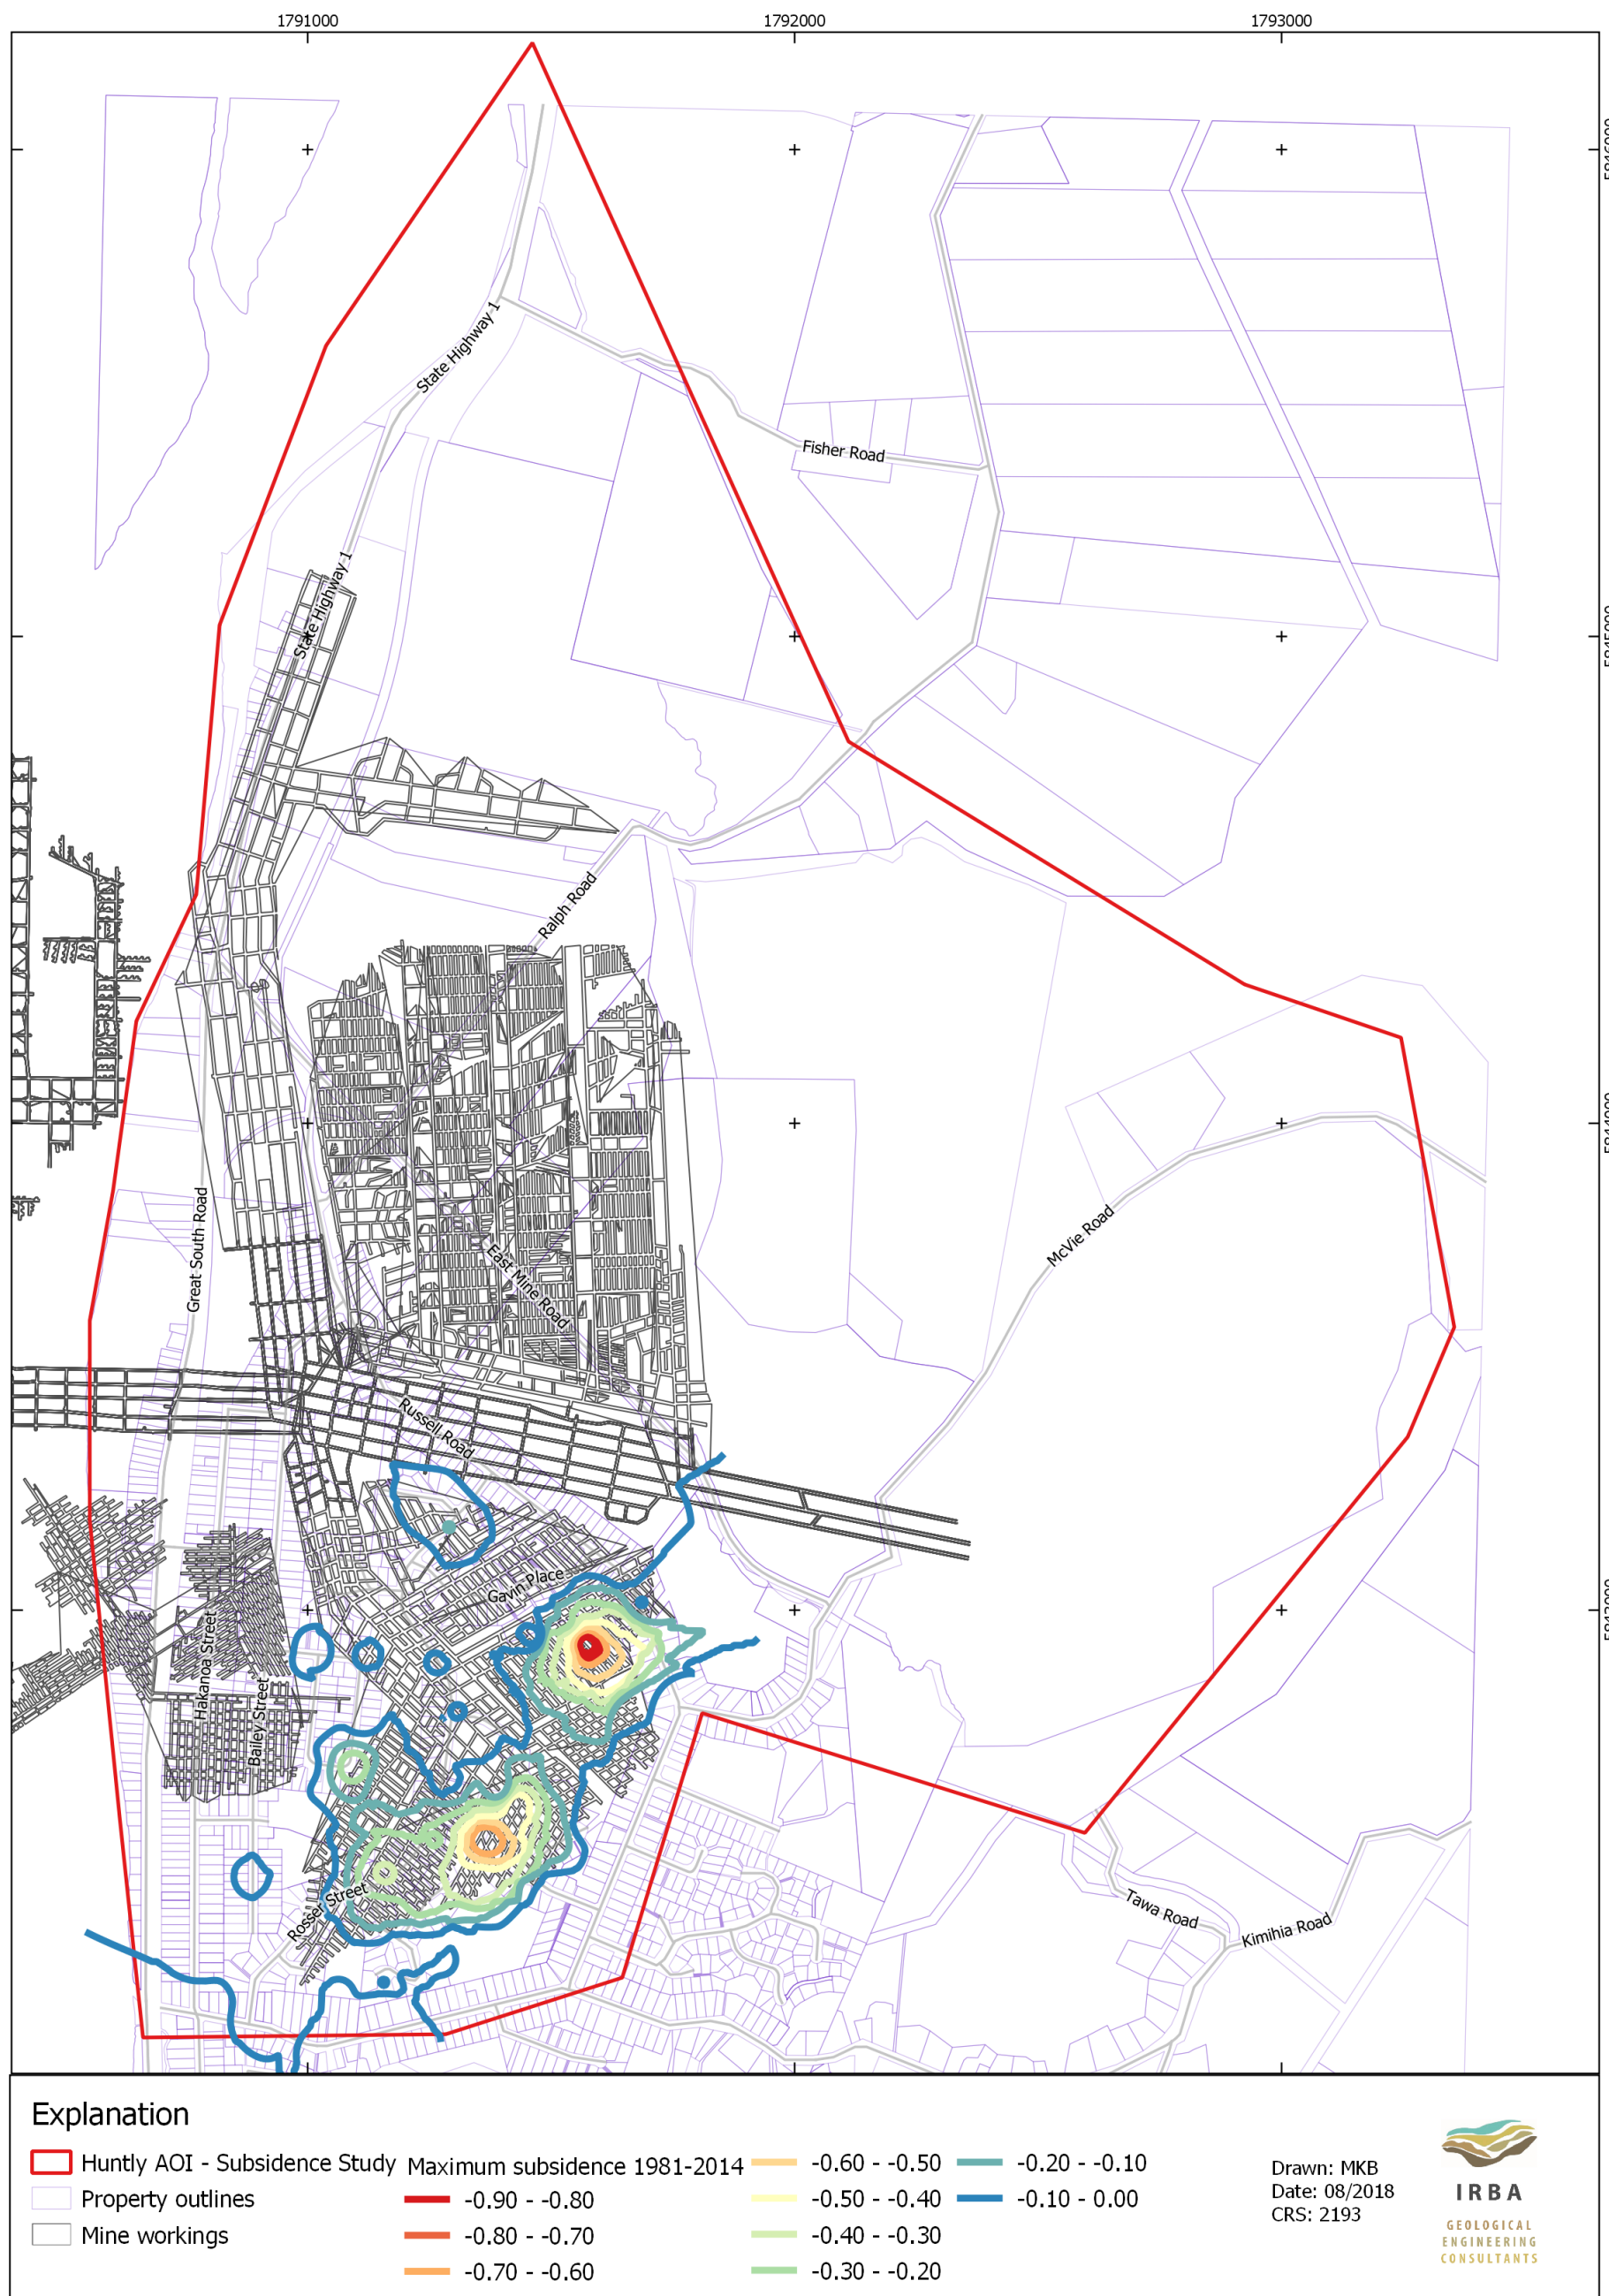
Figure 3 Maximum subsidence 1981 - 2014

The area with greatest measured subsidence is to the south and east of the South Headings (Figure 3). This is where coal was closer to the ground surface, and small pillars were left supporting the workings. Maximum subsidence shown on Figure 3 is about 1 m.

Most of the subsidence occurred soon after mining progressed under the areas that were affected. Our recent survey data gives an indication of subsidence between 2009 and 2014. Although subsidence has continued the rate was low with a maximum of 0.013 m in the 2009 – 2014 period at two bench mark locations.

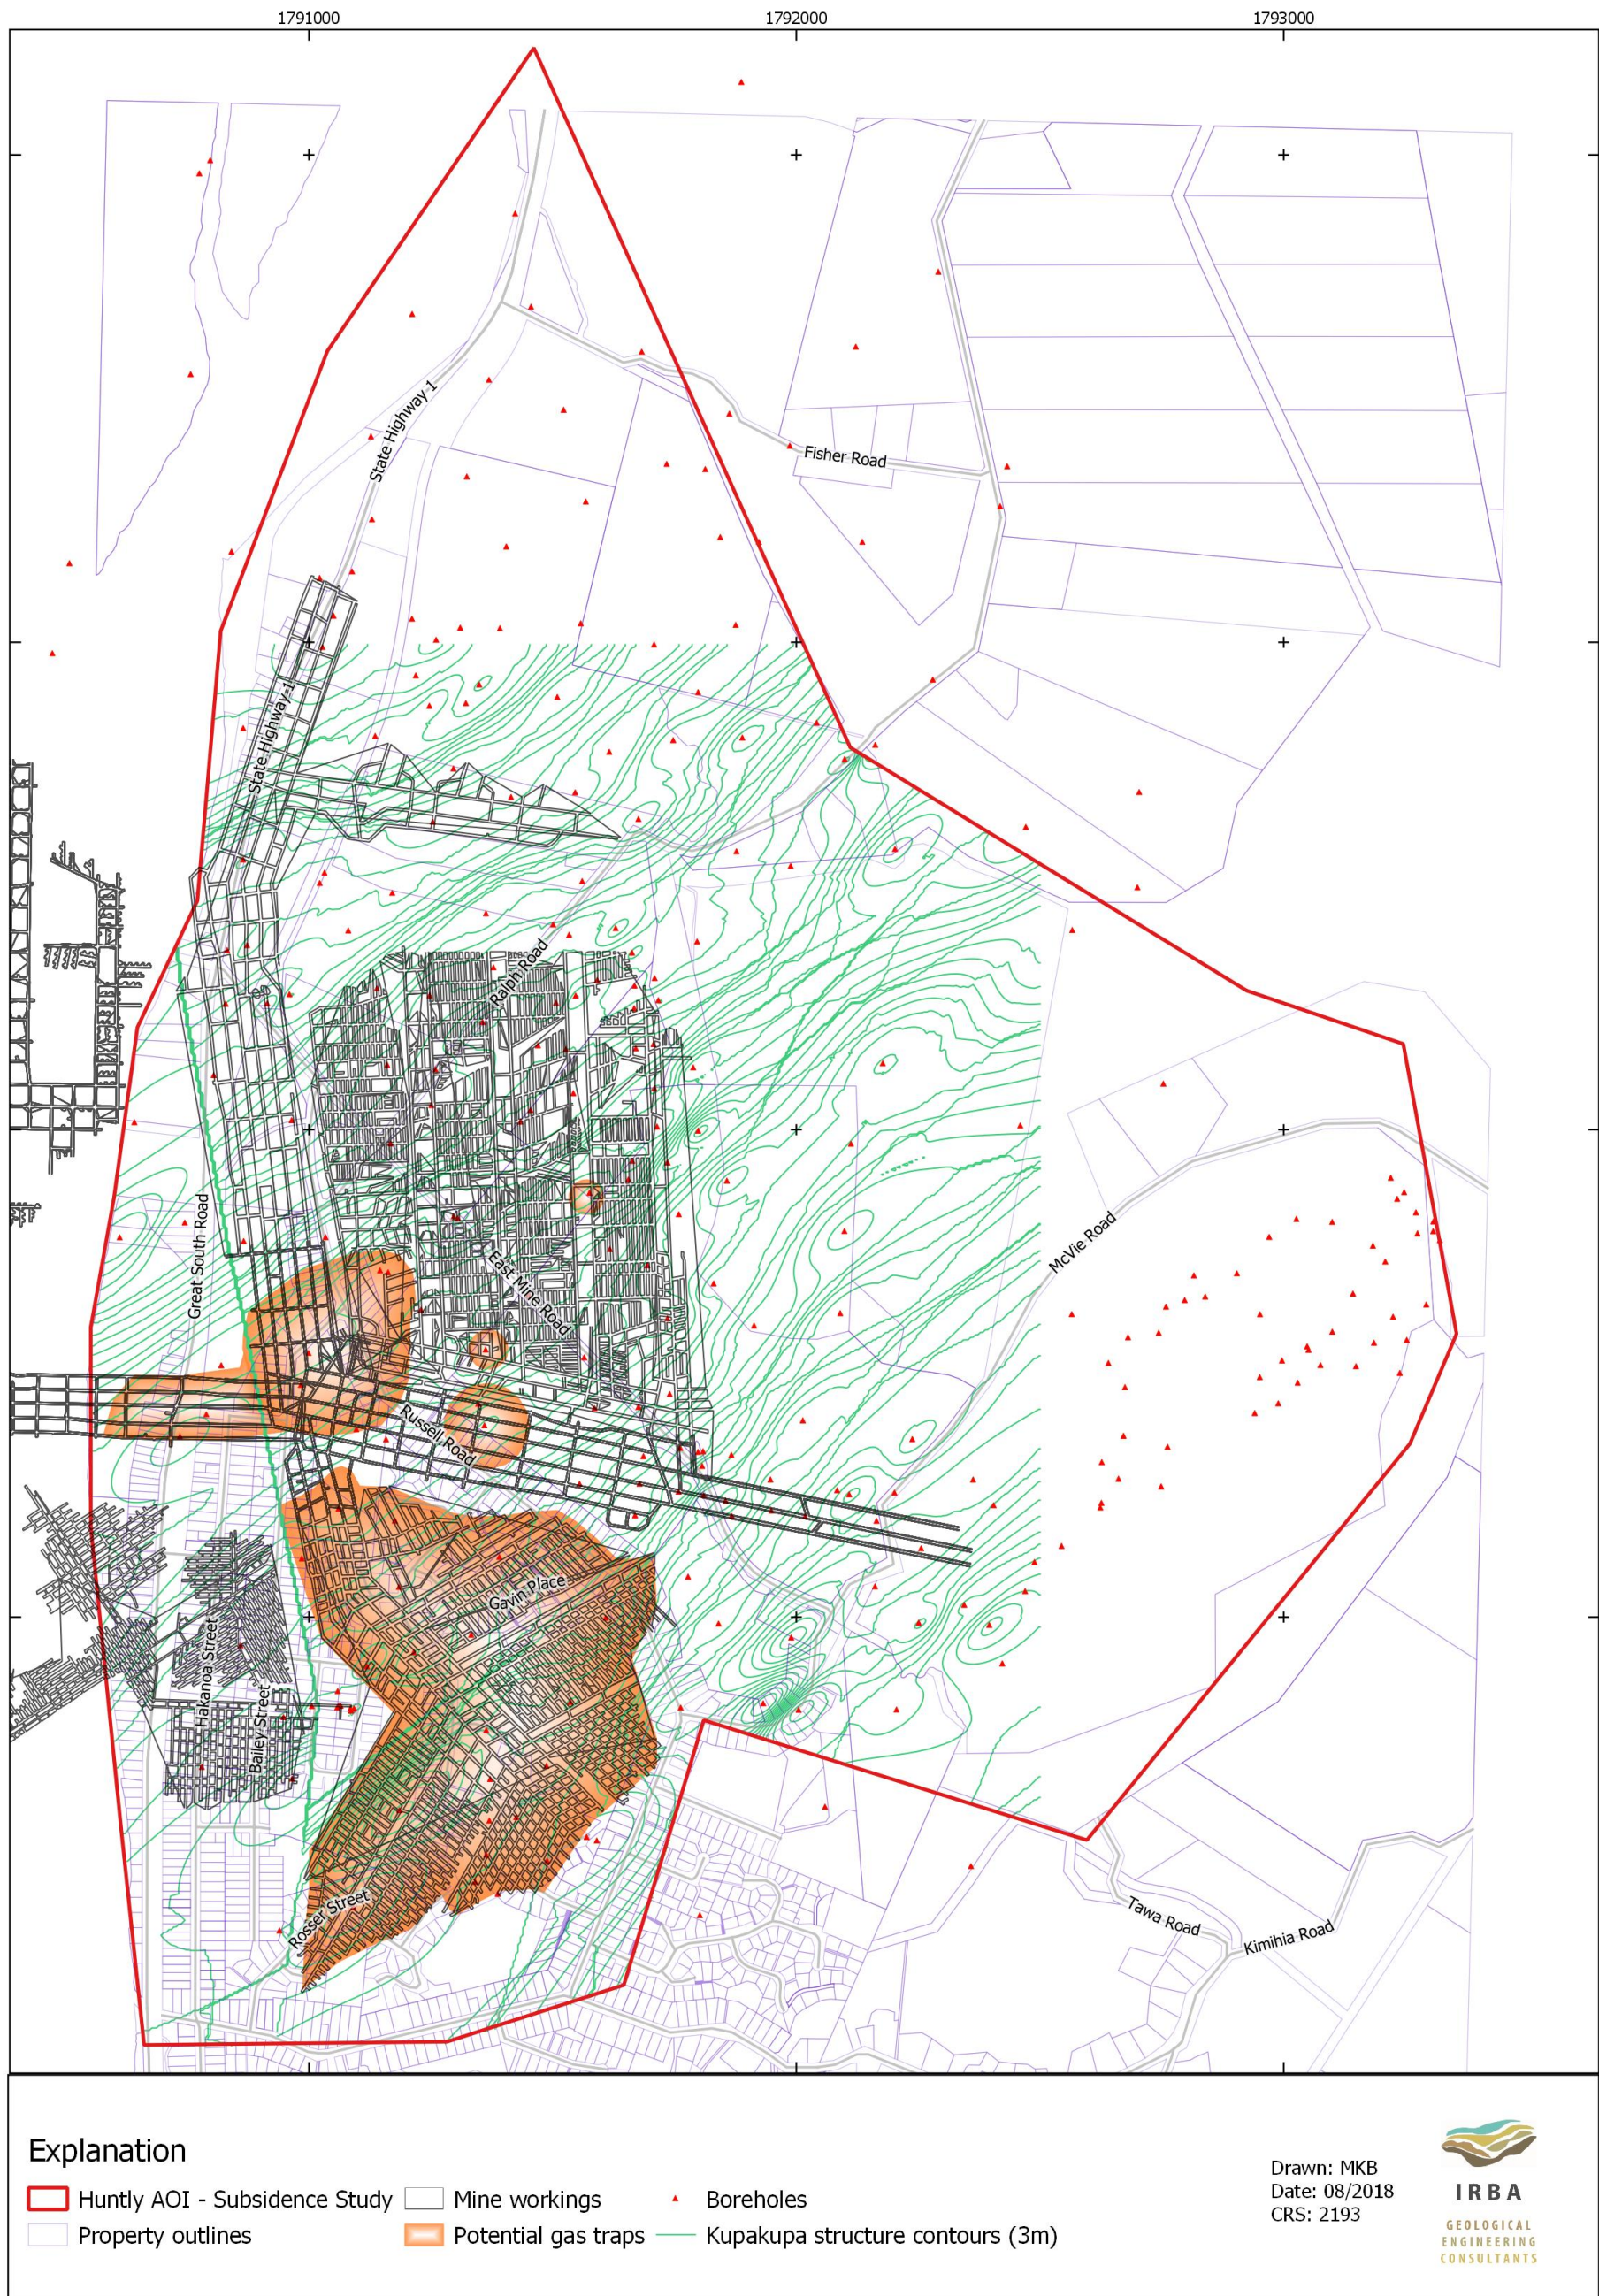
Figure 4 Areas of potential gas trap

We have been able to map out areas of the mine workings where gas can be trapped (Figure 4). This is based on the methodology used to predict where natural gas (and oil) can be found due to the configuration of confining strata. In this case we have used the structural contours on the Kupakupa coal seam floor to show where areas of potential closure are located. In the area of the Southern Headings, once water has built up past the intersection with the main mine entries, the gas in those workings is effectively trapped. This is like a stratigraphic trap in conventional oil and gas.

Once gas is trapped, pressure build up will occur until the seal is breached and gas is able to migrate. We know from previous work that methane has very low solubility at the temperature and pressures we are working with (Christenson, 1999), so it will not be absorbed into the water flooding the workings.

The objective of suppressing spontaneous combustion as part of the mine abandonment appears to have been achieved, based on the recent gas analysis from samples taken at the mine portal. This has resulted in the unintended consequence of allowing the build-up of methane in well-defined traps as water level rises in the mine workings.

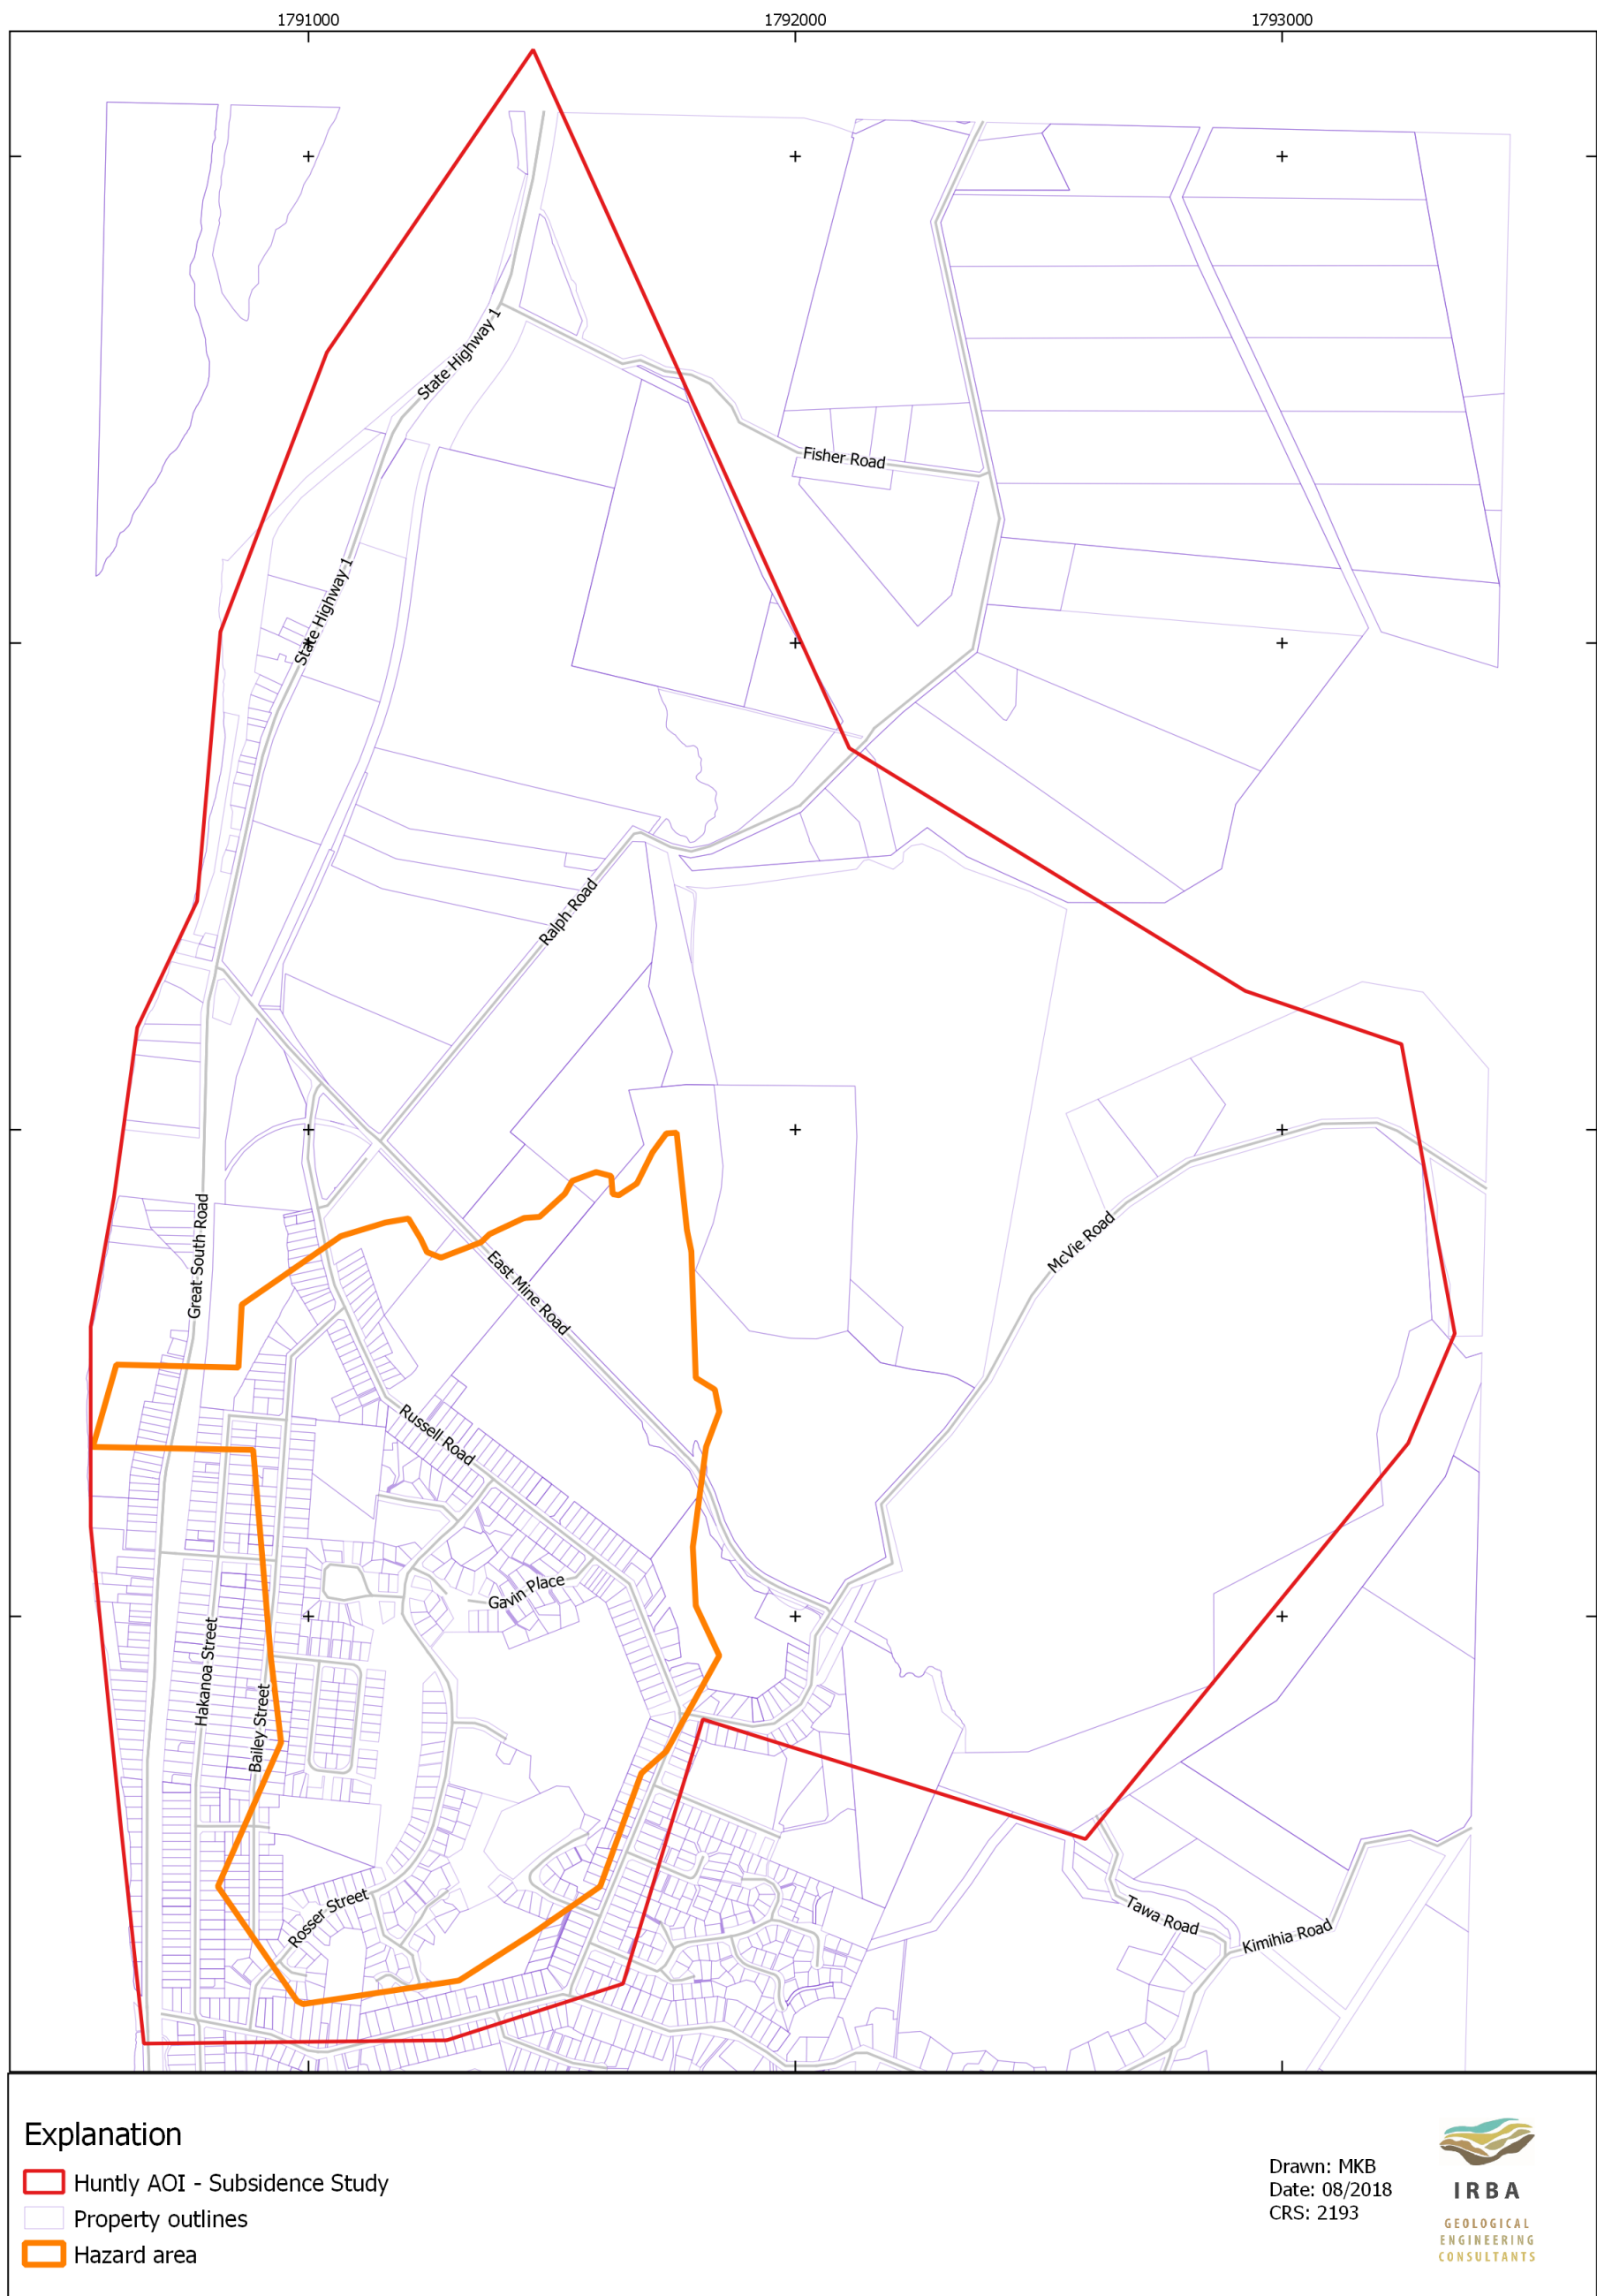
Figure 5 Proposed Hazard Area

We have taken both subsidence and gas hazard into account with our definition of a proposed hazard area (Figure 5). This covers the areas of mine workings that have not filled with water, and the areas where we have shown the presence of a gas trap.

Should Waikato District Council decide to take a precautionary approach to land use in this area, then it would be appropriate to not allow development in this area until all the mine workings have flooded, or mitigation measures have been put in place. However, without appropriate monitoring, it will not be possible to know when that has been achieved.
