**TAMAHERE  
COUNTRY  
CLUB**

**PRELIMINARY  
GEOTECHNICAL  
REPORT**

PROJECT NO: HD2812  
SANDERSON GROUP  
REFERENCE: PCR-1  
01 MAY 2023

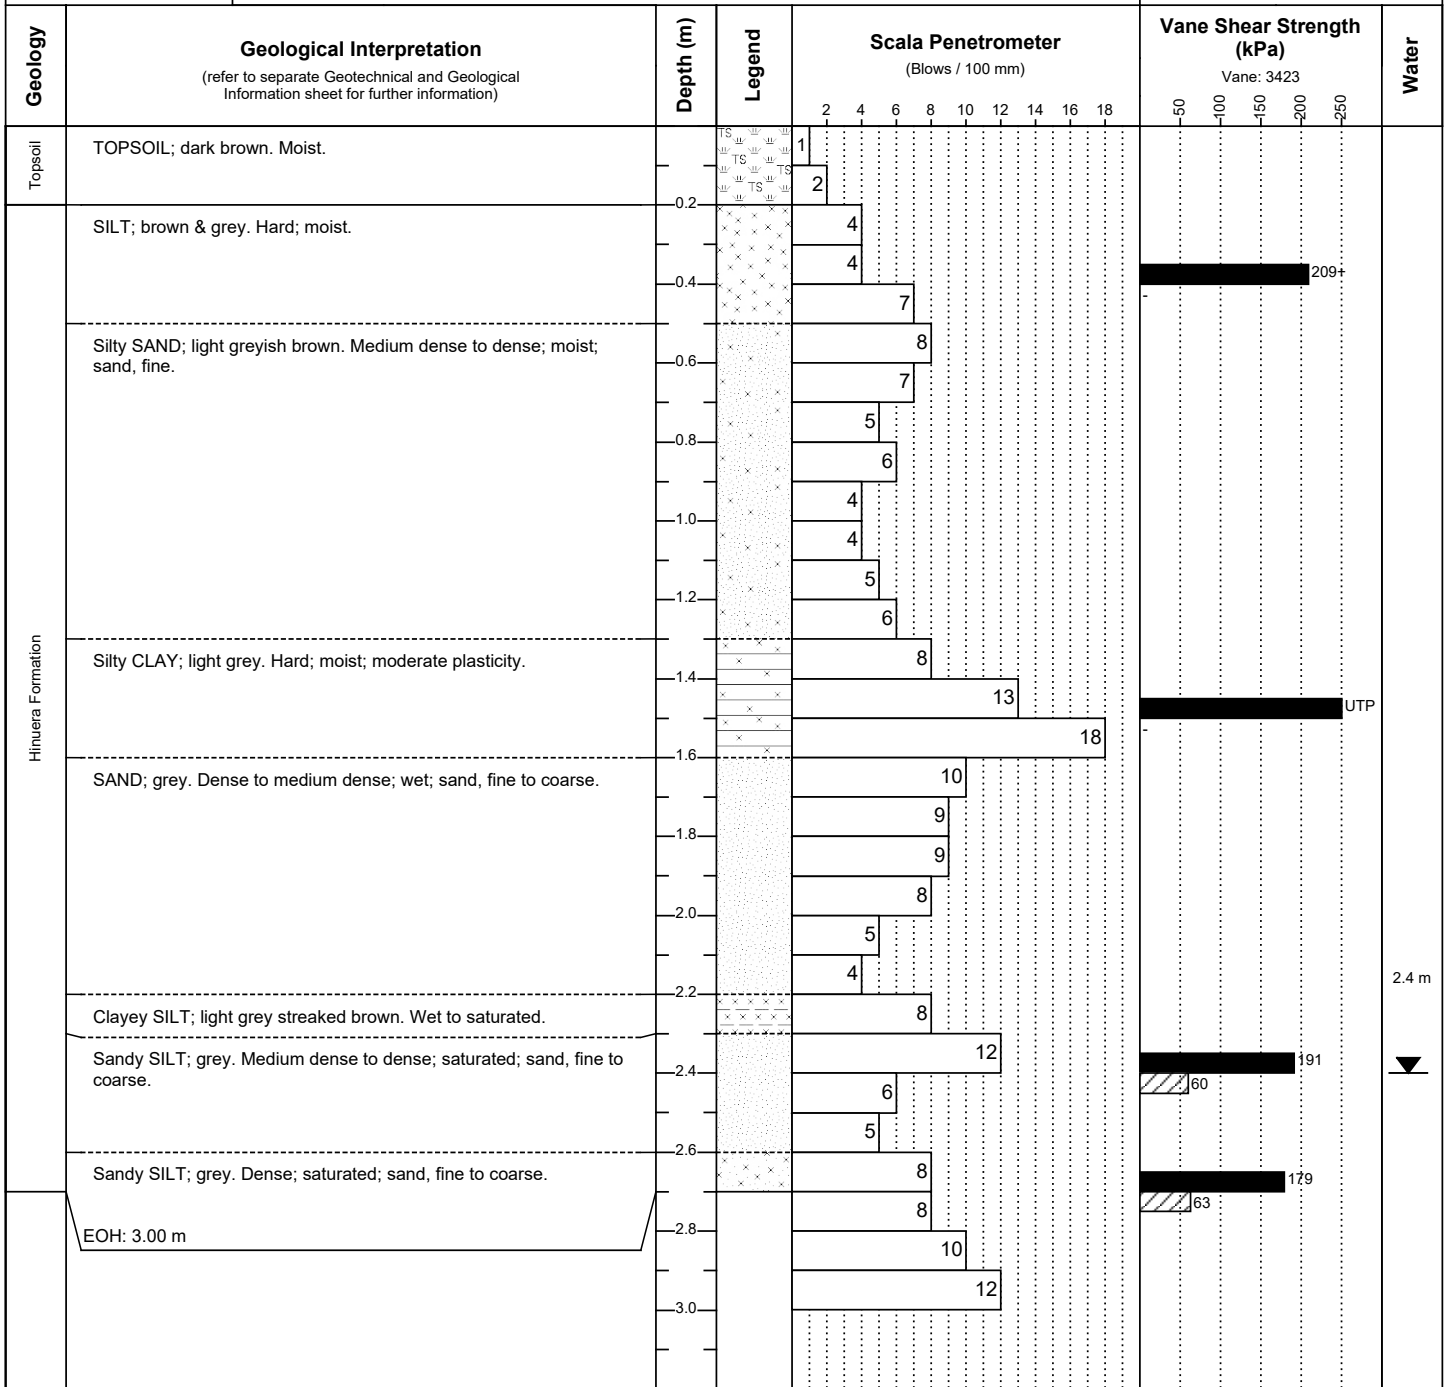
We encountered groundwater within the hand augers at 2.4 m below ground level within HA05. The dynamic pore pressure response within the CPTs indicates that there is perched water within near surface soil layers (top 3 m to 5 m), but consistent response wasn't observed to the depth of testing (43 m).

Given the elevated nature of the site (RL 48) above the gully system (RL 29) to the east, we expect the water we found was perched and global groundwater is deeper. We have used a conservative groundwater level of 3.0 m bgl for our assessment below.

2.4 m

End of log at 2.7m. Could not advance due to hole collapse back to 2.5m.

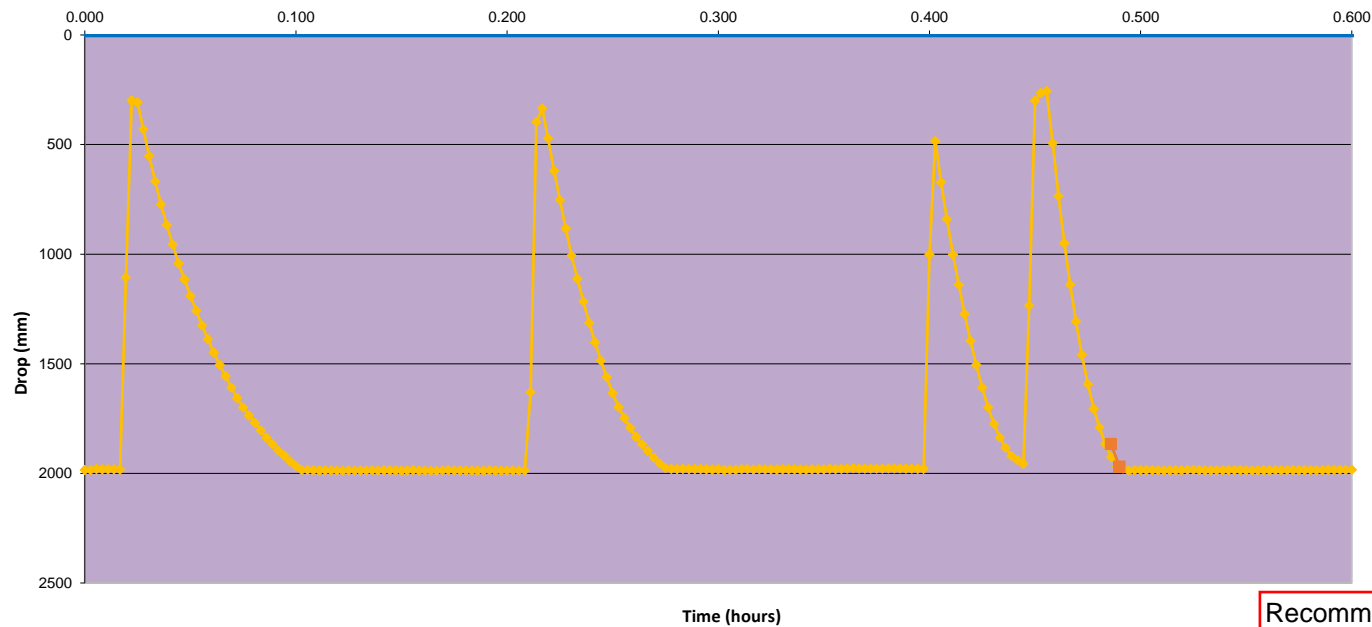
The minimum soakage threshold of 150 mm/hr specified in the RITS manual is achieved for all tests. It is recommended that a design rate of 1500 mm/hr is adopted for ST01.

**Recommended design rate**  
**1500 mm/hr**
