WAIKATO DISTRICT PLAN REVIEW SUBMISSION

SUBMITTER KONING FAMILY TRUST

TOPIC: Extent of residential zoning at Raglan

STATEMENT OF EVIDENCE OF KENNETH JOHN READ

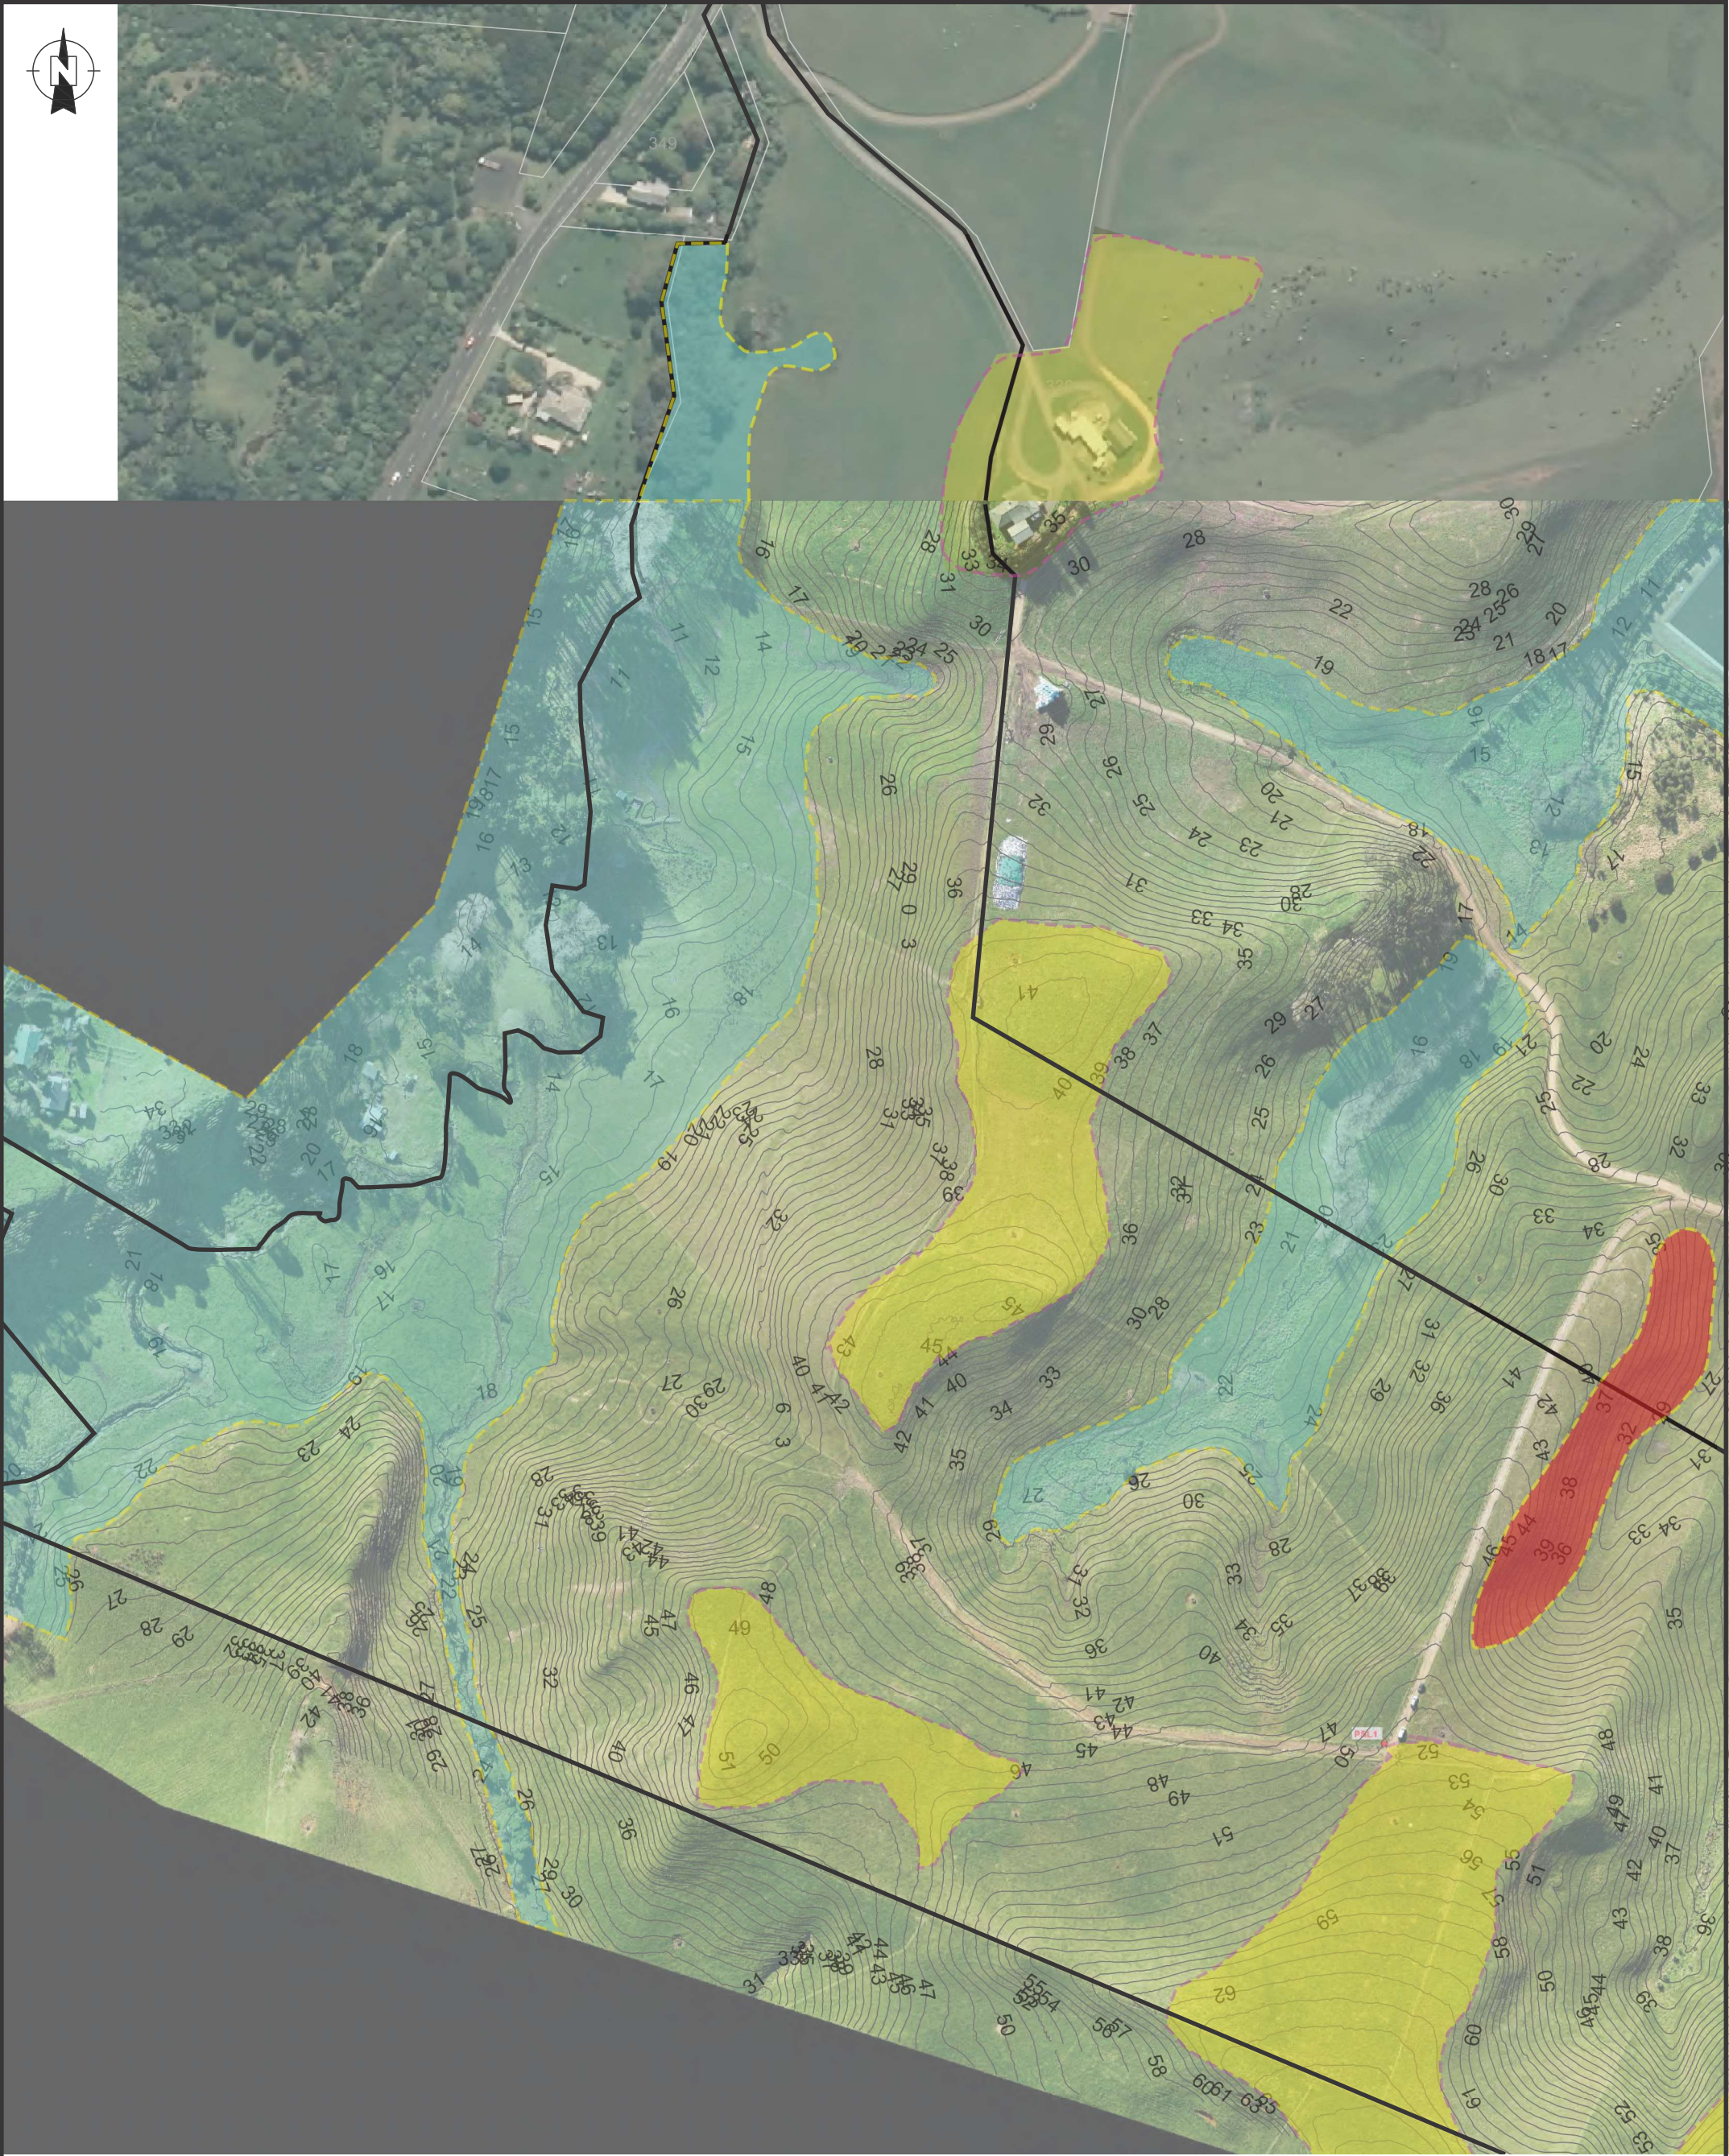
CLIENT:	KONING FAMILY TRUST
PROJECT:	PROPOSED PLAN CHANGE 146 TE HUTEWAI ROAD & 339B WAINUI ROAD, RAGLAN
TITLE:	GEOTECHNICAL HAZARD MAP 1 (WESTERN EXTENT)

20. In my Geotechnical Constraints Mapping report I prepared preliminary zonation maps showing four categories of geotechnical hazard, Low Hazard, Moderate Hazard, High Hazard (soft/wet ground), and High Hazard (slope instability). These are presented on Figures 05, 06 and 07 of that report. Copies of these are appended to my evidence in Appendix A.

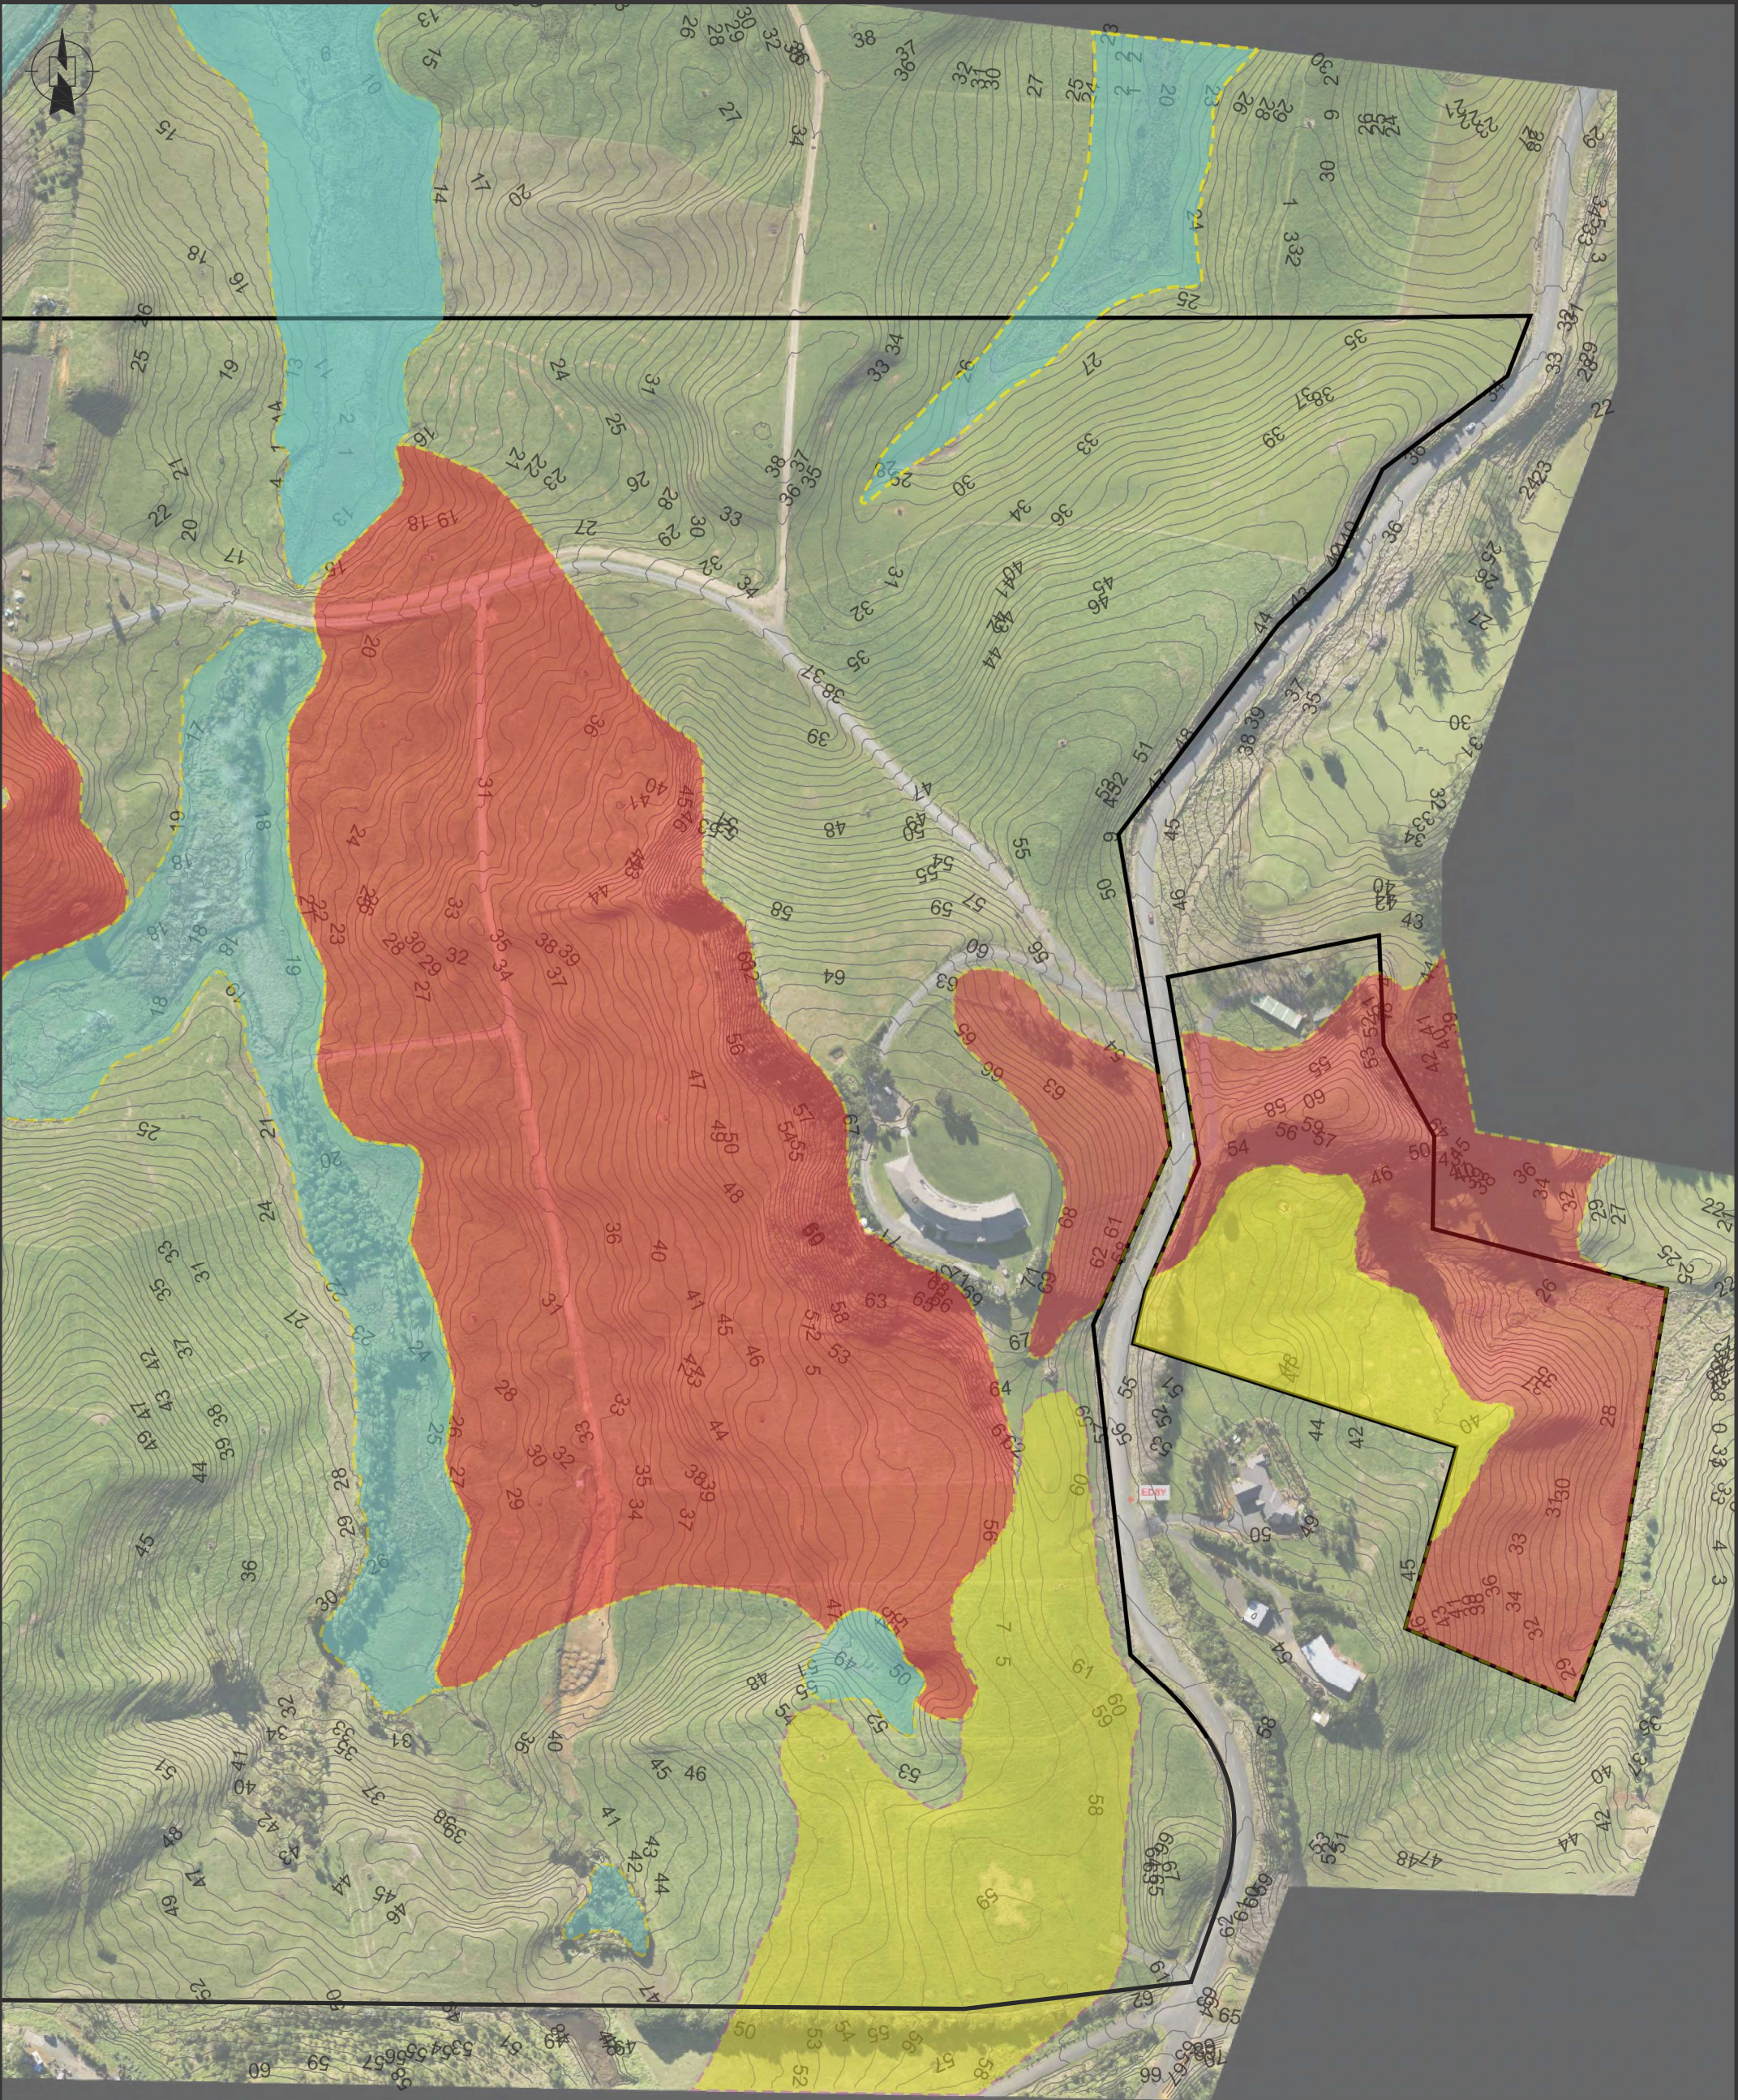
CLIENT:	KONING FAMILY TRUST
PROJECT:	PROPOSED PLAN CHANGE 146 TE HUTEWAI ROAD & 339B WAINUI ROAD, RAGLAN
TITLE:	GEOTECHNICAL HAZARD MAP 3 (EASTERN EXTENT)

22. Of particular concern with respect to the residential development is a large east facing area identified as a 'High Hazard (slope instability)' zone located to the west of Te Hutewai Road. (See Figure 07 in Appendix A.) This area was observed to have a high density of large historic landslips and was considered to show a greater degree of surface deformation than seen elsewhere on the property. Further this slope instability is on a westward slope, whilst all the other comparatively small 'High Hazard (slope instability)' zones are on east or north facing slopes. (See Figures 05, 06 and 07 in Appendix A.) This suggests a possible difference in the geological conditions promoting the observed slope instability.

26. The boreholes encountered stiff to very stiff silts and clays over limestone bedrock. The upper 3.5 to 4.9m of soil is considered to be 'colluvium' derived by slippage and down slope movement. A possible shear plane was observed at 4.9m depth in core from Borehole 2. Colluvium was encountered in the test pits and buried topsoil fragments were also observed in one of the test pits. This confirmed the presence of historic landslips.

27. Borehole 2 located in the northern half of the zone encountered a void within the limestone which was measured to extend a distance of 28m from 15m to 43m below existing ground level.

28. An ERT survey was undertaken to further investigate the nature and extent of possible cavities within the deeper limestone rock. The results of this survey suggest that the limestone rock below this zone is highly fractured, saturated, and may contain some water filled void spaces. No features are observed in the ERT survey results that suggest the presence of a large cavern(s) in the limestone.

29. I consider that there is a strong likelihood that the greater concentration and degree of surface deformation seen over this part of the site (in the form of slips and disturbed ground) may be related to the limestone void features. As such, any remedial works to ensure the integrity of any development within this zone would need to address potential slope stability and settlement risks associated with the limestone bedrock as well as the surface soils. This would require extensive deep ground investigation which still may not fully resolve the level of risk.

30. In my Preliminary Ground Investigation Report, I conclude that the cost of measures to suitably mitigate and resolve the level of risk posed by the voids in the limestone rock would, based on my experience, make development in this area uneconomic.

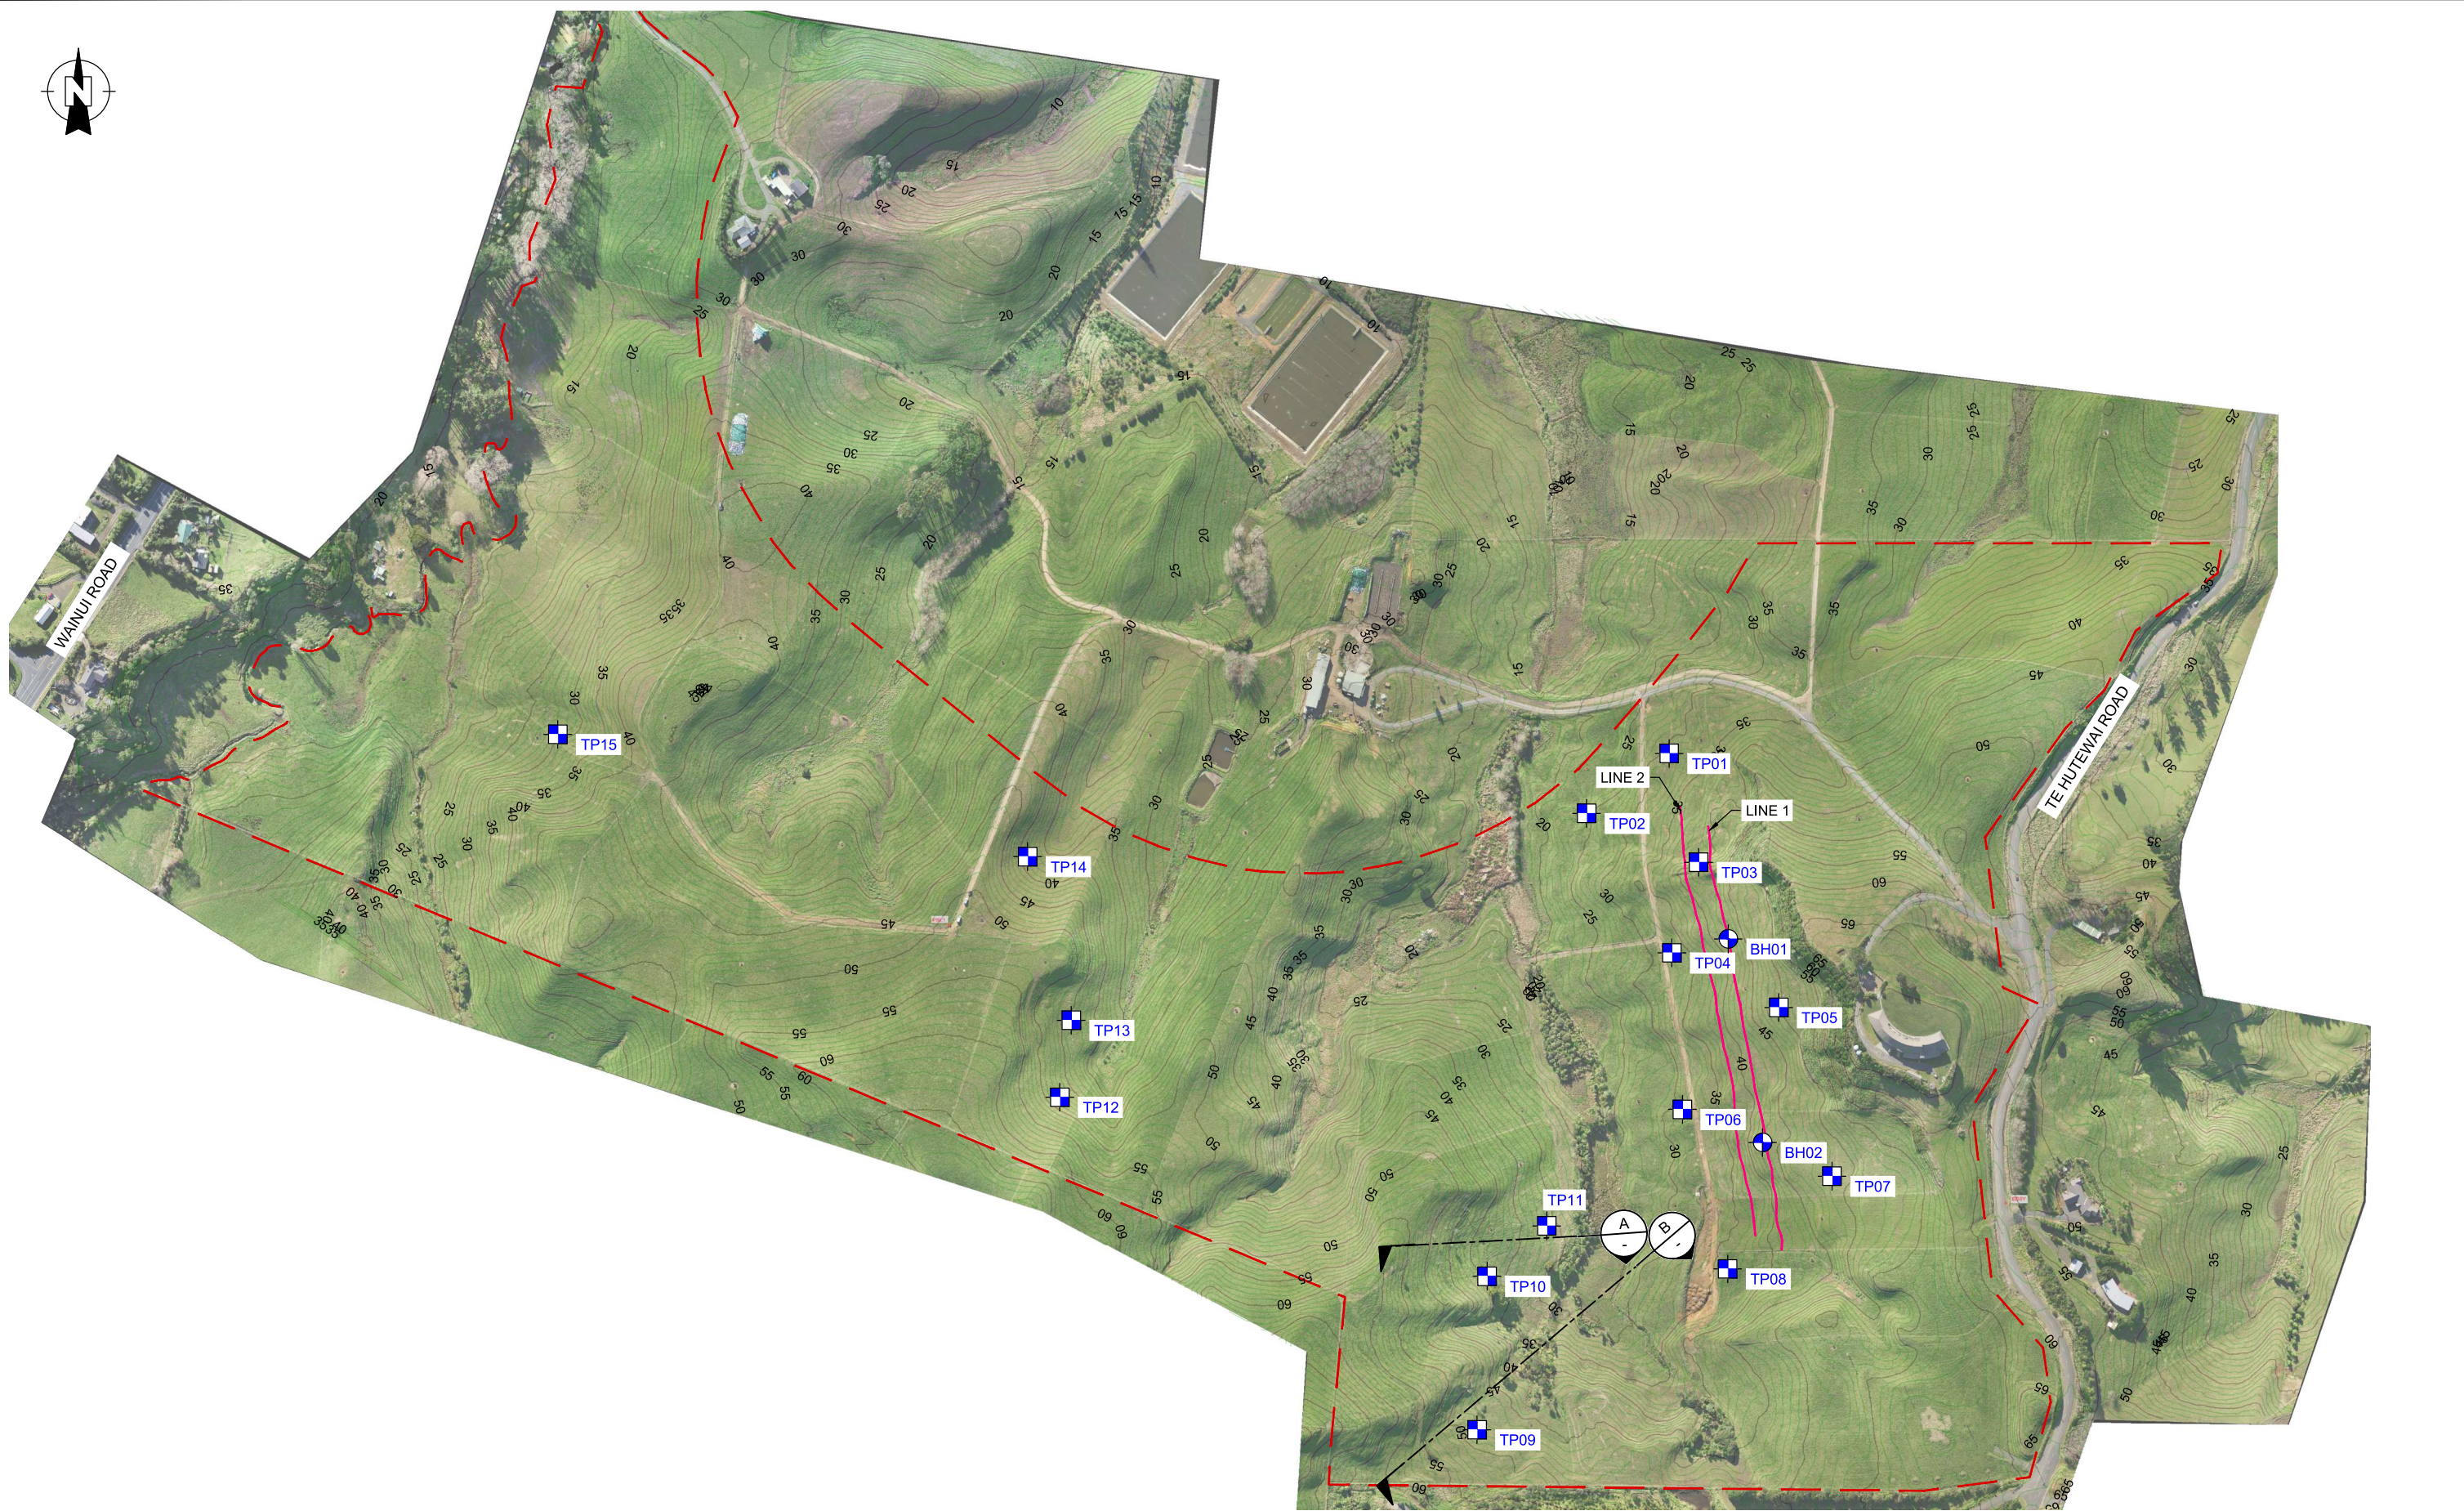
CLIENT:	KONING FAMILY TRUST		DRAWN:	WPJ	PROJECT No:	HAM2018-0021
PROJECT:	KONING DEVELOPMENT		CHECKED:	JW	DRAWING:	01
			REVISION:	0	SCALE:	1:4500
TITLE:	SITE INVESTIGATION PLAN		DATE:	31/07/2020	SHEET:	A3

23. Two machine boreholes and 15 test pits were carried out at selected locations within the targeted High Hazard (slope instability) zone. This was supplemented by a geophysical survey using Electrical Resistivity Tomography (ERT) to aid interpretation of the borehole data. This is discussed in more detail in Paragraphs 26 to 30 of my evidence. Exploratory hole locations are shown on Drawing 01 of my 2020 Geotechnical Investigation Report and a copy of that drawing is appended in Appendix B of my evidence.

24. Both boreholes and seven test pits were located to specifically target the High Hazard (slope instability) zone west of Te Hutewai Road. This was to help assess the causes and risks posed by the apparent ground movement in this area. The remaining seven test pits were primarily located in Moderate and High Hazard zones across the site to help assess the degree of engineering required to allow residential development in those areas.
