**LOT 3 & LOT 32
TAUWHARE
ROAD,
TAUWHARE**

**PRELIMINARY
GEOTECHNICAL
ASSESSMENT**

PROJECT NO: HD1512
BOWROCK PROPERTIES LIMITED
REFERENCE: PGA-1
17 AUGUST 2020

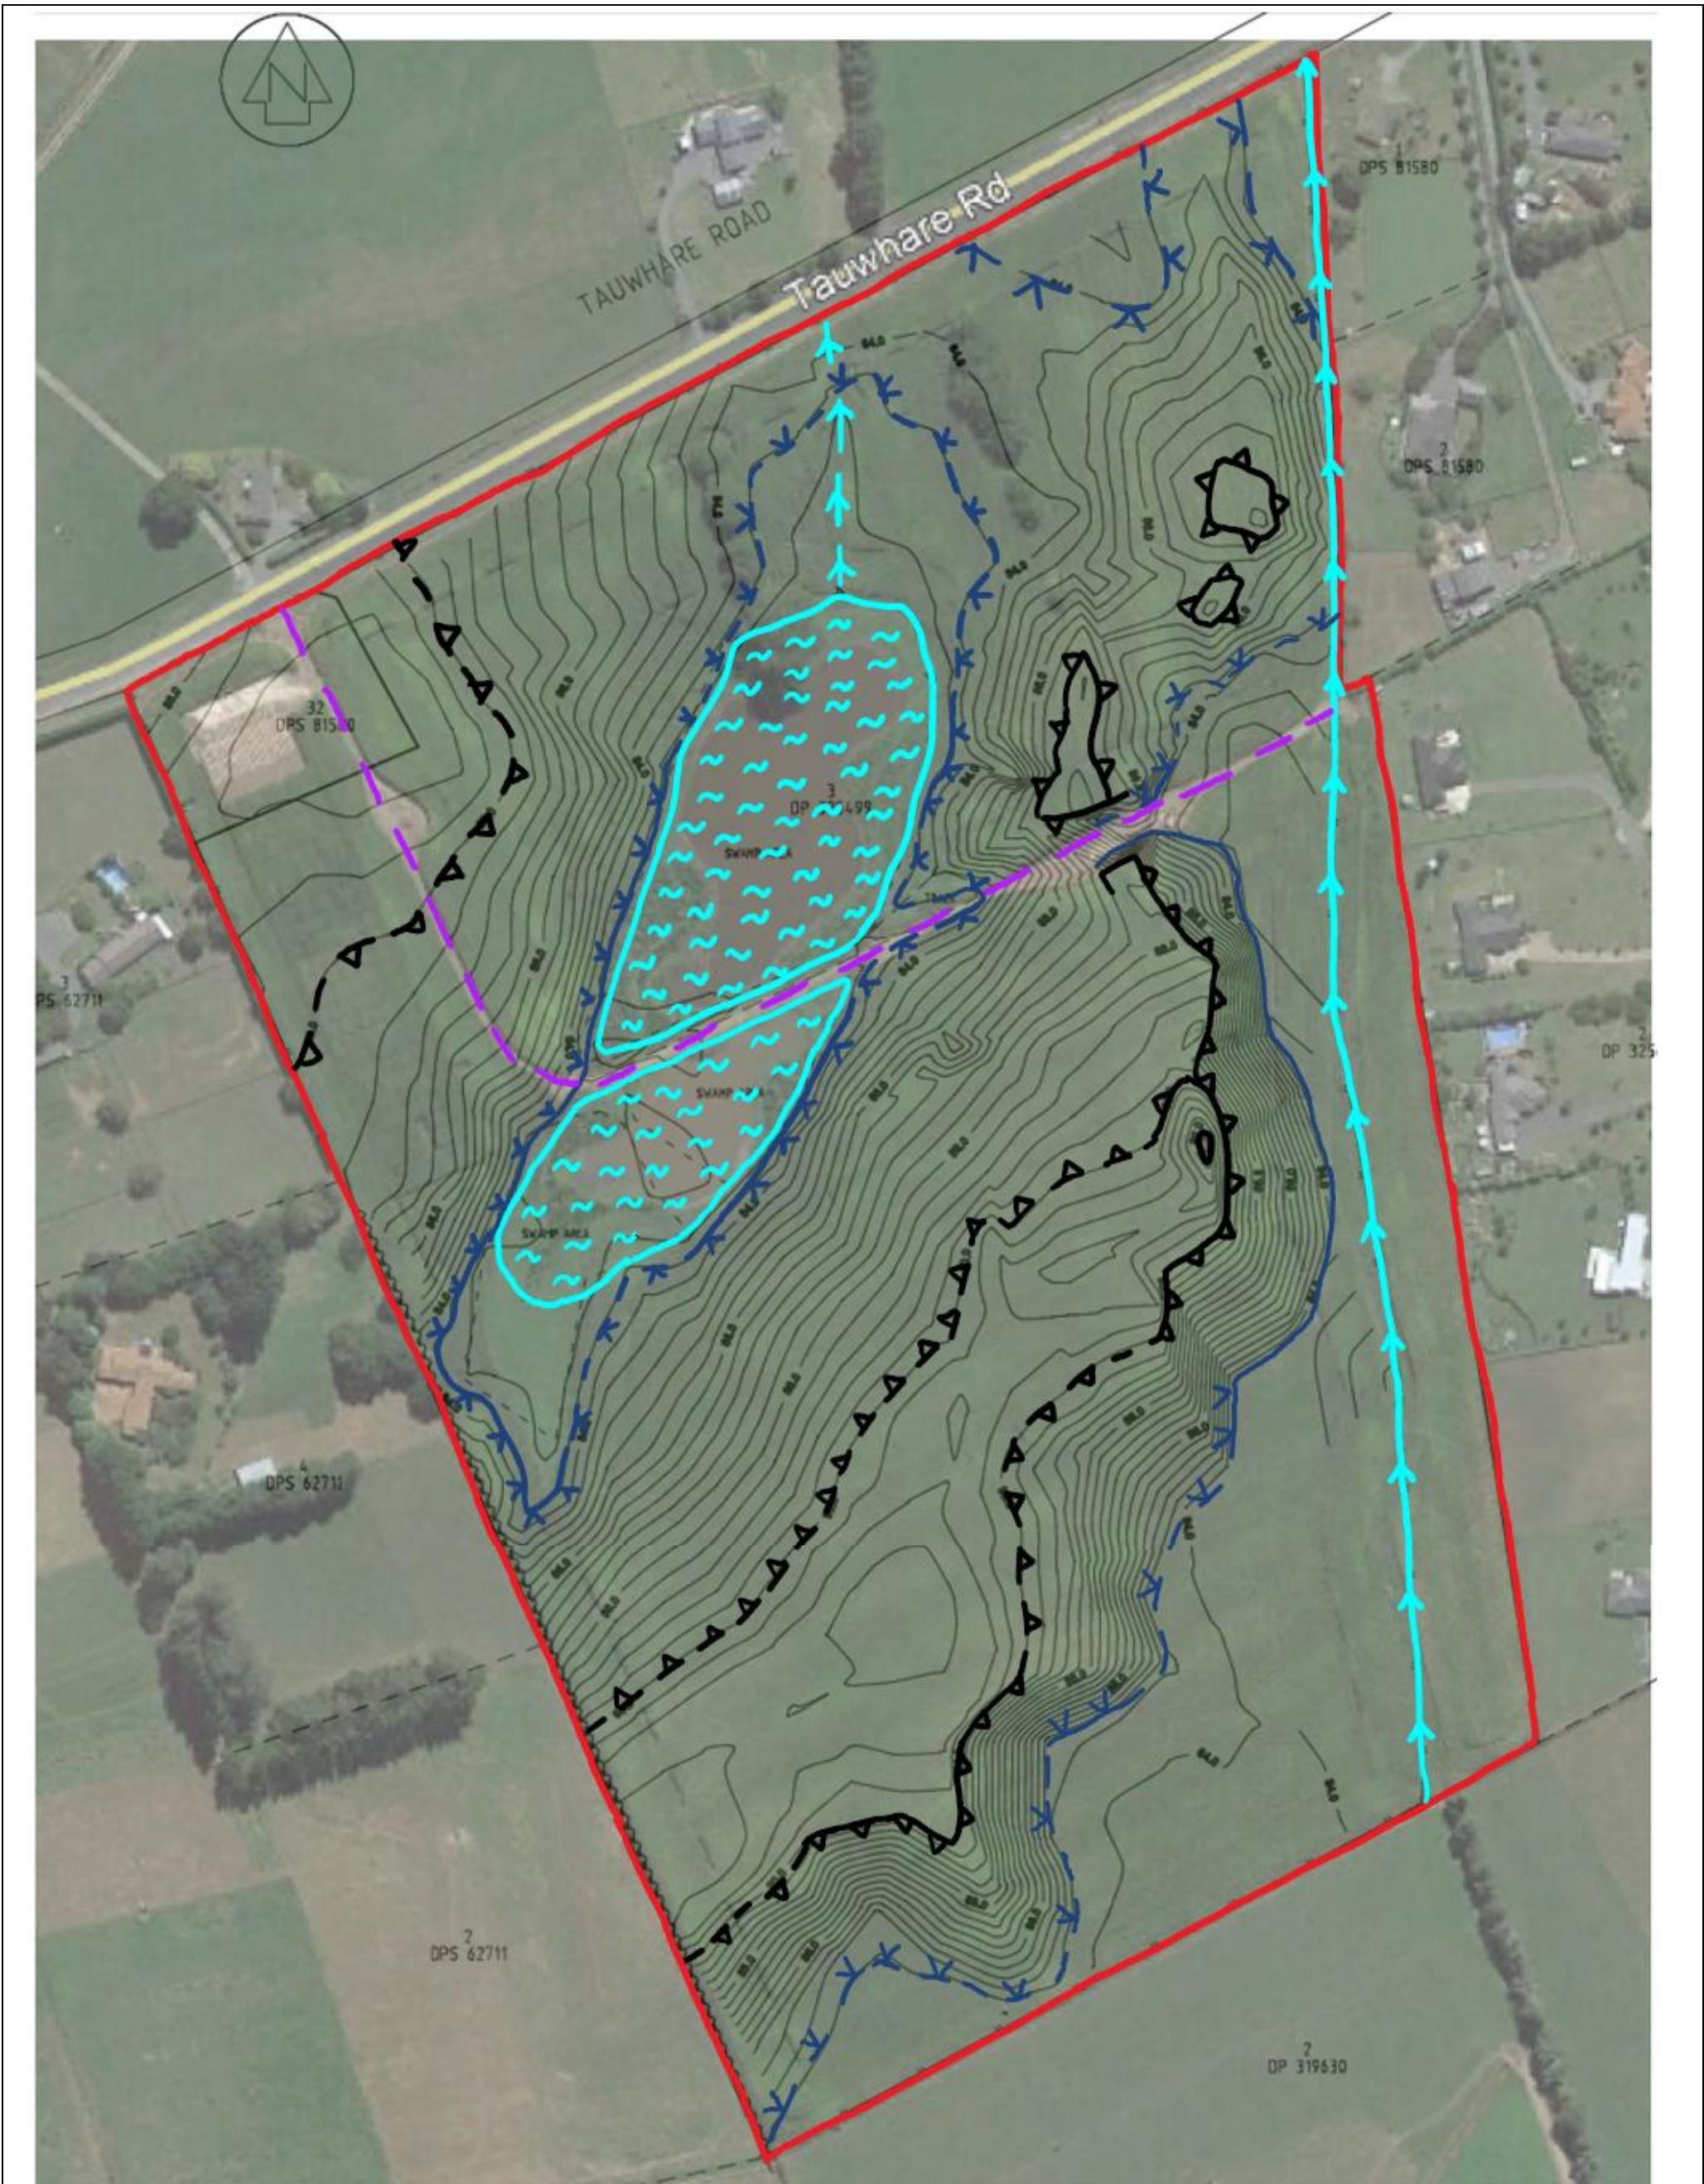
Track	Figure: 1	Rev No: 0
			Drawn by: RR

The site has two distinct geomorphologies, Hills Terrain and Plains Terrain. Hills Terrain is all of the elevated land, typically mapped as Walton Subgroup geology. The Hills Terrain is generally gently to moderately sloping and typically ends abruptly as it meets the Plains Terrain. The Plains Terrain is all of the flat terrain in the area typically mapped as Hinuera Formation. The Plains Terrain is bisected with man-made drains and naturally incised gullies. The drains and gullies tend to be steep sided. The geomorphology of the site is shown in Figure 1 and 2 in Appendix B.

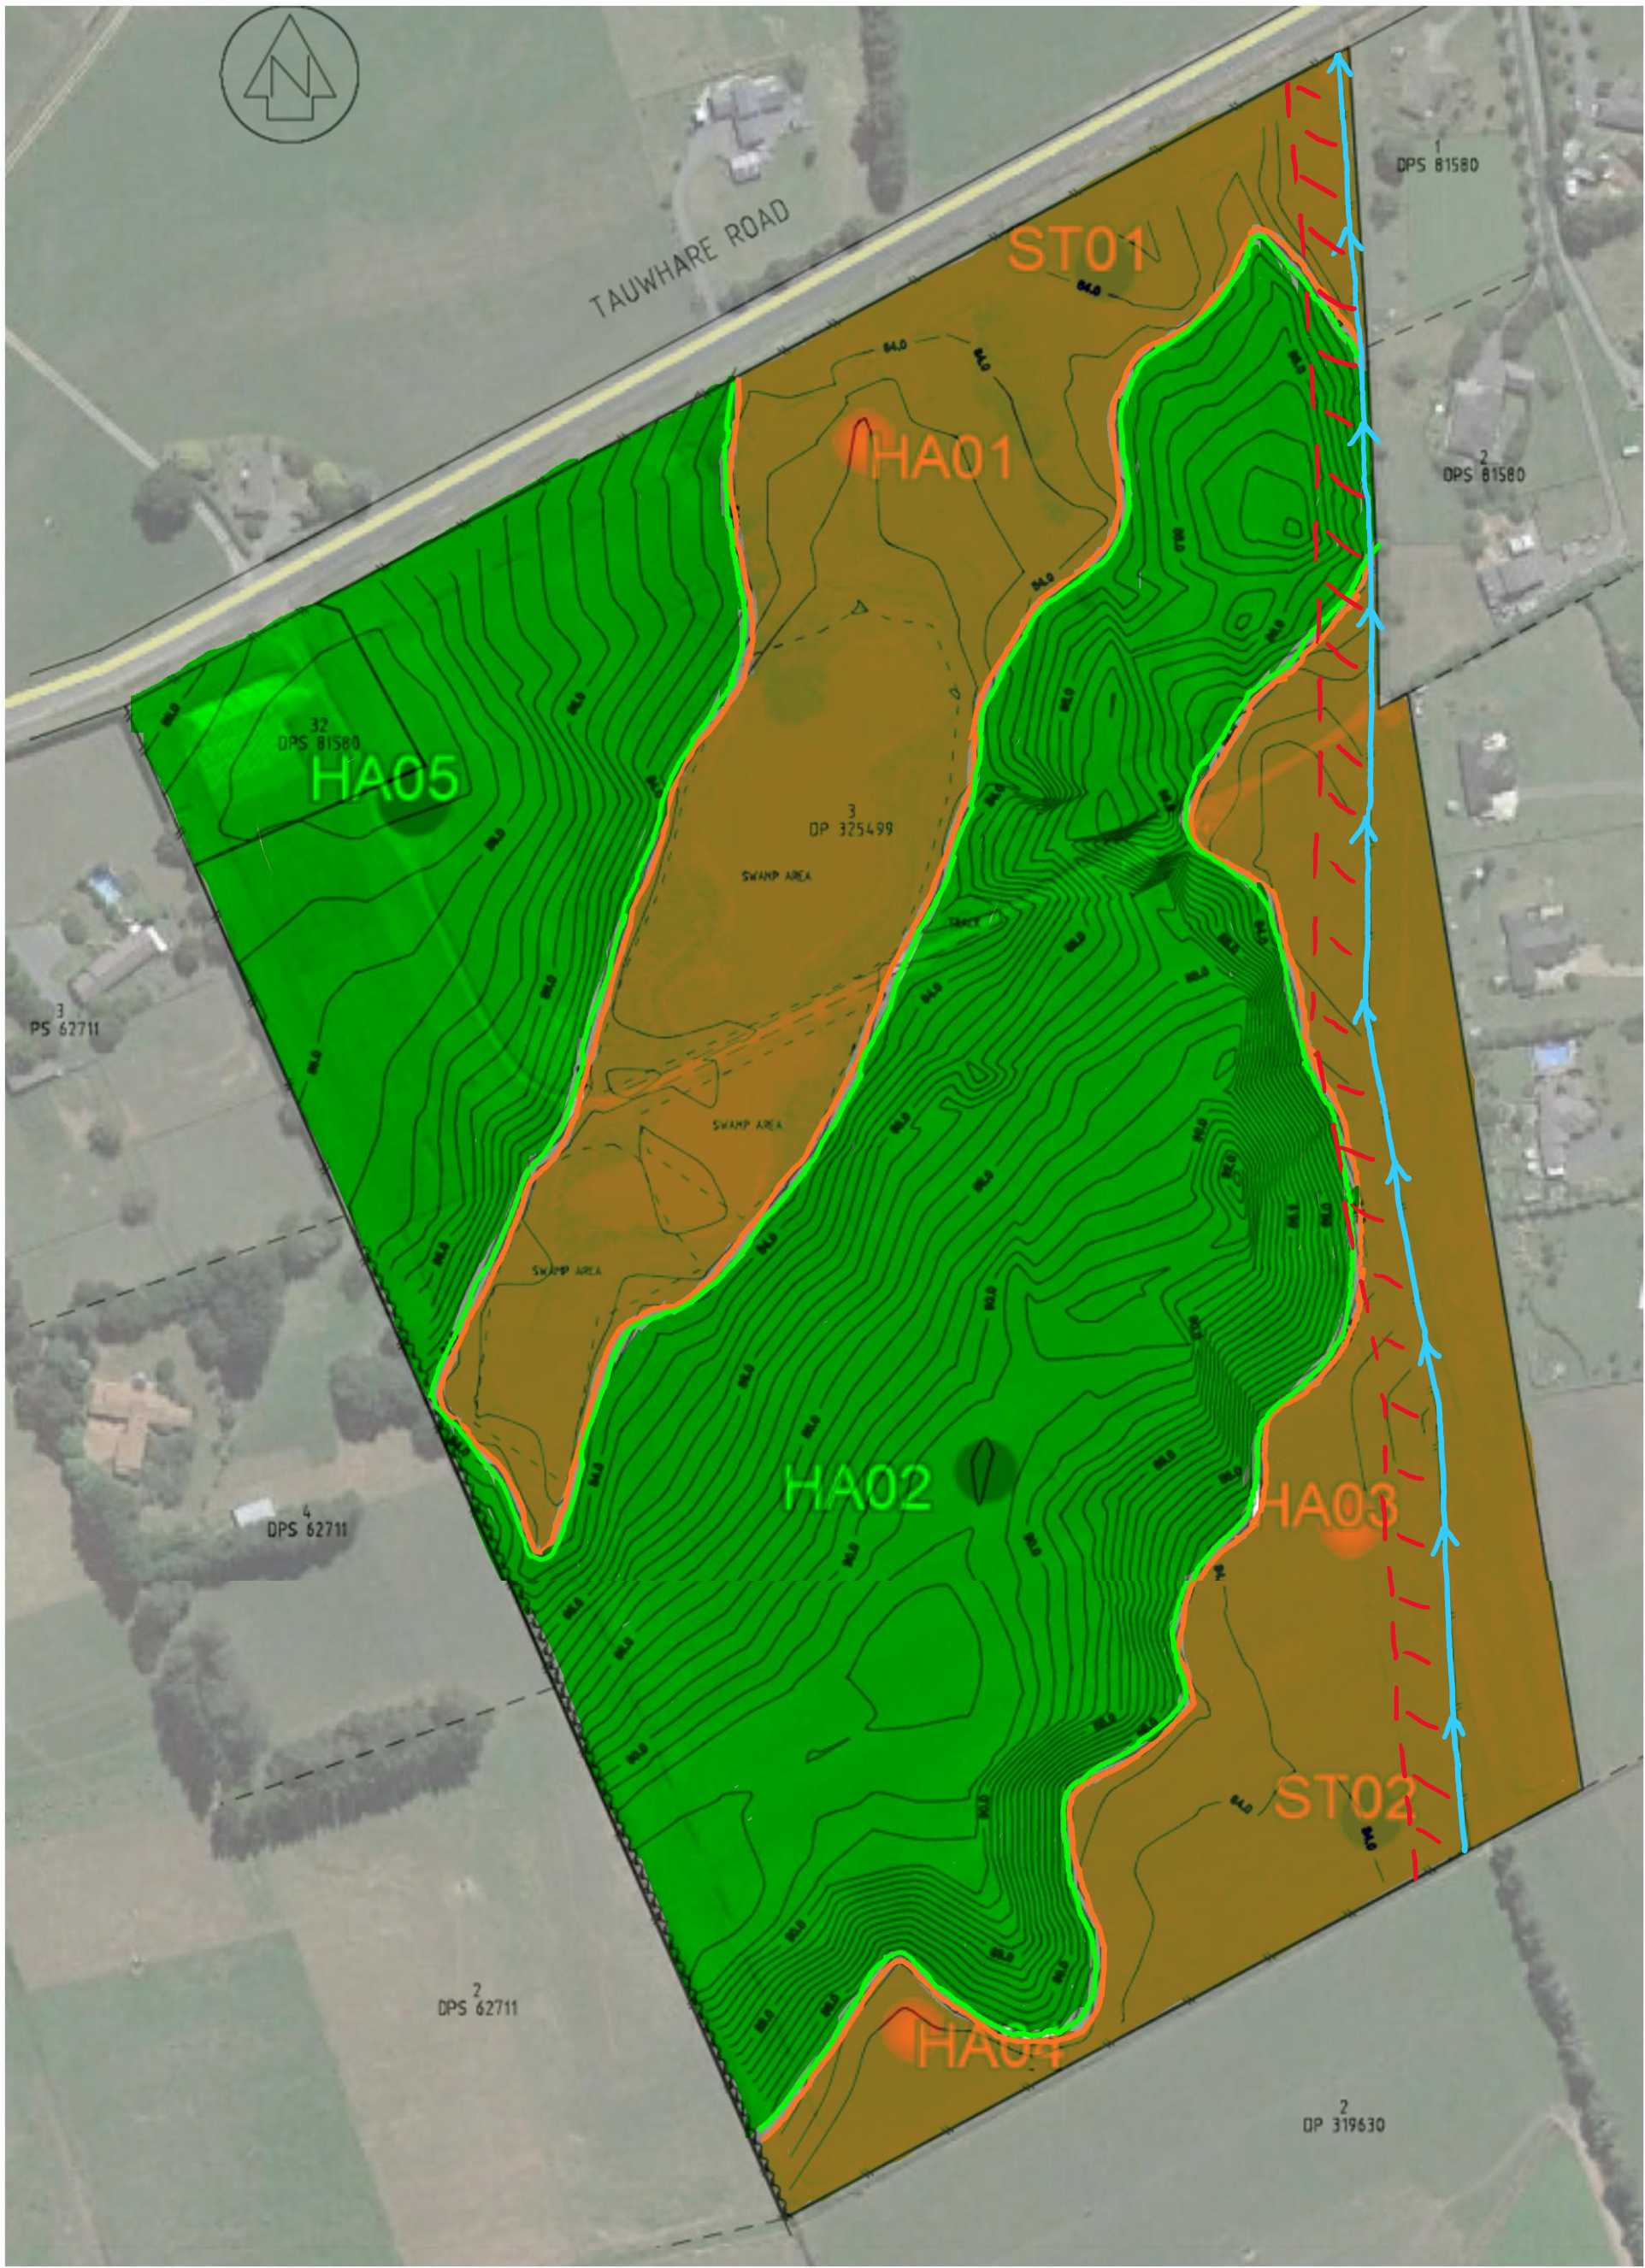
TITLE: Hazard plan – Liquefaction category

We have undertaken a qualitative liquefaction assessment for the site using the latest guidelines⁵. This assessment qualifies as a Level B (calibrated desk study) in accordance with the 2017 planning guideline⁶. Class D soils have been assumed for this assessment. A site plan showing the liquefaction risk on site is provided in Figure 3 Appendix B.

The groundwater at the site is within 1.2 m of the current ground surface within the low-lying area of the site. Using the analysis in the desk study, for an expected groundwater in the upper 2.0m, the degree of liquefaction induced ground damage is likely to be 'moderate'.

On the basis that the soils on the plains terrain are potentially liquefiable and that there is an open-drain along the eastern boundary, the risk of lateral spreading or instability related to seismic loading is assessed as moderate for areas within 20 m of this drain.

Standard foundations are not appropriate, given the potential for liquefaction and low strength soils. The design of the foundations will need to consider the low bearing and potential effects from liquefaction. Raft type foundation systems are likely to be appropriate for the site.

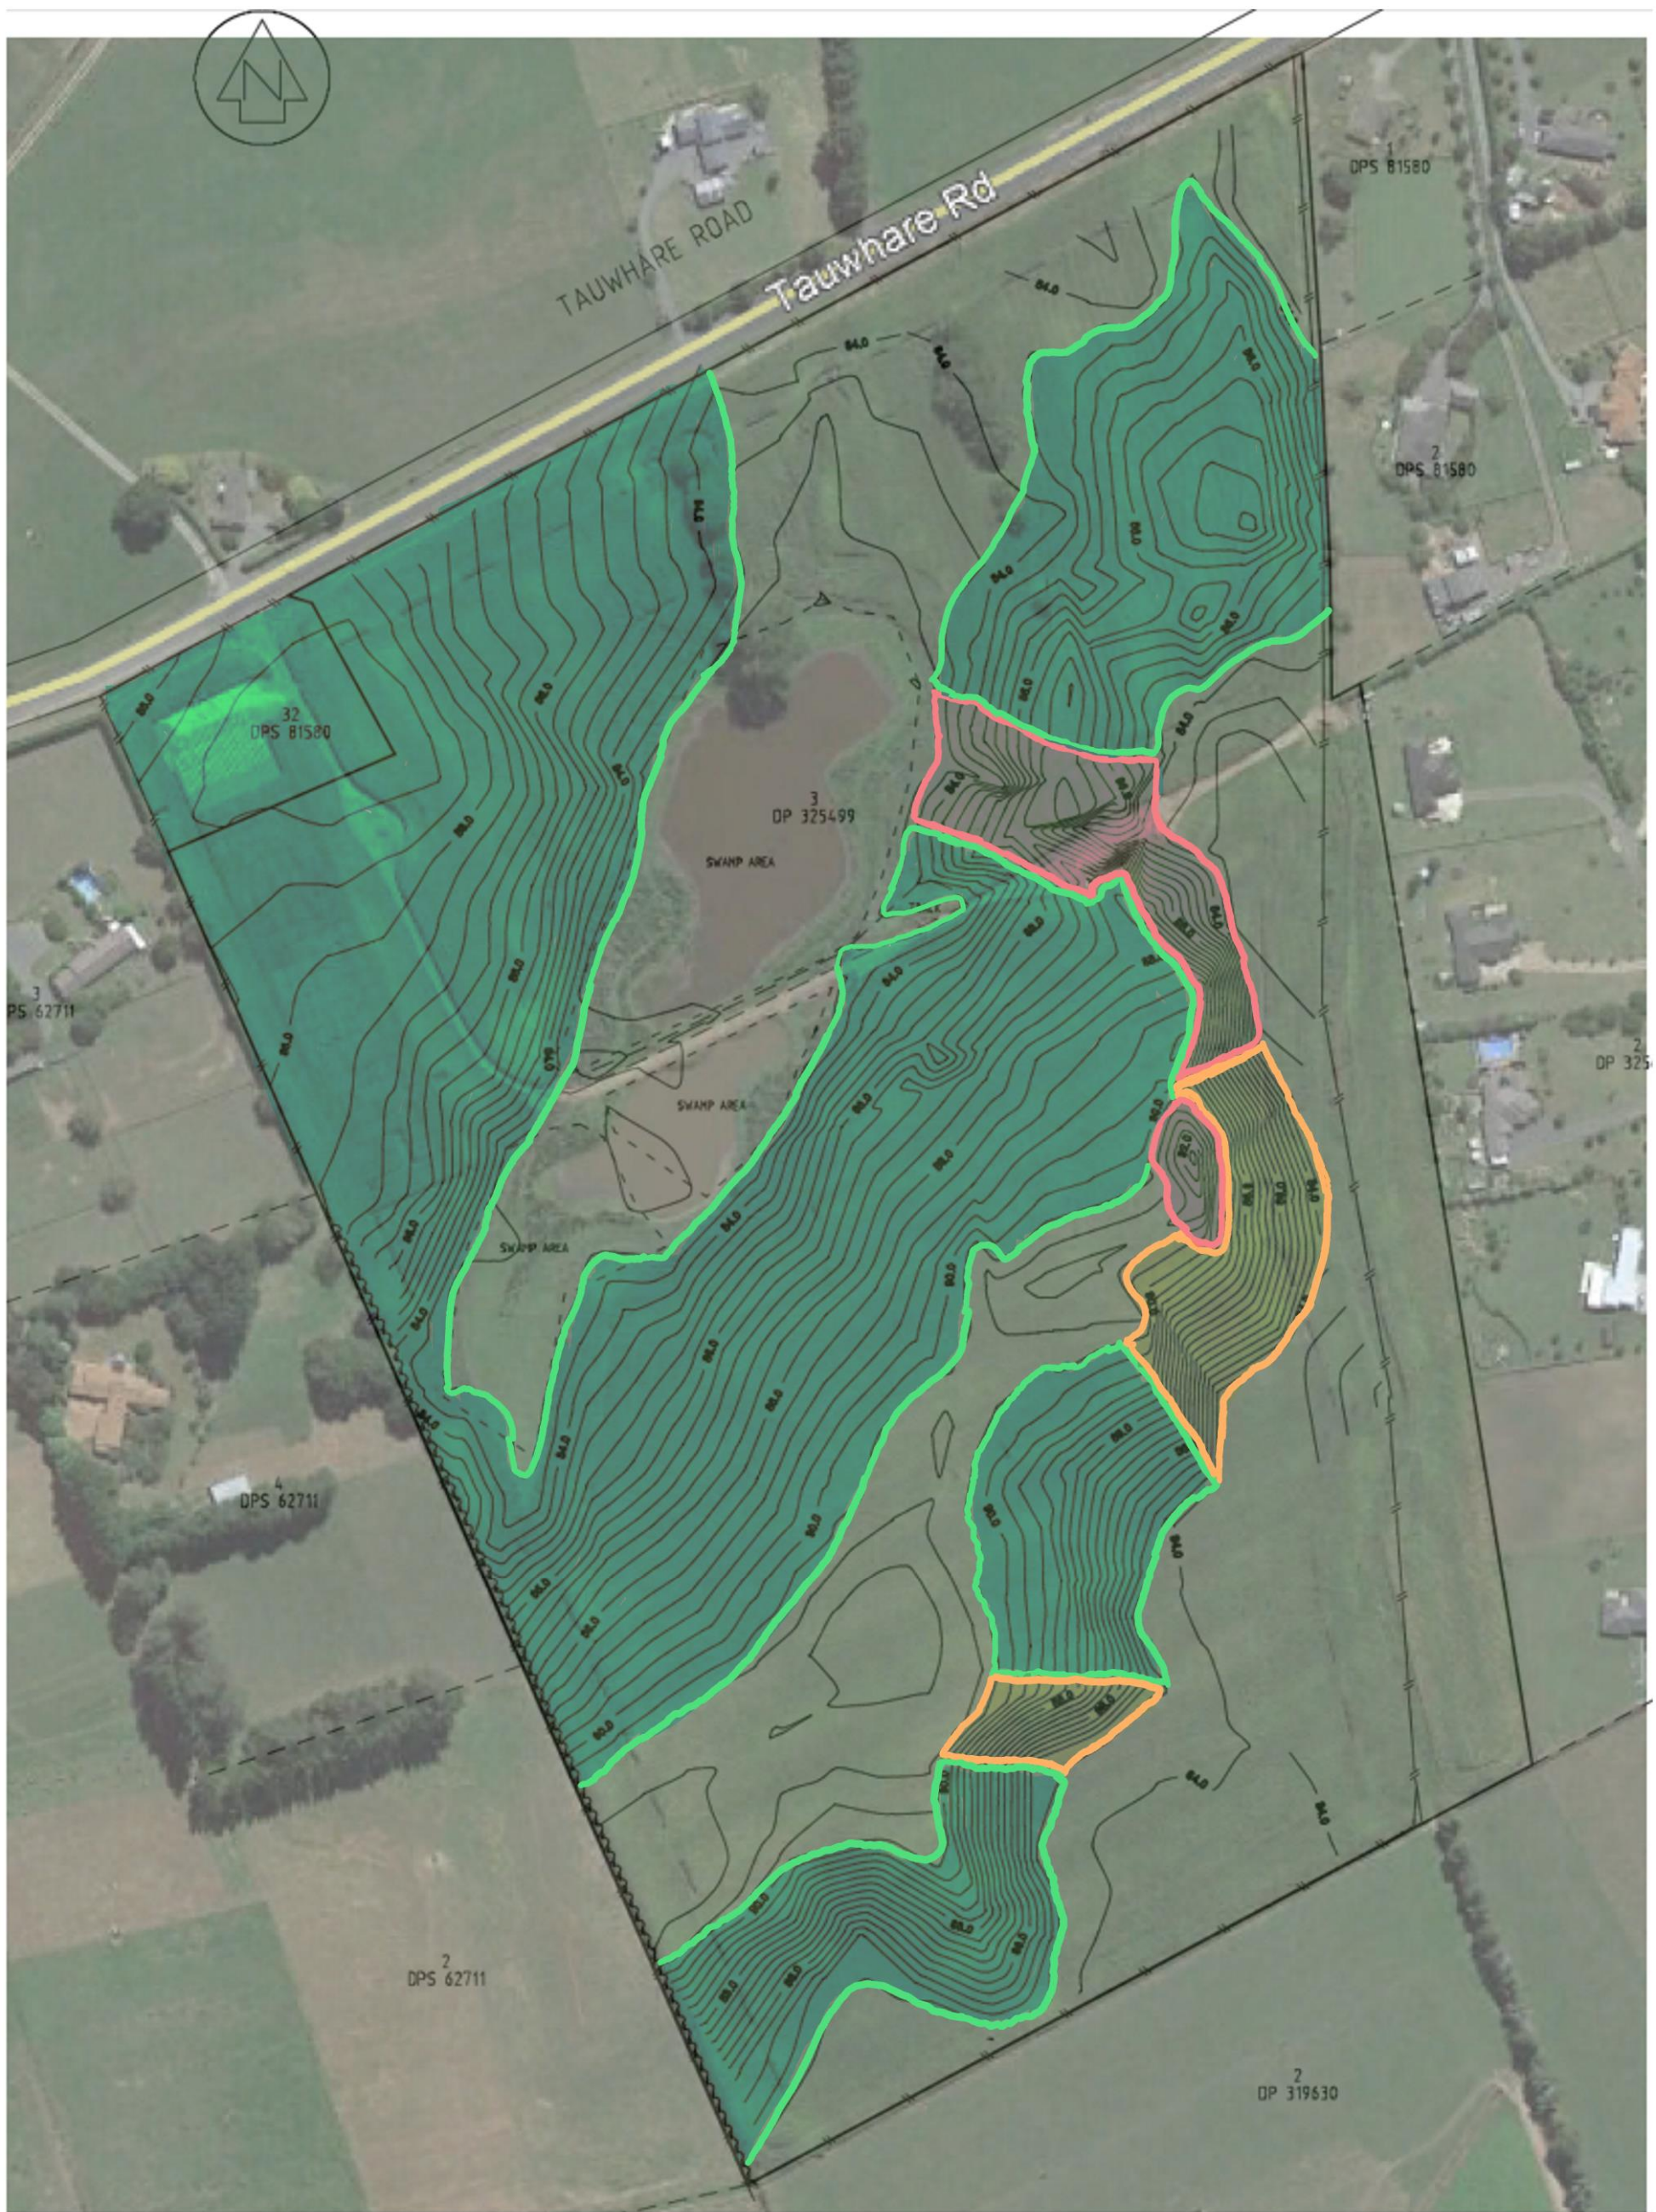
TITLE: Hazard plan – Slope category

No signs of slope instability were observed on the moderate slopes, defined as $\geq 14^\circ$ (1V: 4H) to $\leq 18.4^\circ$ (1V: 3H). We consider these slopes generally stable in their present condition, however developing sites this steep would generally mean significant modification and engineering is likely to be needed (retaining etc).

Steep slopes were defined as $> 18.4^\circ$ (1V: 3H). We consider these slopes generally stable in their present condition but they may not be up to the required factor of safety for residential construction. Engineering is likely to be needed (retaining etc).

Minor erosion was noted along the areas of the slopes above the modified steep cuts along the track ($> 25^\circ$). The steep cut faces are steeper than most natural slopes in the area and are expected to be marginally stable.

An approximate interpretation of the slope zones is presented in Figure 4 Appendix B.

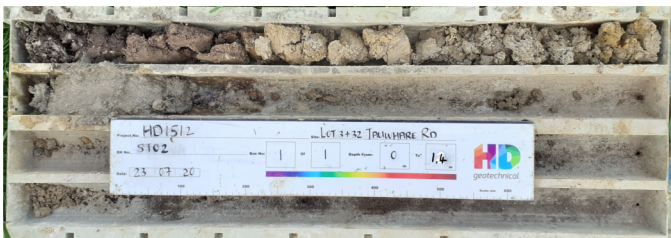
End of log at 1.4 m. Target depth of 2.0 m not achieved due to hole collapse. Groundwater encountered at 0.9 m.															
			Shear Vanes				Water				Investigation Type							
			<div><div></div> Peak</div> <div><div></div> Remoulded</div>				<div><div></div> Standing Water Level</div> <div><div></div> Out flow</div> <div><div></div> In flow</div>				<div><div></div> Hand Auger</div> <div><div></div> Investigation Pit</div> <div><div><input checked="" type="checkbox"/></div> Machine Borehole</div>

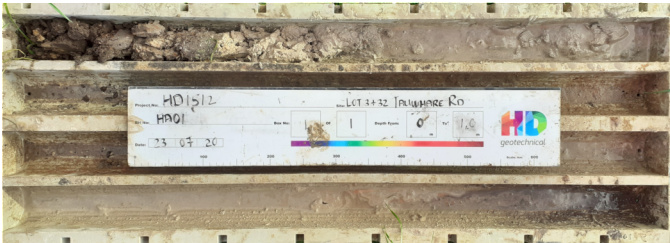
End of log at 1.0 m.
Target depth of 3.0 m not achieved due to no recovery and hole collapse.
Groundwater encountered at 0.6 m.

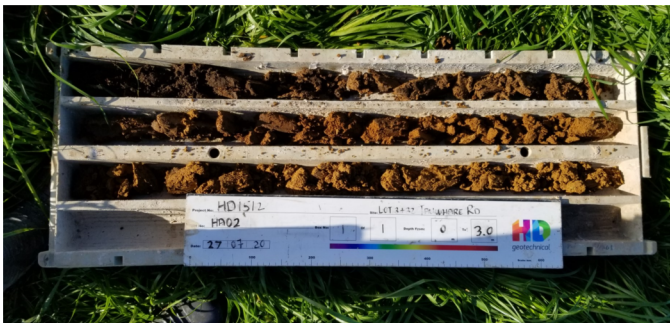
End of log at 3.0 m. Target depth achieved. Groundwater not encountered.																
			Shear Vanes		Water		Investigation Type												
			<div><div></div> Peak</div> <div><div></div> Remoulded</div>		<div><div></div> Standing Water Level</div> <div><div></div> Out flow</div> <div><div></div> In flow</div>		<div><div><input checked="" type="checkbox"/></div> Hand Auger</div> <div><div><input type="checkbox"/></div> Investigation Pit</div> <div><div><input type="checkbox"/></div> Machine Borehole</div>

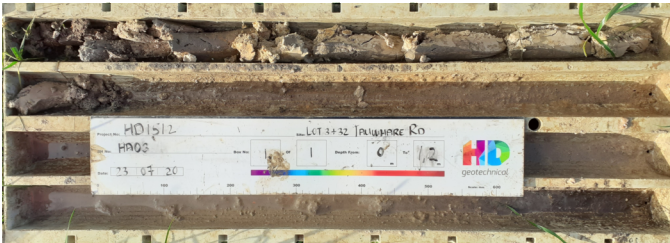
End of log at 1.2 m.
Target depth of 3.0 m not achieved due to no recovery and hole collapse.
Groundwater encountered at 1.1 m.

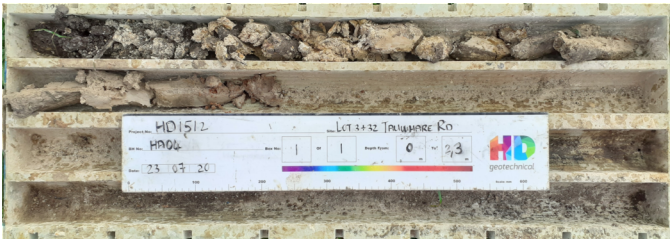
End of log at 1.4 m.
Target depth of 3.0 m not achieved due to no recovery and hole collapse.
Groundwater encountered at 1.2 m.

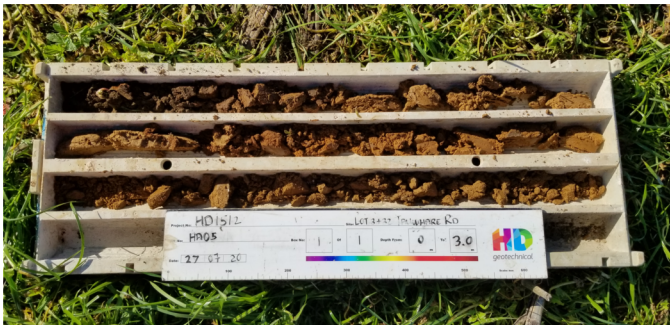
End of log at 3.0 m. Target depth achieved. Groundwater not encountered.																
			Shear Vanes				Water				Investigation Type
