DIAMOND CREEK FARM LTD

STATE HIGHWAY 23, TE UKU,
WAIKATO

GEOTECHNICAL FEASIBILITY ASSESSMENT FOR A PROPOSED SUBDIVISION

REF: R7089-1A
DATE: 12 APRIL 2021

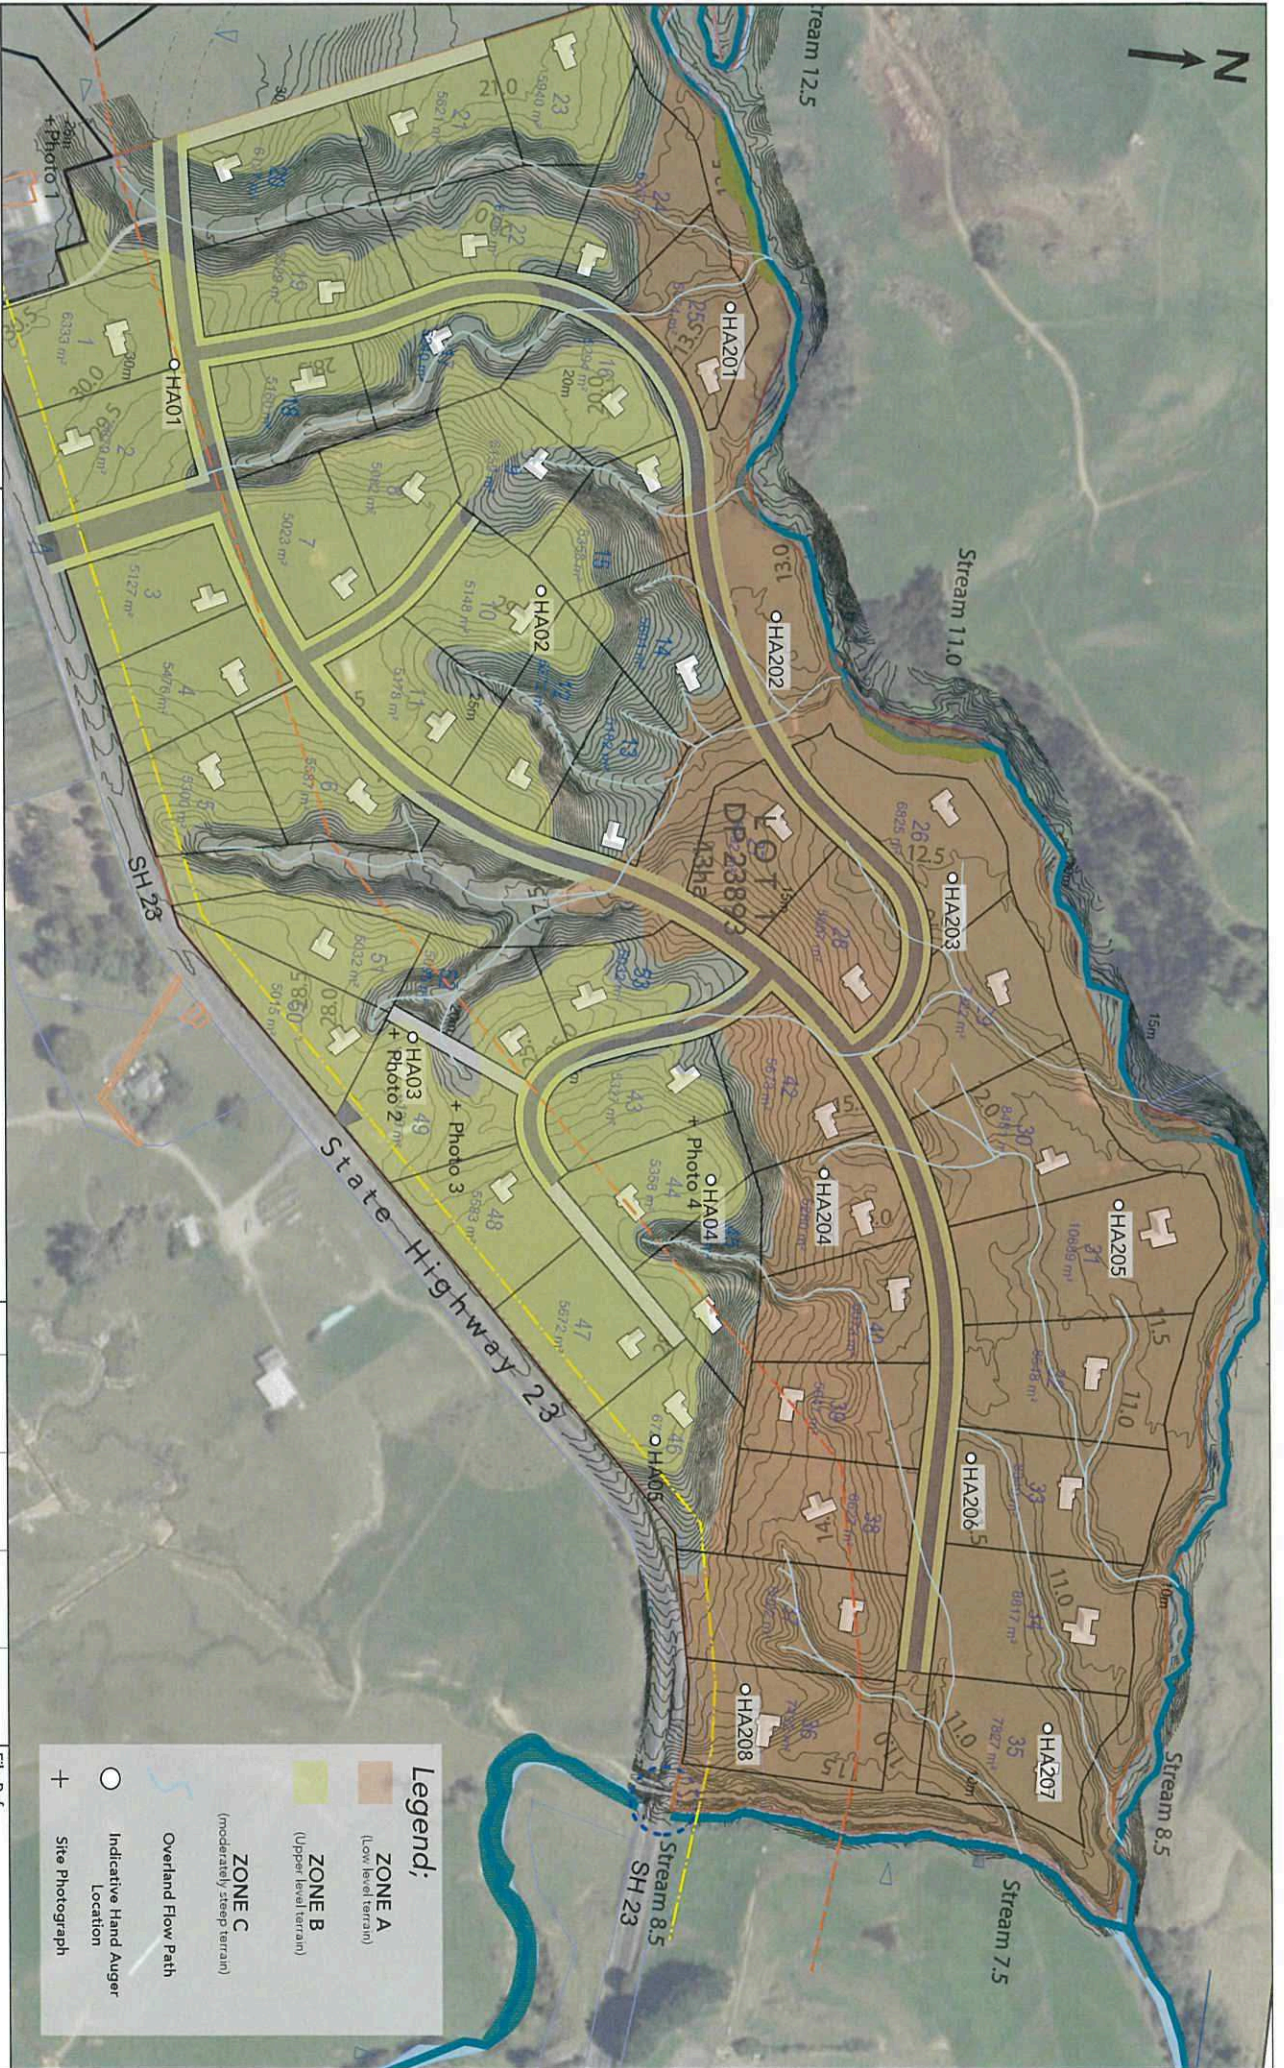
Drawing No. 002

The site contains three main topographic features, a low-lying area labelled Zone A, an upper terrain labelled Zone B and interconnecting slopes labelled Zone C.

The surface water within Zone A is channelled along a series of swampy and grass lined overland flow paths to a stream running along the northern boundary, as depicted on Drawing 002. We are unsure of flood levels associated with the stream.

Zone C is associated with moderately steep slopes which contain terracettes associated with soil creep to an observed depth of between 0.50 to 1.0m in some places, especially within the head of the gully features. These features appear to have been exacerbated by stock use.

Zone C is located on moderately sloping topography which generally contains shallow slope instability features (terraces/soil creep). Zone C is not considered to be suitable for subdivision development/infrastructure in its current form and will require re-grading, undercutting and drainage works in order to provide suitable conditions for subdivision development.

Should Zone C remain undeveloped, suitable building platform set-backs and constraints on earthworks will be required for some fringe areas within Zone B.
