MAFBNZ Investigation of Compliance and Monitoring of the Scion GM Field Test.

11 February 2008

Report prepared by: Kathryn Hurr Operations, Border Standards Group MAF Biosecurity New Zealand

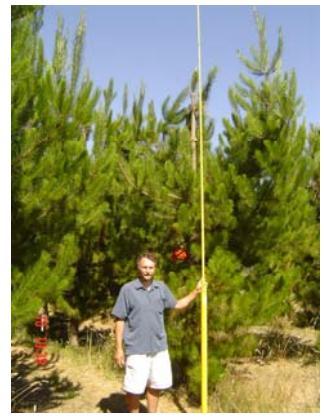
The height of all GM pine trees was verified on January 16 2008 as ranging between 4.5m and 4.8m, as measured against a fiberglass telescopic measuring pole. Topping is scheduled again within the next month to reduce the summer growth which the trees have put on since October.

Photo 1: The telescopic measuring pole used to measure the height of GM pine trees.

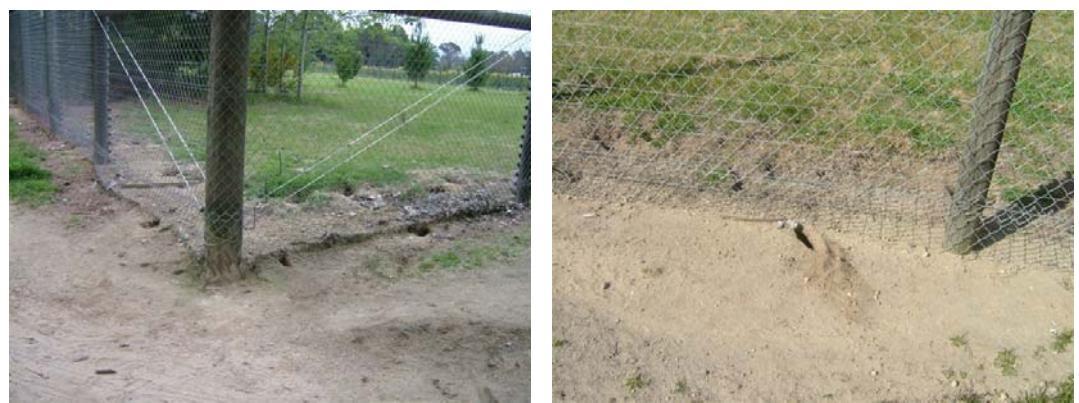
An inspection of the fence was undertaken to look for "holes in and under the fence". No holes were found in the fence, apart from the access point created by protestors in January, which was repaired immediately the Police had concluded their site investigation. There was no evidence of extensive, deep burrowing in the ground in front of, or inside the fence, which could compromise the security of the site. Photographs were supplied to MAFBNZ by Steffan Browning of Soil & Health, which showed deeper holes in the ground in front of the wire netting fence, reportedly taken in November 2007. These are not typical of the rabbit holes observed during the site investigation in January, or depicted in photographs 2 and 3 (also provided by Steffan Browning). MAF is still investigating the cause of these holes, and has not ruled out the possibility these were man-made for publicity purposes.

Many rabbit scratchings and shallow holes were evident around the fence perimeter (see photographs below), and within the field test site. These were estimated variously to be 5-15cm deep.

Photos 2, 3: Rabbit holes and scratchings, typical of those seen during the site investigation.
