Before the Independent Hearing Panel

IN THE MATTER of Variation 3 to the Proposed Waikato District Plan

Statement of evidence of Anna Ruth Noakes on behalf of Anna Noakes and MSBCA Fruhling Trustee's Company Limited

Dated: 4 July 2023

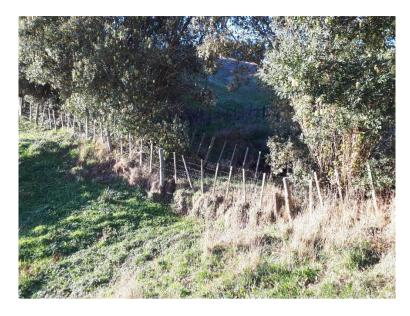
There is no question that the gully was completely dry during our site visit on 13 May 2019 and you report that it is dry for long periods over summer and even at times during the winter. The D2 gully joins a much larger tributary valley which was also completely dry as far as the railway line culvert on 13 May 2019.

In our opinion, the D2 gully is ephemeral, not perennial and the other three are simply gullies.

Wetland D2 Gully Looking North-east, 13 May 2019

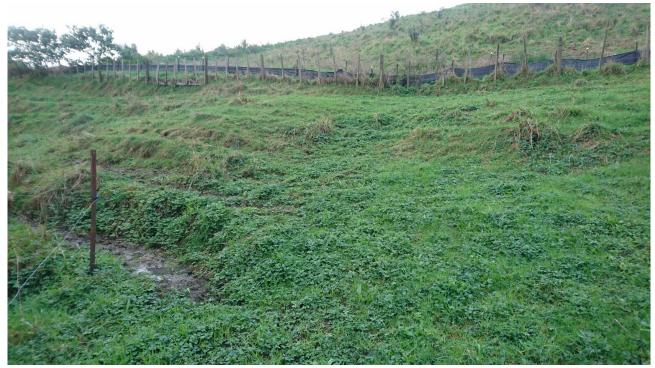
Stage 5 # discharge 1 northern showing effects of long term wetting, erosion effects on grazing paddock. Photo ref: DSC_1206 17 June 2023.

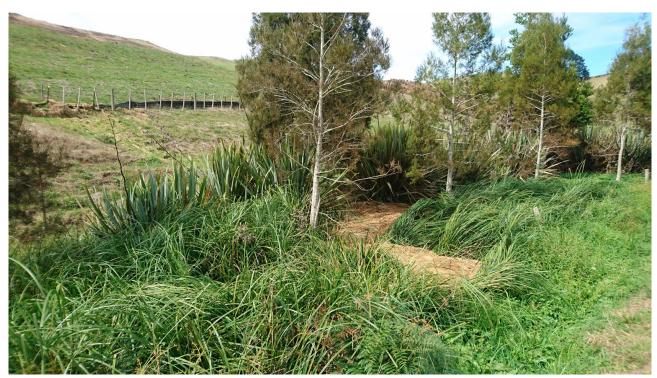
Discharge #1 Stage 5 eroding the stock tracks, clay & gravel in plantings B. Photo ref: DSC_1376-1 27 March 2022.

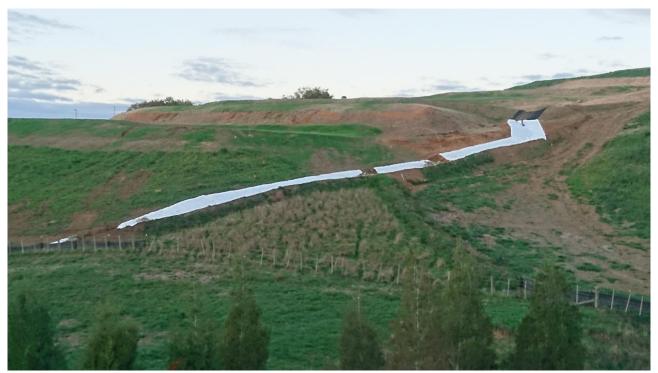
Stage 5 discharge #1. Dines created structure to slow the water flow of their artificial discharge onto my land. Photo ref: DSC_1470_1 29 April 2022.

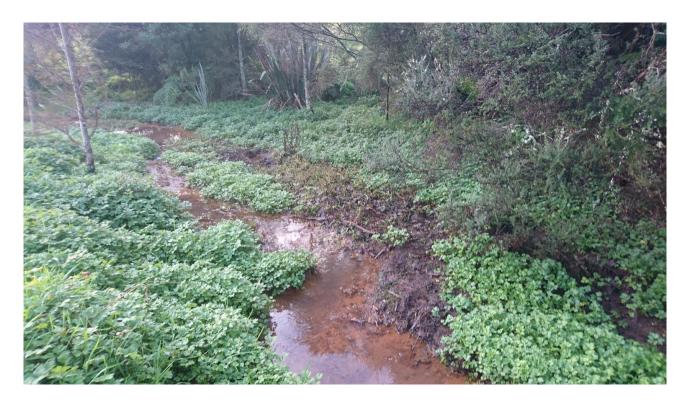
- 5. Since 2020 when the discharge from D2 created an artificial permanent flow I have noticed that the water flow path from the junction to the small holding pond is progressively scouring out a wider path in all parts and in some places has become too wide for me to be able to jump across.

Water flow path between D2 junction and small holding pond. Photo ref: DSC_1210 17 June 2023

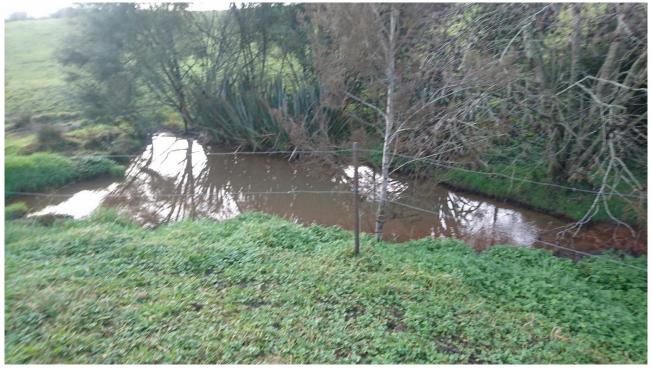
- 6. My small holding pond no longer offers me any filling capacity. The pond outlet is being scoured out and widened with every season. The pond's footprint gets longer every season.

- 7. During periods of very heavy rain fall the quantity and force of the stormwater is so great that the water floods up and over the ponds edge.
- 8. The stock crossing 2 is unable to cope with the quantity of water and is choked pushing the water up and over the crossing. The culvert is ~460mm internal diameter. The concrete slabs that formed the base of the stock Crossing 2 are now slumping and falling into the water.

Small holding pond located above stock vehicle culvert crossing. Photo ref: DSC_1212 17 June 2023

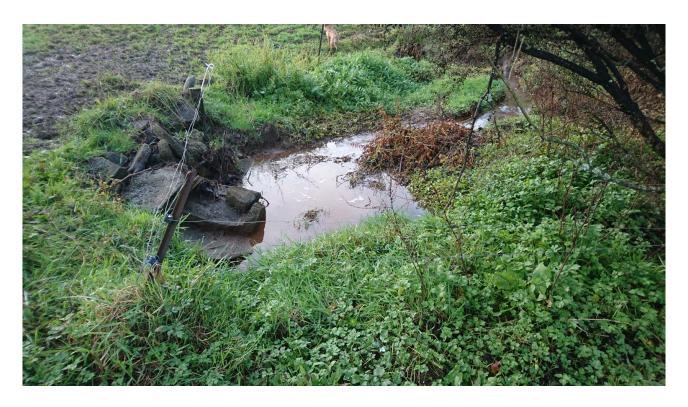
Upper side vehicle, stock culvert crossing showing erosion. Photo ref: DSC_1215 17 June 2023.

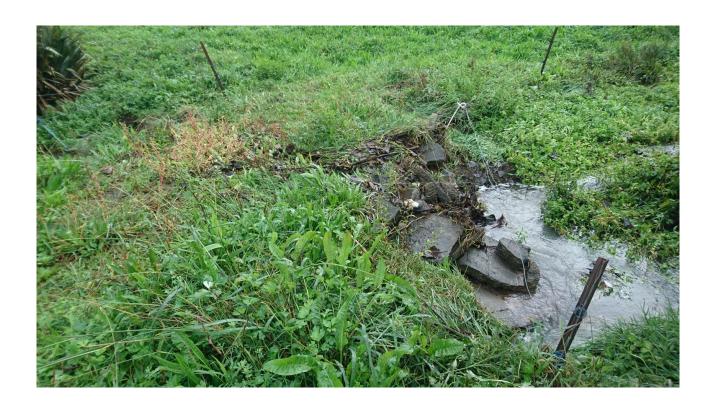
Upper side vehicle, stock culvert crossing not coping with storm water volume. Photo ref: DSC_0849 10 May 2023.

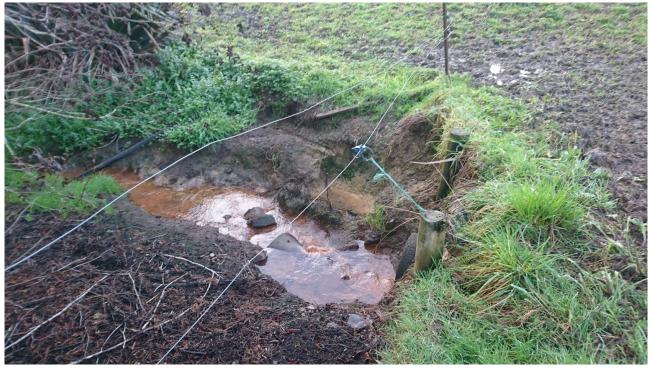
- 9. The lower side of the stock crossing #2 is progressively eroding and the flow path to NIMT #2 widening.
- 10. Attached in **Annexure Seven** are photos showing the stormwater environment downstream of D2 before and after the construction of D2.

Lower side vehicle, stock culvert crossing showing erosion. Photo ref: DSC_1217 17 June 2023.

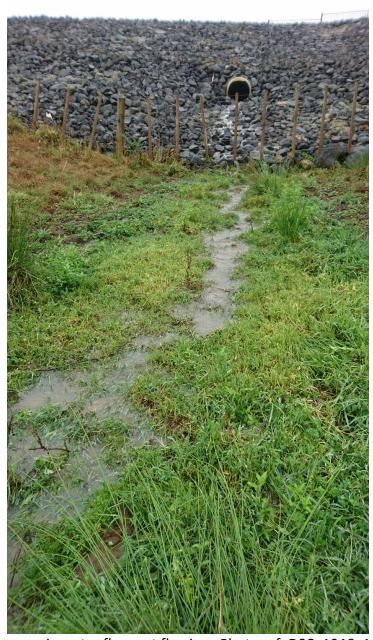
- 3. During the dry season this entire length should naturally dry out. The discharge from D2 has created an artificial and permanently wetted area on the Property.

D2 discharging when main water flow not flowing. Photo ref: DSC_1046_1 7 February 2022.

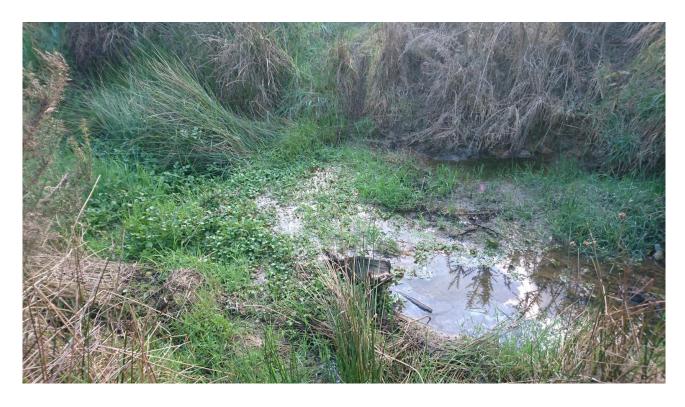
D1 discharge near NIMT culvert entrance sediment and erosion visible. Photo ref: DSC_1171 11 June 2023.

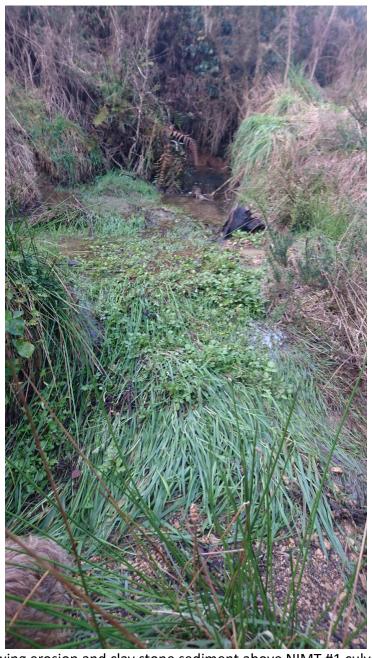
D1 discharge showing erosion and clay stone sediment above NIMT #1 culvert. Photo ref: DSC_0938 13 May 2023.
