Ecological Mitigation Monitoring Report

**Gleeson Huntly Quarry
Gleeson & Cox Ltd**

May 2022

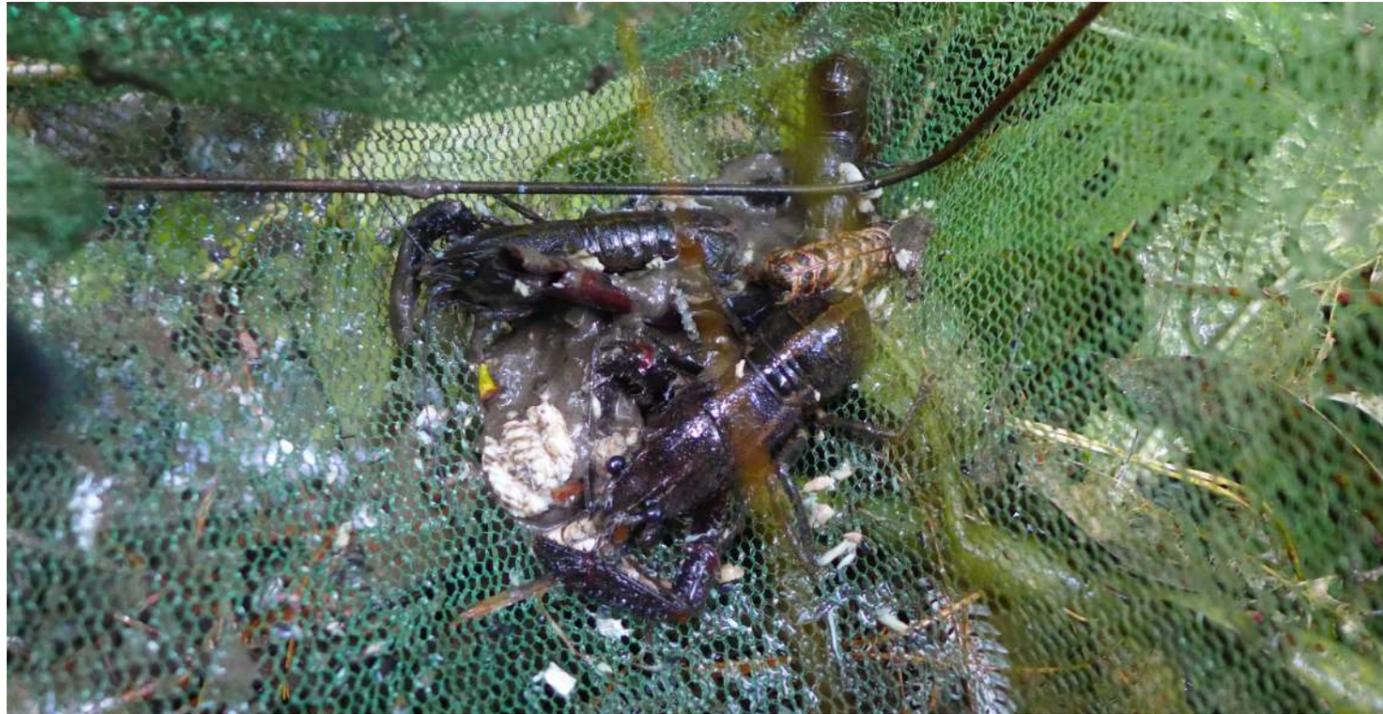
Figure 1: Several koura captured in a bait trap in the Fill Area 5 watercourse.

A stop net was constructed on the 17th May at the downstream end of the watercourse to prevent fish returning or migrating into the affected area. A total of 150 koura (*Paranephrops planifrons*) were captured and relocated over a three day period (17th - 20th May) using bait traps and hand searching, with the majority captured on the second day. Electrofishing was carried out in the upper section of watercourse but yielded no results. All koura (*Paranephrops planifrons*) were relocated downstream of the impact area in similar suitable habitat.

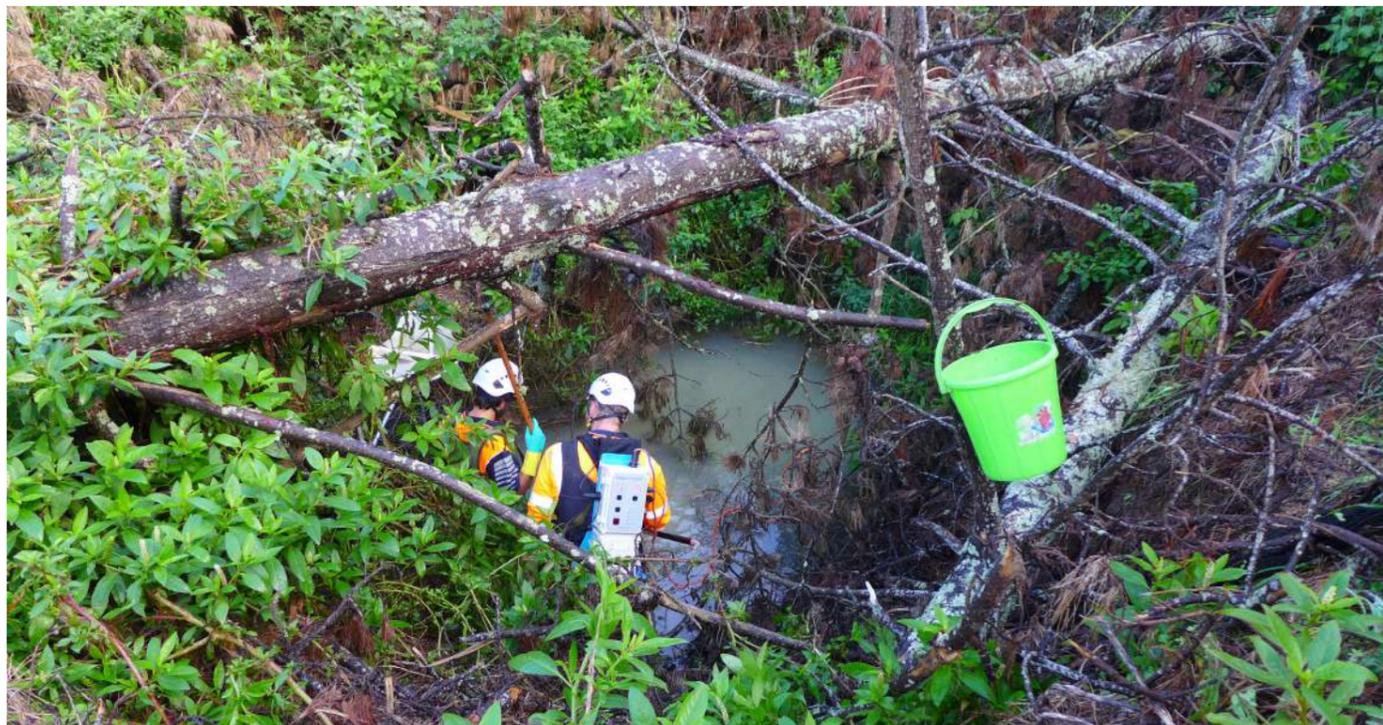
Figure 3: Ecologists electric fishing in a pool in the upper part of the watercourse.

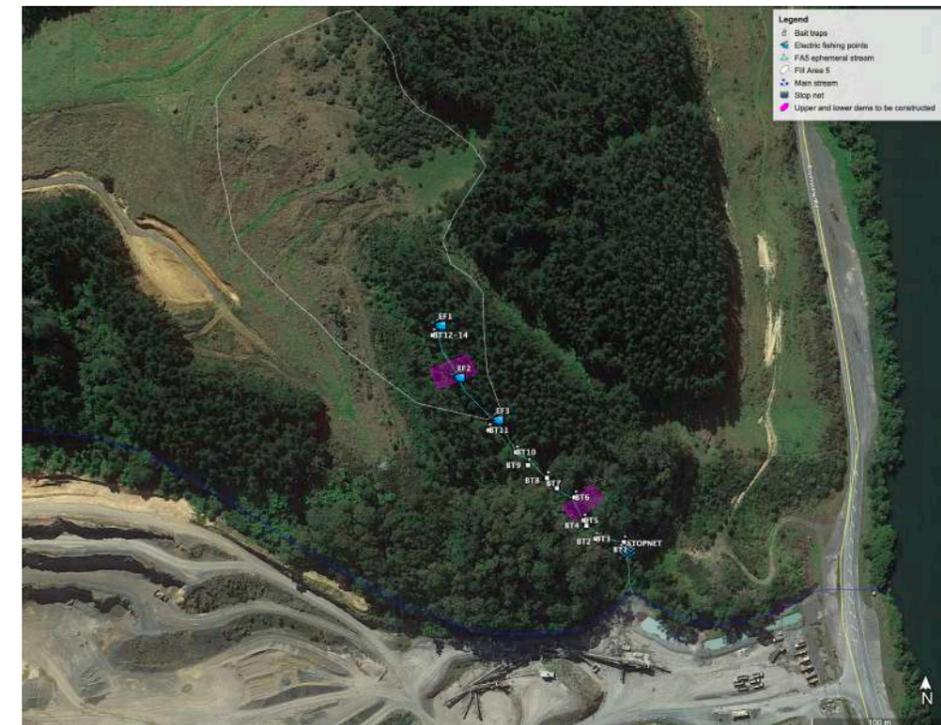
Figure 4: Map of Fill Area 5 and fish sampling points.

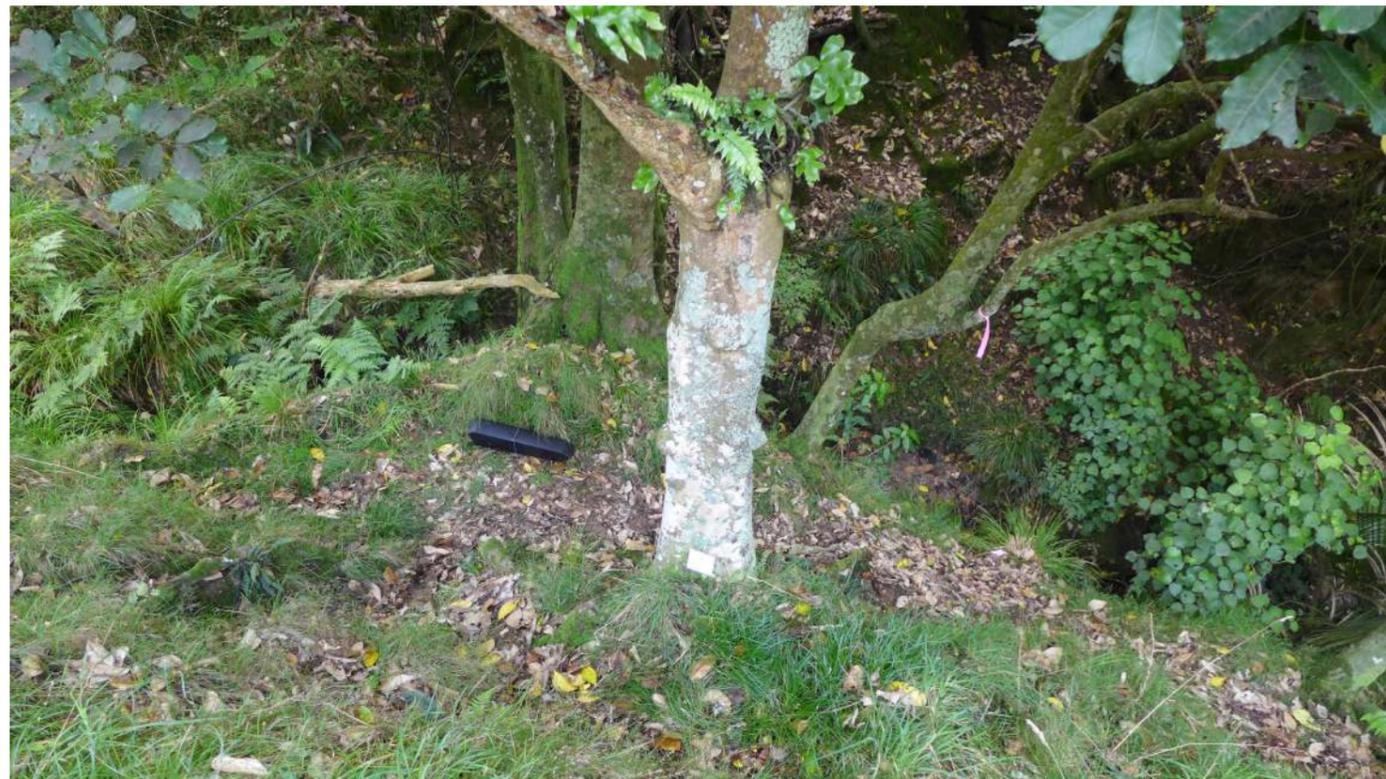
Figure 5: Tracking tunnel and chew card set in the south-western gully area of the SNA.

Pest animal monitoring is done to monitor the presence or absence of pest animal species at a given time and location in order to track changes over time. A monitoring event was done prior to pest animal traps being set to gauge baseline presence of pest animals. Monitoring involves placing ink tracking cards within 18 permanently placed tracking tunnels and placing 16 peanut butter filled chew cards on trees throughout the site. Tracking tunnels and chew cards are set for 2 nights during fine weather. Monitoring events will be done three times per year with the aim of tracking the presence of pest animals as a response to trapping and baiting operations. Further monitoring of possums will be done using wax tags and leg hold traps in order to obtain a residual trap catch index (RTCI), giving a more accurate relative population density of possums within the site.

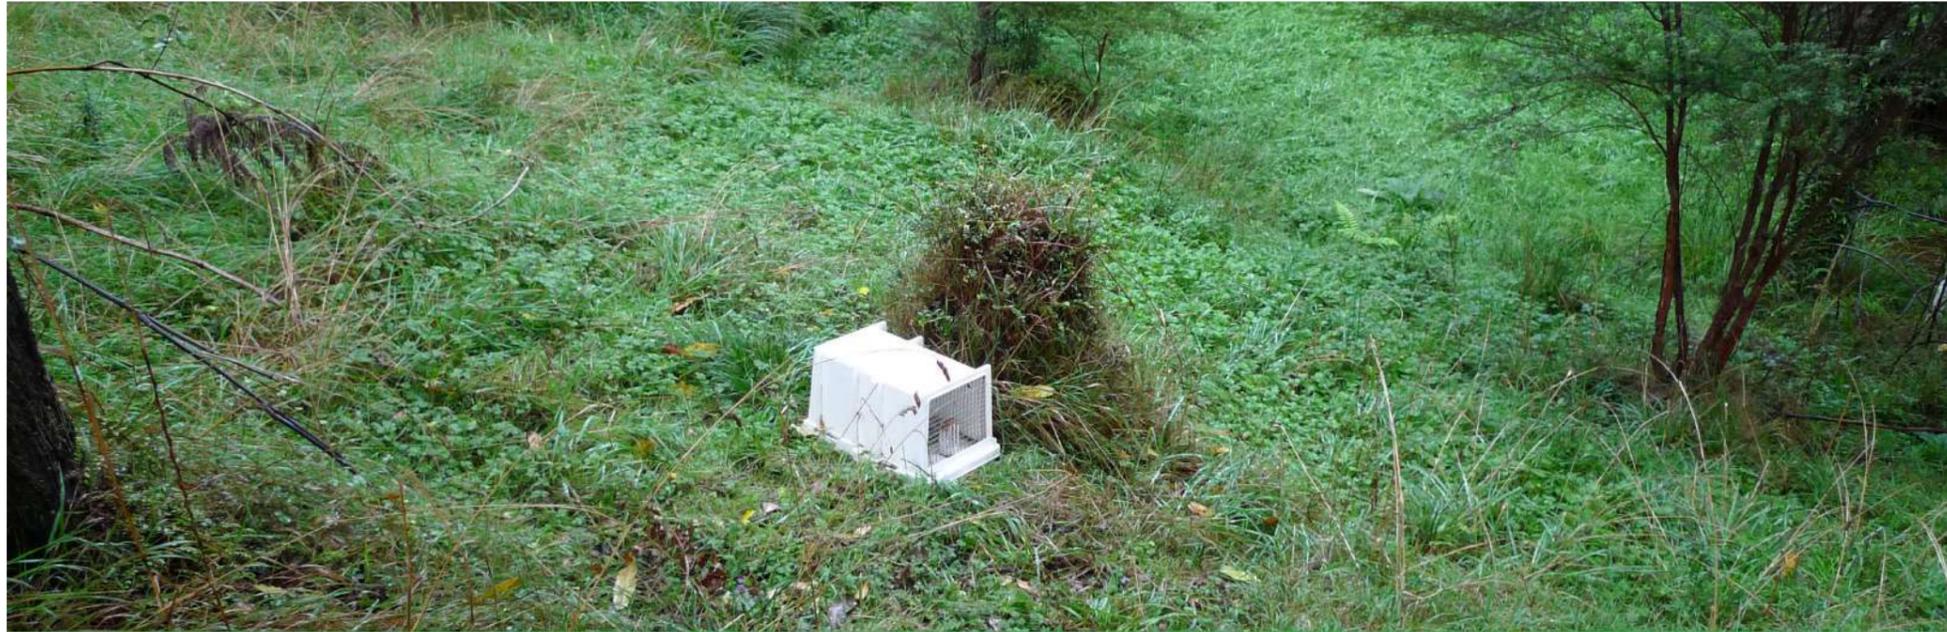
Figure 7: DOC200 baited with peanut butter within the gully forest.

23 DOC 200 traps (targeting rats, mice, mustelids and hedgehogs) and 5 Trapinator traps (targeting possums) were set up across the site during September and October 2021. Initially the traps were left empty and unset for a period of 2 weeks to allow the animals to get used to having them in the environment. The traps were baited with peanut butter but left unset for a further 2 weeks to encourage interaction with the traps. Trapping has occurred one a week with results detailed in the Table 2 (below). Trapping breaks occur approximately three times per year when catch rates decline, during this time traps are de-set and shifted to new locations with a pre-feed period of two weeks prior to being baited and set again.

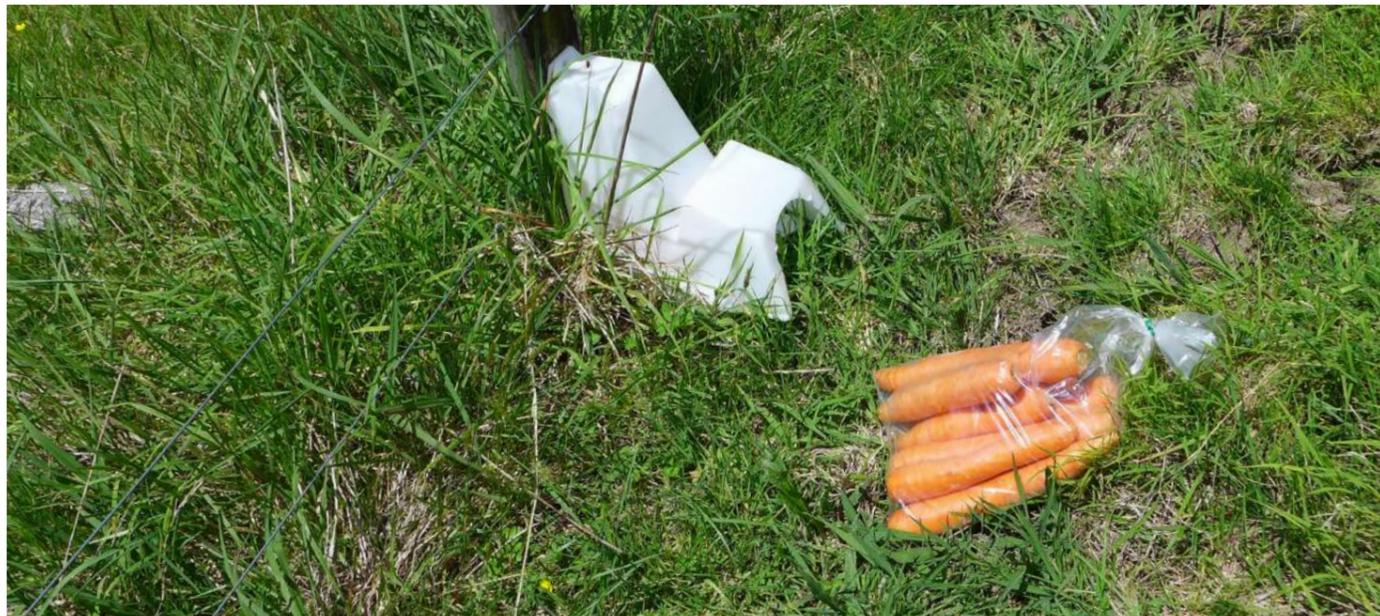
Figure 8: Pre-feeding bait station with carrots to encourage interaction.

11 bait stations (targeting hares, rabbits, rats and possums) were set up across the site during May 2021. The bait stations were initially left empty to allow animals to become familiar with them, as hares and rabbits are particularly neophobic. Carrots were used as a pre-feed bait for 2 weeks after this period to encourage interaction with the bait stations prior to poison bait being added. Four 'bait pulses' are scheduled each year, which involves a 2 week period of pre-feeding and a 4 week period of poisoning. 200g of bait is added to each bait station and amount taken is recorded on a weekly basis. Pindone is used in the hare and rabbit bait stations and brodifacoum used in the possum and rabbit bait stations. Two bait pulses have occurred so far, with a total of 4.4kg bait taken during December 2021 and a total of 8.8kg taken in April-May 2022.

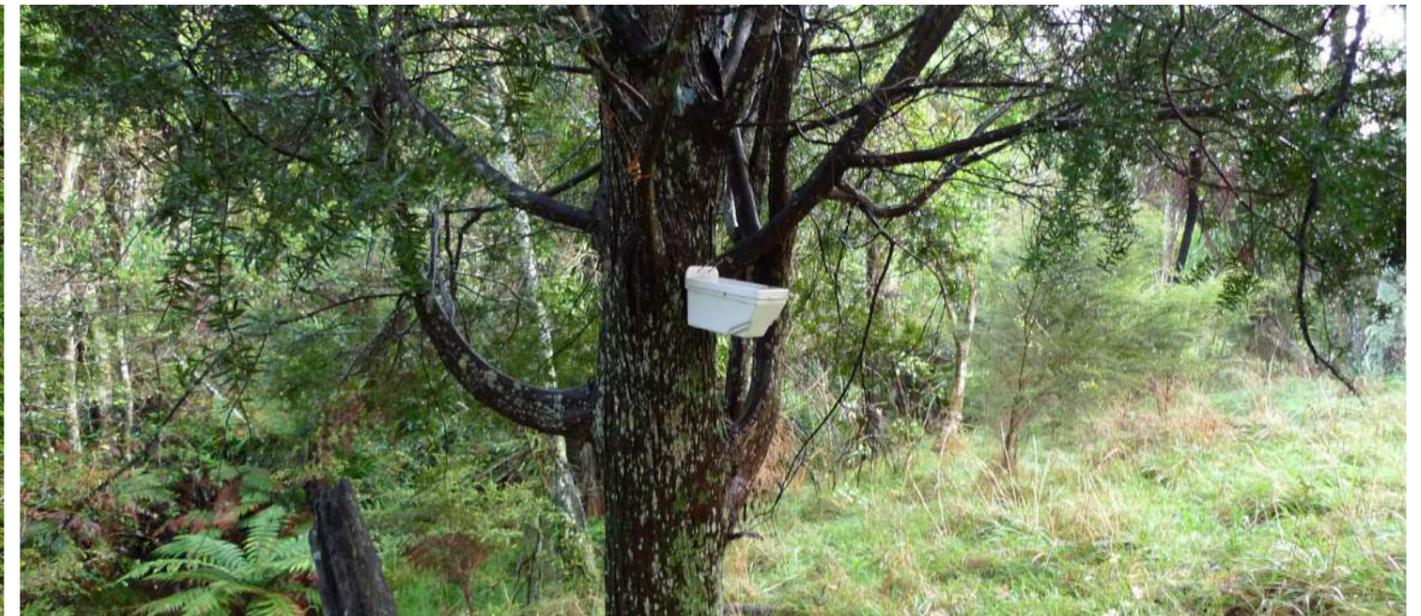
Figure 9: Trapinator trap set in a totara near the stream.

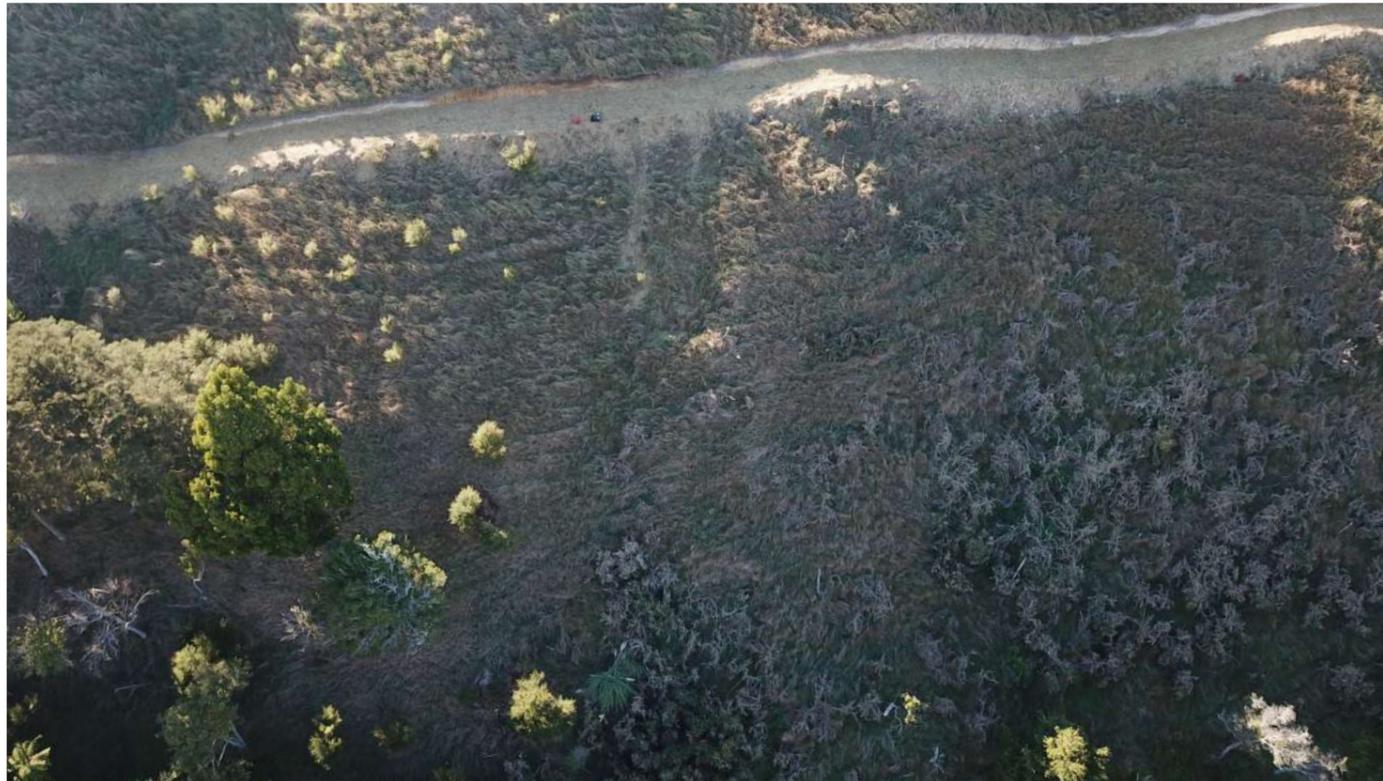
Figure 10: Sprayed gorse on the eastern edge of the SNA (March 2022).

Ligustrum sinense (Chinese privet) and *Ulex europaeus* (gorse) are the most prevalent pest plants on site, and have been targeted across the whole site with planting areas as a priority. Dead pest plants on the eastern boundary of the SNA as a result of aerial herbicide spraying in 2020 have been cut and piled to create room for planting. Where pest plants were not impacted by the herbicide application, they were removed using chainsaws and hand saws and the cut stumps pasted with glyphosate gel to prevent regrowth.

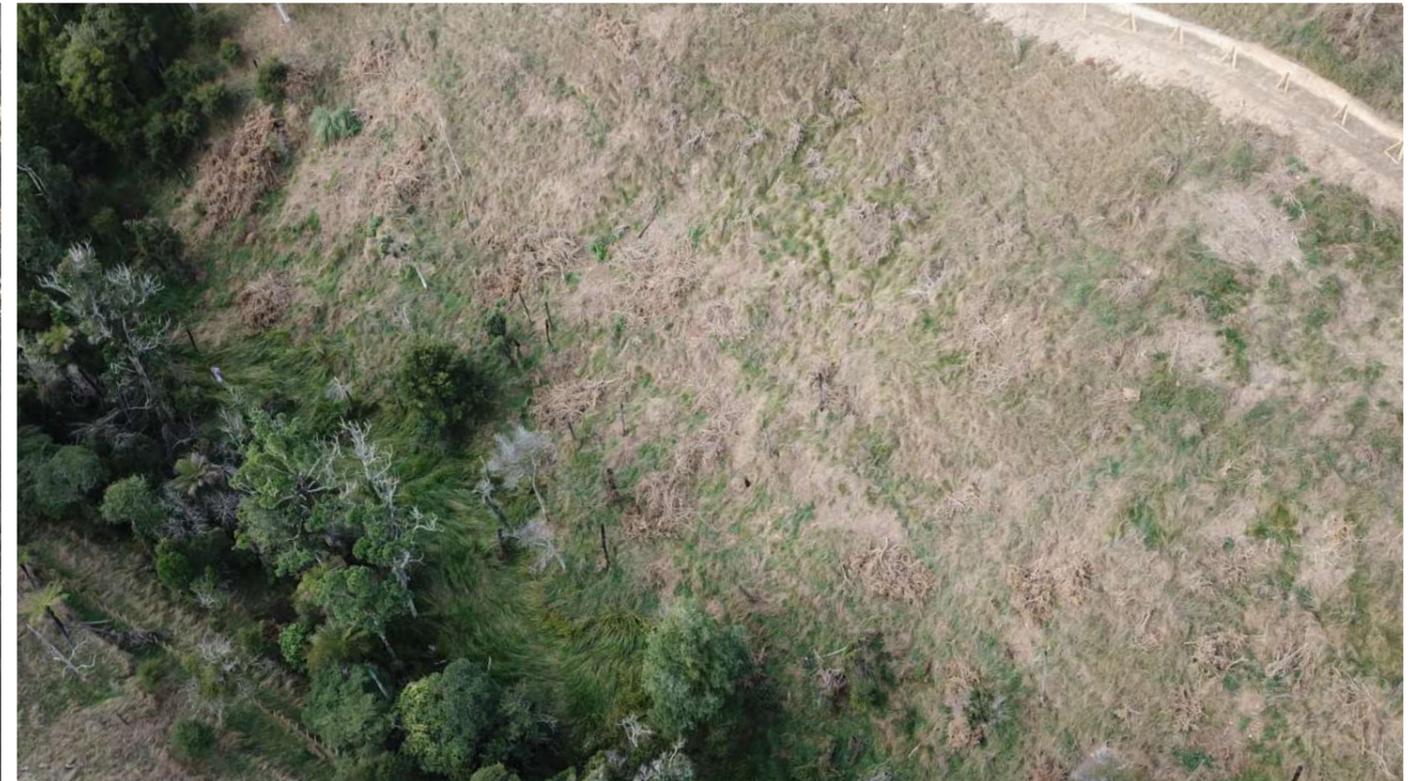
Figure 11: Gorse after being cut and piled (April 2022).

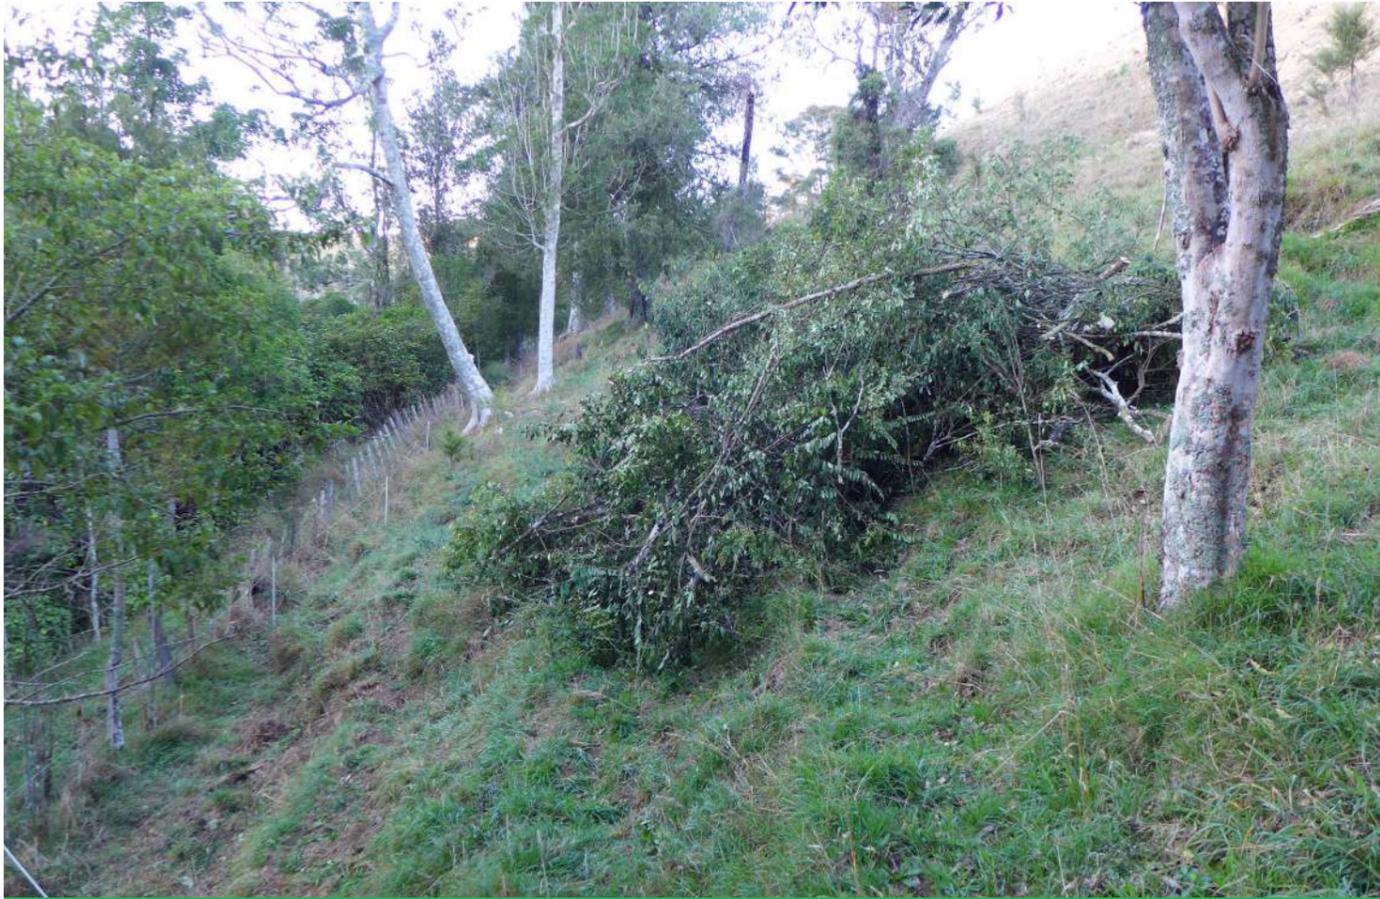
Figure 12: Chinese privet removed with chainsaws on the western side of the stream to prepare the area for planting.

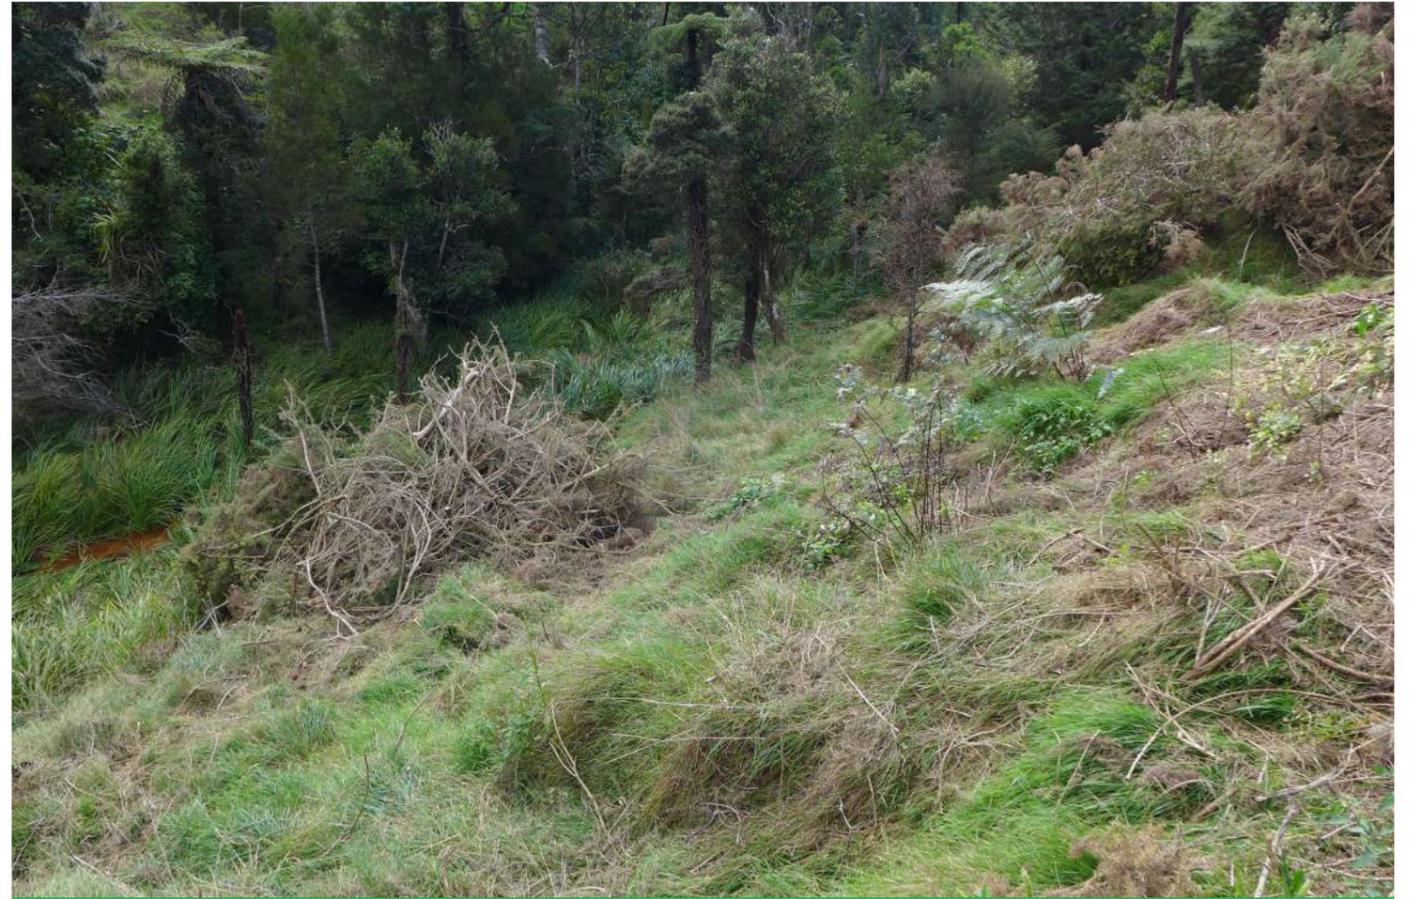
Figure 13: Gorse removed with chainsaws on the eastern side of the stream to prepare the area for planting.

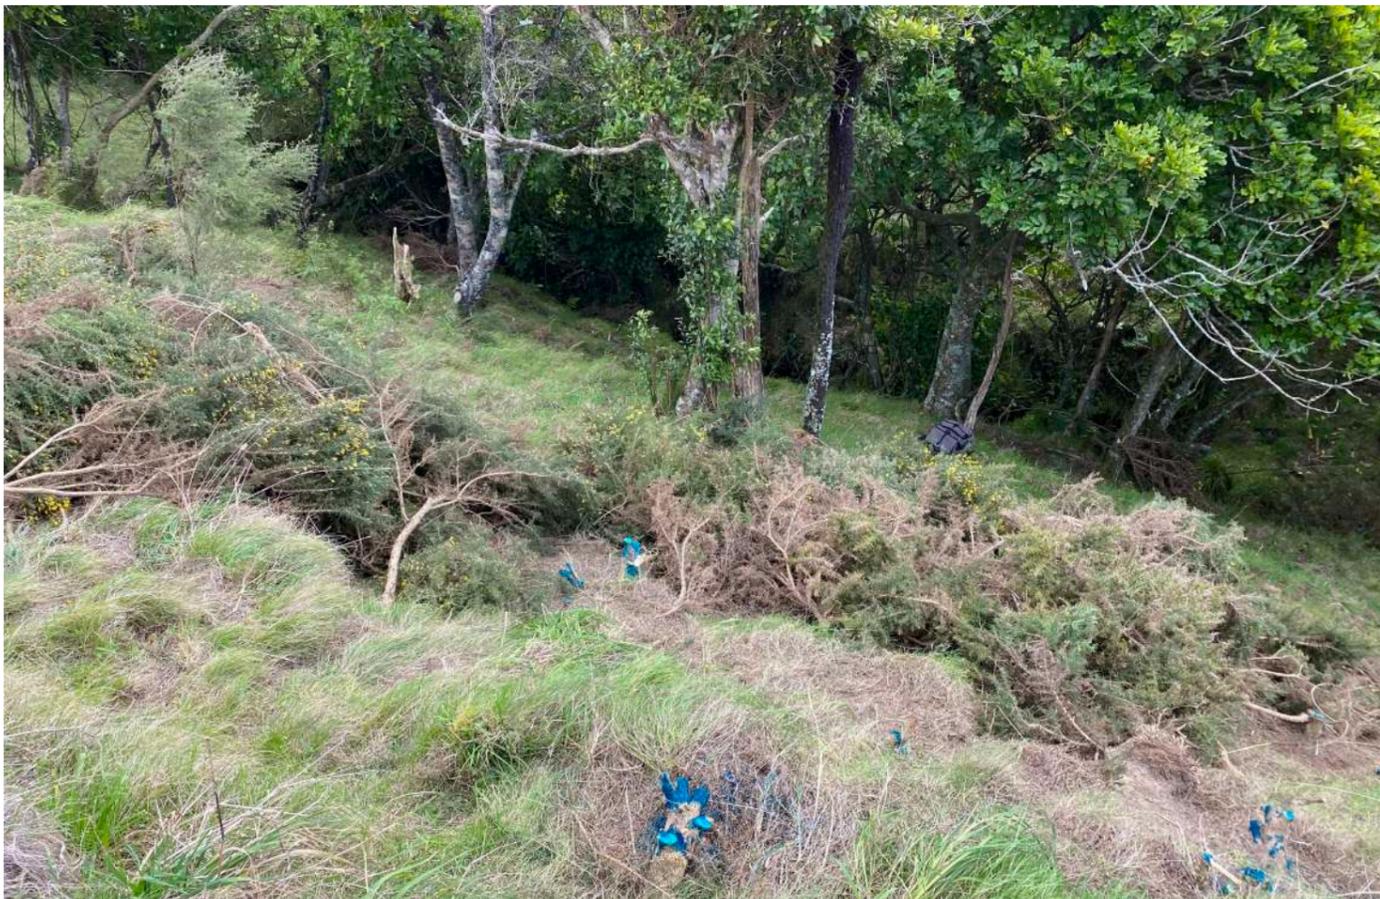
Figure 14: Gorse removed with a hand saw and grazon herbicide applied to cut stumps.

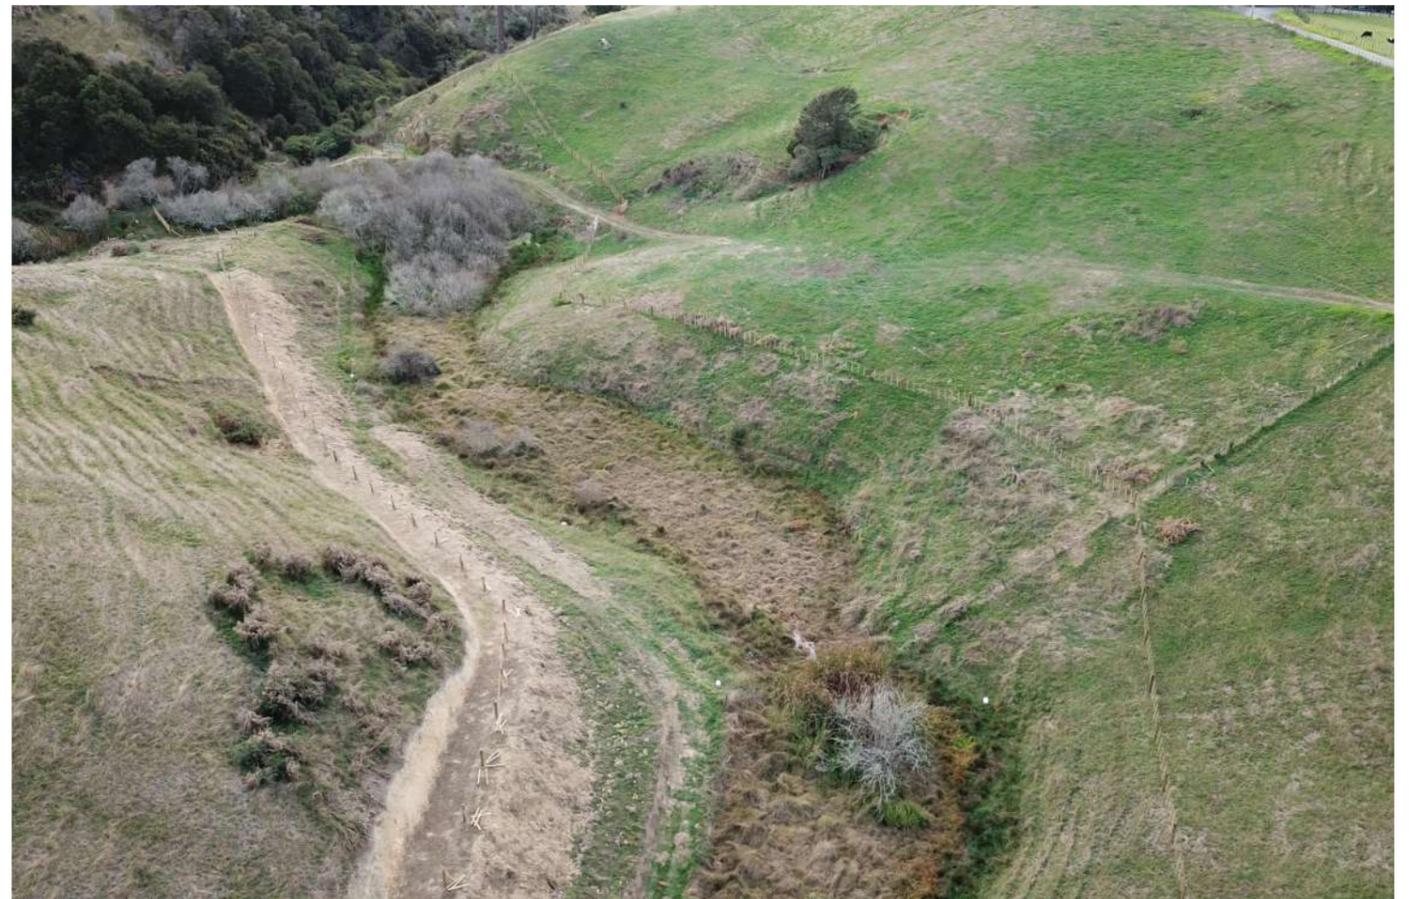
Figure 15: Results of willow poisoning and spraying of Mercer grass in the wetland.

An area of wetland approximately 1400m² at the northern end of the gully is dominated by mature *Salix cinerea* (grey willow). During September and October 2021 these willows were targeted using the drill and poison method (active ingredient: 540 g/L glyphosate). There has been an estimated 80% kill rate, with follow-up poisoning on remaining willows scheduled for the coming spring.

The exotic grass species *Paspalum distichum* (Mercer grass) was present within the wetland channel and formed a thick mat, hindering the establishment of native wetland species. This grass was targeted using herbicide application with a quick-reel and spray gun using 100 g/litre haloxyfop-P present as haloxyfop-P-methyl. This herbicide was also used to target small *Cordarteria selloana* (pampas) infestations at the top of the gully.

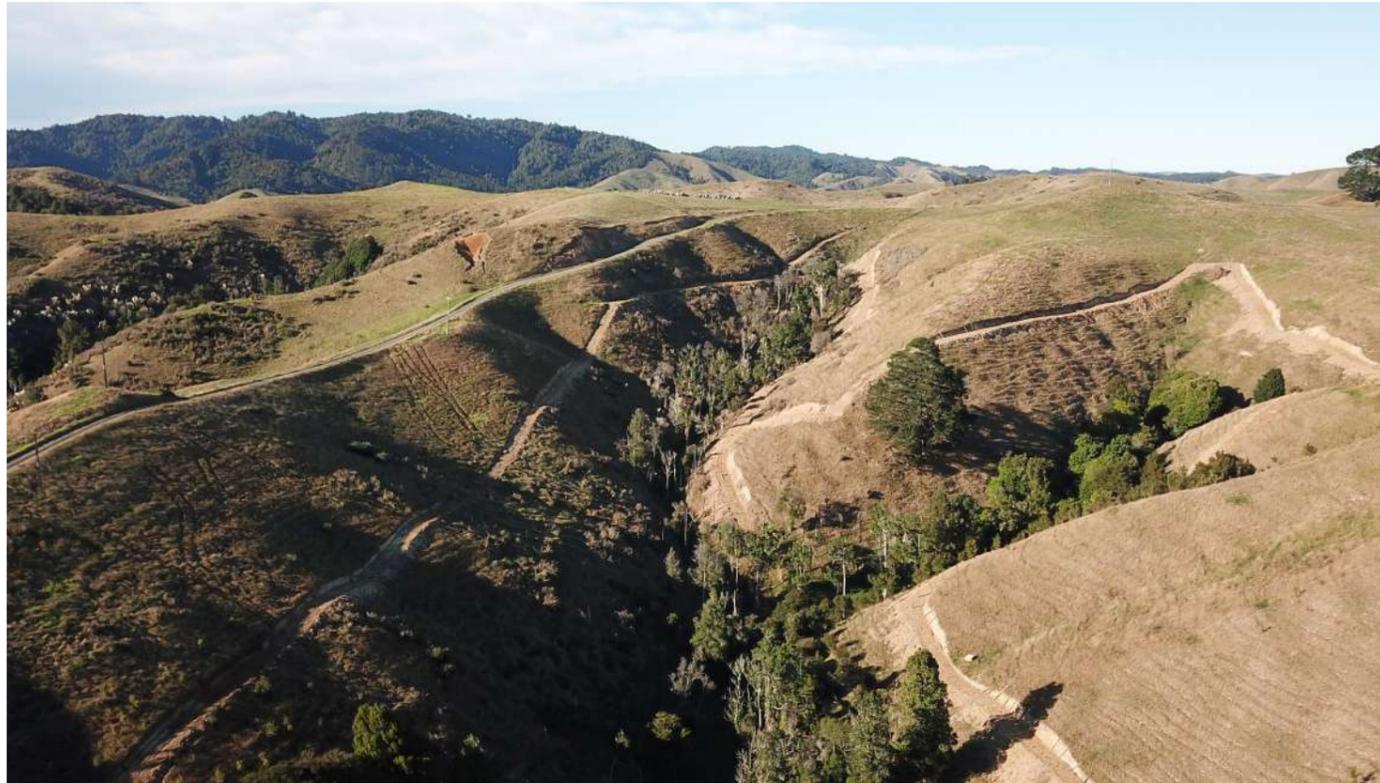
Figure 17: Fencing progress at the top of the gully, looking south. March 2022.

A seven-wire post and batten fence was completed around the entire perimeter of the SNA to prevent stock access. A bench was cut around much of the perimeter in order for the fence to be constructed and for ease of access for small mobile machinery. The benches were hay mulched to prevent erosion and encourage grass growth on the exposed soil.

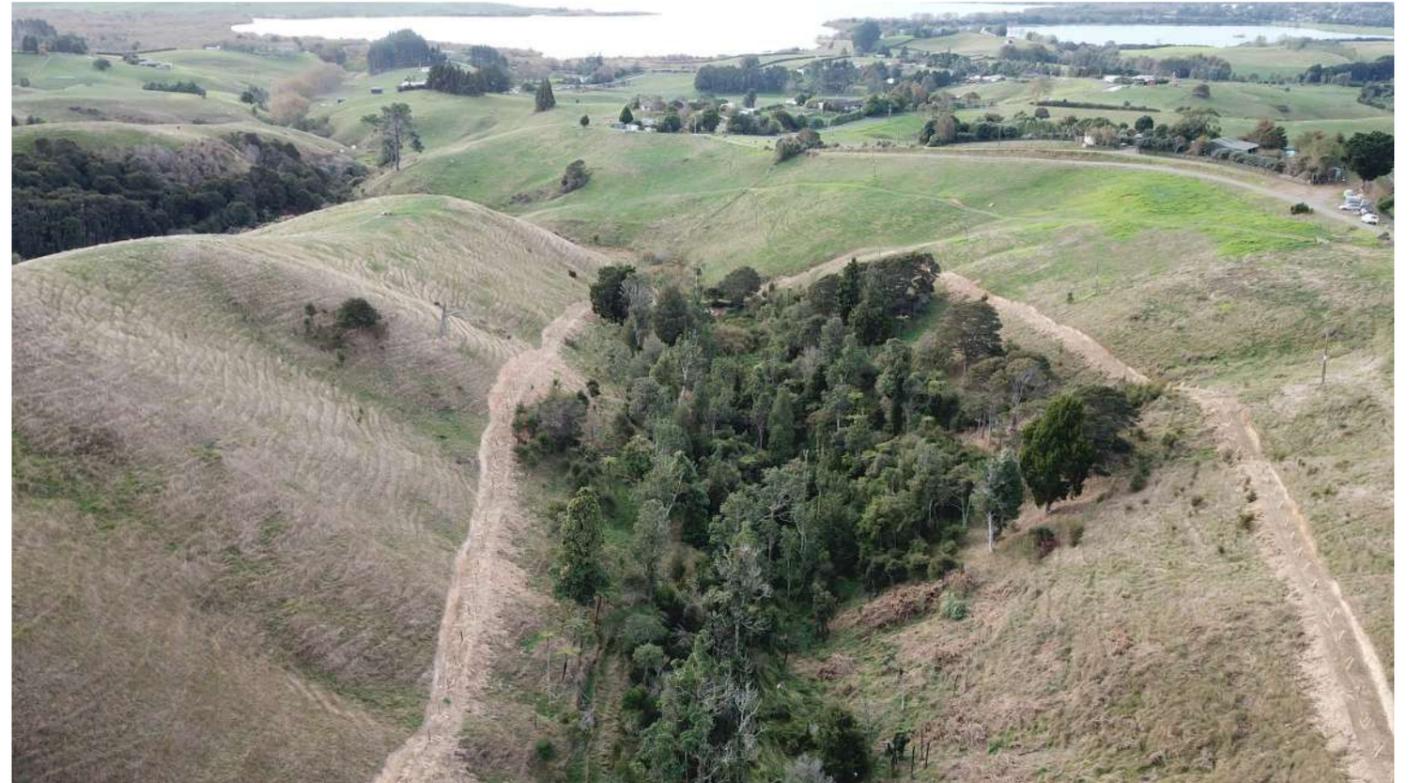
Figure 18: Fencing progress in the middle of the gully, looking north. March 2022.

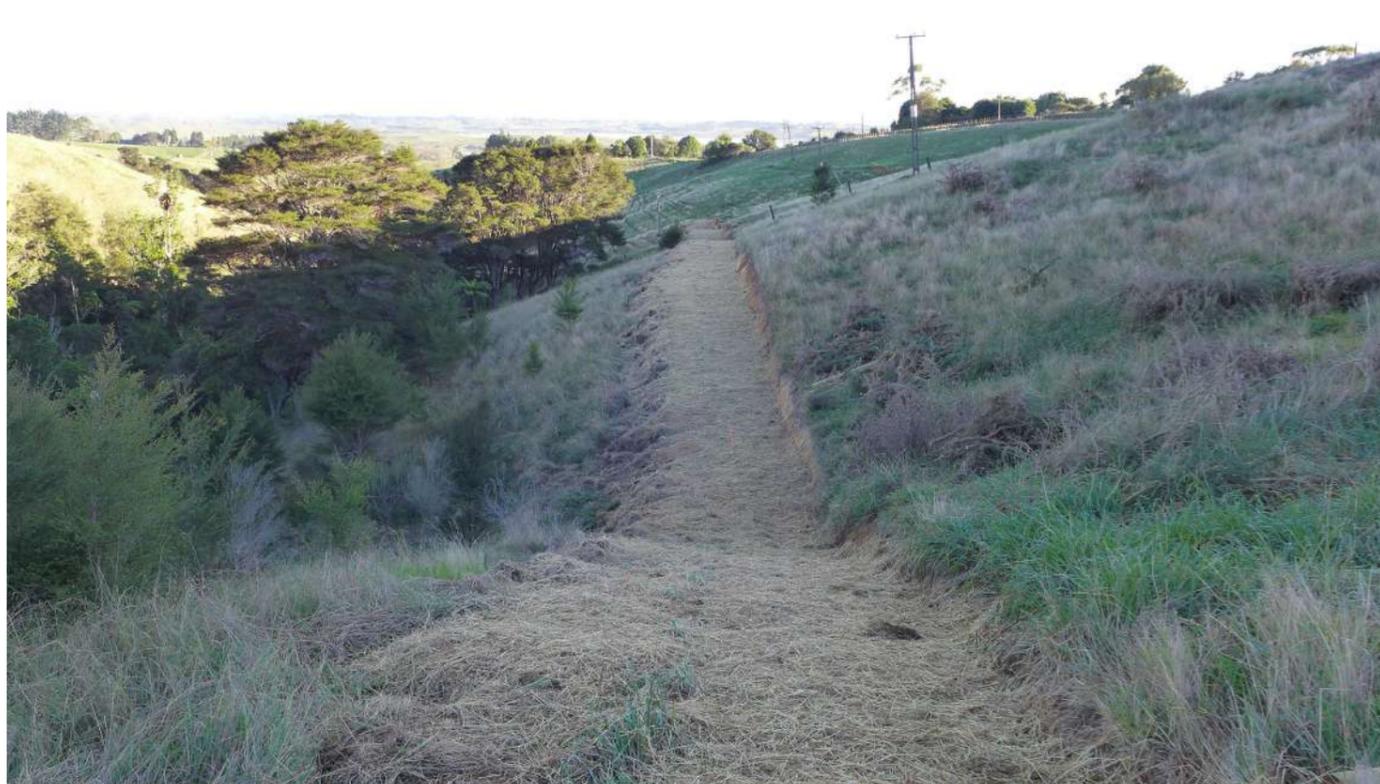
Figure 19: Hay applied to recently cut bench. March 2022.

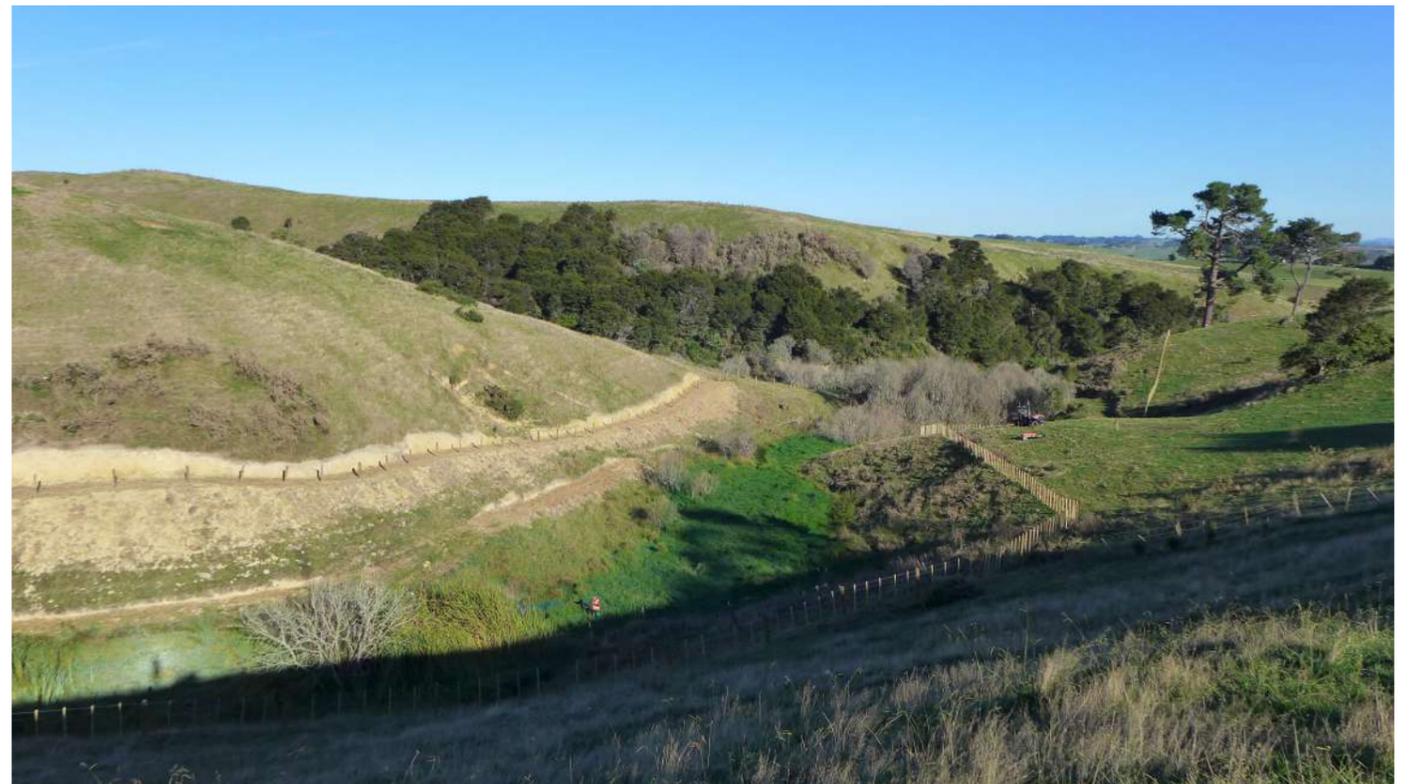
Figure 20: Fencing progress around the wetland, looking north-west. March 2022.

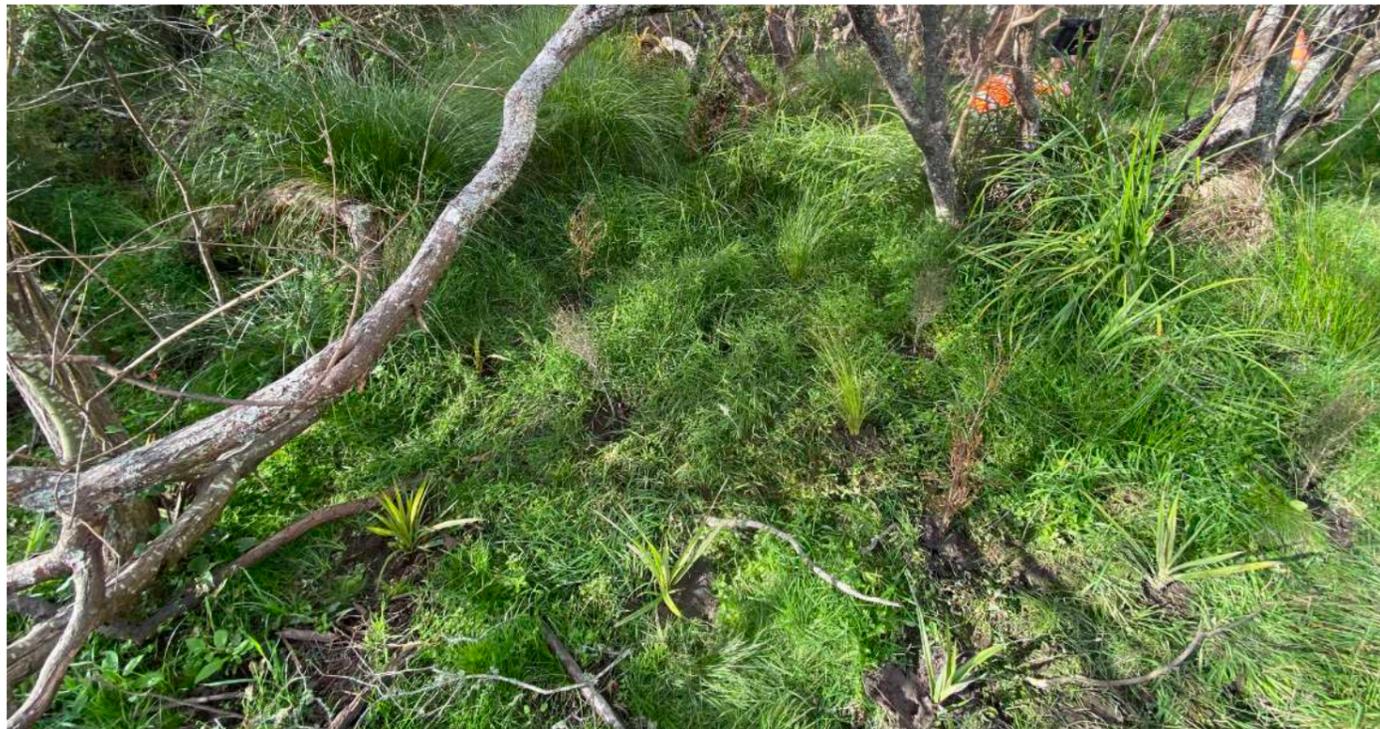
Figure 23: Planting the wetland area underneath dead willows.

The planting schedule involves approximately 14,200 plants across 12 areas situated around the SNA. The goal of the planting is to fill in bare areas that would otherwise be colonised by pest plants with the aim of creating contiguous canopy cover with existing remnant vegetation. A range of fast-growing pioneer species suited to the site were chosen, with slower-growing tree species characteristic of the local forest type to be added in once sufficient canopy cover has been achieved within the pioneer planting. Approximately half of the planting is complete. Measures of success for the planting will be estimated with the establishment of 5x5m plots within planting areas of each different habitat type. Growth of plants and establishment of new species will be monitored over time to ensure restoration goals are being met. A rain gauge has been set up on site to monitor monthly rainfall.

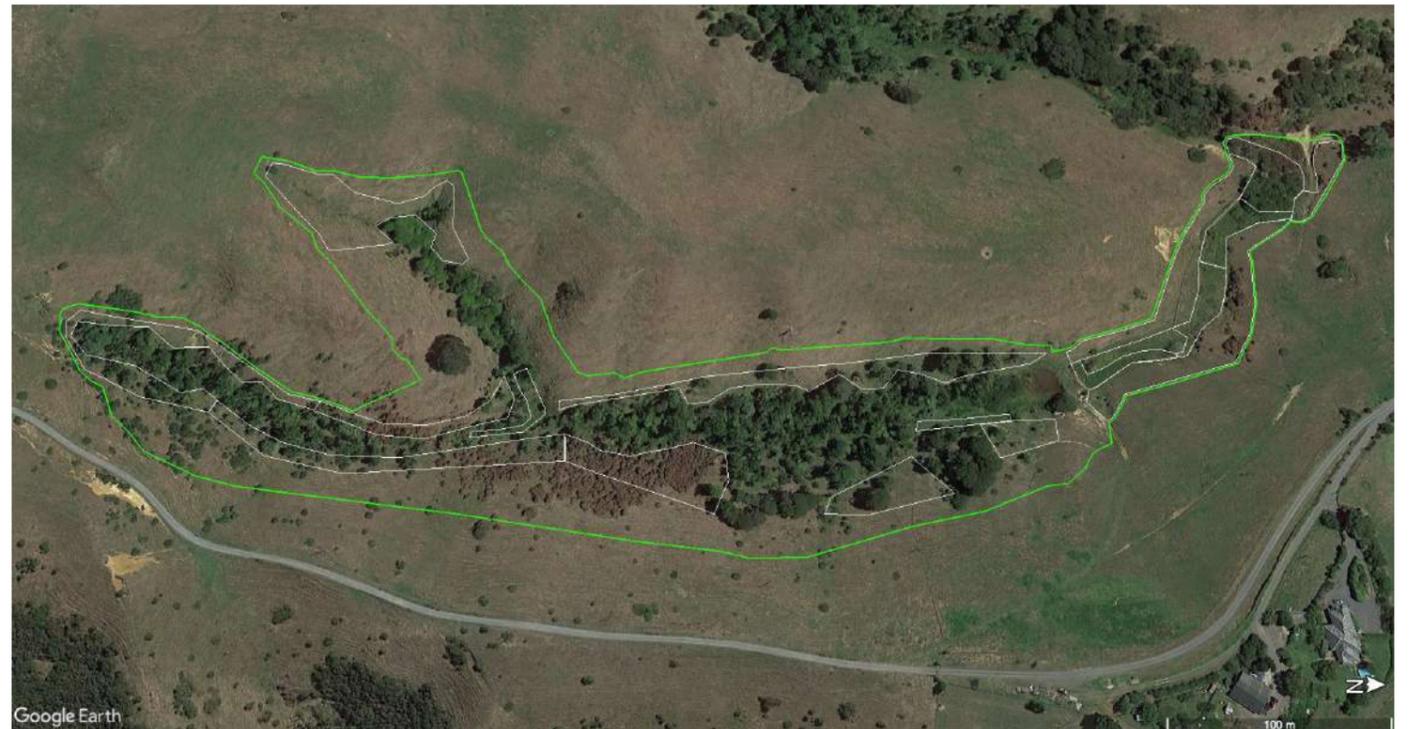
Figure 24: Map of fence line (green) and planting areas (white).
