Ecological Mitigation Monitoring Report

**Gleeson Huntly Quarry
Gleeson & Cox Ltd**

May 2022

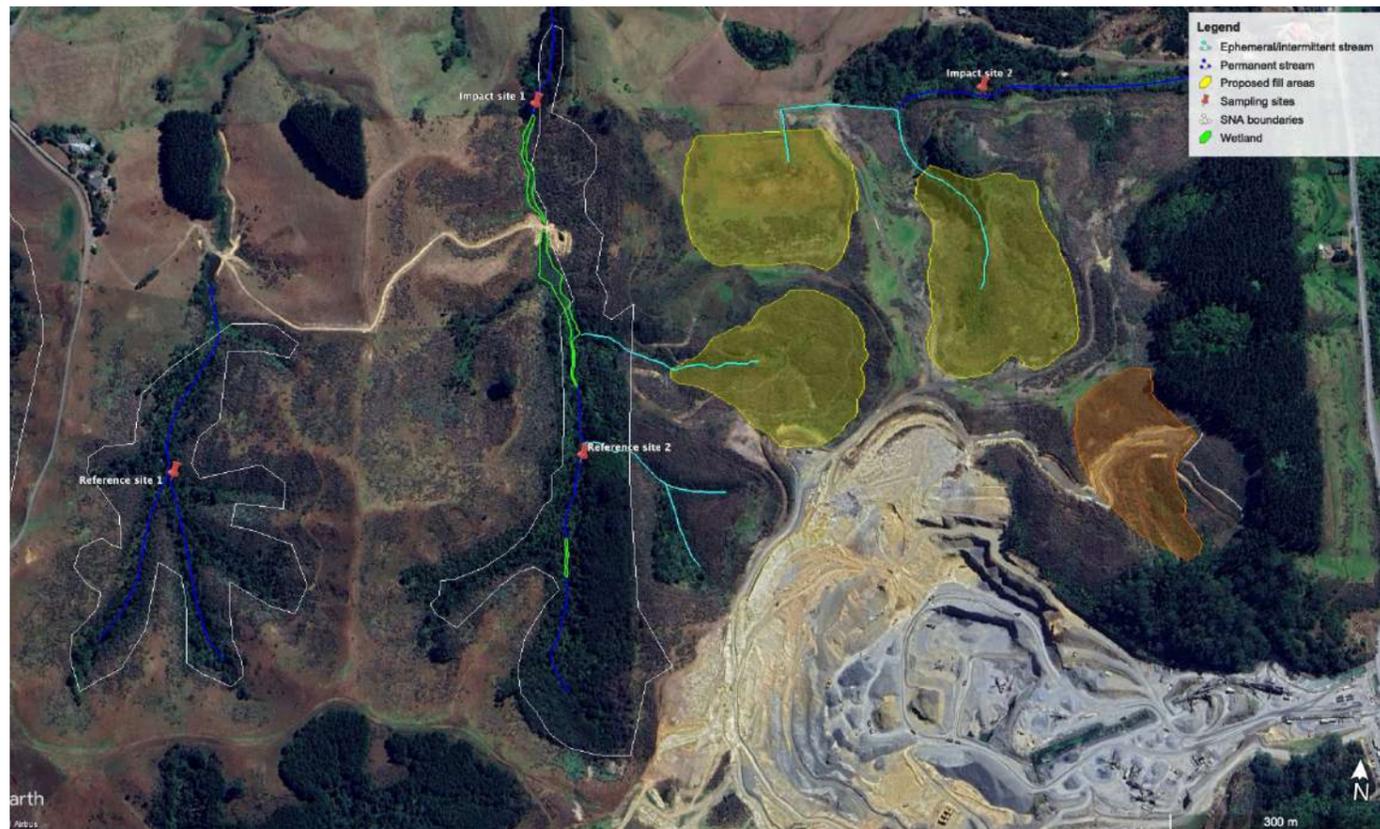
Figure 25: Map of macroinvertebrate sampling sites in relation to the quarry and fill areas.

Two reference sites and two impact sites were sampled to obtain MCI (Macroinvertebrate Community Index) values in order to gauge the baseline condition of watercourses that may potentially be impacted by three proposed fill areas. It is proposed that these sites will be monitored over time to track any changes in water quality, which will be evidenced by changes in the macroinvertebrate community. Both reference sites had MCI scores reflective of high water quality and a diverse assemblage of macroinvertebrates with a range of tolerances to pollution/nutrient enrichment. In contrast, both impact sites had MCI scores reflective of average to poor water quality and macroinvertebrate habitat, which is also indicative of moderate to severe pollution/nutrient enrichment. This may be attributed to the modified environment within the catchment, lack of suitable sampling areas (low flow conditions, lack of riffle habitat) and pollution/sedimentation from runoff from the surrounding land.

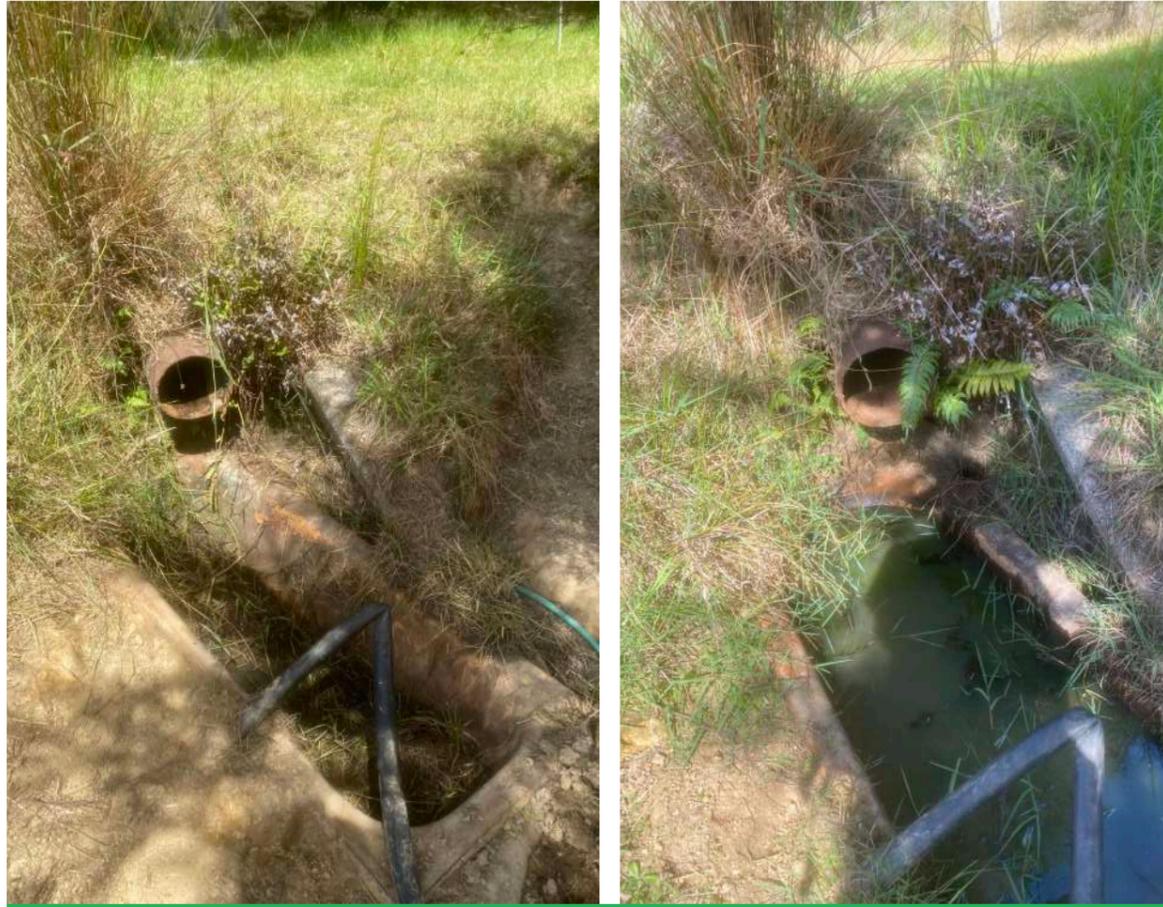
Figure 27: Perched culvert by pump shed in March 2022 (left) and May 2022 (right).

Two barriers to fish passage have been identified within the SNA that will need to be rectified to ensure native migratory fish are able to travel up and down the waterways. The barriers are perched culverts that are located at the outlet of the wetland at the northern end of the SNA and at the outlet of the pond by the pump shed (Figure 27). Under the Waikato Regional Plan (permitted activity rule 4.2.9.2), culverts are permitted as long as they provide for safe passage of fish both upstream and downstream. It is recommended that a fish ladder be installed at both culverts to allow for the migration of native fish up through the watercourse. A constructed ramp with a rough surface and V-shaped cross section would maintain a continuous low velocity flow between the culvert and the stream below, allowing easier access for migrating fish to travel up and down the stream.

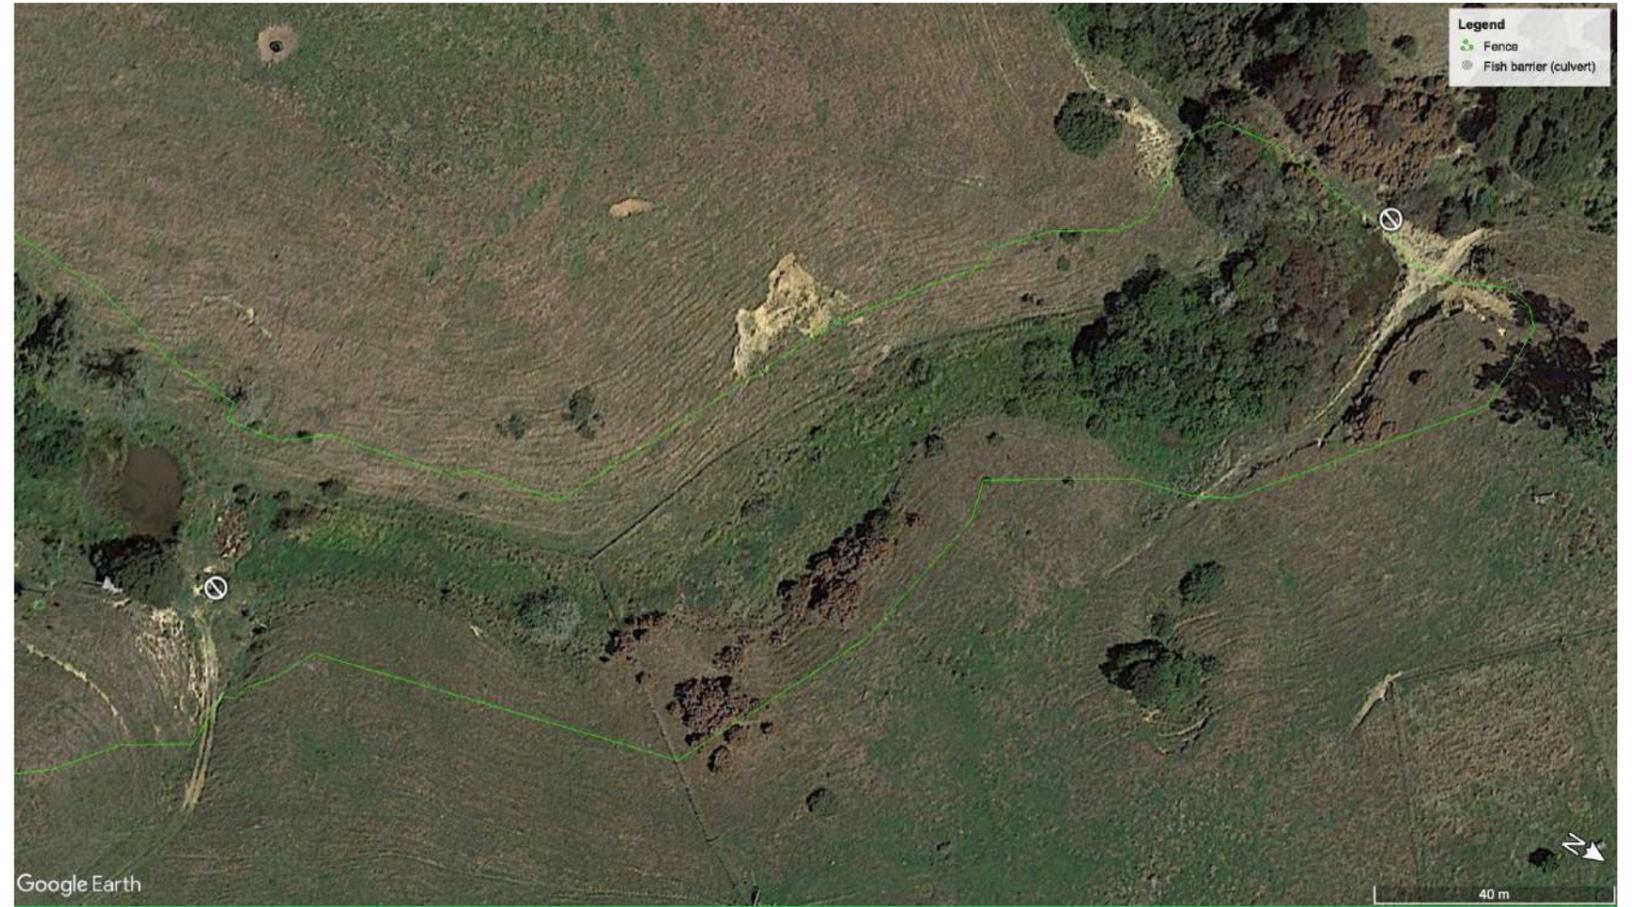
Figure 28: Map of northern end of SNA showing locations of fish barriers (perched culverts).
