Ecological Mitigation Monitoring Report

**Gleeson Huntly Quarry
Gleeson & Cox Ltd**

May 2022

This Ecological Mitigation Monitoring Report is required as a general condition under the operative resource consents, and details works completed in the preceding 12 months associated with the Ecological Management Plan.

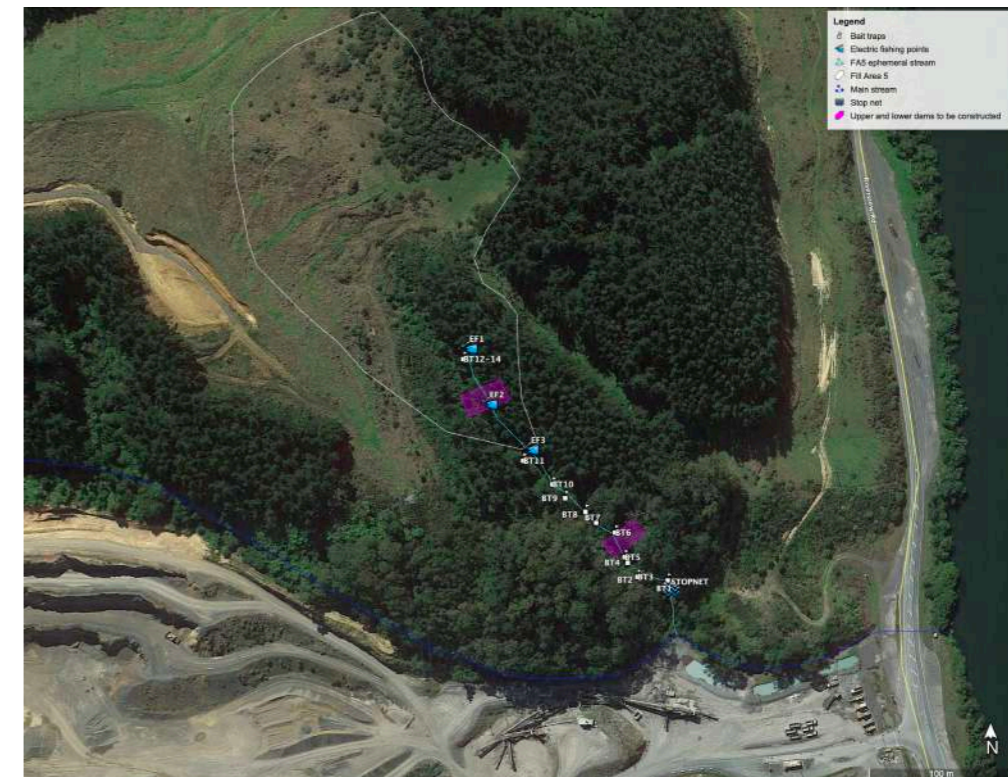
Figure 4: Map of Fill Area 5 and fish sampling points.

A stop net was constructed on the 17th May at the downstream end of the watercourse to prevent fish returning or migrating into the affected area. A total of 150 koura (*Paranephrops planifrons*) were captured and relocated over a three day period (17th - 20th May) using bait traps and hand searching, with the majority captured on the second day. Electrofishing was carried out in the upper section of watercourse but yielded no results. All koura (*Paranephrops planifrons*) were relocated downstream of the impact area in similar suitable habitat.

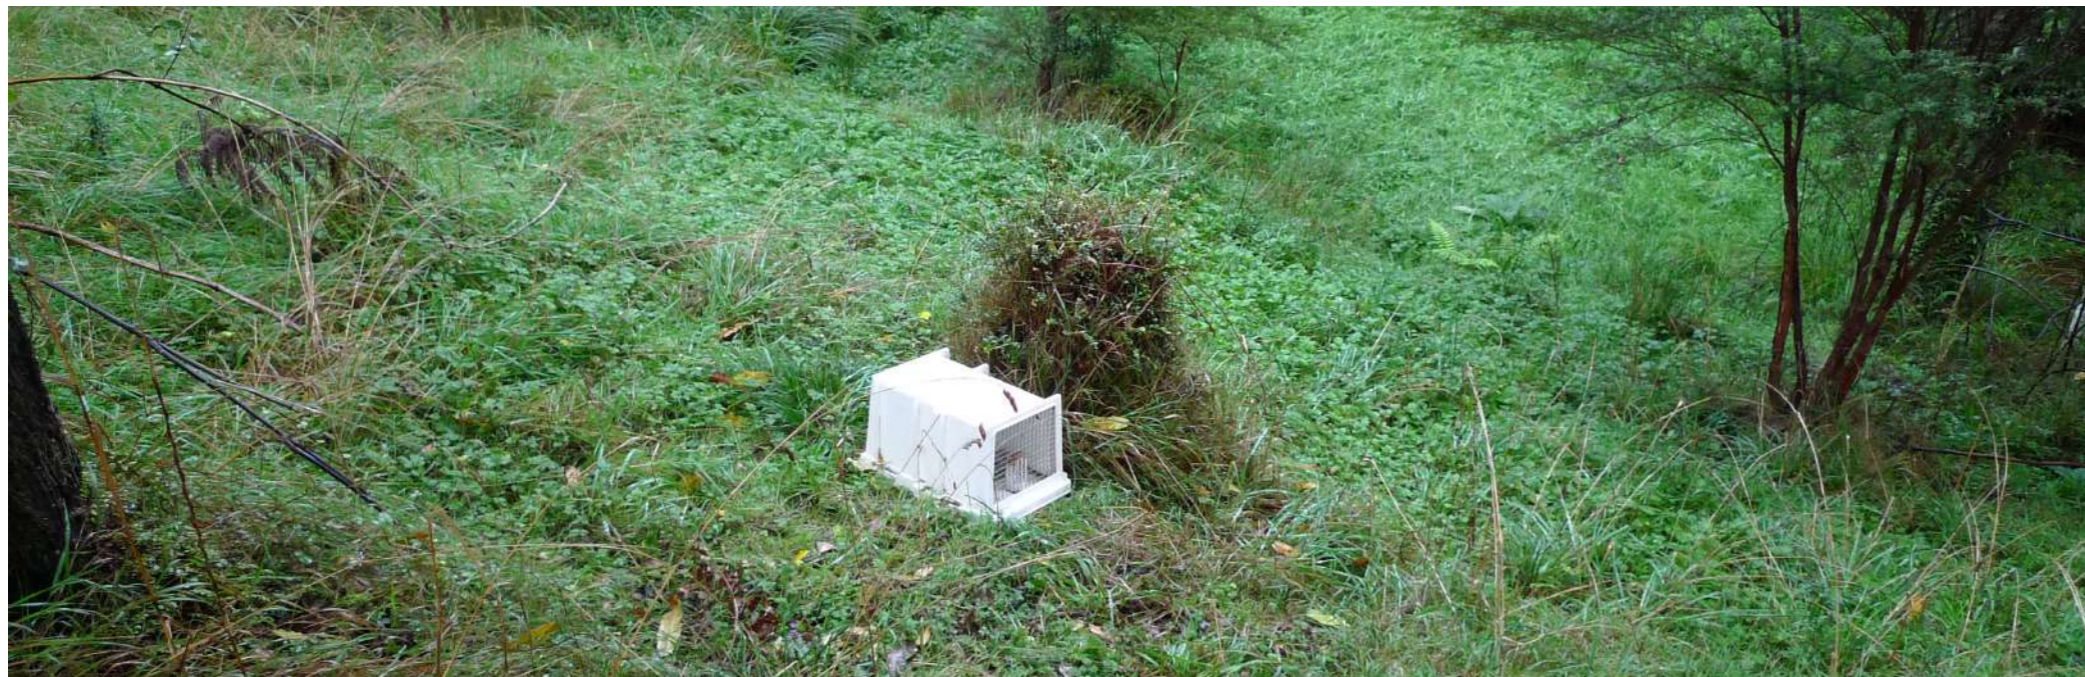
Figure 7: DOC200 baited with peanut butter within the gully forest.

23 DOC 200 traps (targeting rats, mice, mustelids and hedgehogs) and 5 Trapinator traps (targeting possums) were set up across the site during September and October 2021. Initially the traps were left empty and unset for a period of 2 weeks to allow the animals to get used to having them in the environment. The traps were baited with peanut butter but left unset for a further 2 weeks to encourage interaction with the traps. Trapping has occurred one a week with results detailed in the Table 2 (below). Trapping breaks occur approximately three times per year when catch rates decline, during this time traps are de-set and shifted to new locations with a pre-feed period of two weeks prior to being baited and set again.

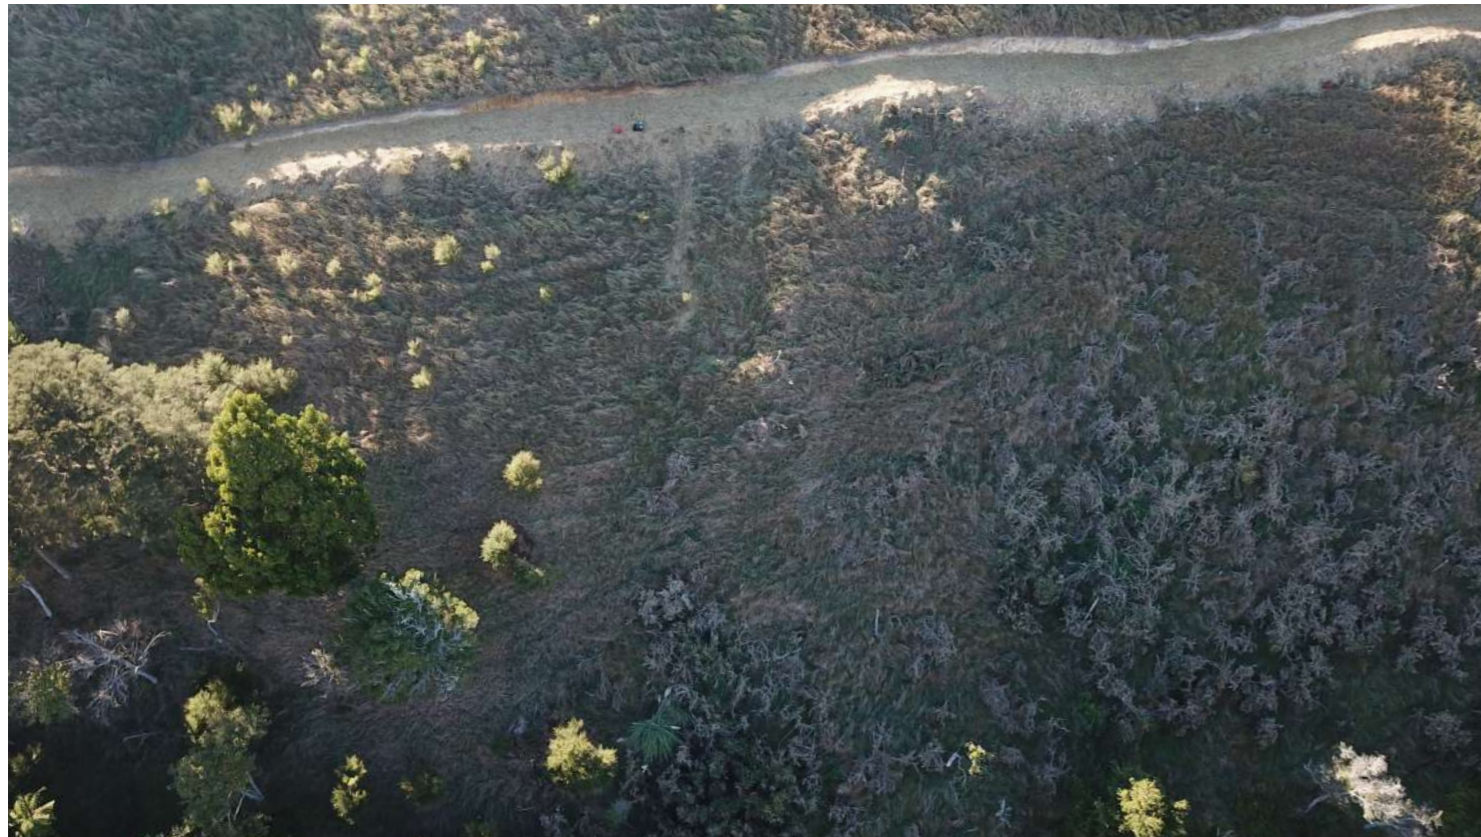
Figure 10: Sprayed gorse on the eastern edge of the SNA (March 2022).

Ligustrum sinense (Chinese privet) and *Ulex europaeus* (gorse) are the most prevalent pest plants on site, and have been targeted across the whole site with planting areas as a priority. Dead pest plants on the eastern boundary of the SNA as a result of aerial herbicide spraying in 2020 have been cut and piled to create room for planting. Where pest plants were not impacted by the herbicide application, they were removed using chainsaws and hand saws and the cut stumps pasted with glyphosate gel to prevent regrowth.

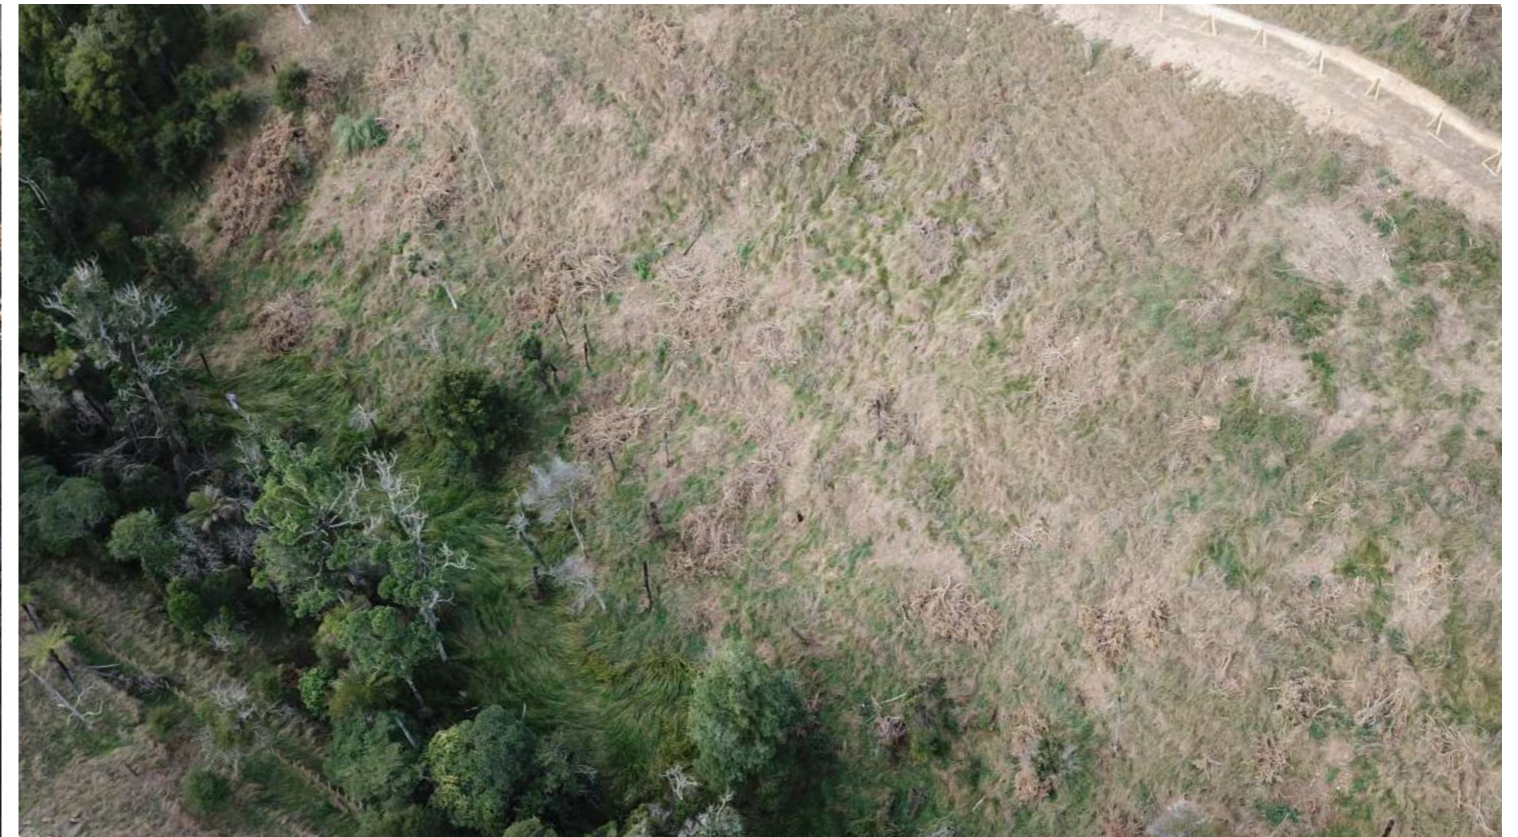
Figure 11: Gorse after being cut and piled (April 2022).

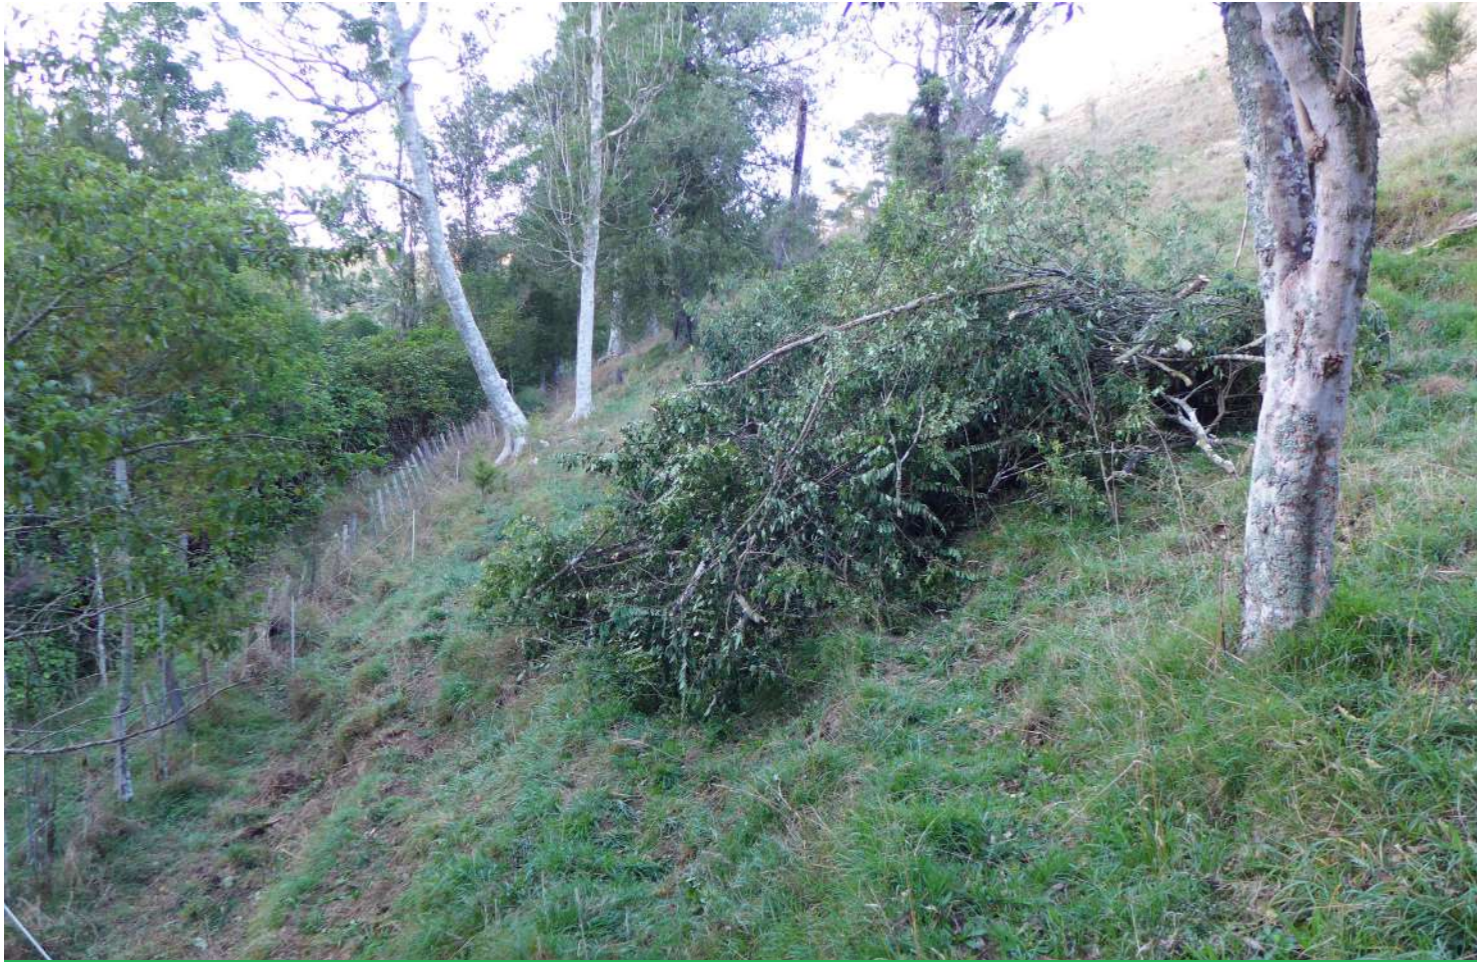
Figure 12: Chinese privet removed with chainsaws on the western side of the stream to prepare the area for planting.

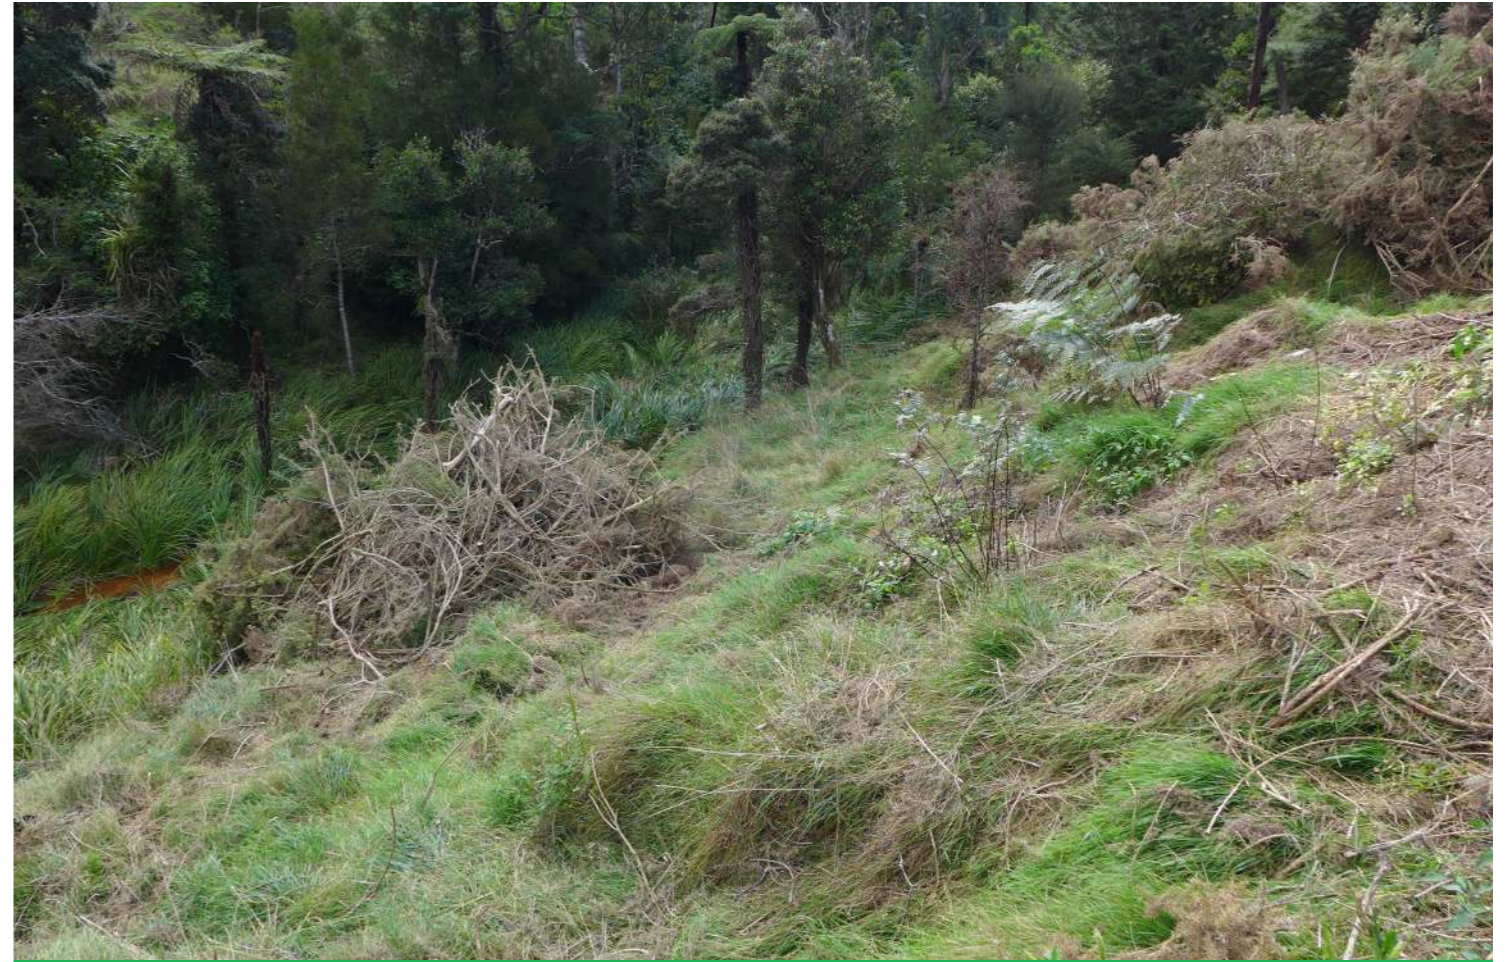
Figure 13: Gorse removed with chainsaws on the eastern side of the stream to prepare the area for planting.

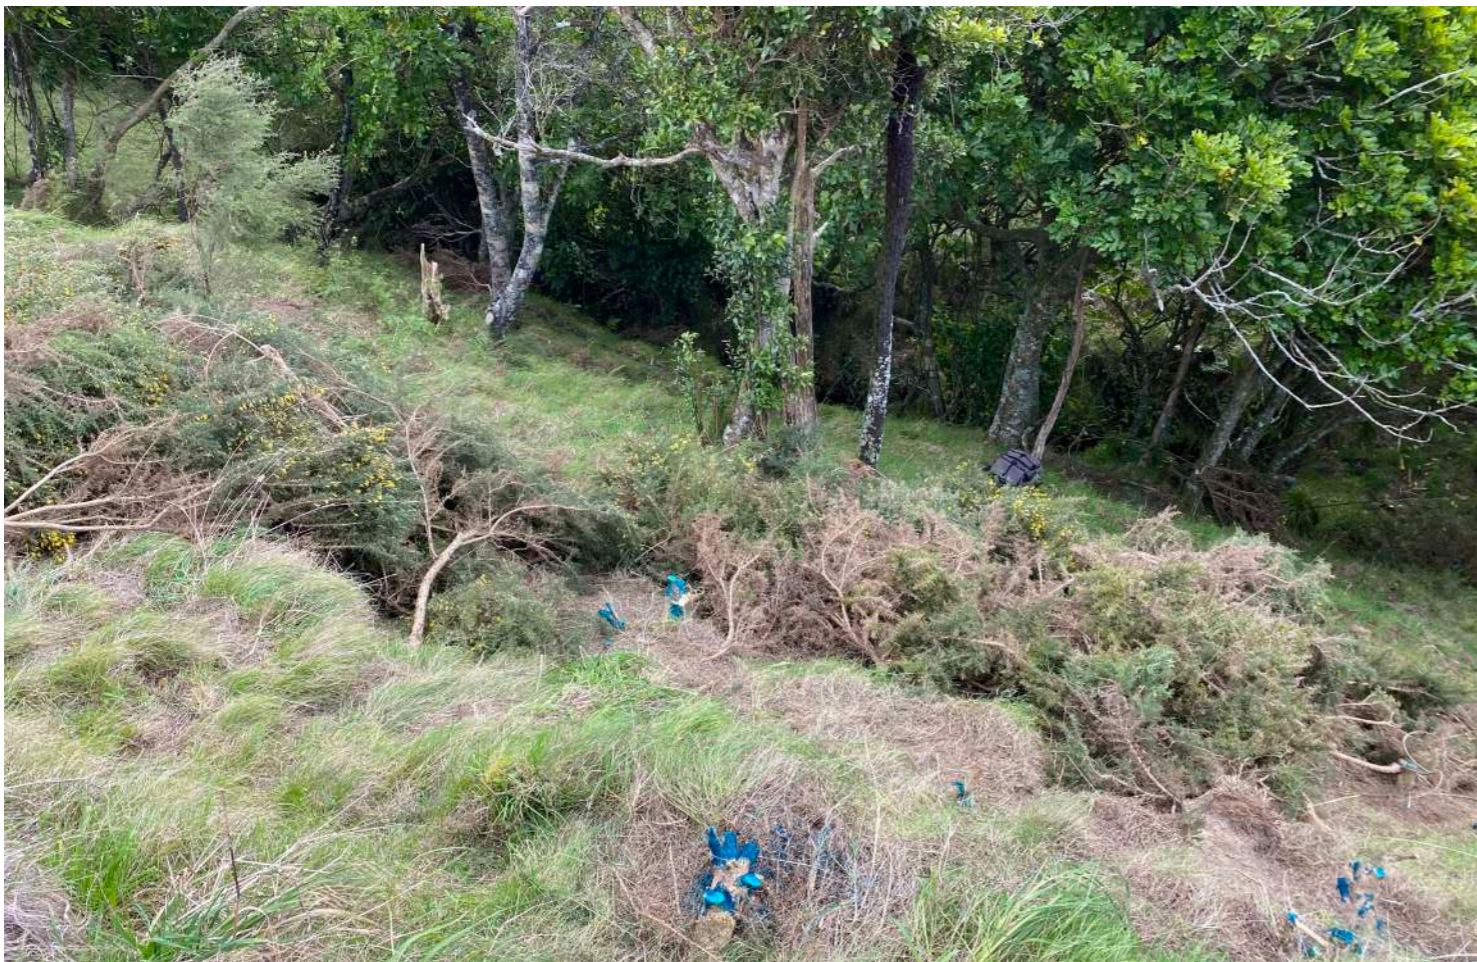
Figure 14: Gorse removed with a hand saw and grazon herbicide applied to cut stumps.

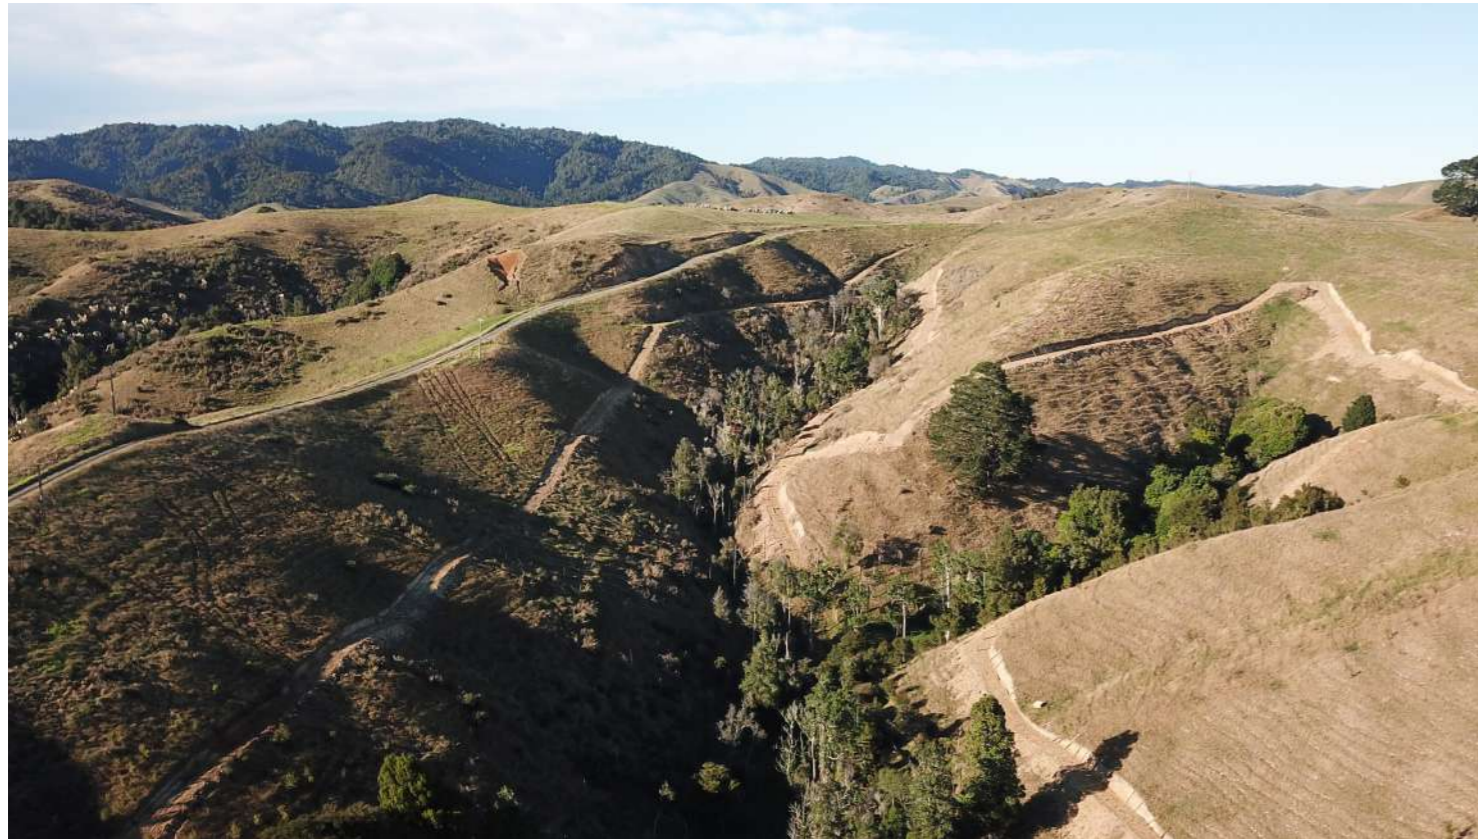
Figure 17: Fencing progress at the top of the gully, looking south. March 2022.

A seven-wire post and batten fence was completed around the entire perimeter of the SNA to prevent stock access. A bench was cut around much of the perimeter in order for the fence to be constructed and for ease of access for small mobile machinery. The benches were hay mulched to prevent erosion and encourage grass growth on the exposed soil.

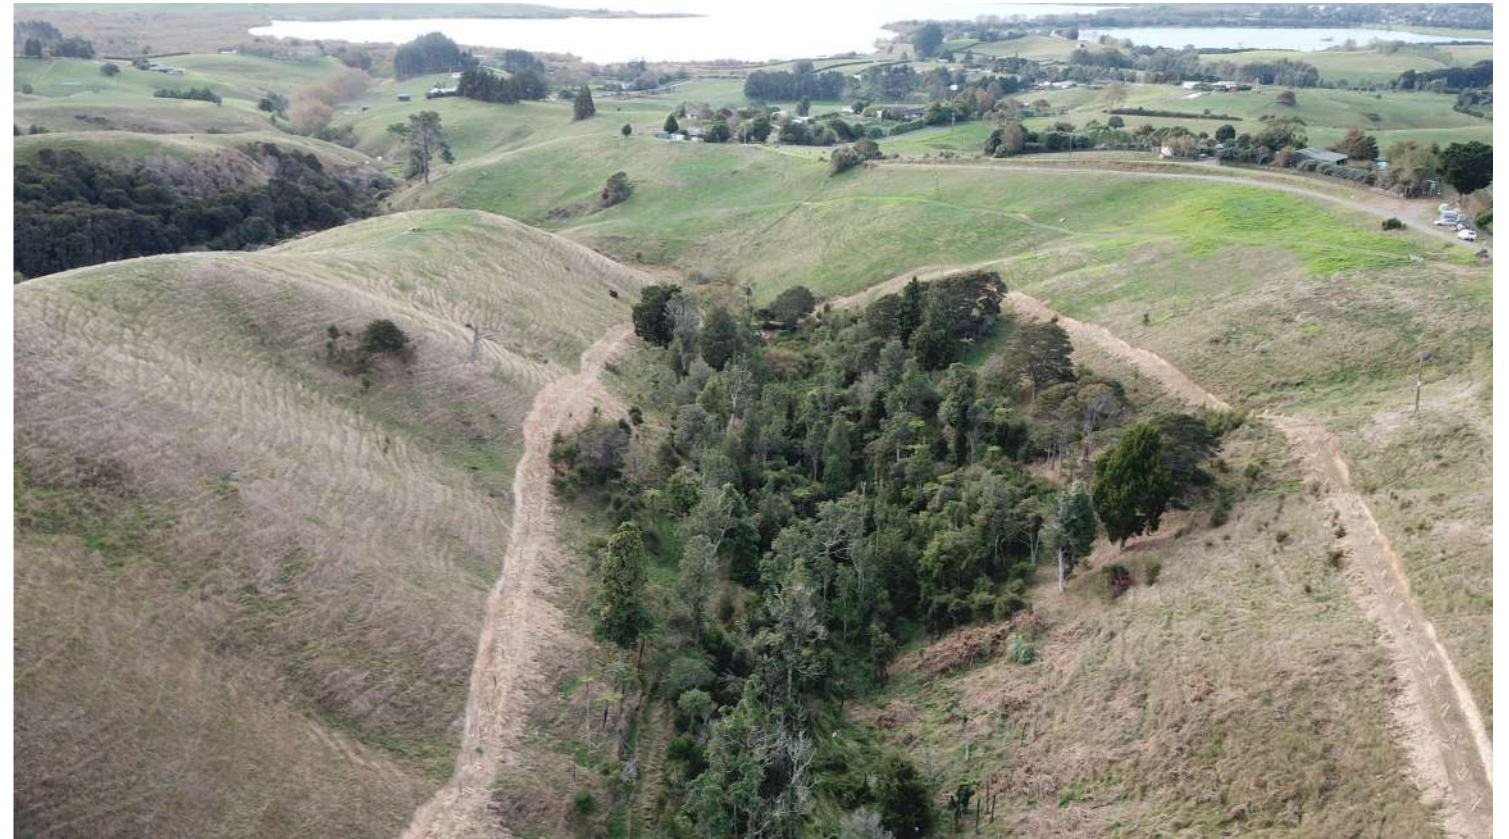
Figure 18: Fencing progress in the middle of the gully, looking north. March 2022.

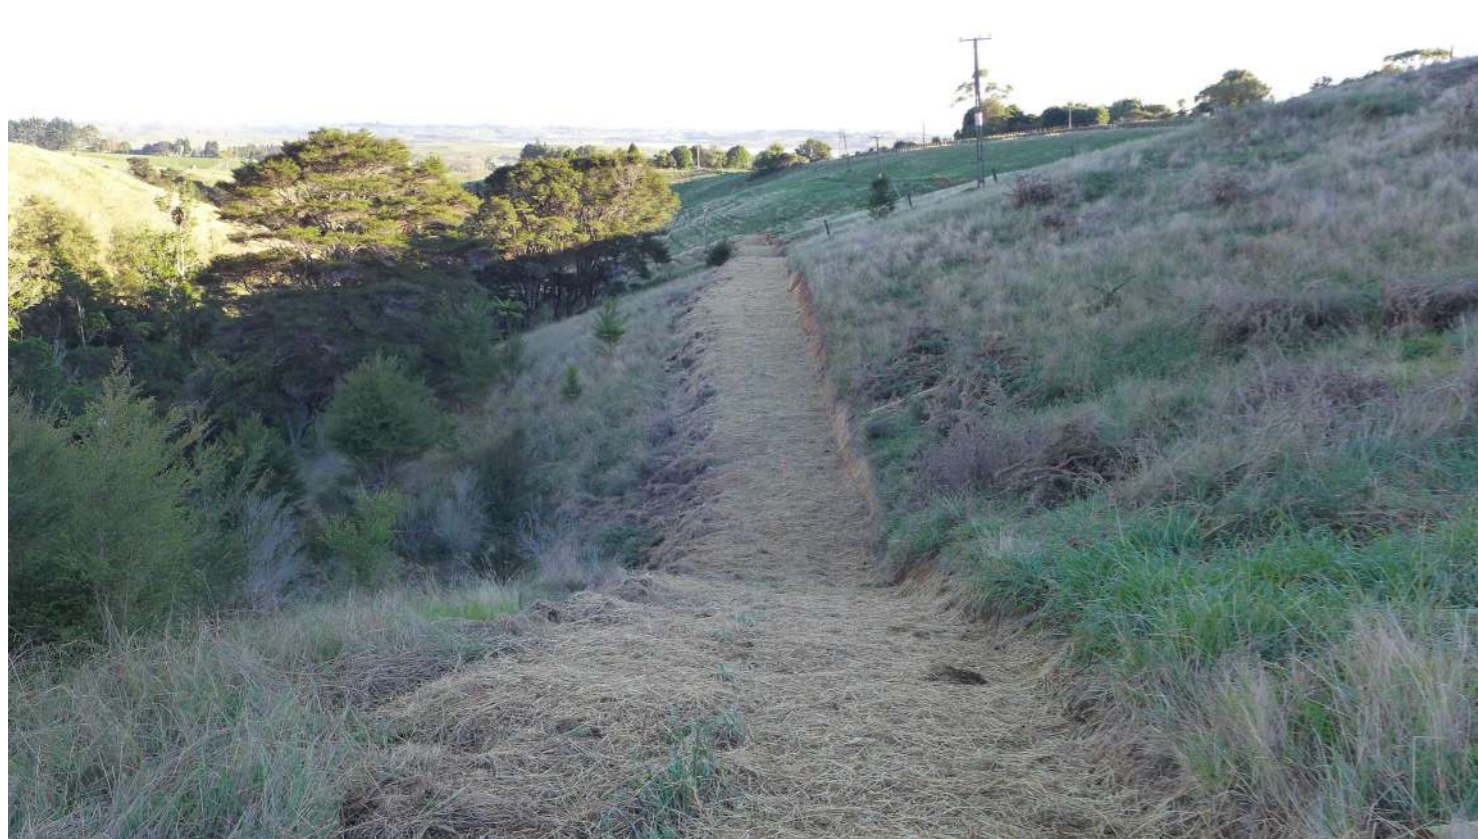
Figure 19: Hay applied to recently cut bench. March 2022.

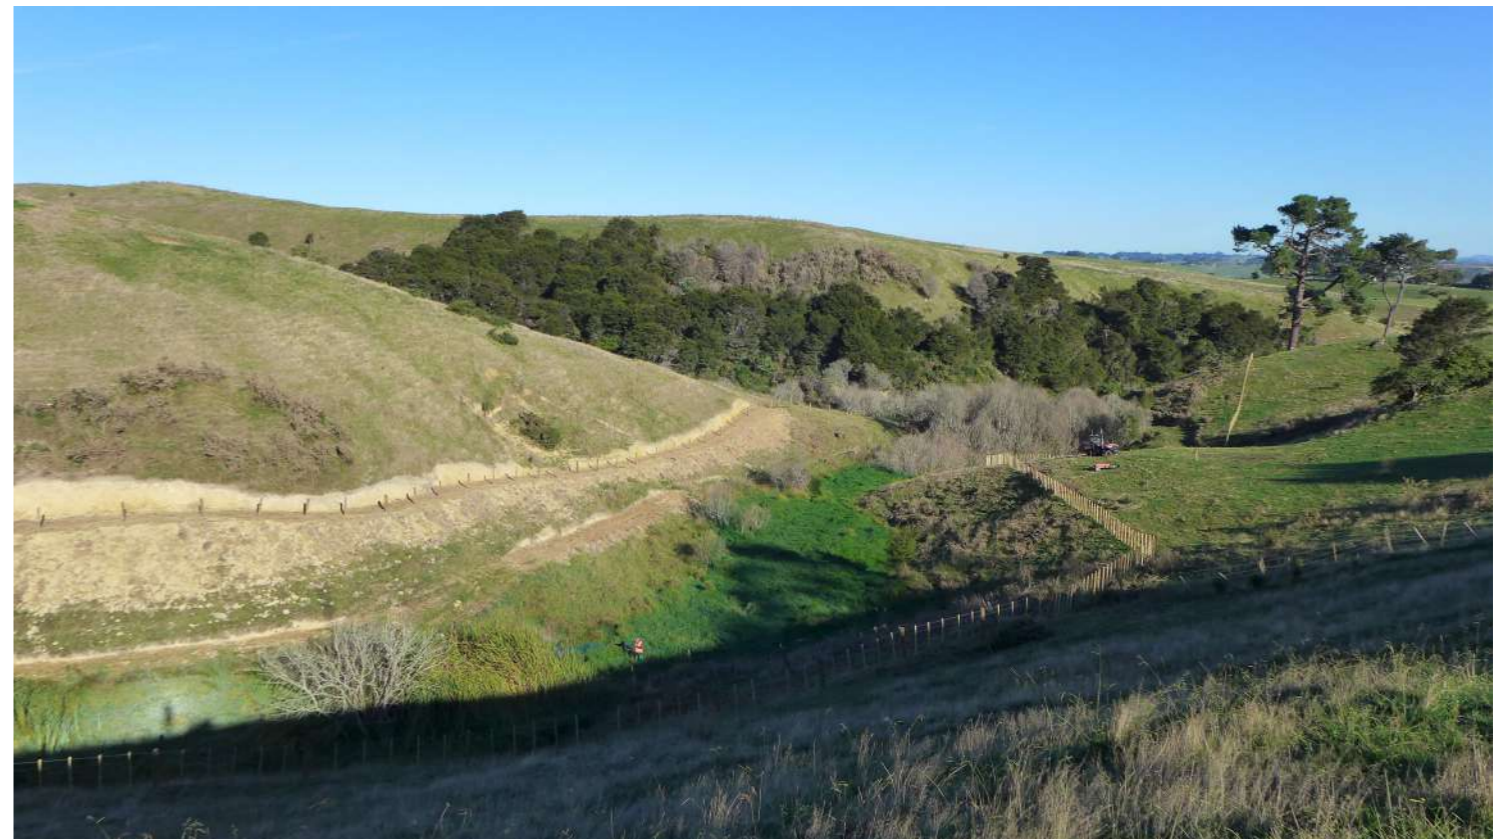
Figure 20: Fencing progress around the wetland, looking north-west. March 2022.

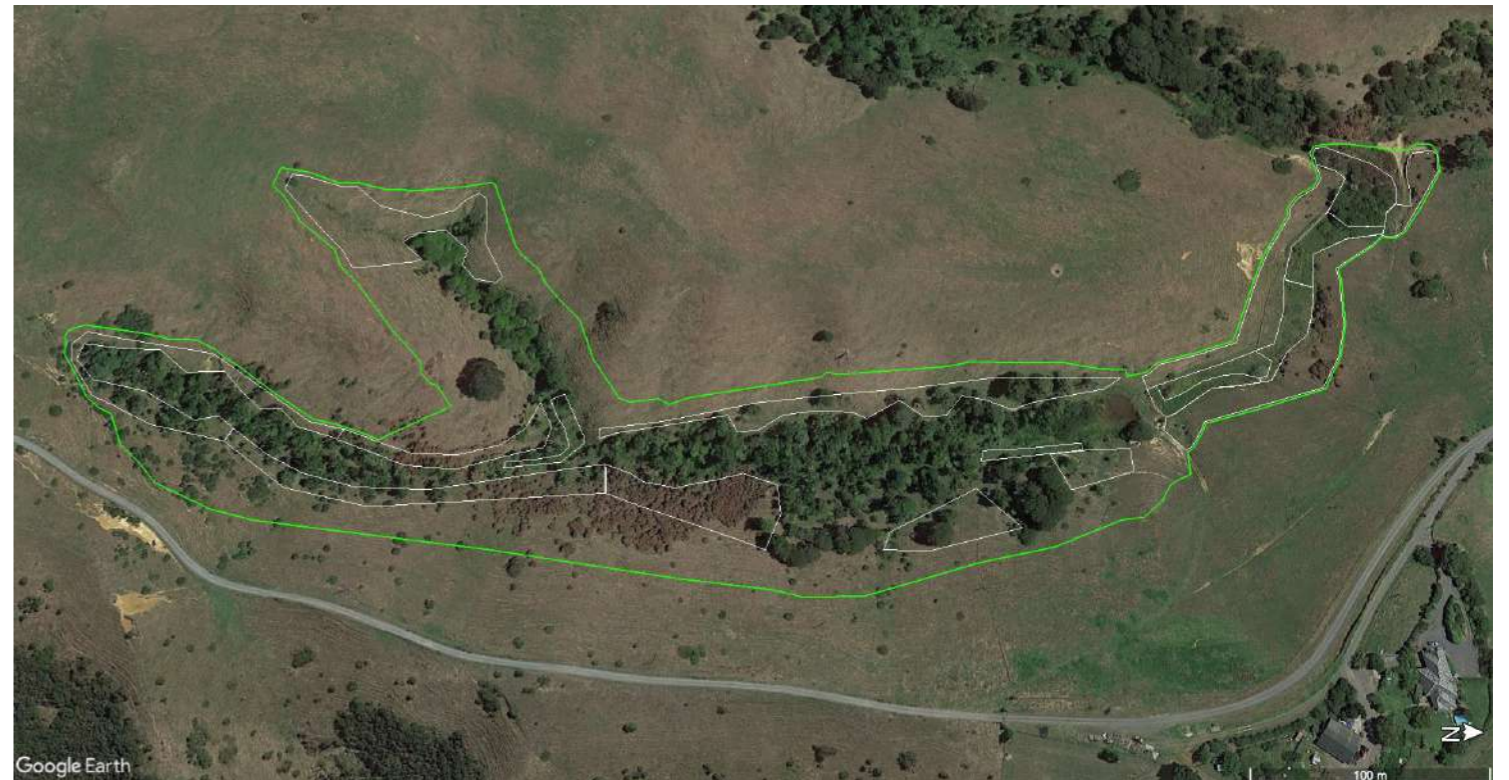
Figure 24: Map of fence line (green) and planting areas (white).

The planting schedule involves approximately 14,200 plants across 12 areas situated around the SNA. The goal of the planting is to fill in bare areas that would otherwise be colonised by pest plants with the aim of creating contiguous canopy cover with existing remnant vegetation. A range of fast-growing pioneer species suited to the site were chosen, with slower-growing tree species characteristic of the local forest type to be added in once sufficient canopy cover has been achieved within the pioneer planting. Approximately half of the planting is complete. Measures of success for the planting will be estimated with the establishment of 5x5m plots within planting areas of each different habitat type. Growth of plants and establishment of new species will be monitored over time to ensure restoration goals are being met. A rain gauge has been set up on site to monitor monthly rainfall.

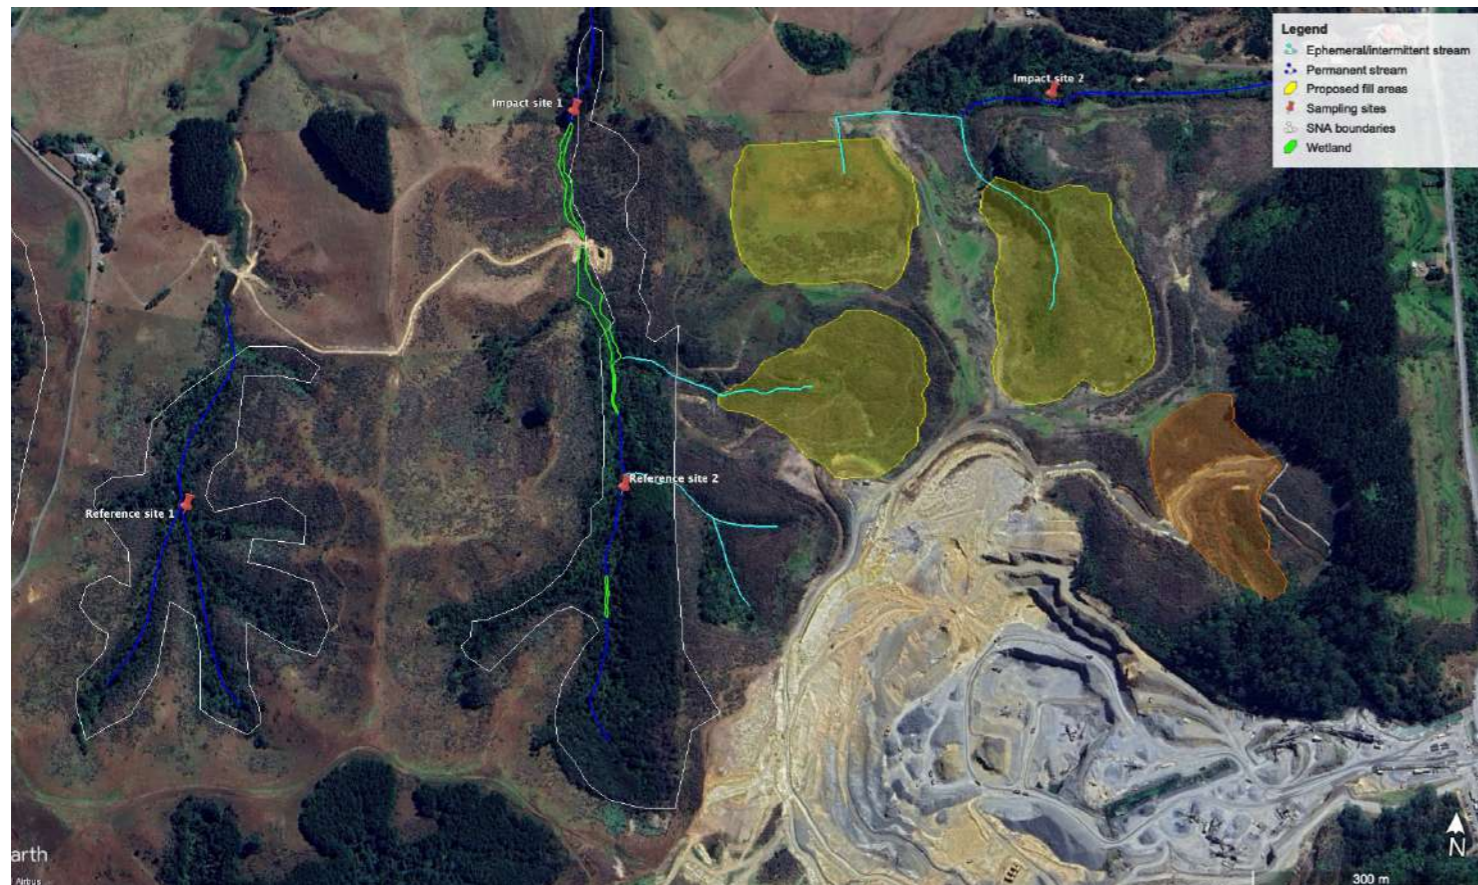
Figure 25: Map of macroinvertebrate sampling sites in relation to the quarry and fill areas.

Two reference sites and two impact sites were sampled to obtain MCI (Macroinvertebrate Community Index) values in order to gauge the baseline condition of watercourses that may potentially be impacted by three proposed fill areas. It is proposed that these sites will be monitored over time to track any changes in water quality, which will be evidenced by changes in the macroinvertebrate community. Both reference sites had MCI scores reflective of high water quality and a diverse assemblage of macroinvertebrates with a range of tolerances to pollution/nutrient enrichment. In contrast, both impact sites had MCI scores reflective of average to poor water quality and macroinvertebrate habitat, which is also indicative of moderate to severe pollution/nutrient enrichment. This may be attributed to the modified environment within the catchment, lack of suitable sampling areas (low flow conditions, lack of riffle habitat) and pollution/sedimentation from runoff from the surrounding land.

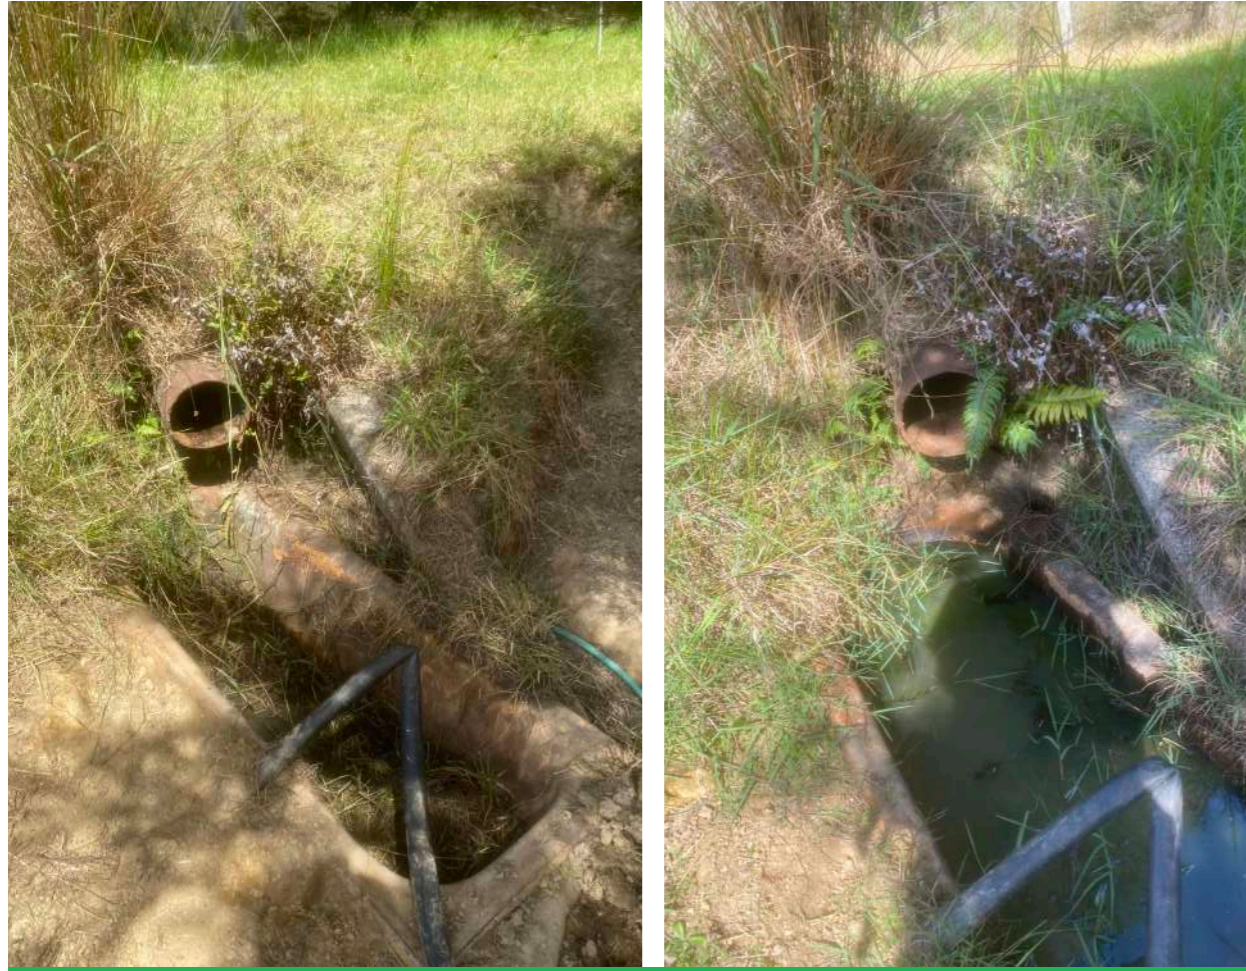
Two barriers to fish passage have been identified within the SNA that will need to be rectified to ensure native migratory fish are able to travel up and down the waterways. The barriers are perched culverts that are located at the outlet of the wetland at the northern end of the SNA and at the outlet of the pond by the pump shed (Figure 27). Under the Waikato Regional Plan (permitted activity rule 4.2.9.2), culverts are permitted as long as they provide for safe passage of fish both upstream and downstream. It is recommended that a fish ladder be installed at both culverts to allow for the migration of native fish up through the watercourse. A constructed ramp with a rough surface and V-shaped cross section would maintain a continuous low velocity flow between the culvert and the stream below, allowing easier access for migrating fish to travel up and down the stream.

Figure 27: Perched culvert by pump shed in March 2022 (left) and May 2022 (right).

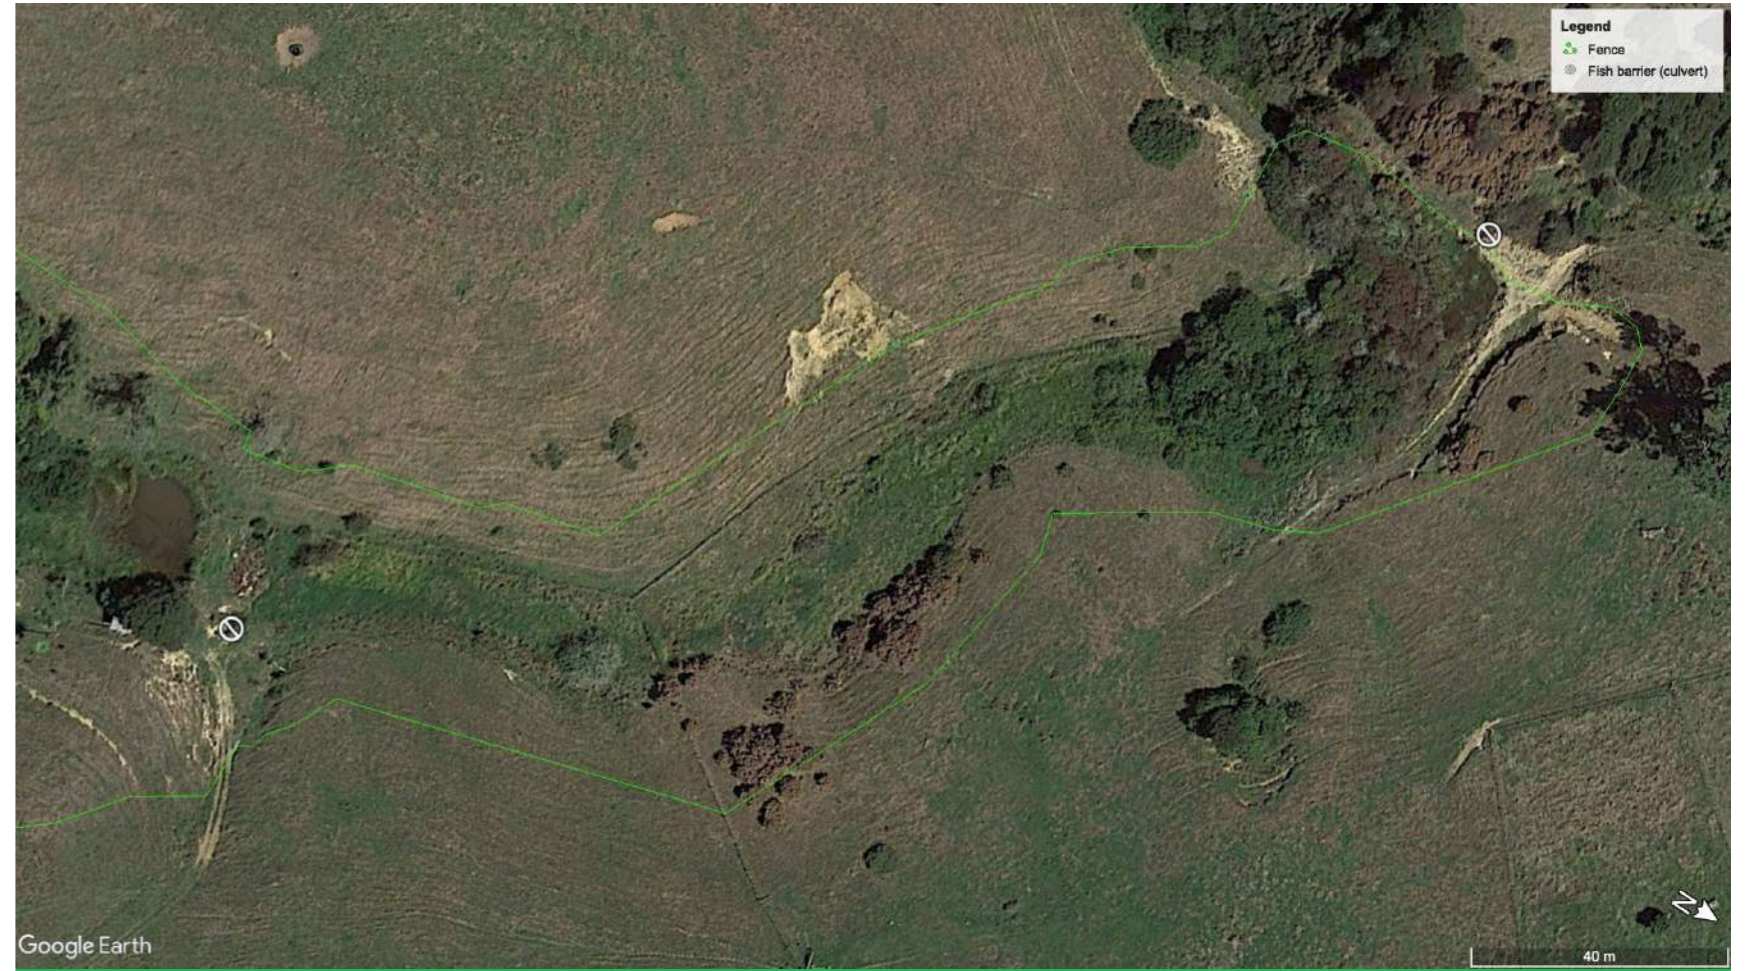
Figure 28: Map of northern end of SNA showing locations of fish barriers (perched culverts).
