Gleeson Quarries Ltd

Huntly Quarry Disposal Sites

# Fill Site 2 – Geotechnical Design Report

**Revision B**

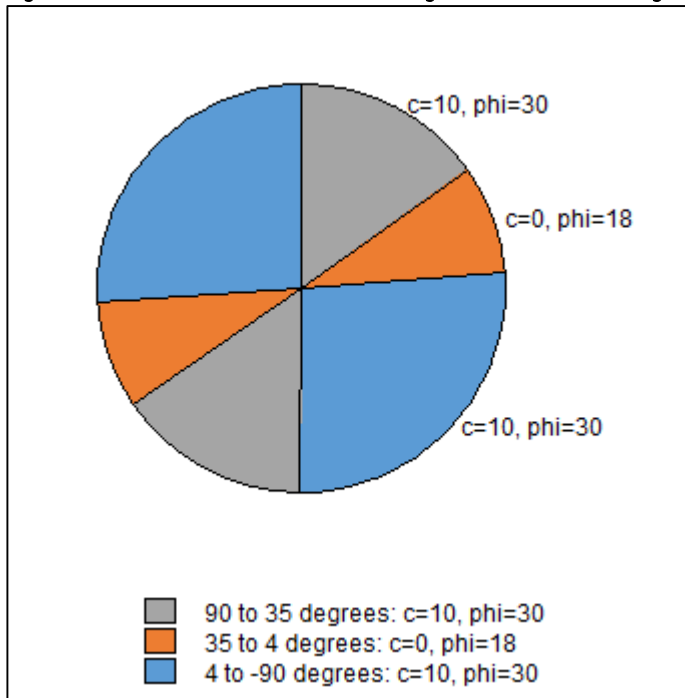
Figure 3: Waikato Coal Measures - Bedding Parallel Shears Strength Parameters

During mapping of the area, bedding was observed but was not able to be mapped to a level of certainty suitable for modelling. As such, Waikato Coal Measures bedding has been modelled using a worst credible case anisotropic strength function. The worst-case strength function comprises a  $c'=0\text{kPa}$  and  $\Phi=18^\circ$  at an angular range of between  $4^\circ$  and  $35^\circ$  dipping out of the proposed slope. The anisotropic strength parameters are summarised in Figure 3: Waikato Coal Measures - Bedding Parallel Shears Strength Parameters below.

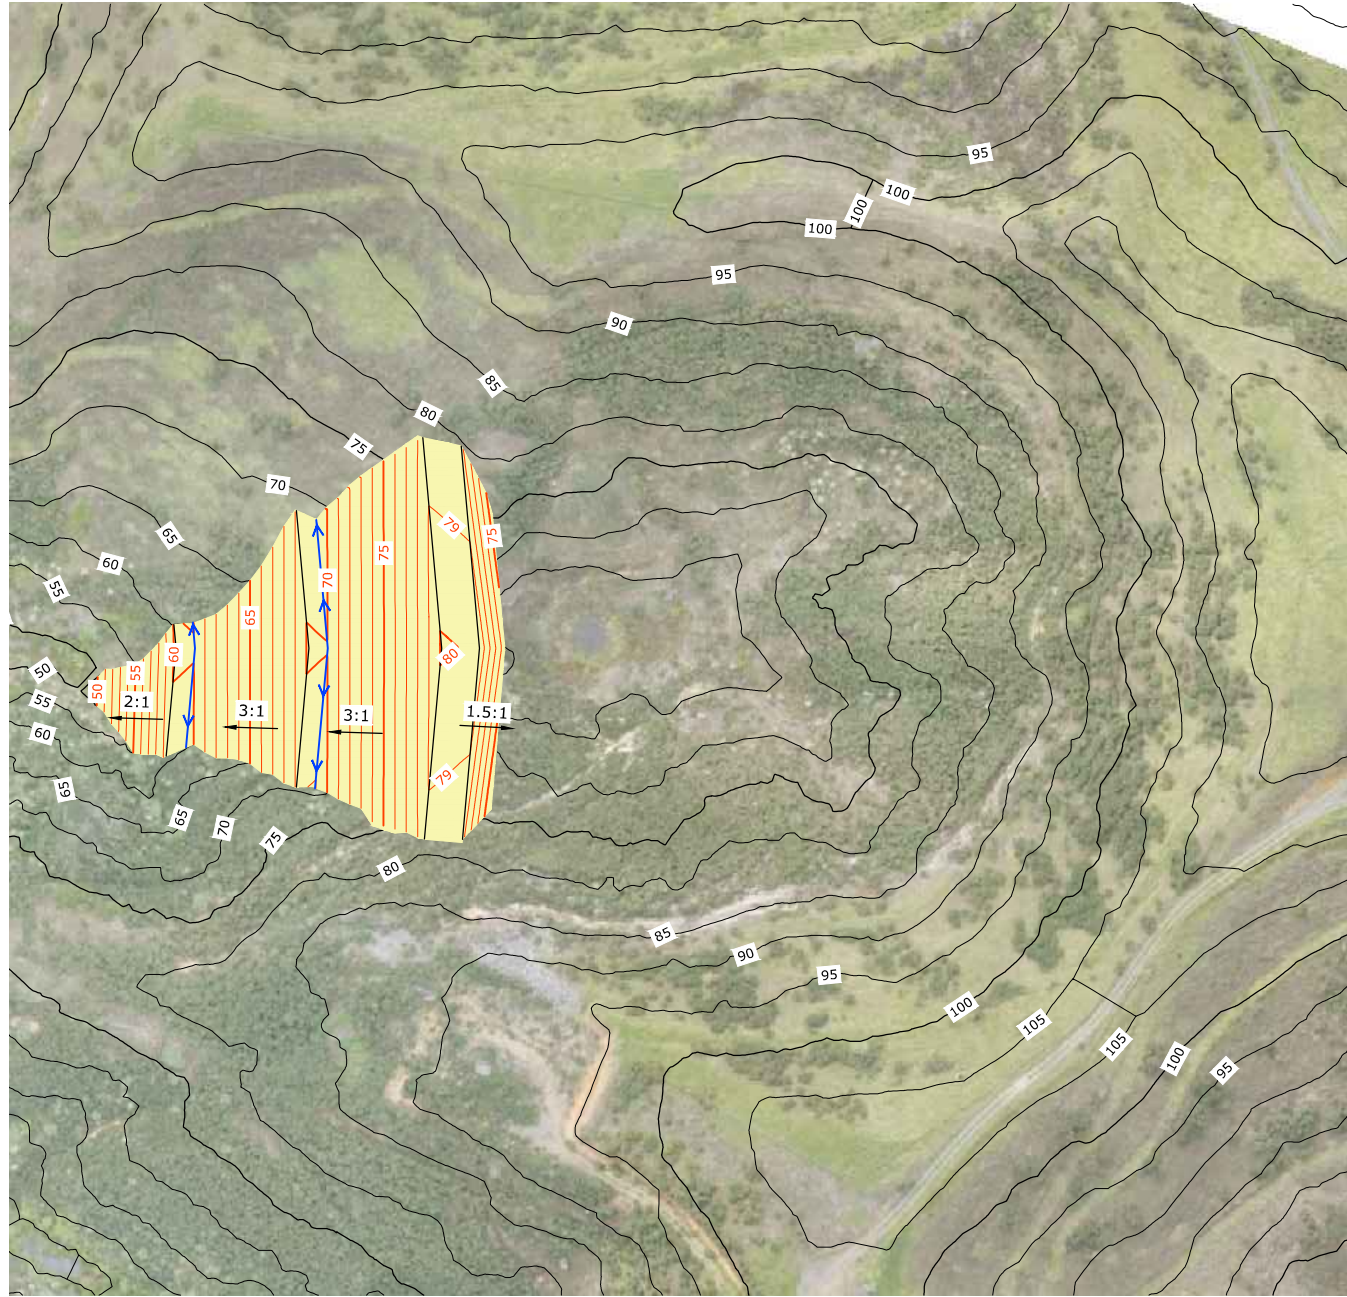
**MANAGED FILL VOLUME: 51,575m<sup>3</sup>**  
**DRAINAGE BLANKET VOLUME: 6,025m<sup>3</sup>**

**STAGE 2.2: STRUCTURAL FILL (BUND) LAYOUT**  
SCALE 1:2000

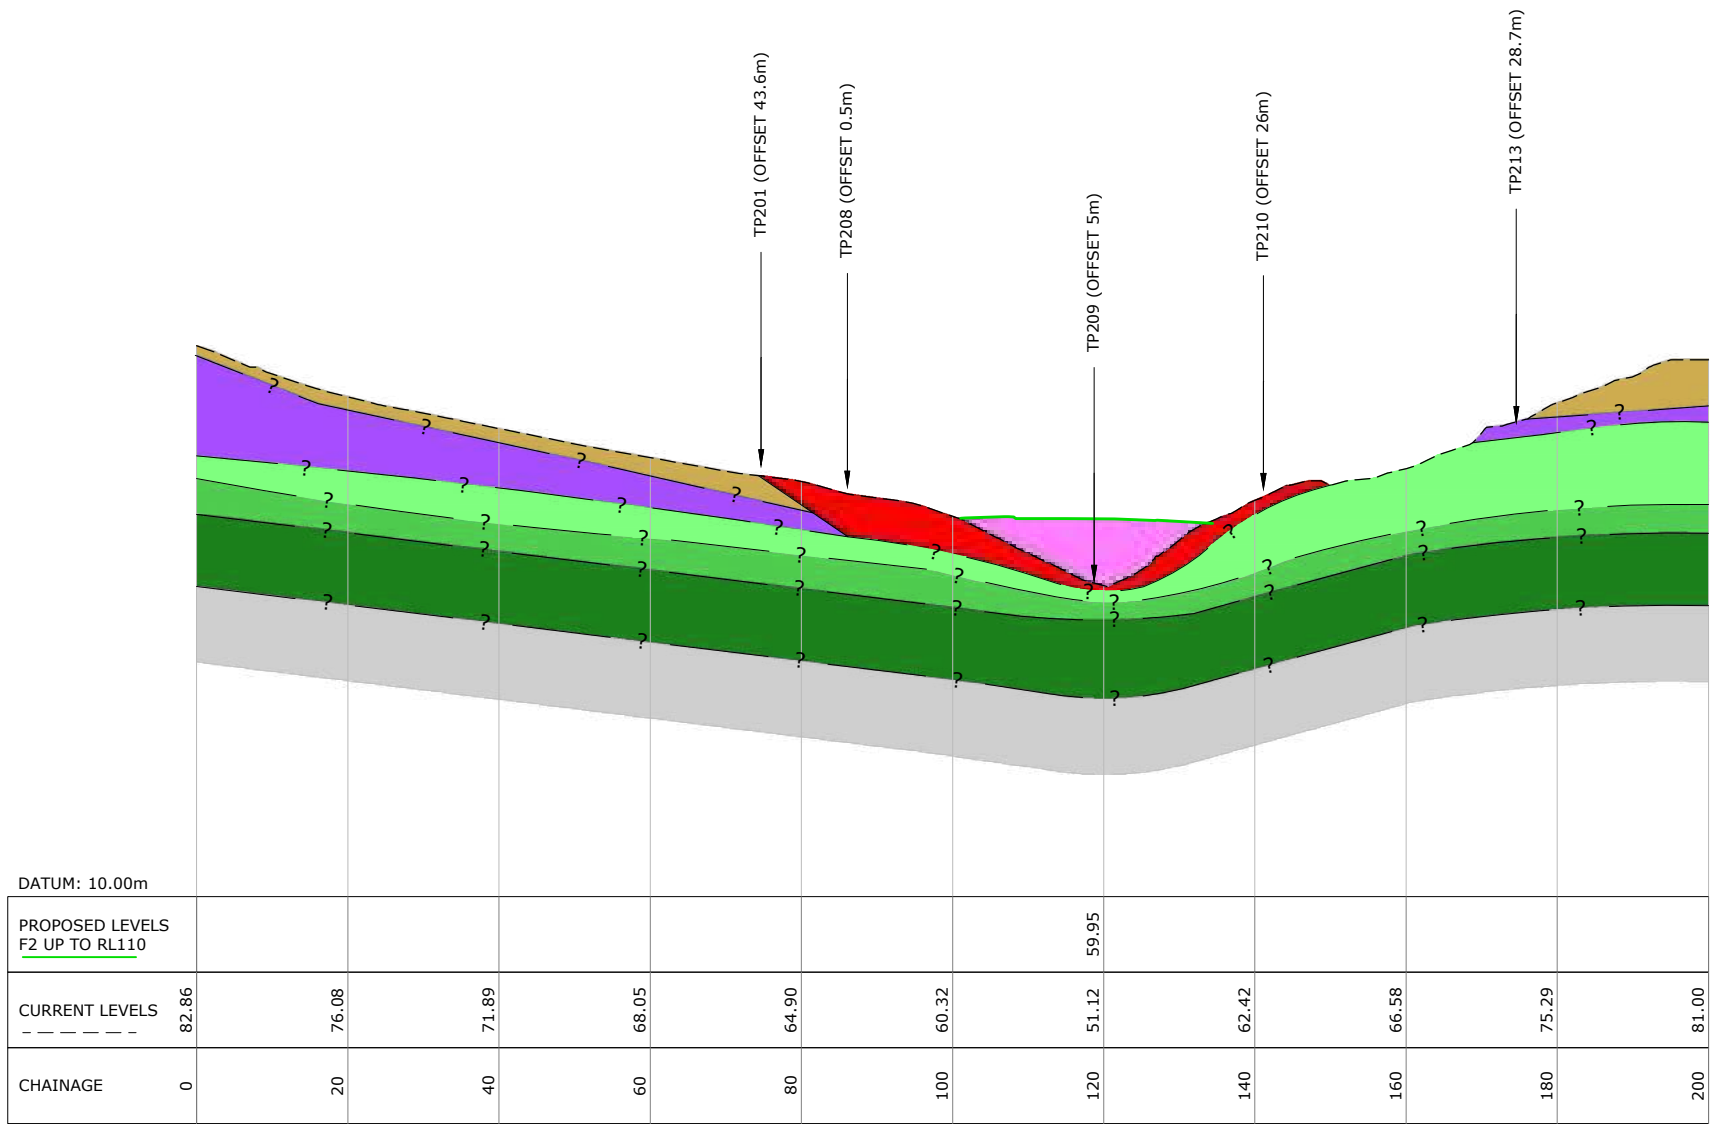
- PROPOSED FILL
- RECENT COLLUVIUM AND ALLUVIUM - SOFT TO FIRM CLAY WITH VARYING ORGANIC CONTENT
- RESIDUALLY WEATHERED WAIKATO COAL MEASURES - STIFF TO VERY STIFF CLAY/SILT
- MODERATELY TO SLIGHTLY WEATHERED WAIKATO COAL MEASURES - VERY WEAK MUDSTONE/FINE SANDSTONE
- RESIDUALLY AND COMPLETELY WEATHERED NEWCASTLE GROUP GREYWACKE - VERY STIFF CLAYEY SILT
- HIGHLY WEATHERED NEWCASTLE GROUP GREYWACKE - VERY STIFF TO HARD SILTS
- MODERATELY WEATHERED NEW CASTLE GROUP GREYWACKE
- INFERRERD NEWCASTLE GROUP GREYWACKE BEDROCK

**SECTION 3**  
SCALE 1:1000 (A3)

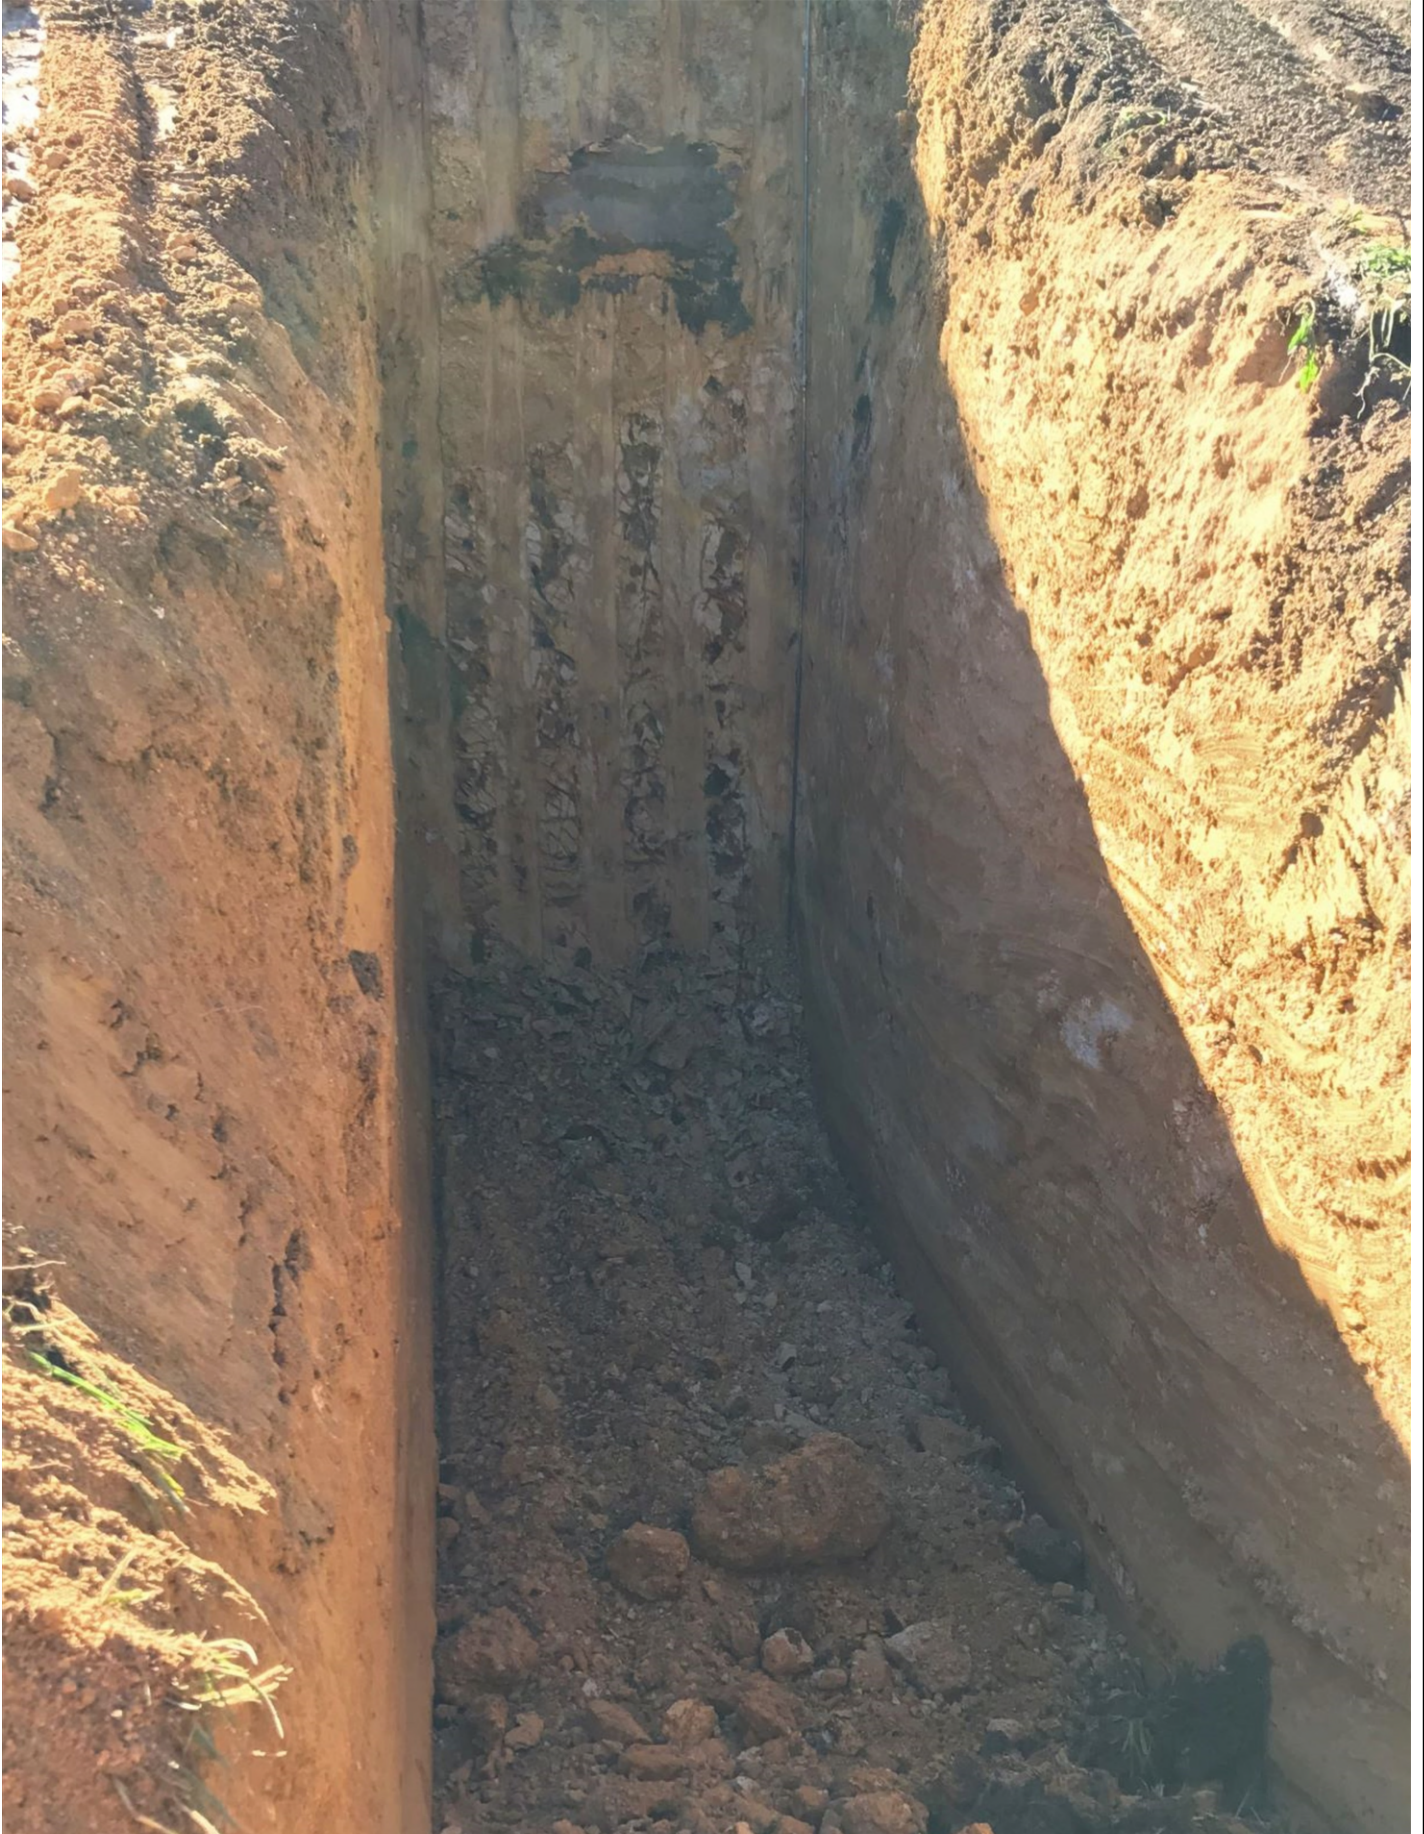
Soil/Rock Description	Depth (m)	Graphic Log	Geologic Unit	Ground water	Vane Shear Strength (kPa)		Scala (blows/100mm)					Sample ID	Sample Type	R.L (m)	
					Tp	Tr	2	4	6	8	10				12
0.00-0.20 m TOPSOIL															
0.20-1.50 m Silty CLAY; light grey and orange. Very stiff, moist, low to moderate plasticity, insensitive.	1				134	68									69.0
	1				188+										
	2				188+										68.0
1.50-4.50 m Completely weathered, light grey with orange streaks, MUDSTONE; extremely weak [clayey SILT; Hard, moist, non plastic].	2		Waikato Coal Measures		188+										67.0
	3														
	4														66.0
	4														
End of Pit @ 4.5 m	5														65.0
	5														
	6														64.0

Contractor: Gleeson Civil Ltd. Plant: Hitatch 30t Excavator Logged: MK Checked: KCC Approved: KCC	Remarks:	Groundwater notes:
	SV readings corrected to BS1377 - Dial No. 1872	Groundwater Not Encountered
Logged in accordance with NZ Geotechnical Society (2005) guidelines

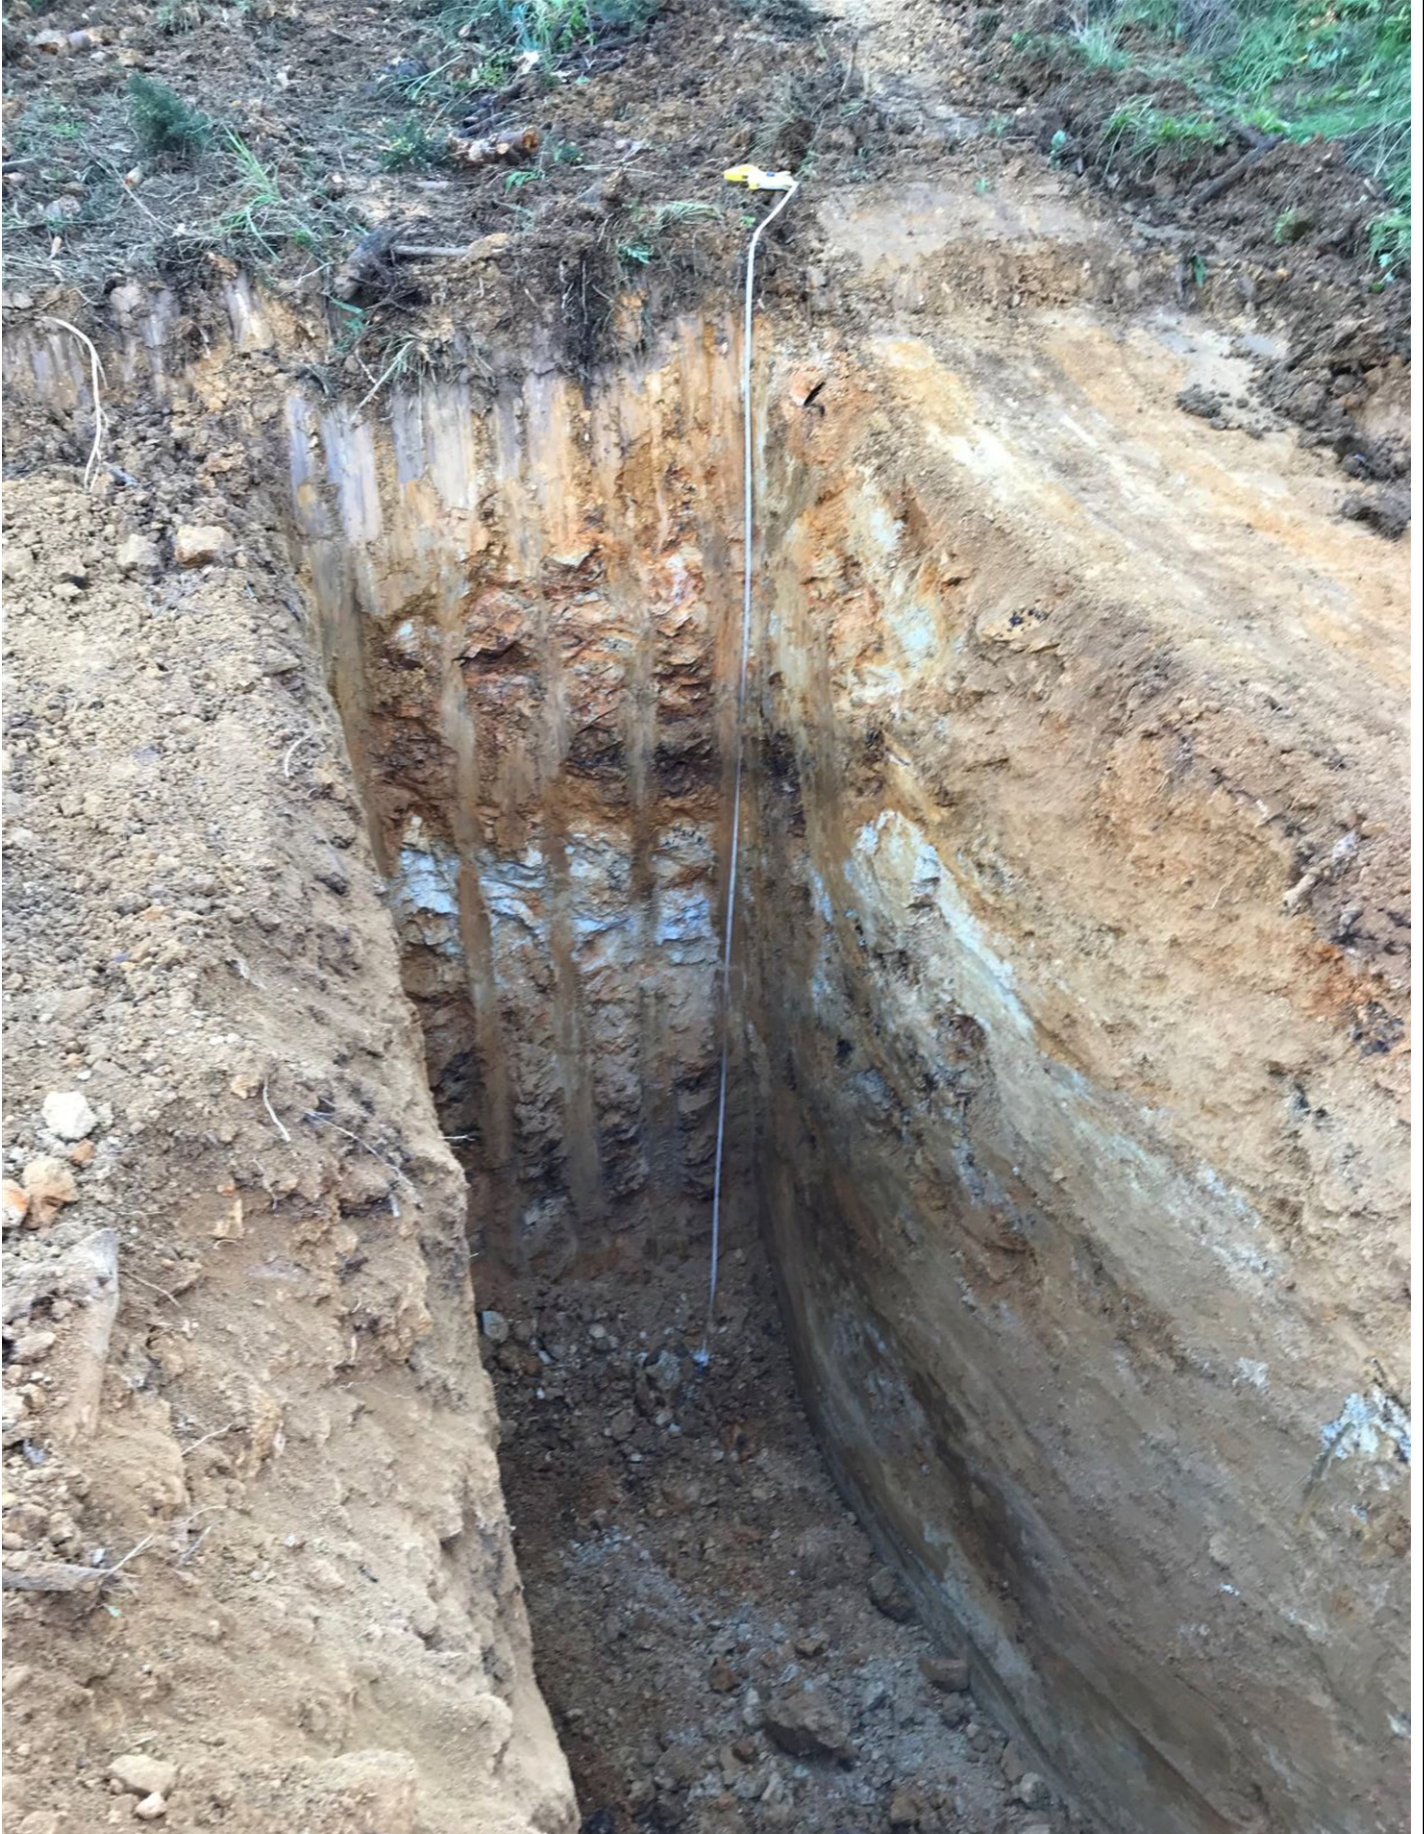
Soil/Rock Description	Depth(m)	Graphic Log	Geologic Unit	Ground water	Vane Shear Strength (kPa)		Scala (blows/100mm)					Sample ID	Sample Type	R.L (m)	
					Tp	Tr	2	4	6	8	10				12
0.00-1.00 m Completely weathered, light grey with orange streaks, MUDSTONE; extremely weak [clayey SILT; Hard, moist, non plastic].															60.0
1.00-4.50 m Highly weathered, light grey and orange with red streaks, sandy MUDSTONE; extremely weak, limonite and MnO staining on defects [clayey SILT; hard, moist, low plasticity]. @ 1.0m - becoming completely weathered to highly weathered, light grey and orange with red streaks. Limonite and MnO staining on joint surfaces.	1 2 3 4		Waikato Coal Measures		188+										59.0 58.0 57.0 56.0
End of Pit @ 4.5 m	5				188+										55.0
	6

Contractor: Gleeson Civil Ltd.	Remarks: SV readings corrected to BS1377 - Dial No. 1872	Groundwater notes:
Plant: Hitatch 30t Excavator		Groundwater Not Encountered
Logged: MK		
Checked: KCC		
Approved: KCC	Logged in accordance with NZ Geotechnical Society (2005) guidelines

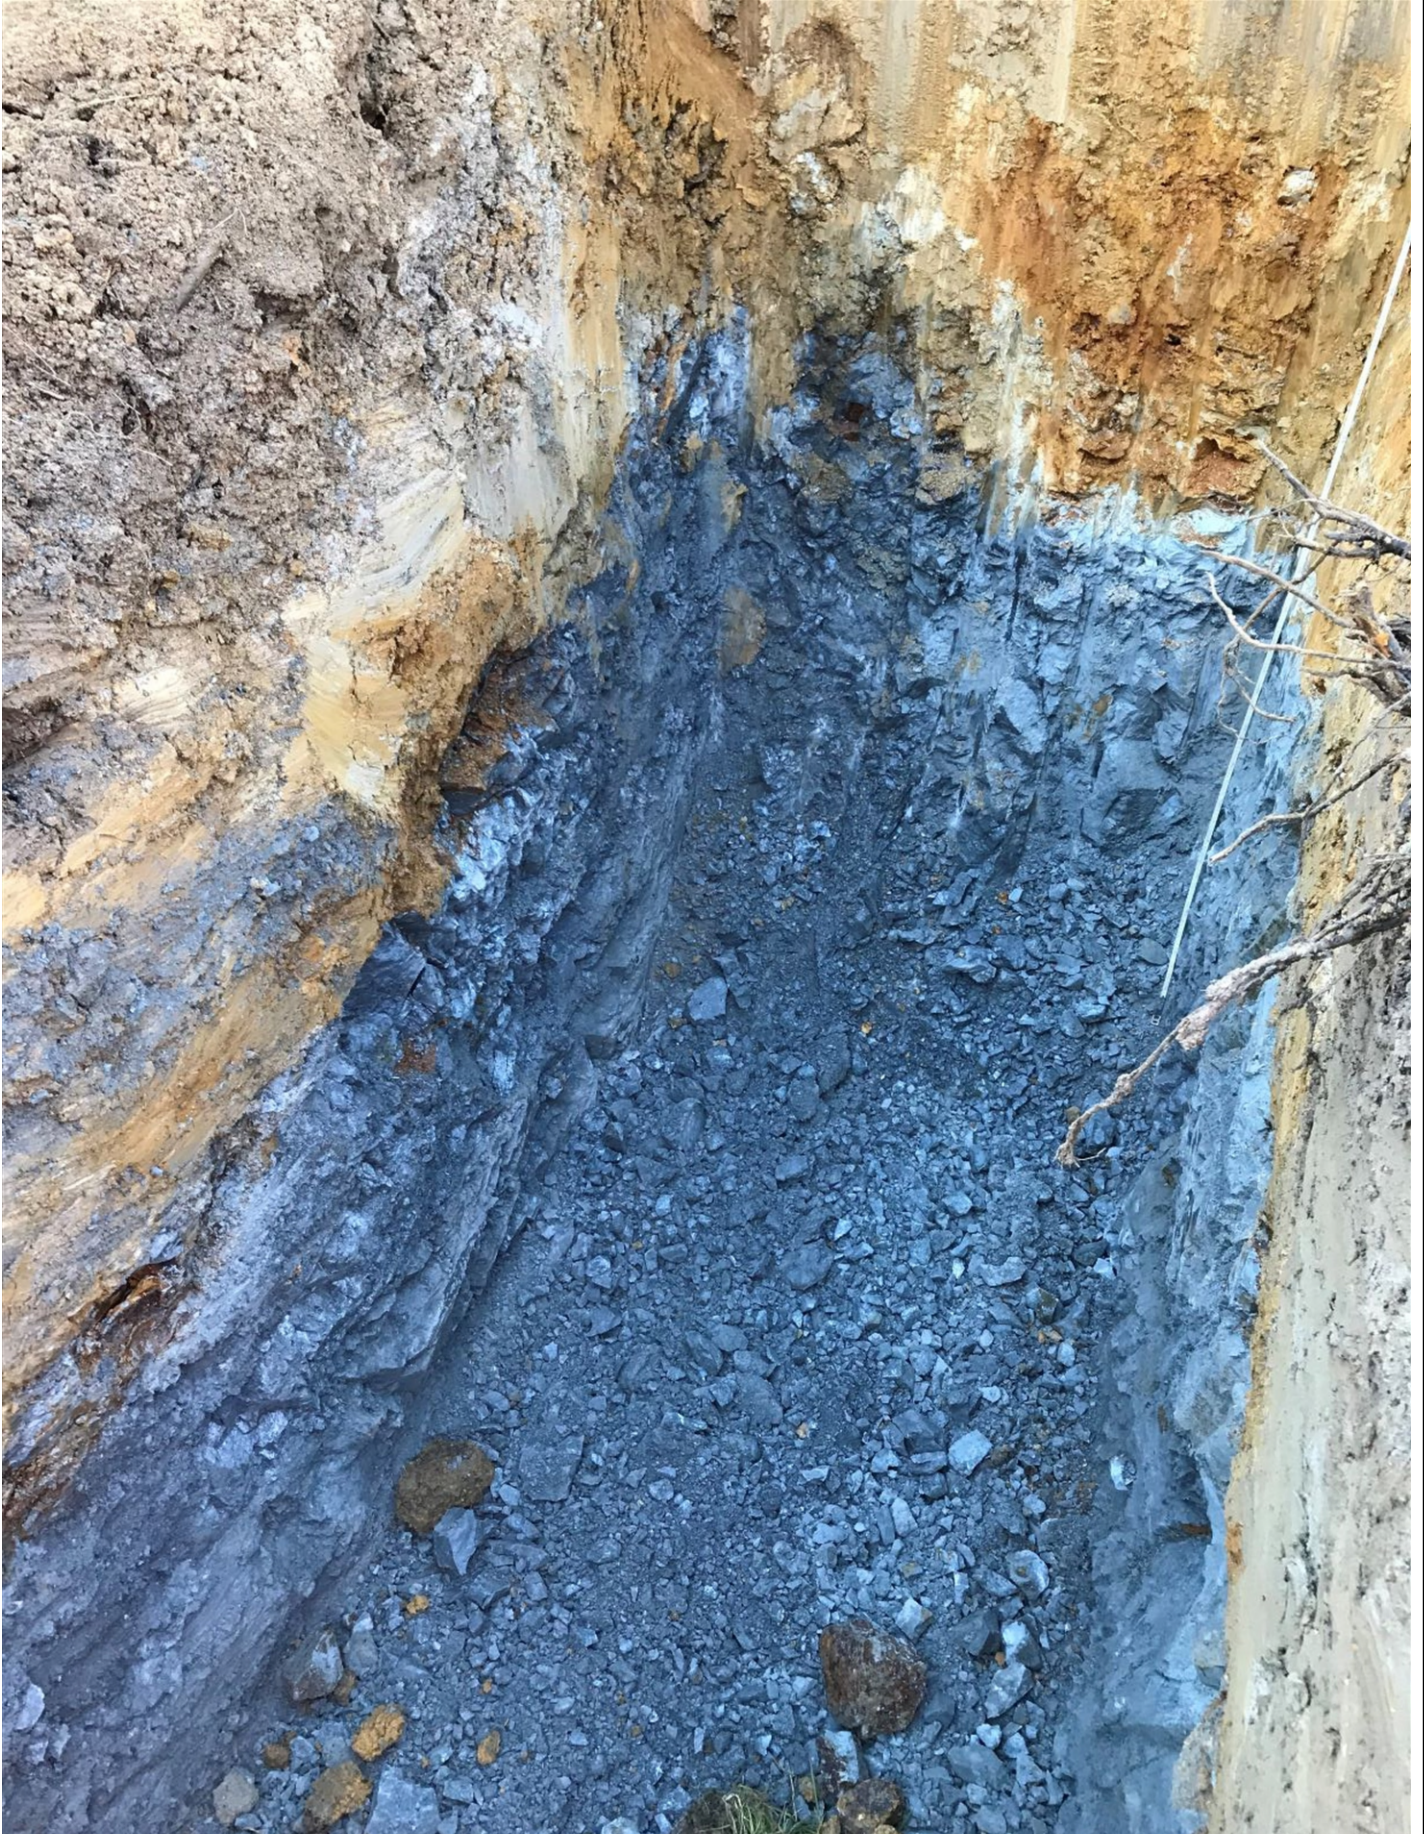
Soil/Rock Description	Depth(m)	Graphic Log	Geologic Unit	Ground water	Vane Shear Strength (kPa)		Scala (blows/100mm)					Sample ID	Sample Type	R.L (m)
					Tp	Tr	2	4	6	8	10			
0.00-1.00 m Clayey SILT; brown-grey with orange streaks. Very stiff, moist, low plasticity, moderately sensitive [disturbed texture].		[X pattern]	Waikato Coal Measures		129	41								63.0
1.00-1.50 m Completely to highly weathered, light grey with orange streaks, MUDSTONE; extremely weak [clayey SILT; Very stiff, moist, low plasticity].	1	[X pattern]			143	52								
1.50-3.00 m Moderately weathered, light grey, sandy MUDSTONE; very weak; sheared fabric.	2	[Horizontal lines]			UTP									62.0
End of Pit @ 3.0 m	3												61.0	
	4												60.0	
	5												59.0	
	6												58.0

Contractor: Gleeson Civil Ltd. Plant: Hitatch 30t Excavator Logged: MK Checked: KCC Approved: KCC	Remarks: SV readings corrected to BS1377 - Dial No. 1872 Terminated Due to Hard Digging	Groundwater notes: Groundwater Not Encountered
	Logged in accordance with NZ Geotechnical Society (2005) guidelines

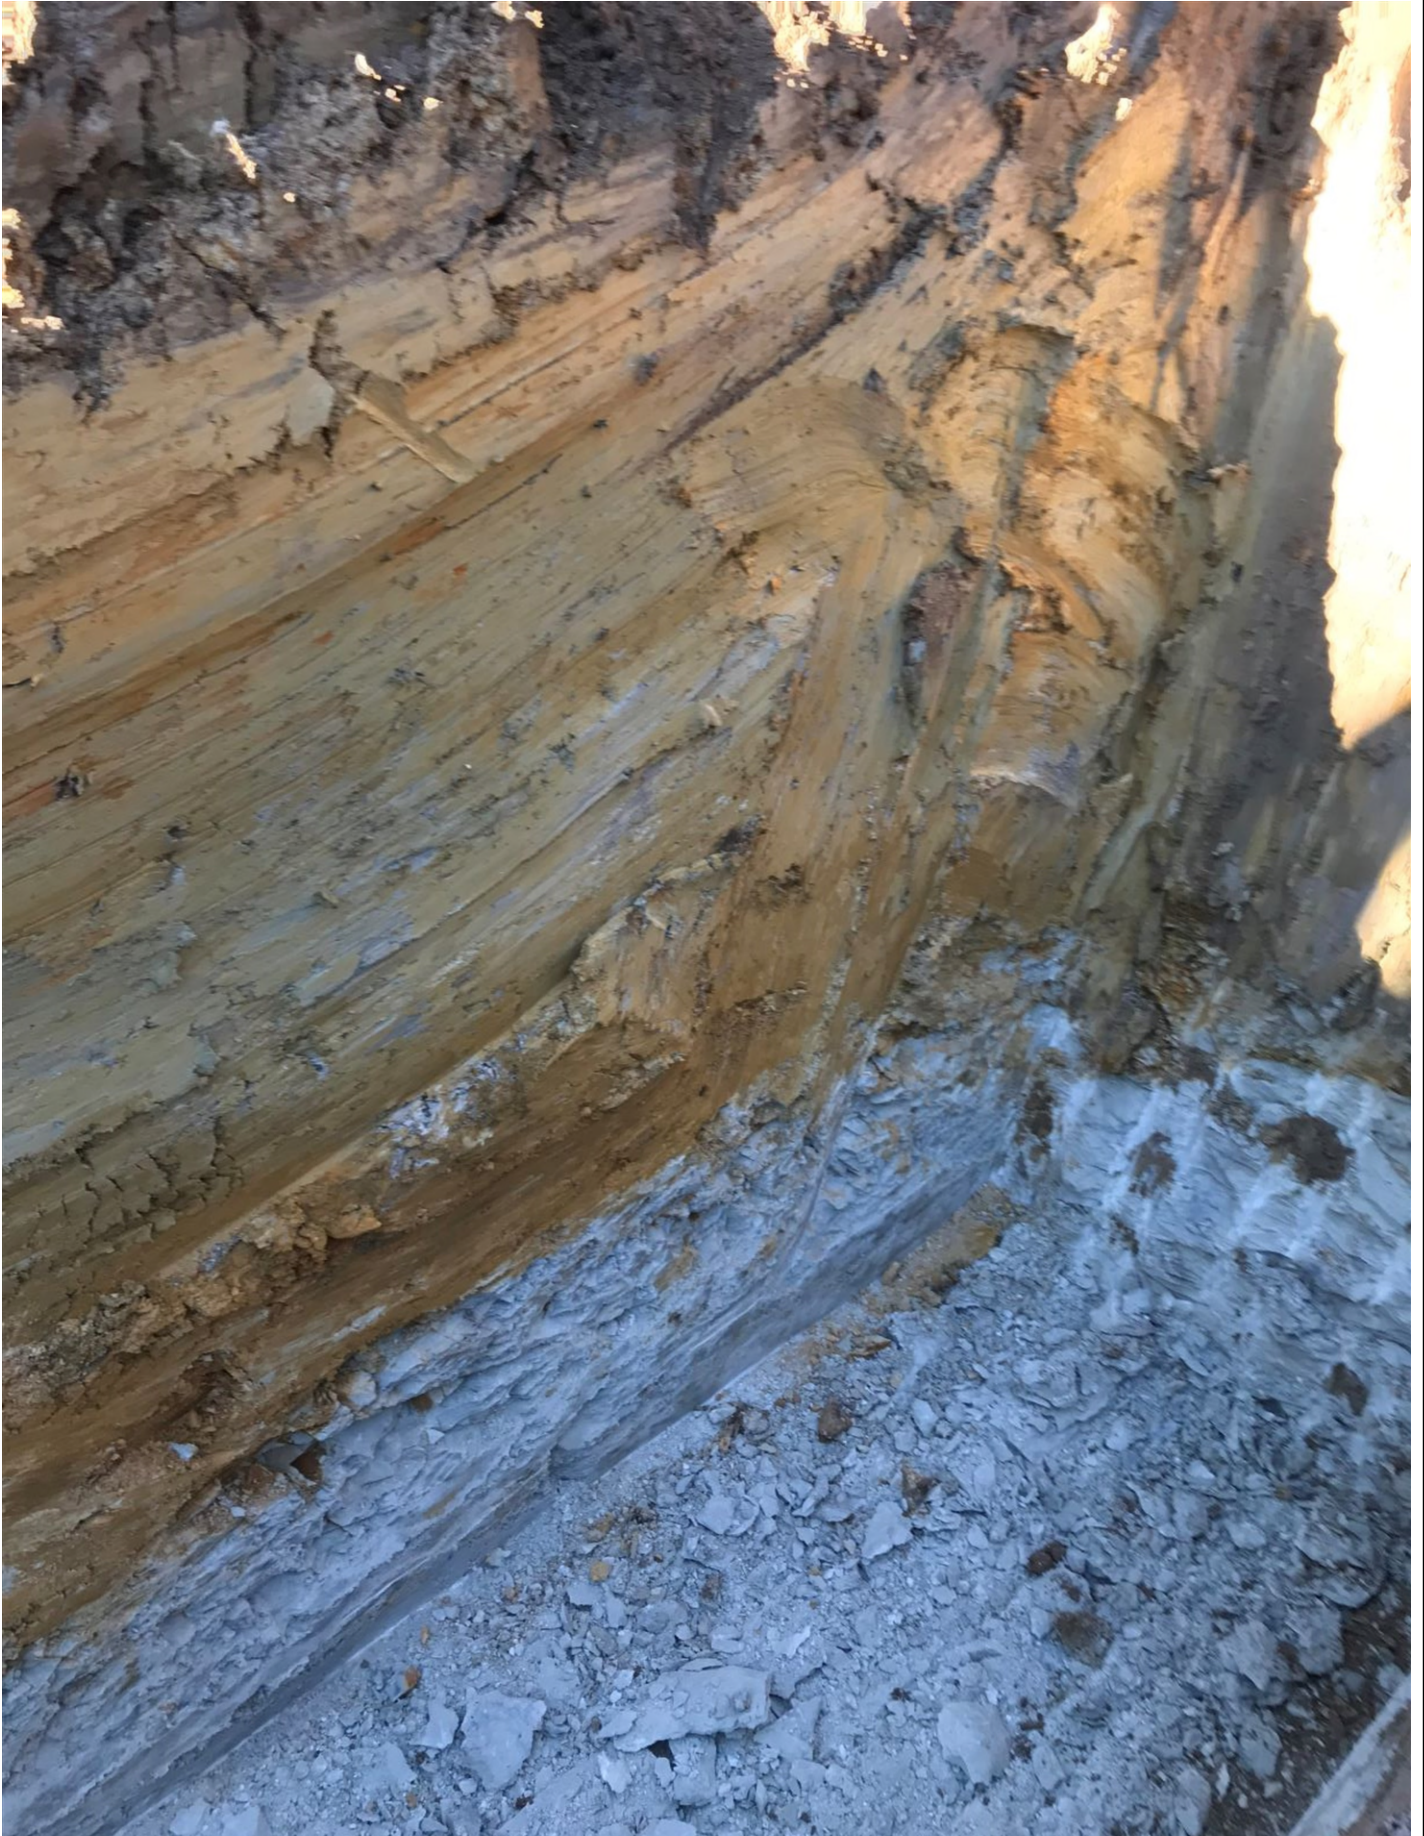
Soil/Rock Description	Depth (m)	Graphic Log	Geologic Unit	Ground water	Vane Shear Strength (kPa)		Scala (blows/100mm)					Sample ID	Sample Type	R.L (m)	
					Tp	Tr	2	4	6	8	10				12
0.00-0.10 m TOPSOIL			Colluvium												
0.10-0.50 m Silty CLAY; grey and orange. Firm, moist, low plasticity.															
0.50-3.00 m Silty CLAY with some fibrous organics; grey-brown with black mottles; Firm, wet to saturated, low plasticity, moderately sensitive.	1		Alluvium		188+									63.0	
						45	16								
	2					41	14								62.0
3.00-4.00 m Moderately weathered, light grey, massive, sandy MUDSTONE; very weak; sheared fabric.	3		Waikato Coal Measures											61.0	
End of Pit @ 4.0 m	4														60.0
	5													59.0	
	6													58.0

Contractor: Gleeson Civil Ltd.	Remarks:	Groundwater notes:
Plant: Hitatch 30t Excavator	SV readings corrected to BS1377 - Dial No. 1872	Groundwater Not Encountered
Logged: MK	Terminated Due to Hard Digging	
Checked: KCC		
Approved: KCC	Logged in accordance with NZ Geotechnical Society (2005) guidelines

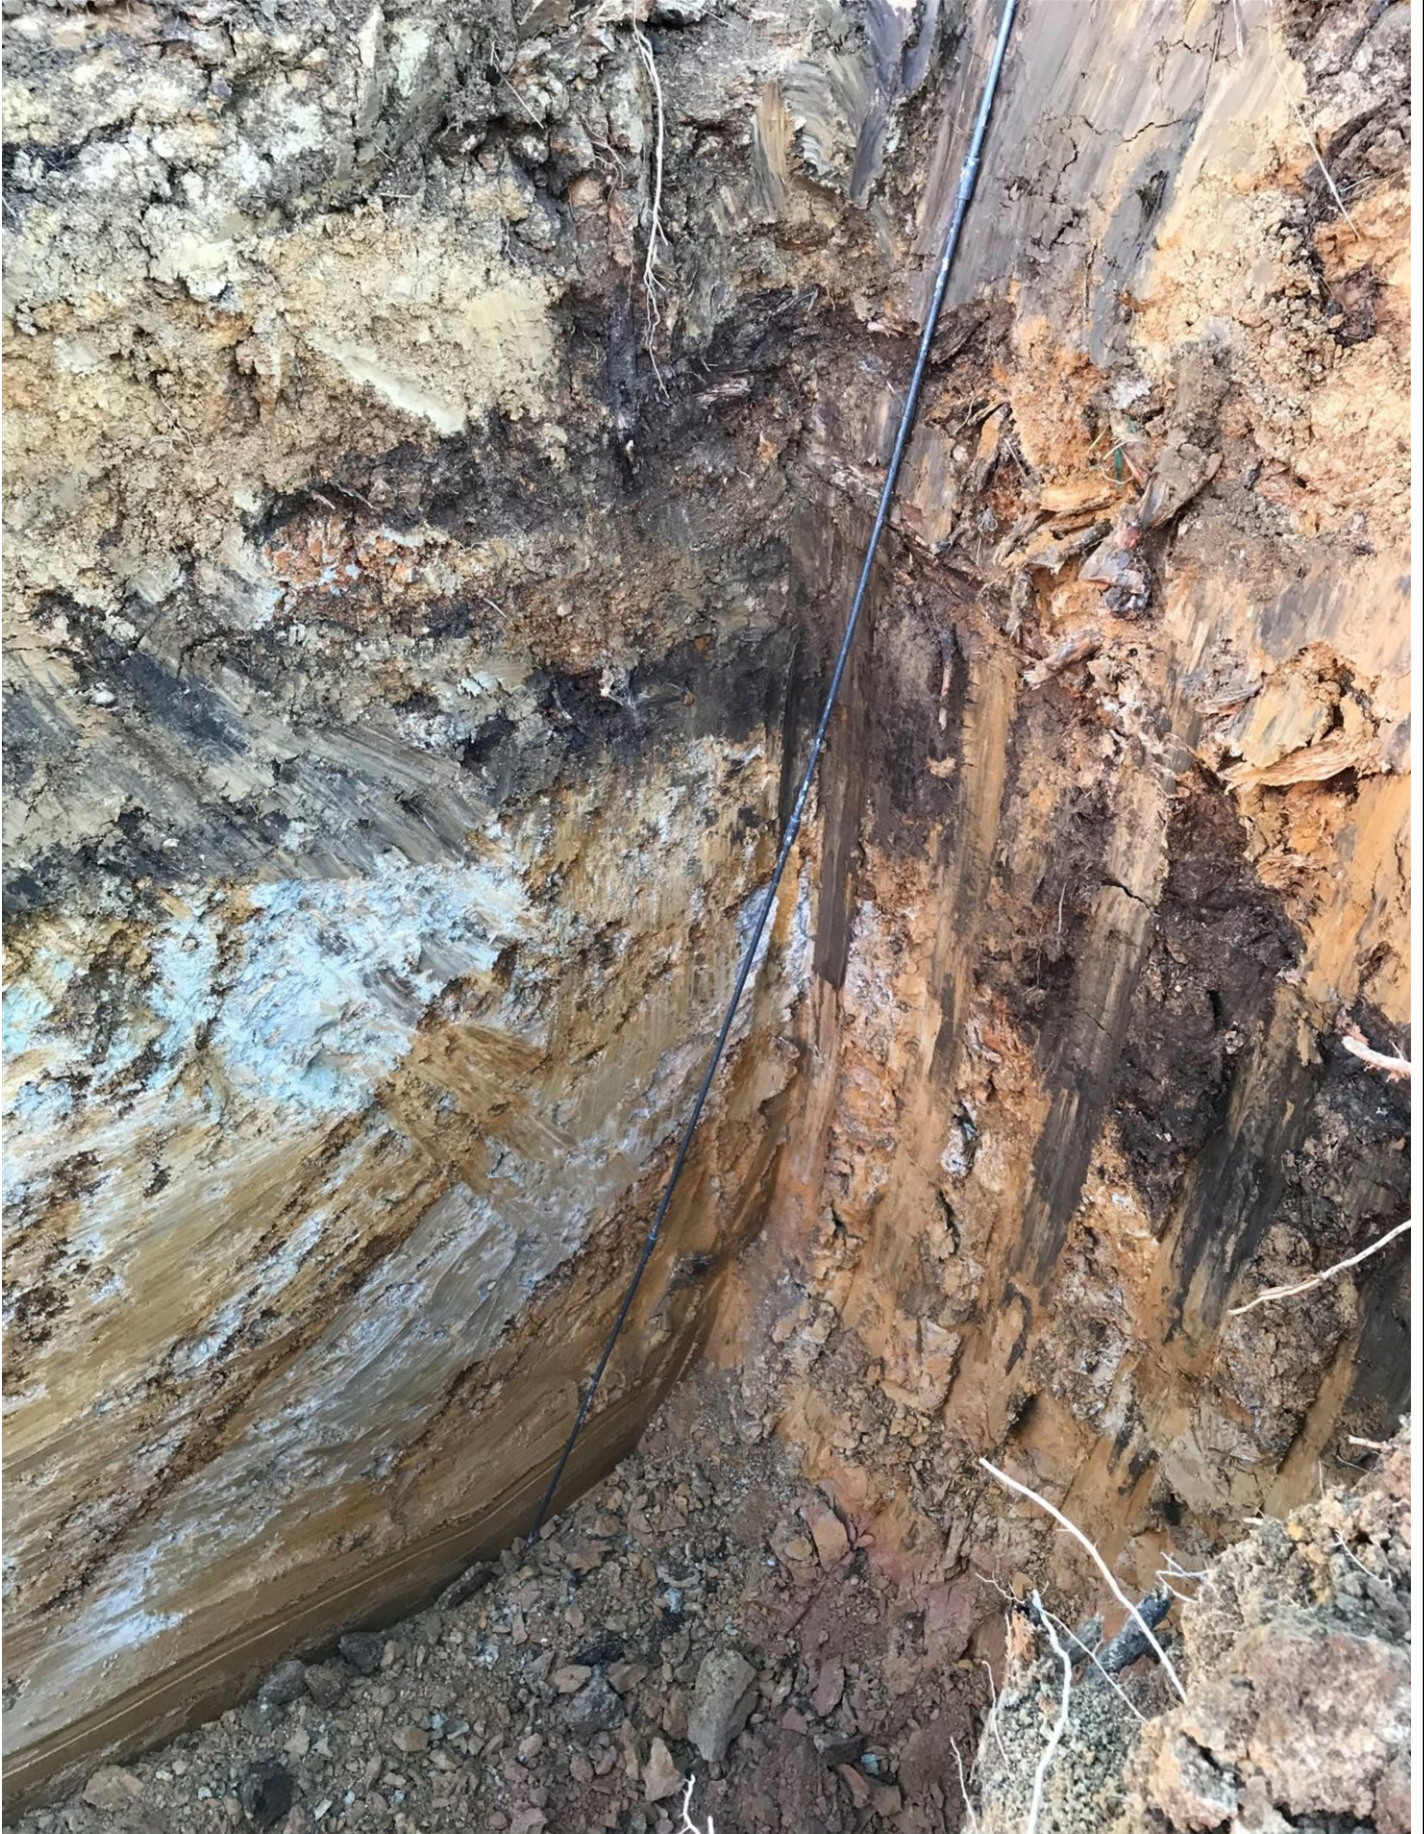
Soil/Rock Description	Depth(m)	Graphic Log	Geologic Unit	Ground water	Vane Shear Strength (kPa)		Scala (blows/100mm)					Sample ID	Sample Type	R.L (m)
					Tp	Tr	2	4	6	8	10			
0.00-1.50 m Clayey SILT; light grey, orange and brown. Very stiff, moist, low plasticity.	0 to 1	[X pattern]	FILL											73.0
1.50-3.50 m Clayey SILT; light grey and dark orange. Very stiff, moist, low plasticity.	1 to 2	[X pattern]	Waikato Coal Measures											72.0
@3.0m - becoming light grey and orange with pink streaks	2 to 3	[X pattern]												71.0
End of Pit @ 3.5 m	3 to 4	[X pattern]												70.0
	4 to 5													69.0
	5 to 6													68.0

Contractor: Gleeson Civil Ltd.	Remarks:	Groundwater notes:
Plant: Hitatch 30t Excavator	SV readings corrected to BS1377 - Dial No. 1872	Groundwater Not Encountered
Logged: MK		
Checked: KCC		
Approved: KCC	Logged in accordance with NZ Geotechnical Society (2005) guidelines

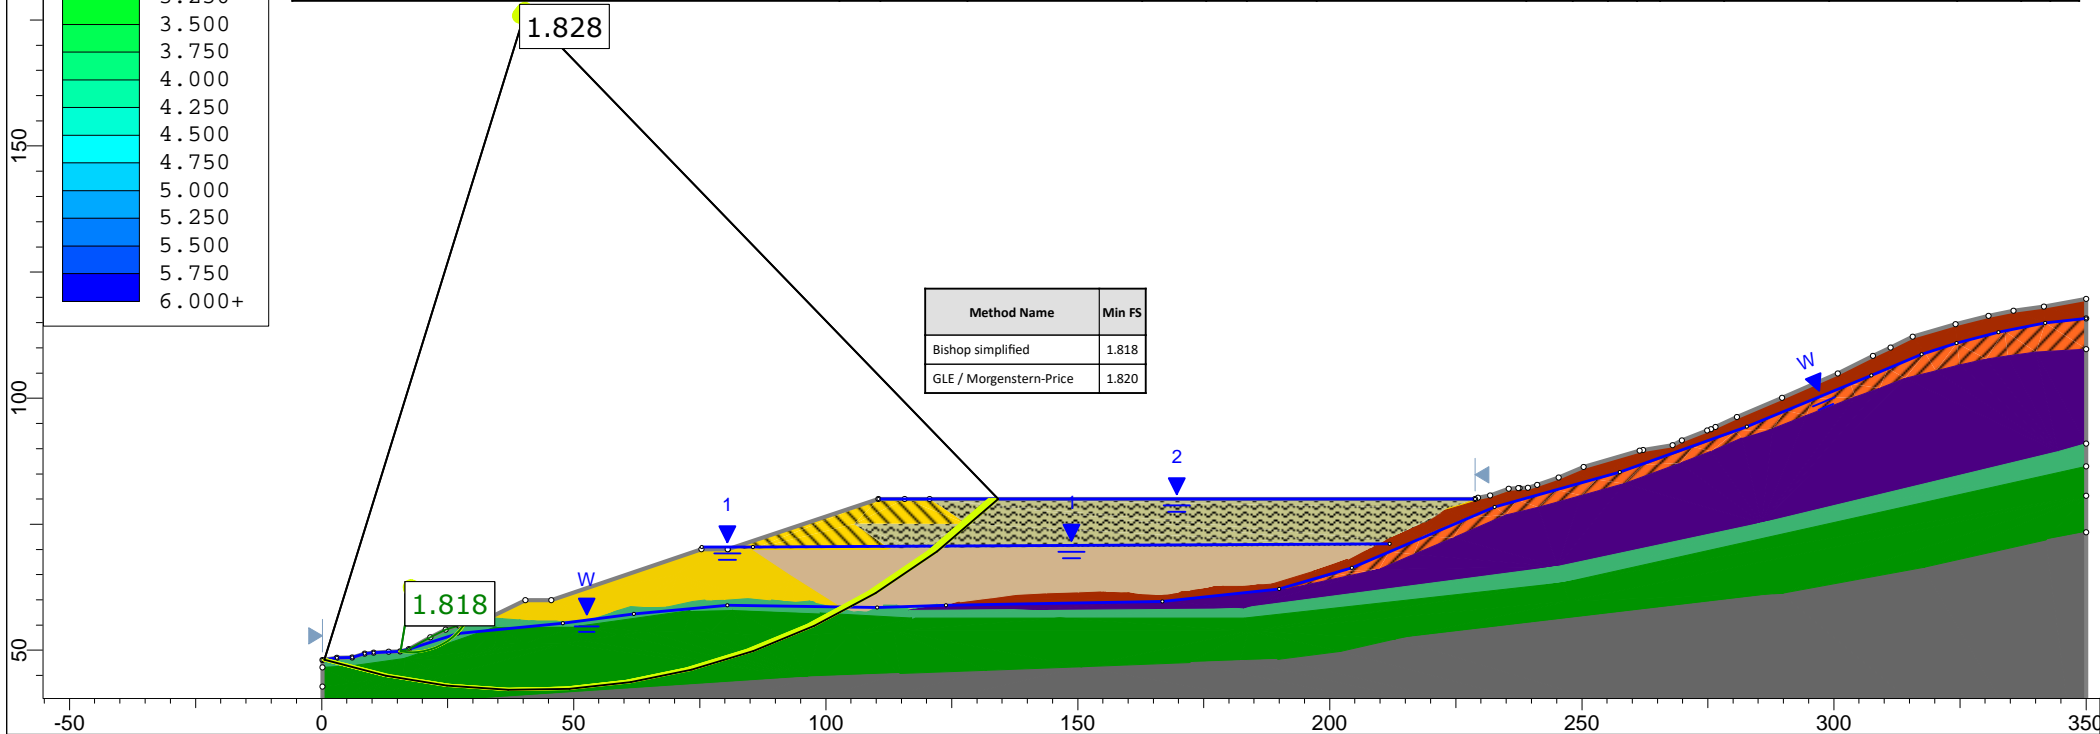
Project		Huntly Quarry - Fill Disposal Sites	
	Analysis Description		Fill Site 2, Proposed Fill - Stage 2 - Material Variability	
	Drawn By	MK	Scale	1:1500
	Date		Feb. 2020	
		Company	Gaia Engineers Ltd.	
		File Name	Fill Site 2 - Piezometric Lines Analysis.slmd
