Whāingaroa / Raglan WWTP Discharge Consent Project

June 2025 – Community Meeting

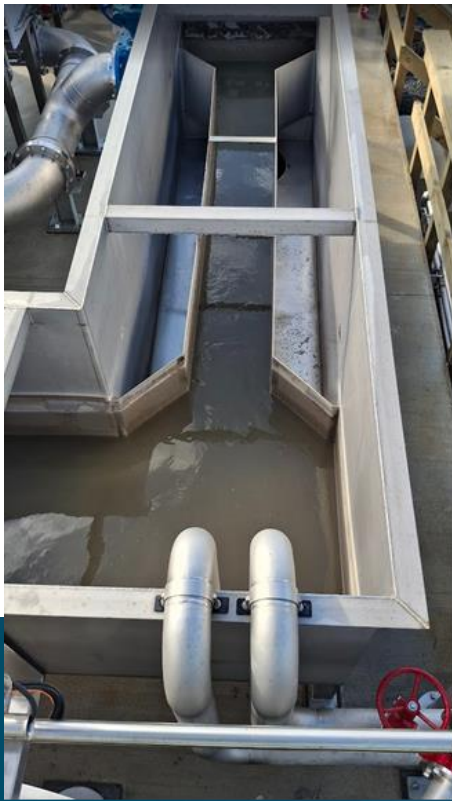
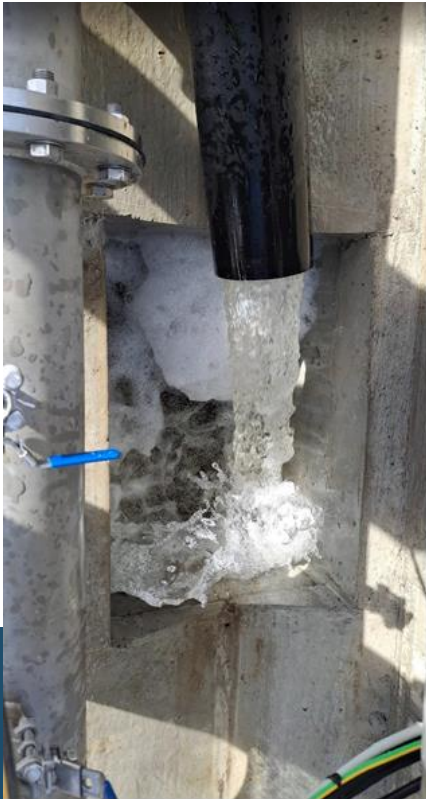
- The MBR WWTP has now started treating full flow this week. Permeate is discharged to the head of the oxidation ponds.
- The buildup of MBR biology is ongoing, improving the permeate.
- The oxidation ponds with the reduced loading, are also visibly improving.
- Initial results returned indicate an improvement when compared to the latest compliance sampling.

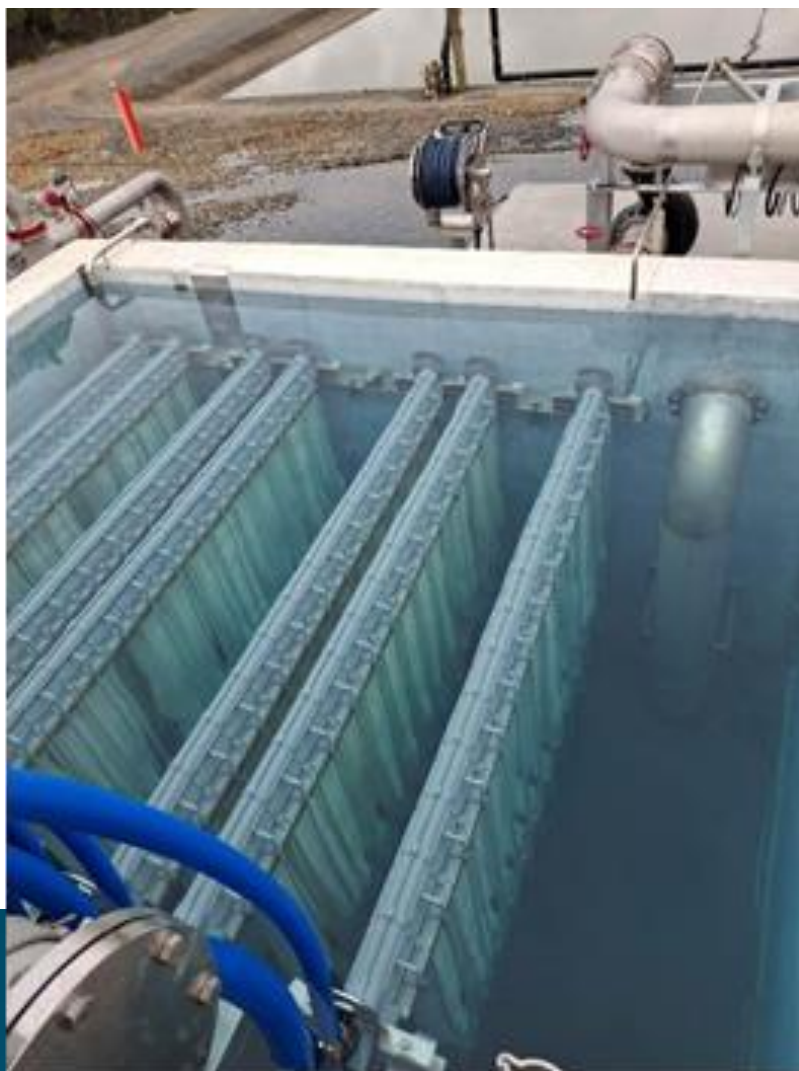
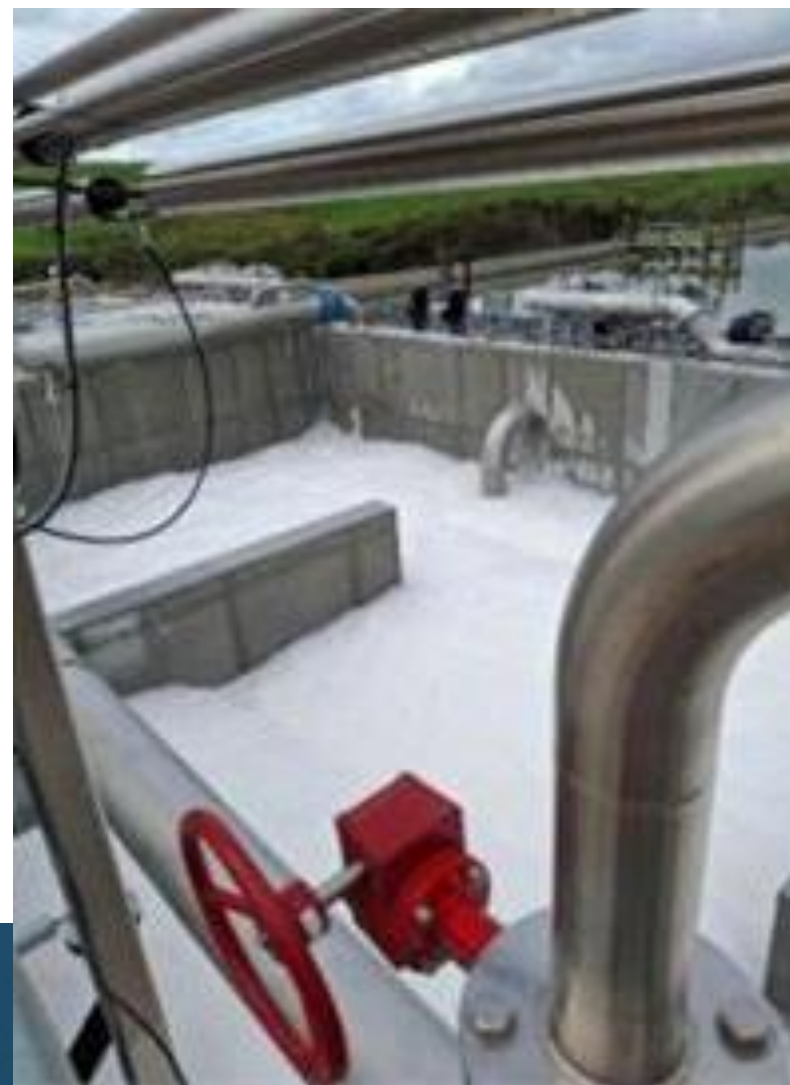
- The 6,000 m³/day Raglan WWTP MABR/MBR Upgrade has commenced key equipment testing.
- Water cycling of the process equipment is underway.
- The electrical and software testing is well underway.
- Once the plant commissioning is complete, preparations will be made for turning into service. Performance testing will follow.

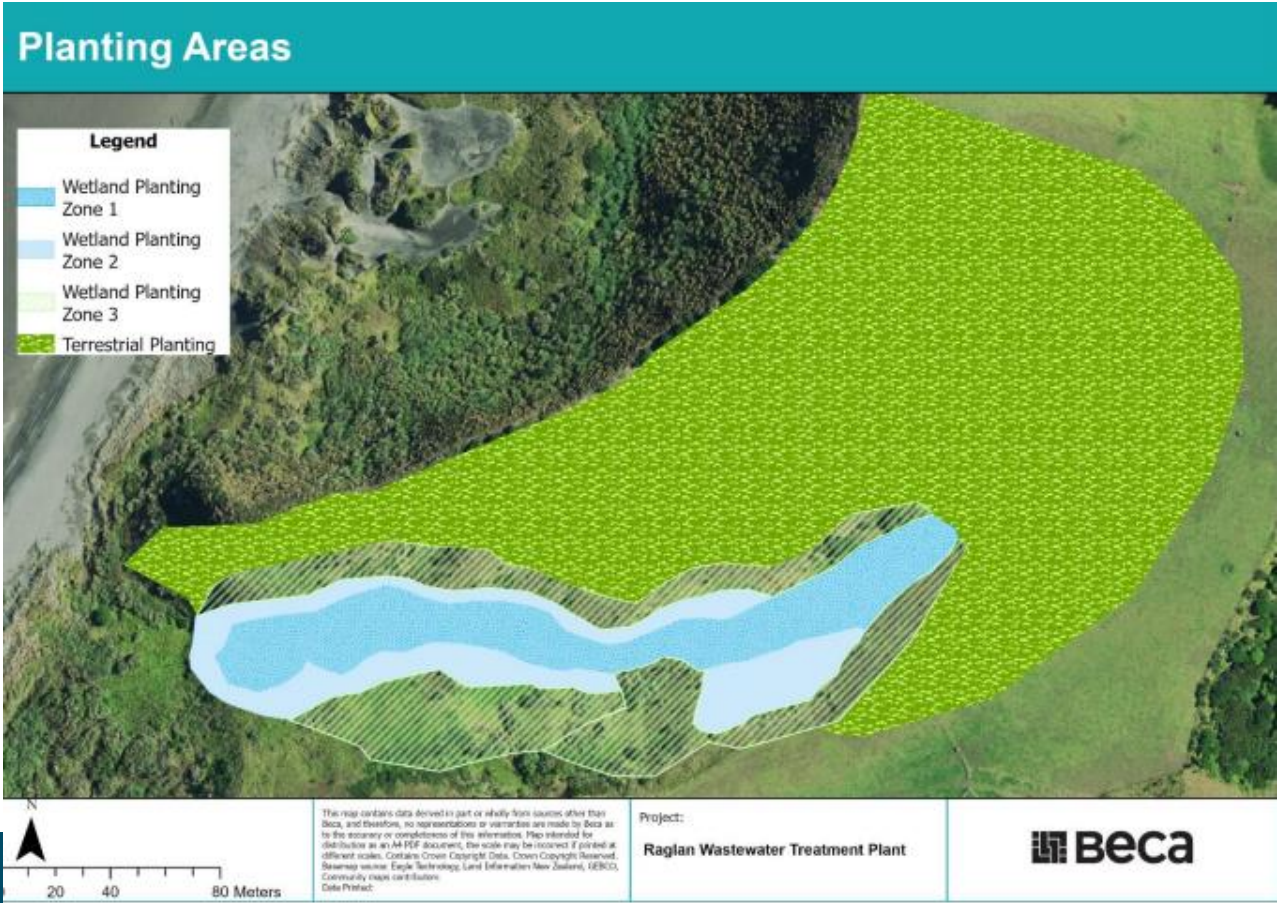
Ecology and Planting Plan

- Overall low ecological value in the gully, but with a significant restoration potential. The scheme will improve the ecology of the gully.
- Biological transformation of residual nutrients/toxins - phytoremediations.
