# Archaeological assessment of the proposed wastewater outlet pipeline within Wainui Reserve.

By Dr Warren Gumbley

September 2024

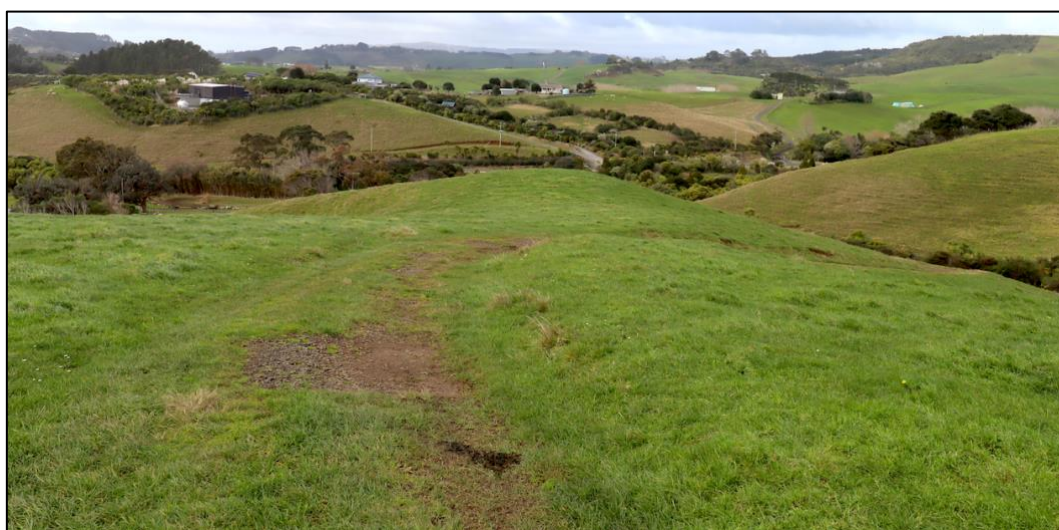
Figure 5: View east down the lower part of the access track from the manager's house.

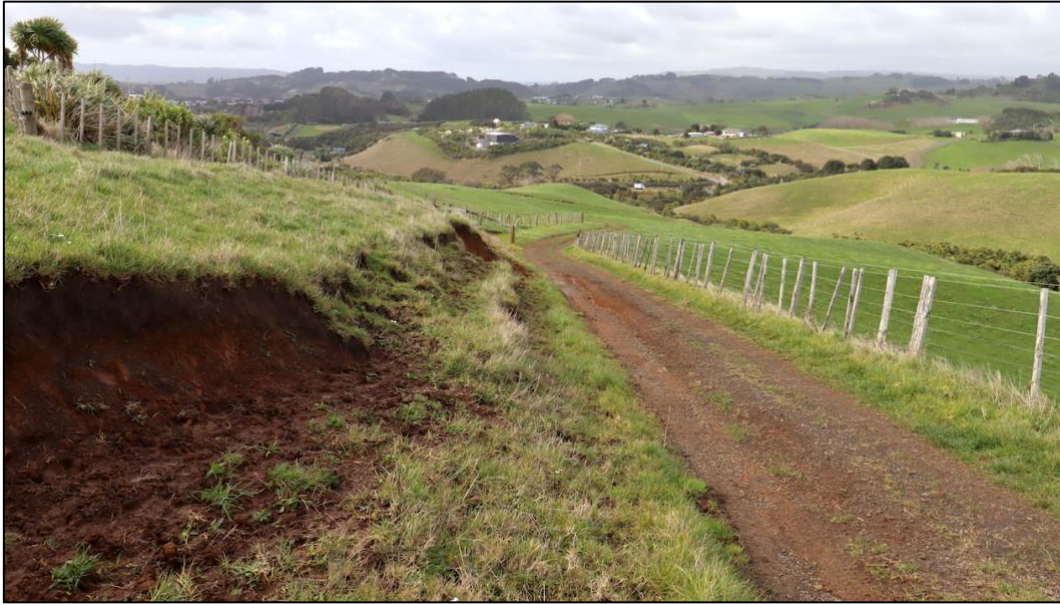
Figure 6: View down the upper part of the track from the manager's house.

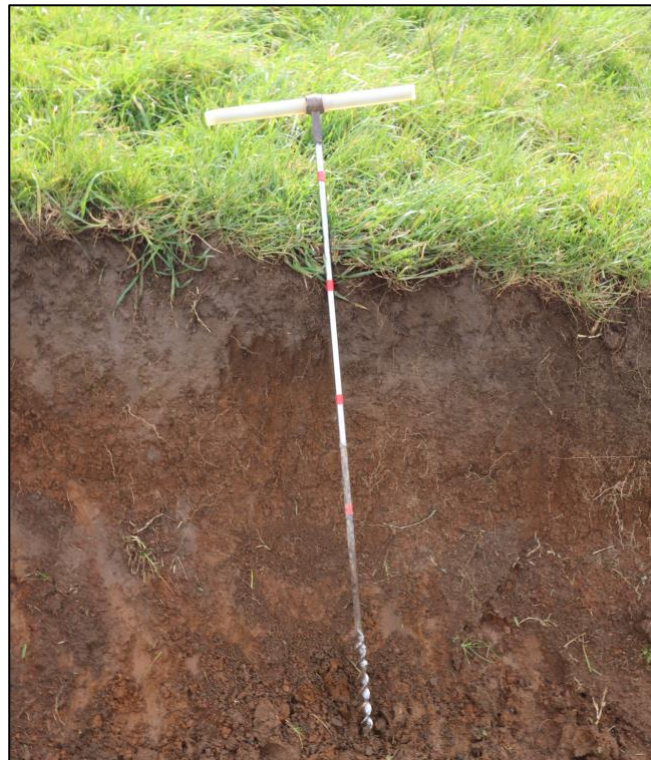
Figure 7: Typical soil profile seen in the track cutting.

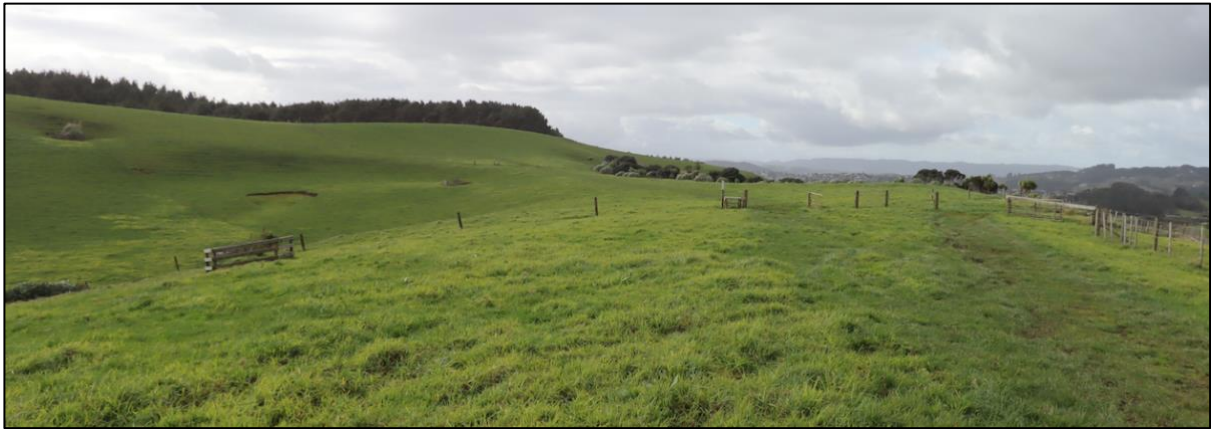
Figure 8: View north along the ridge crest showing where the track from the manager's house meets the ridge crest (gate centre-right). The head of the gully can be seen in the centre-left of the image.

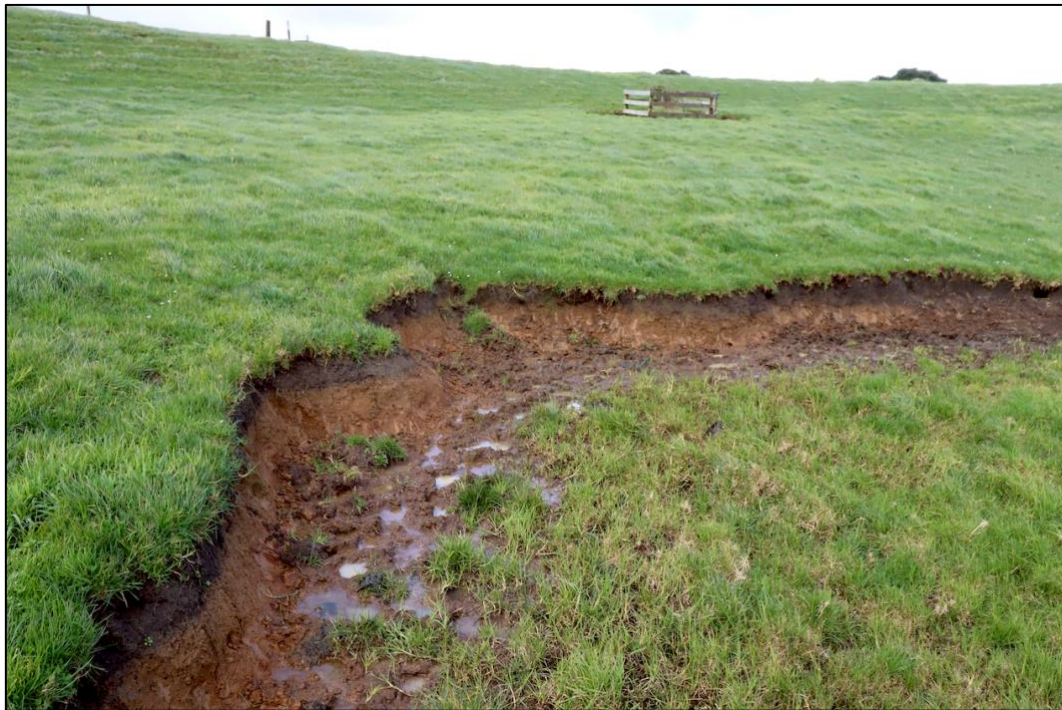
Figure 9: Stock cutting showing a typical soil profile at the head of the gully.

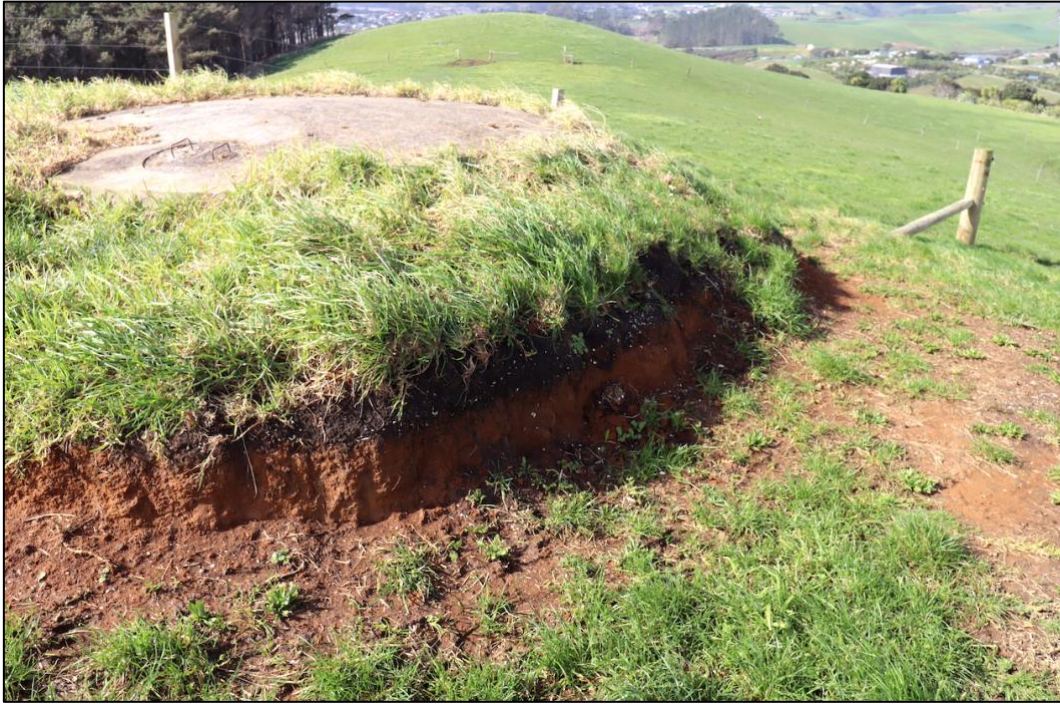
However, shell midden was exposed around the water tank adjacent to the maramataka 'circle' on the ridge crest immediately above the gully. While this exposure of shell midden is disturbed by the installation of the water tank, it indicates that the level area where the maramataka circle is sited contains archaeology and probably functioned as an extension of pā R14/63. Therefore, this area has been recorded in the national archaeological site database as R14/470.

Figure 10: Shell midden visible in the stock cutting around the water tank at R14/470.

The identification of shell midden, with the potential for further archaeological deposits within and surrounding the flat area where the maramataka circle is located, has implications for the final location of the proposed predator-proof fence and the associated native plantings. Both should be located downslope of the flat area where the circle is located. Similarly, the

The pipeline route appears to avoid archaeology, but associated activities, such as the predator-proof fence, the native vegetation plantings in the gully, and the proposed mountain bike track, could affect archaeology. These need to be finalised to avoid impact on archaeology. There is no need to apply to Heritage New Zealand for an archaeological authority to install the pipe. Good planning for the location of the predator-proof fence and plantings will mean that these should not need an authority either. To achieve this, it is recommended that an archaeologist vets the final design for these to ensure that archaeology is avoided.

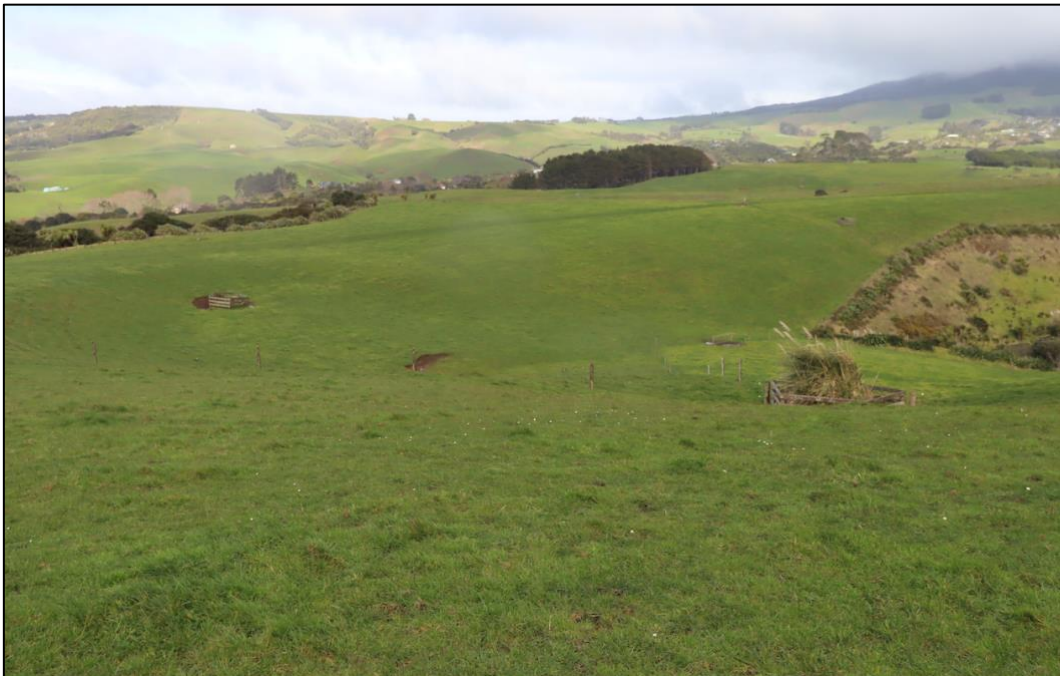
Figure 11: View from the water tank looking south east across the head of the gully.
