# Raglan Wastewater Consent

## Groundwater Risks Assessment

Prepared for Watercare Services Ltd

Prepared by Beca Limited

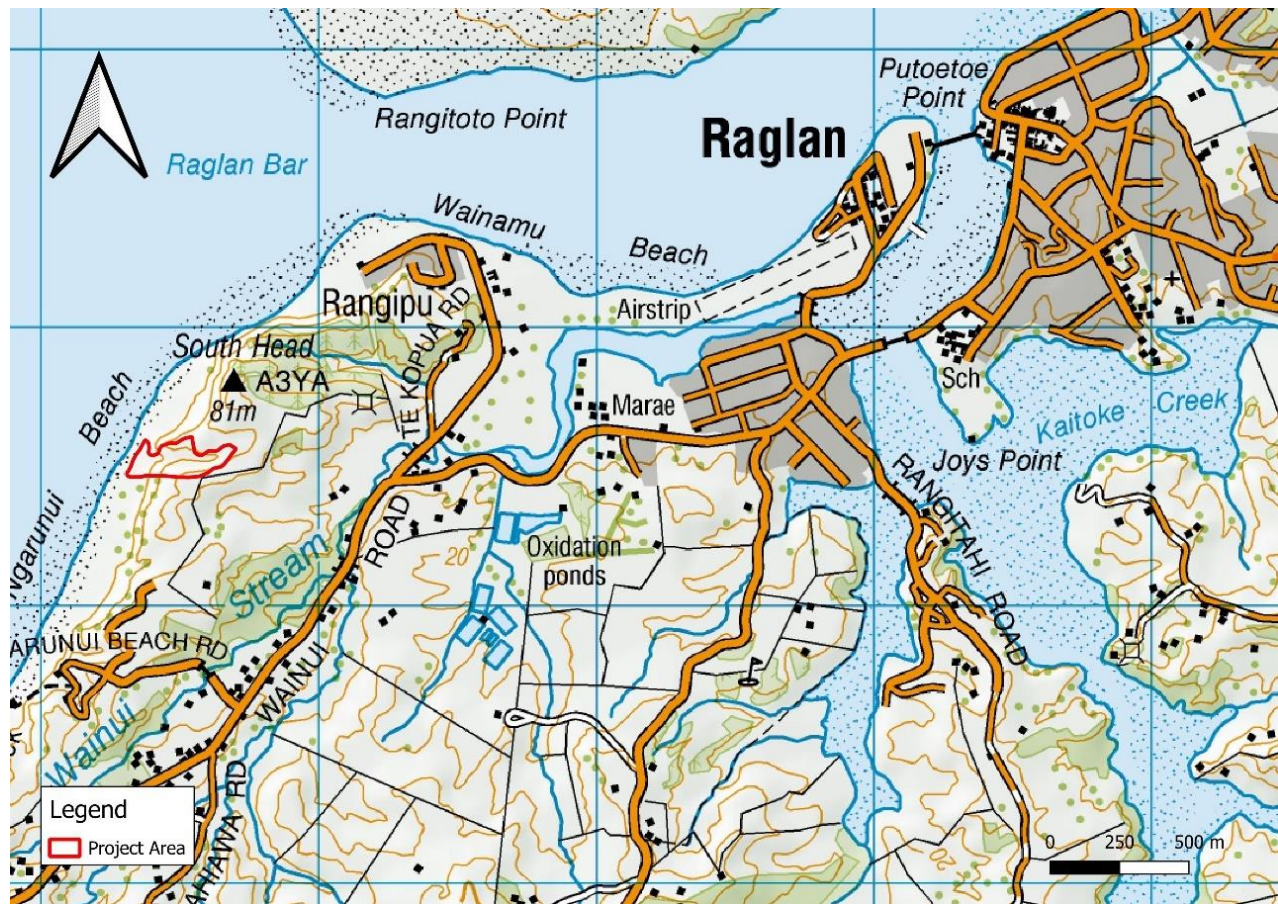
Figure 1. Project site area.

The proposed discharge site is into a gully located in Wainui Reserve, located at 316 Wainui Road, approximately 3 km southwest of Raglan (Figure 1).

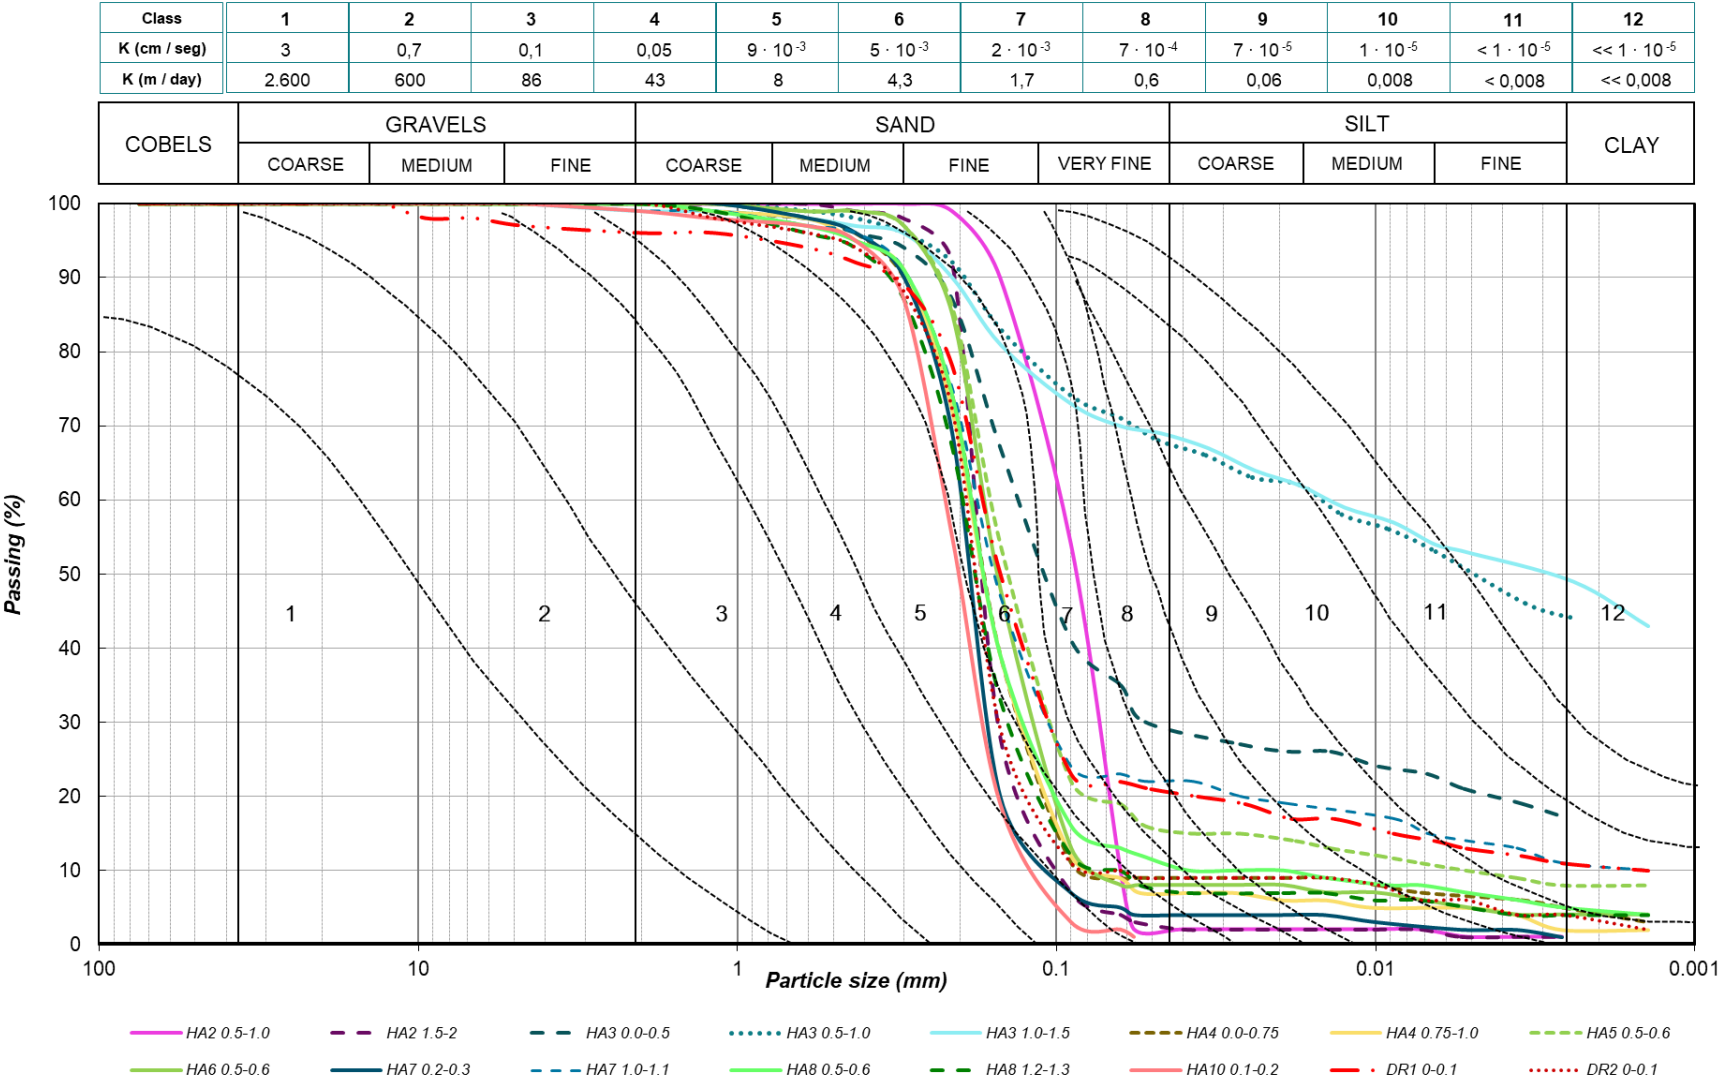
Figure 6. Particle size distribution curves.

More generally, when comparing the PSD curves to the permeability estimations it can be seen that the finest of the samples (HA05 0.5-0.6m, DR1 0-0.1 m, HA07 1.0-1.1 and HA03 0-0.5m) do yield the lowest permeability values ( $10^{-6}$  to  $10^{-9}$  m/s); however, the remaining values are high (typically  $10^{-5}$  m/s) for soils with 5 -10 % fines. Additionally, even between Hazen and Kasenow there can be large variability for the same soil highlighting the importance of the factors identified above.

It is noted that grain size correlations such as these have limitations for estimating permeability, especially in fine-grained soils or for sands with a long ‘fines tail’ (i.e. high proportion of silts and clays which as noted above will significantly influence hydraulic behaviour. Factors like density changes, void ratio variations, and clay content affect permeability in ways that grain size alone cannot capture. While these correlations work well for coarse-grained materials, they often fail to account for the complex interactions in fine particles, leading to inaccurate assessments.

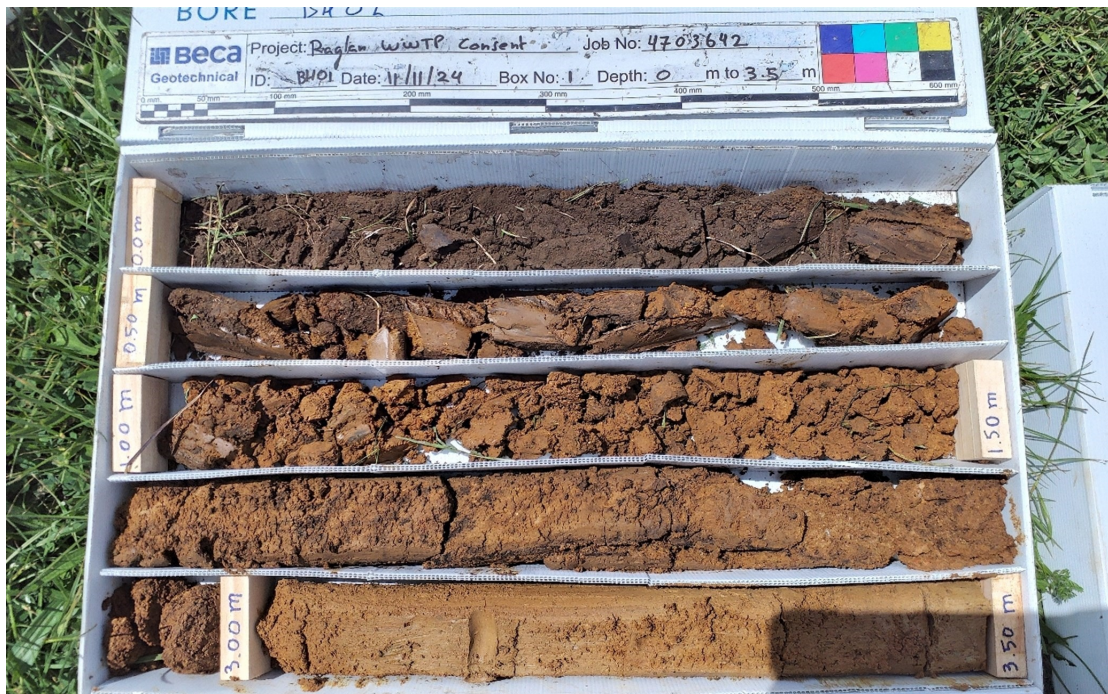
Core Box 01 - 0.00mbgl to 3.50mbgl

<b>Date started:</b>	11/11/2024	<b>Date end:</b>	13/11/2024	<b>Comments:</b>
<b>Logged by:</b>	JC	<b>Drilled by:</b>	McMillan Drilling Ltd	GW at 6.44 m bgl on 12/11 at 07:30am at 10.5 m depth and 3m casing.
<b>Vane ID:</b>	N/A	<b>Equipment:</b>	N102	GW at 15.39 on 13/11 at 07:40am at 39 m bgl and 3m casing.
<b>Vane type:</b>	N/A	<b>Method:</b>	TT/HA	GW at 28.39 on 14/11 at 08:30am on completed piezometer.
<b>Vane width:</b>	N/A	<b>Inclination:</b>	90°	GW at 29.10 on 14/11 at 05:30pm on piezometer after development.
<b>SPT No:</b>	N/A	<b>Diameter:</b>	96mm	GW at 29.60 on 15/11 at 07:30am on piezometer.
<b>SPT efficiency:</b>	N/A	<b>Fluid type:</b>	Polymer/Water	Strength/stiffness inferred from SPT tests completed in BH02 offset 5m from BH01

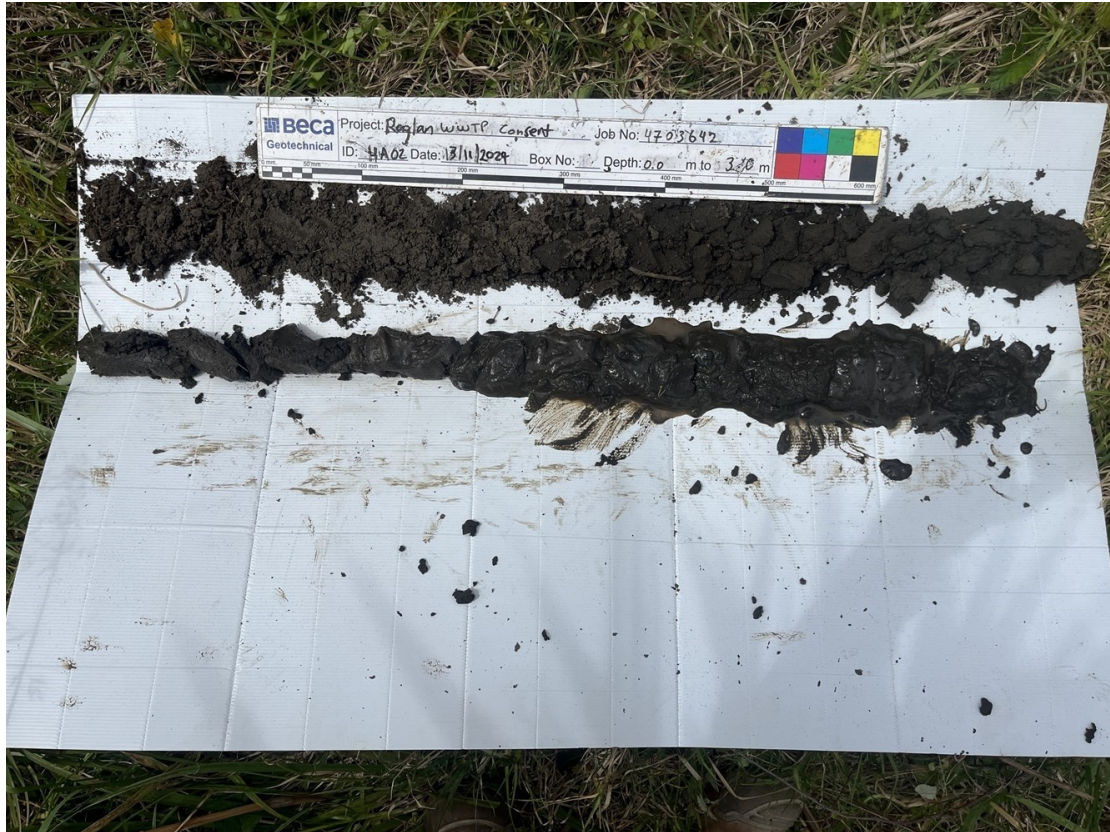
Box 1 - 0.00mbgl to 2.00mbgl

<b>Project:</b>	Raglan Wastewater Consent	<b>Project number:</b>	4703642
<b>Site location:</b>	316 Wainui Rd. Raglan.	<b>Client Name:</b>	Watercare Waikato
<b>Location:</b>	Centre of the gully	<b>Coordinate system:</b>	NZTM2000
		<b>Vertical datum:</b>	NZVD 2016
		<b>Northings:</b>	5813522.9
		<b>Ground level (mRL):</b>	37.00
		<b>Easting:</b>	1761584.2
		<b>Location method:</b>	GPS +/- 10m

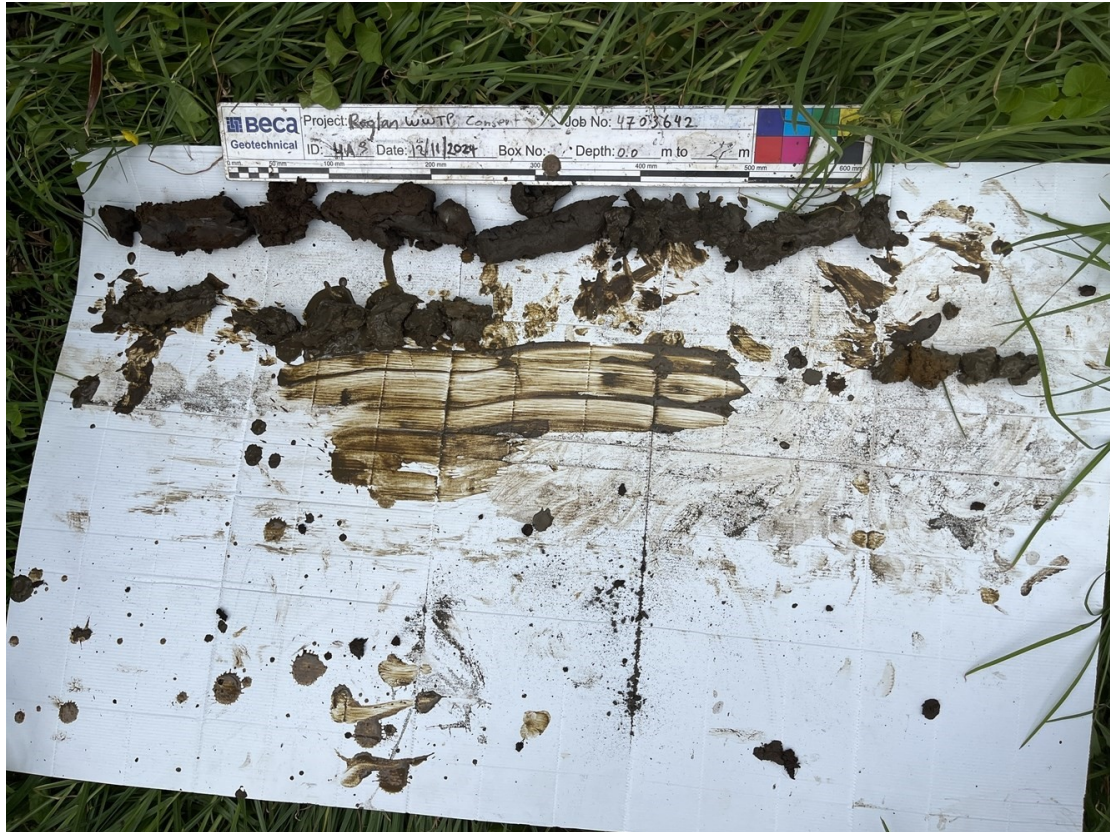
Box 1 - 0.00mbgl to 1.90mbgl

Hand auger terminated due to hole collapse. Groundwater measured on completion of hand auger. The geological unit Karioi Volcanic Formation is abbreviated to KVF.

<b>Project:</b>	Raglan Wastewater Consent	<b>Project number:</b>	4703642
<b>Site location:</b>	316 Wainui Rd. Raglan.	<b>Client Name:</b>	Watercare Waikato
<b>Location:</b>	Gully head	<b>Coordinate system:</b>	NZTM2000
		<b>Vertical datum:</b>	NZVD 2016
		<b>Northings:</b>	5813562.2
		<b>Ground level (mRL):</b>	43.00
		<b>Easting:</b>	1761665.8
		<b>Location method:</b>	GPS +/- 10m

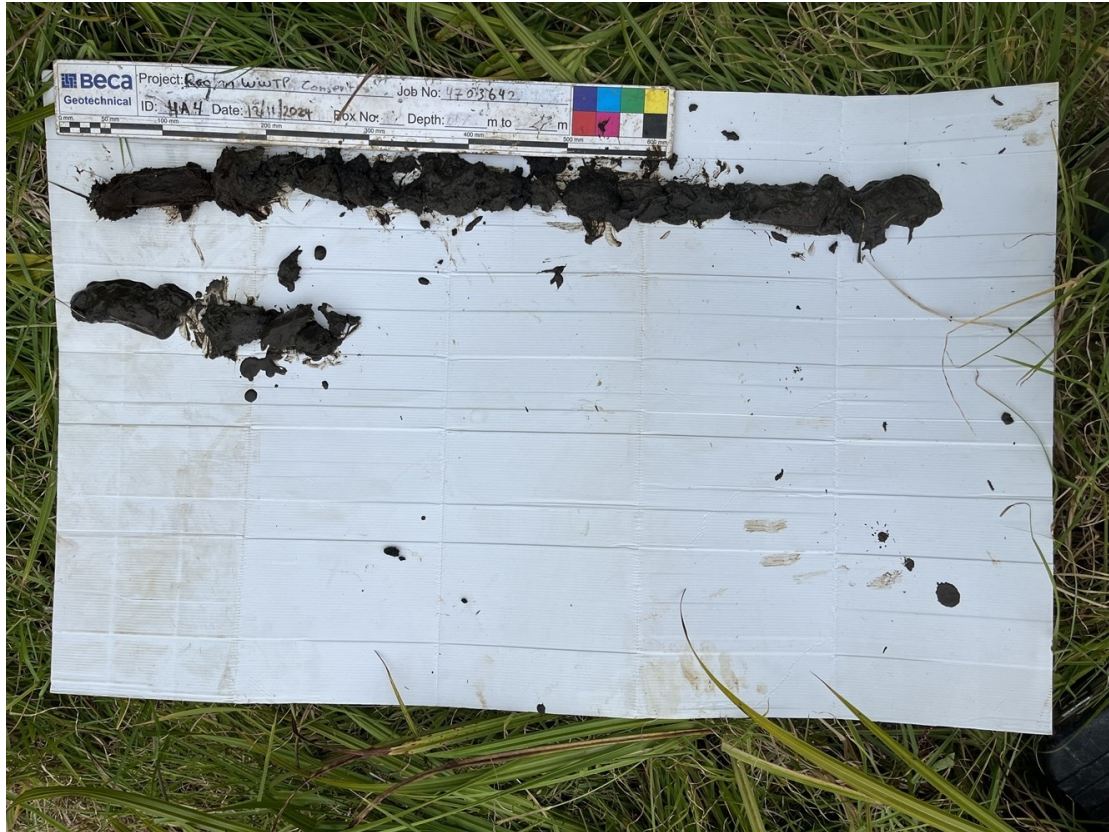
Box 1 - 0.00mbgl to 2.00mbgl

Date Started:	13/11/2024	Vane ID:	Geo1249	Comments:	Hand auger terminated due to hole collapse. Groundwater measured on completion of hand auger.
Logged By:	TTW	Vane Width:	19mm		
Diameter:	50mm	Vane Type:	Down hole

<b>Project:</b>	Raglan Wastewater Consent	<b>Project number:</b>	4703642
<b>Site location:</b>	316 Wainui Rd. Raglan.	<b>Client Name:</b>	Watercare Waikato
<b>Location:</b>	Gully mouth	<b>Coordinate system:</b>	NZTM2000
		<b>Vertical datum:</b>	NZVD 2016
		<b>Northings:</b>	5813529.9
		<b>Ground level (mRL):</b>	14.00
		<b>Easting:</b>	1761408.9
		<b>Location method:</b>	GPS +/- 10m

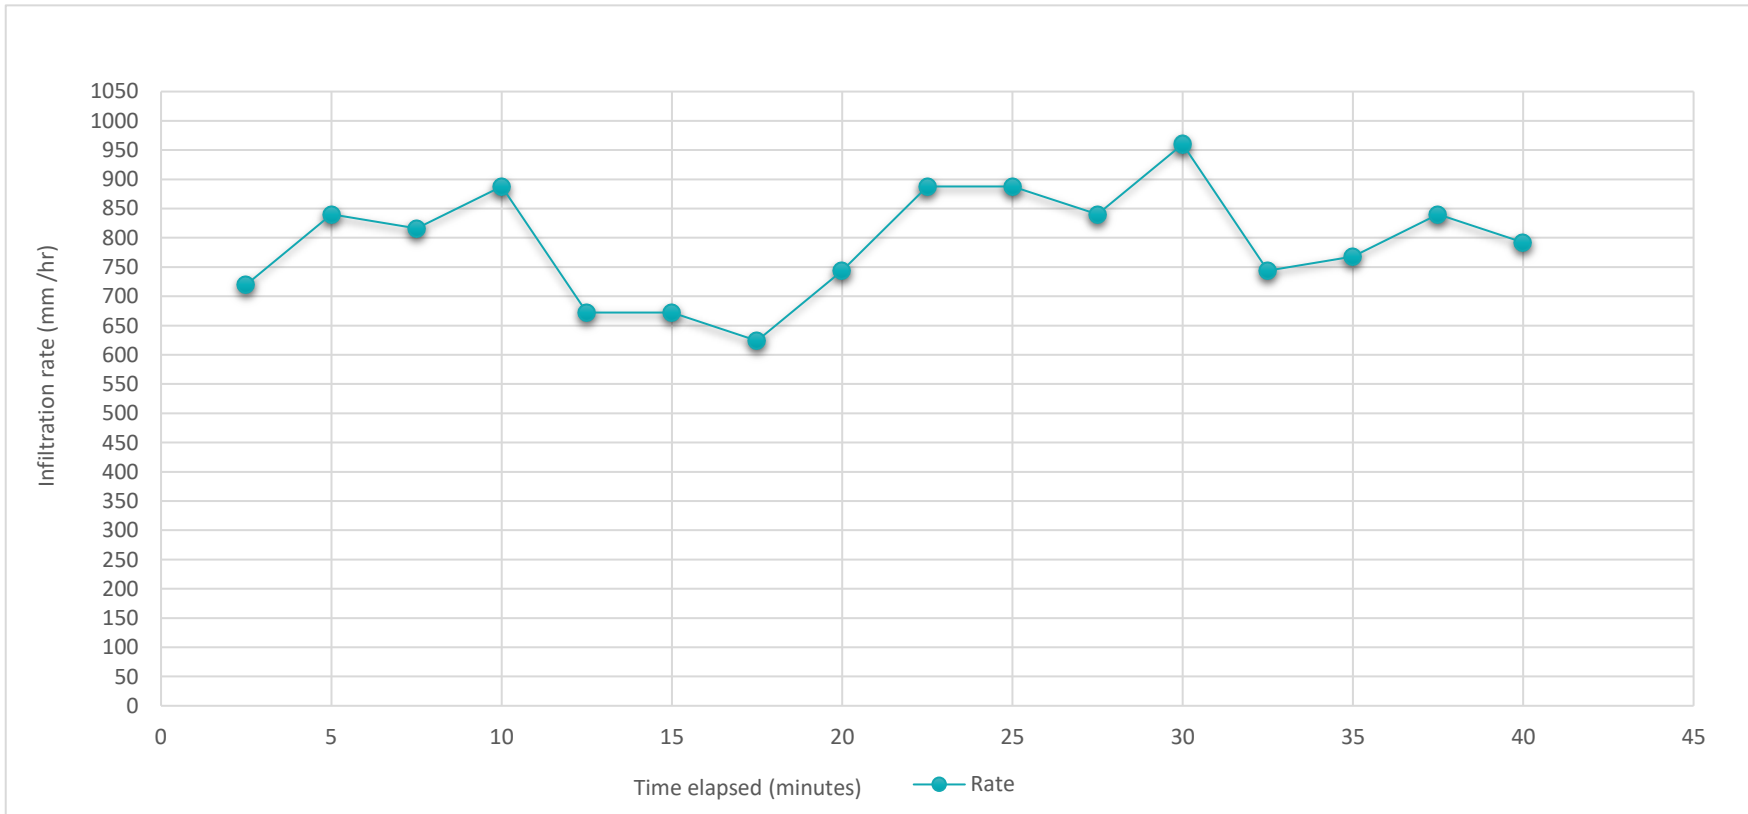
Double Ring Infiltrometer Test					
Job Name	Raglan Wastewater Consent			Job Number	4703642
Client	Watercare Waikato			Test ID	DR04
Location	Nganurui Beach Gully			Easting	1761377.686
Tested by	HF/JC	Date	7/03/2025	Northing	5813555.111
Groundwater level	-	Start time	12:00	Elevation (mRL)	5.4
Pre-soak	No	Base of test (mBGL)	0.1	Circuit (method)	Mt Eden
Inner ring (cm)	15	Outer ring (cm)	30	Datum (method)	NZTM
Tested Soil	Medium to coarse SAND (beach sands)			Infiltration Rate (mm/hr)	804

Test	Test depth (m BGL)	Raw Field Infiltration Rate (mm/h)	Raw Field Infiltration Rate (m/s)	Lithology
DR1	0.1	1	$2 \times 10^{-7}$	Clayey SILT
DR2	0.2	54	$2 \times 10^{-5}$	Silty SAND
DR3	0.1	108	$3 \times 10^{-5}$	Silty SAND
DR4	0.25	804	$2 \times 10^{-4}$	SAND
