Raglan Treatment plant

Repeat out-of-cycle discharge

2 November 2023

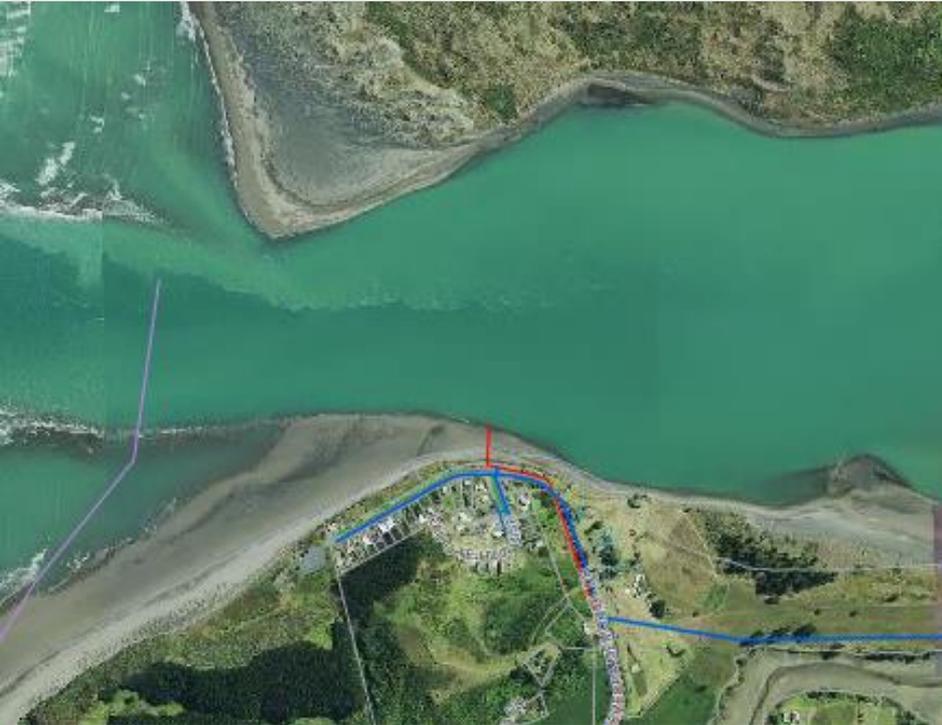
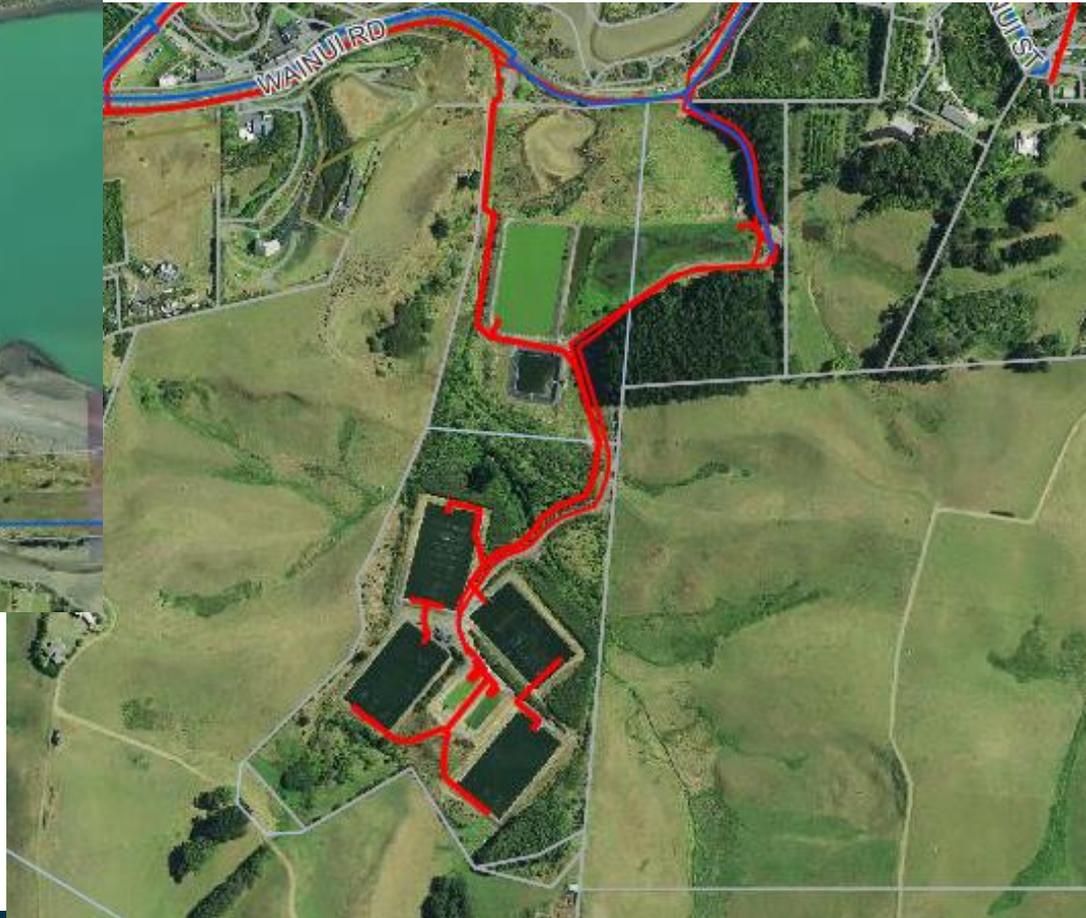
How the plant works

Aeration pond-based system.

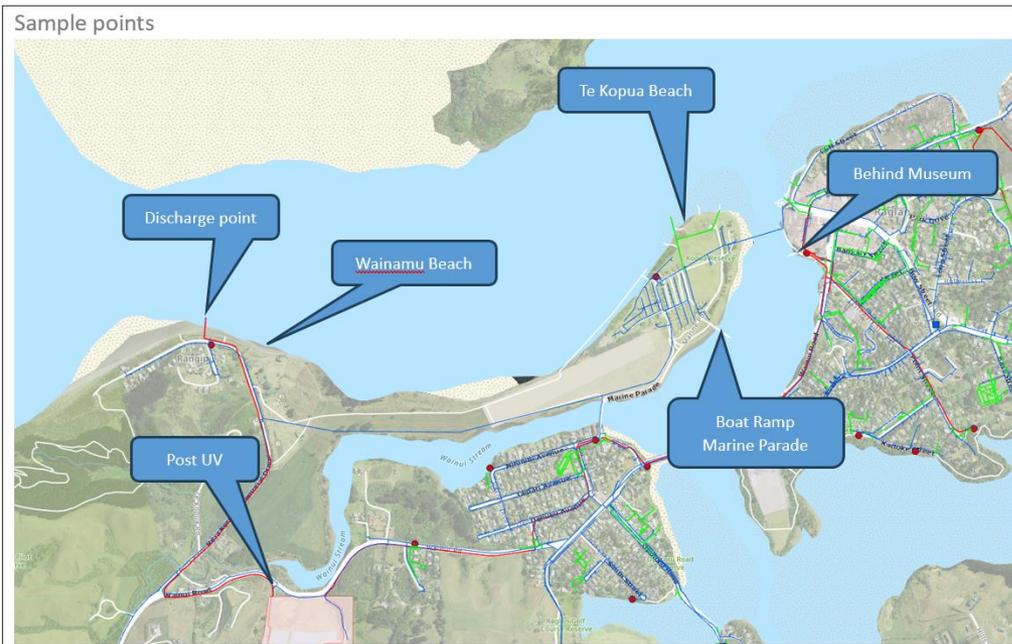
Location/ Date/Time	12/10 12:17- 12:41	13/10 9:30- 11:00	15/10 12:16- 12:47	27/10 9:15 – 9:50	28/10 9:50 – 10:45	29/10 11:17 – 12:06
Post UV				1.6	1.6	<1.6
Wainamu Beach	<1.6	<1.6	33	23	58	13
Te Kopua Beach	3.3	3.3	16	18	8.2	15
Boat Ramp off Marine Parade	8.2	1.6	660	120	6.6	40
Behind Raglan Museum		<1.6	240	74	<1.6	800
