# Lake Waikare - Water Quality Effects Assessment

Te Kauwhata Wastewater Treatment Plant

Prepared for Watercare Services Ltd

Prepared by Beca Limited

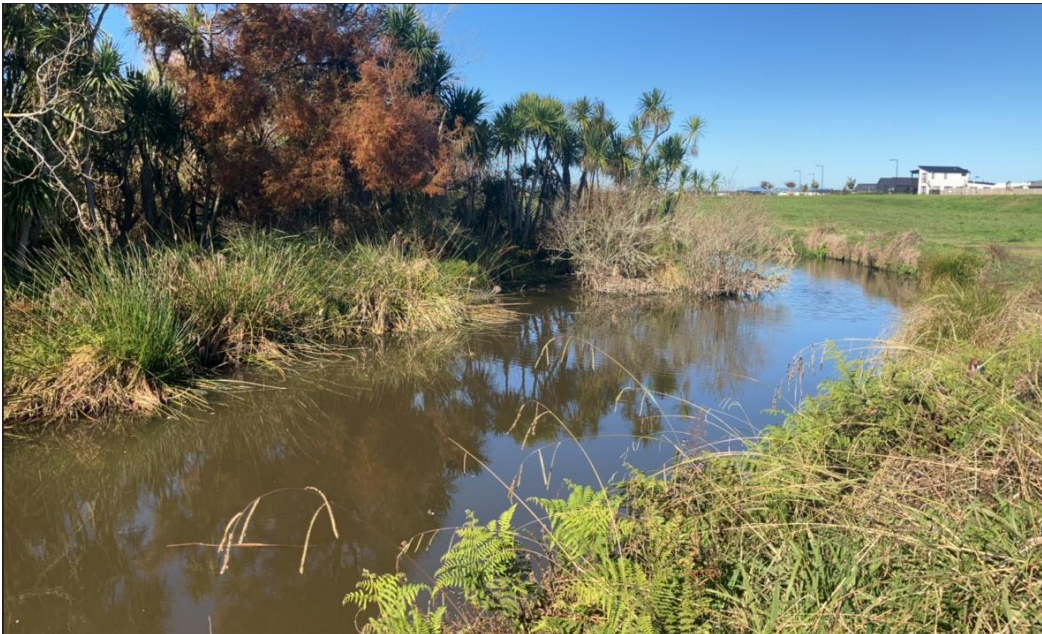
Figure 3: Discharge channel

The WWTP discharge enters Lake Waikare via an approximately 400 m long channel (known hereafter as the “discharge channel” which runs between Rimu Street and a patch of wetland vegetation to the west of the WWTP oxidation ponds (Figure 3). Lake Waikare is a shallow riverine lake (Matahuru catchment size 210km<sup>2</sup>), with several inlets (one of which is gate controlled) and one outlet into Pungarehu Stream. Pungarehu Stream then discharges into the Whangamarino River, located within the Whangamarino wetland. The Whangamarino river discharges into the Waikato River near Mercer.
