Catchment Management Plan
Horotiu Structure Plan Area

Report prepared for:
Waikato District Council

March 2015

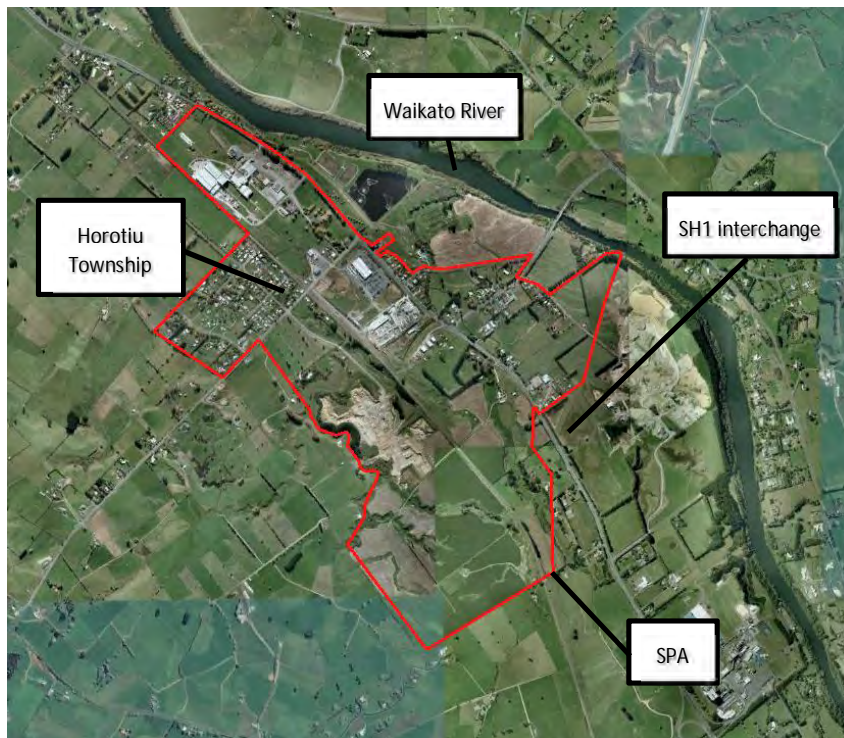
Figure 1. Horotiu SPA location (Image sourced from Google Earth, 2014)

The Horotiu SPA surrounds the township of Horotiu, and is located on the western side of the Waikato River, approximately 13 km north of Hamilton City. The Waikato Expressway and interchange with Great North Road is adjacent to the southeast boundary of the SPA. The North Island Main Trunk Line railway line runs through Horotiu. The location of the Horotiu SPA is presented in Figure 1. The SPA (red outline) covers approximately 258 ha.

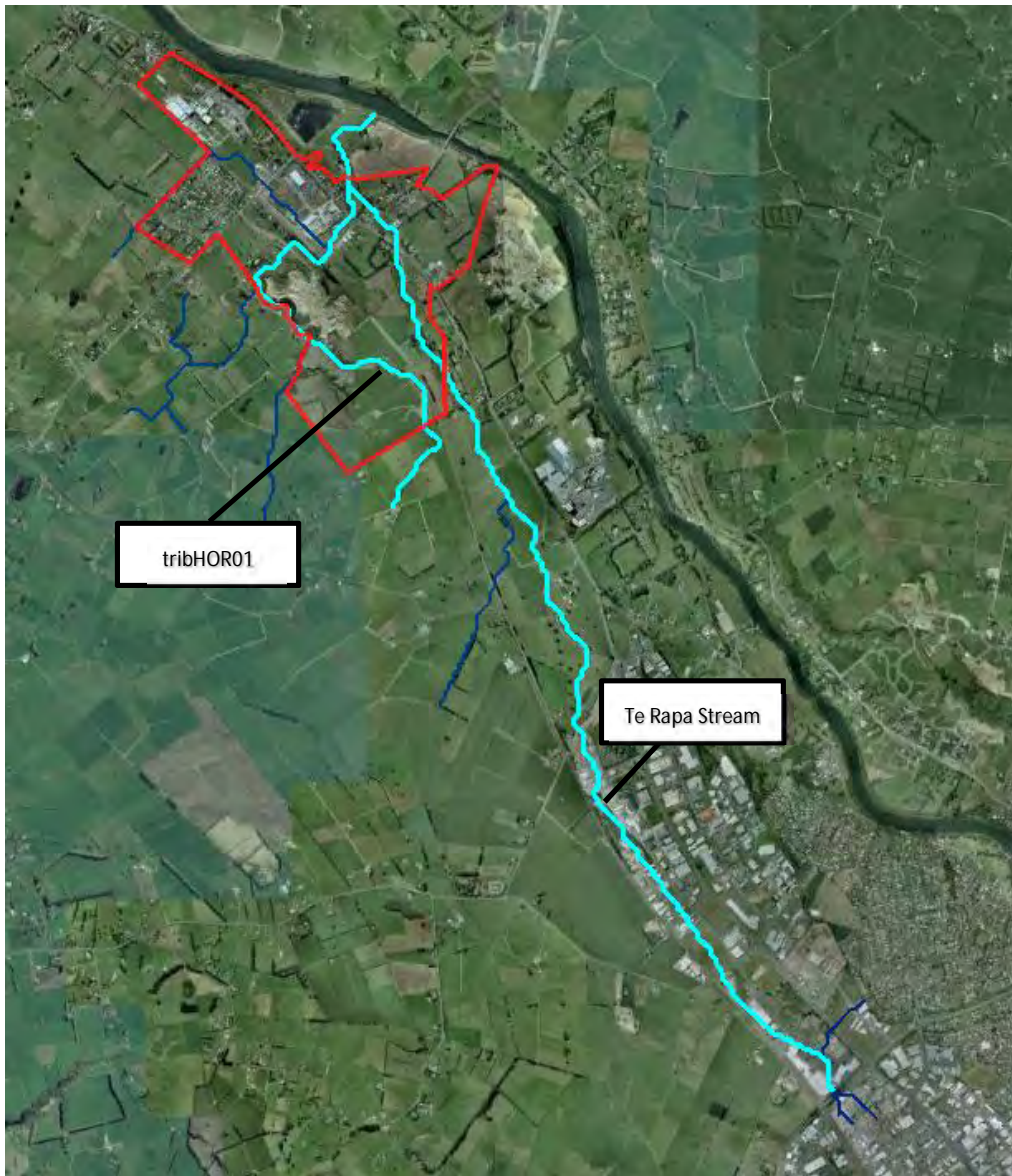
Figure 3. Main water courses (light blue) and tributaries (dark blue) within the catchment.

There are two main watercourses flowing through the existing Horotiu Township; the Te Rapa Stream and an unnamed tributary of Te Rapa Stream labelled tribHOR01. These streams are described below and shown (light blue) in Figure 3 below.

The Te Rapa Stream drains a portion of land in the east SPA and significant areas of rural land and industrial land in the north of Hamilton City. The upper and middle reaches south of the SPA receive runoff from Hamilton City and agricultural lands with the lower reach (the majority of which is within the SPA) receiving runoff from a mix of industrial and agricultural land. Only a small section of the land currently discharging to the unnamed tributary is residential land. Te Rapa Stream discharges into the Waikato River northeast of Horotiu just outside the SPA. From the Waikato River to its headwaters, the Te Rapa Stream is approximately 8.3 km long with approximately 6 km upstream of the SPA boundary.

The unnamed tributary drains the majority of the SPA and a significant portion of rural land to the southwest of the SPA. The upper reach southwest of the SPA receives runoff from mainly agricultural lands with the middle and lower reaches (the majority of which are within the SPA) receives runoff from a mix of industrial and agricultural land. As per the Te Rapa Stream, only a small section of the land currently discharging to the unnamed tributary is residential land. The unnamed tributary discharges into the Te Rapa Stream within the SPA.

There are a number of smaller unnamed tributaries within the Horotiu SPA that feed into the Te Rapa Stream and tribHOR01. The unnamed tributaries drain a mixture of industrial, agricultural and residential land. These unnamed tributaries are shown in Figure 3 above.

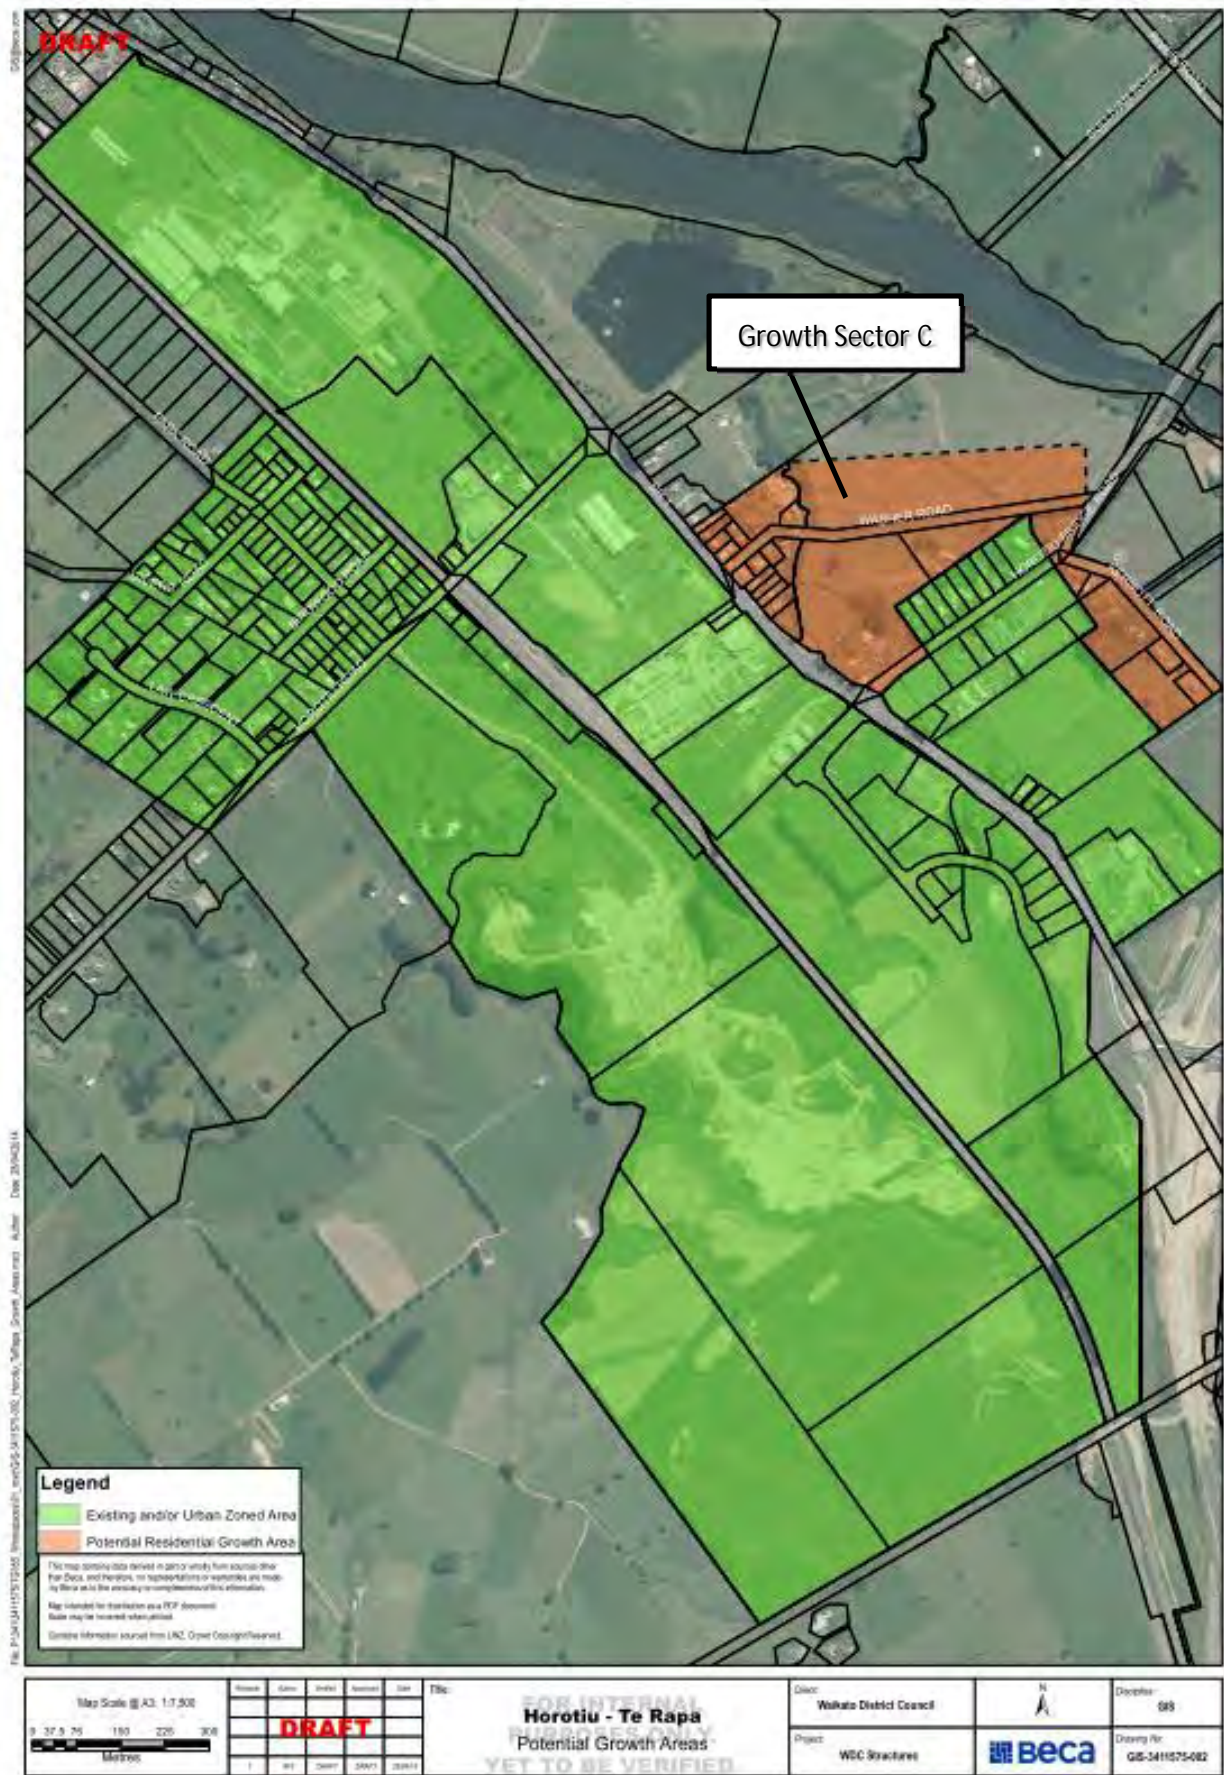
Figure 4. Horotiu growth plan provided by WDC and Growth Sector used for reporting

Future growth within the SPA has been provided by WDC and is shown in Figure 4 below. The figure shows that the future land use is anticipated to be only residential.

For reporting purposes, the growth area defined by WDC have been categorised into "Growth Sector" C. This is also presented in Figure 4. It is noted that the growth area provided by WDC and presented in Figure 4 extends beyond the SPA boundary provided by WDC.

For reporting purposes, the area of potential growth has been labelled a "Growth Sector". Within the Horotiu SPA, there is one Growth Sector – C. The location of this Growth Sector can be seen in Figure 4 above and Figures 242 to 243 in Appendix BA. The Growth Sector contains only proposed residential land.

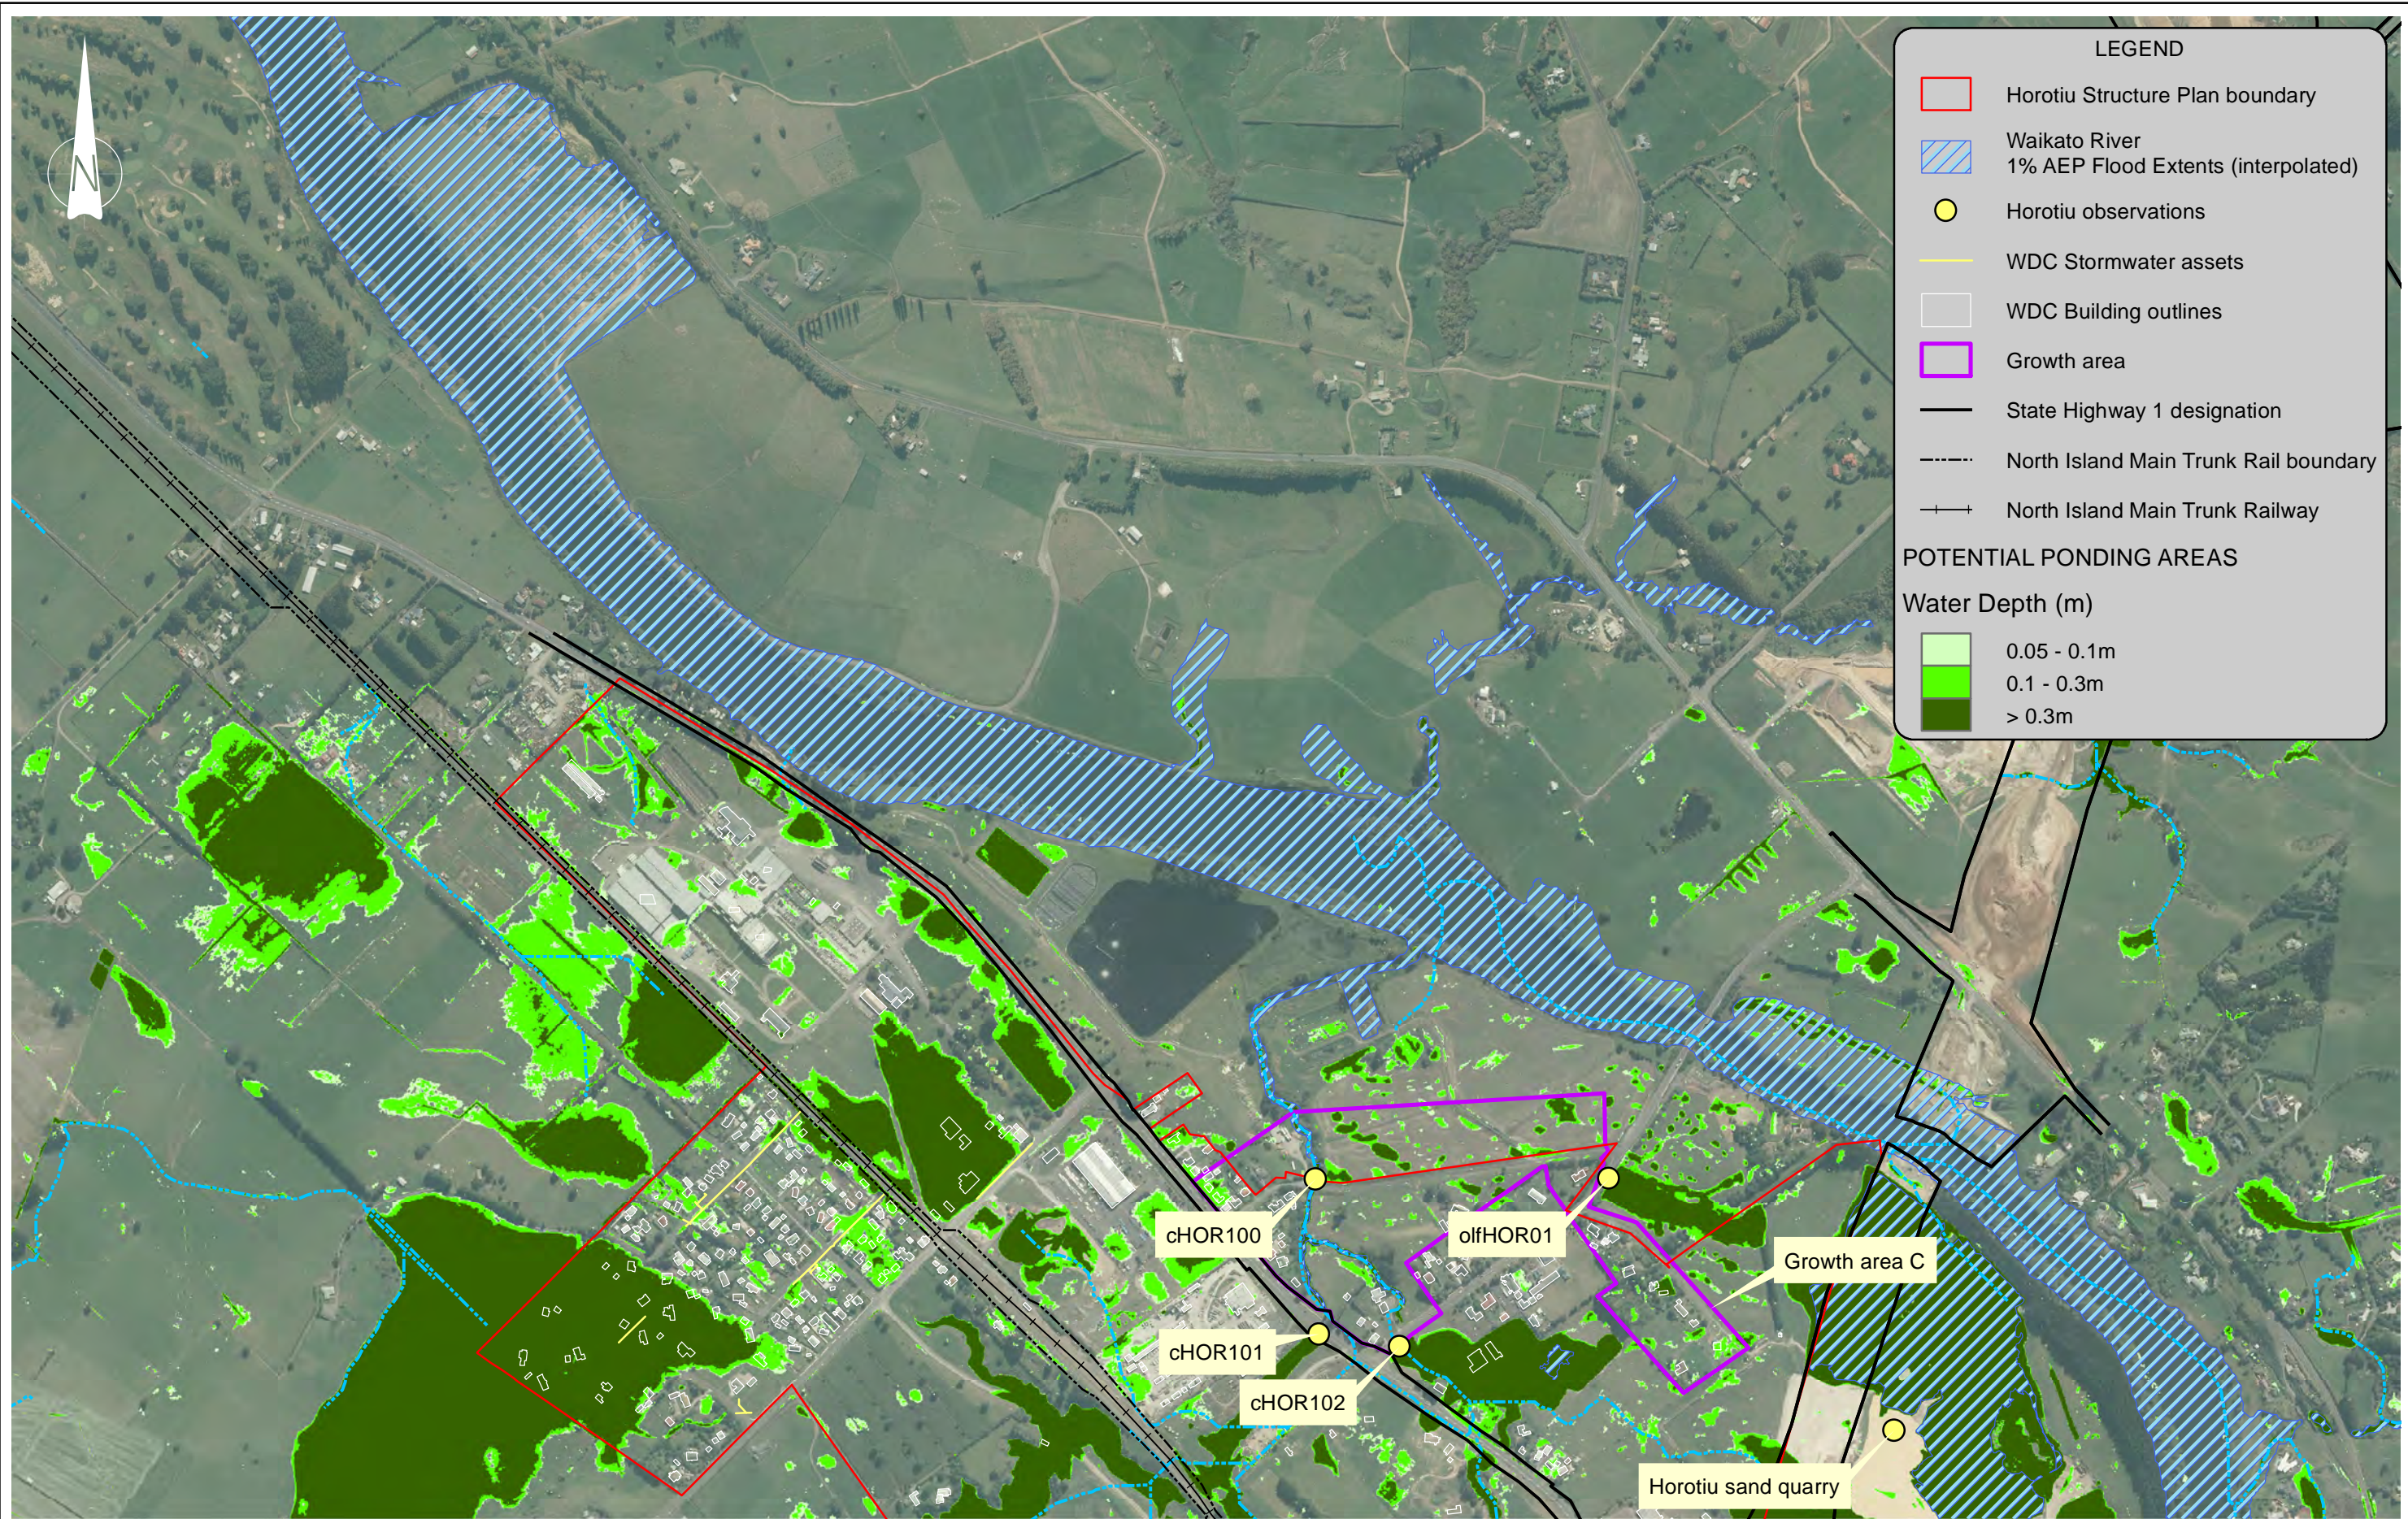
**WAIKATO DISTRICT COUNCIL
 CATCHMENT MANAGEMENT PLAN
 HOROTIU STRUCTURE PLAN AREA
 Flooding Map - Sheet 1 of 2**

The WRC cross sections indicate that the Waikato River 1% AEP (with no climate change) flood level ranges from approximately 15 mRL to 14.8 mRL within the Horotiu SPA. The interpolated 1% AEP river flood extents (with no allowance for climate change) are presented in Figures 242 to 243 in Appendix BA.

The results from the ponding assessment are presented in Figures 242 and 243 in Appendix BA. The ponding assessment entails a high level overview of the model provided in these figures and reviews the feasibility of the proposed residential area.

Figures 242 to 243 in Appendix BA shows the locations of these streams, and their proximity to the Waikato River northeast of Horotiu.

The key culverts that may influence the ponding areas have been identified on Figures 242 and 243 in Appendix BA and also in Table 3.

The unnamed tributary tribHOR01 flows through the western section of the growth sector from underneath the Thermal Explorer Highway (cHOR101), while the Te Rapa Stream flows into the growth sector from beneath Horotiu Bridge Road (cHOR102). The confluence of these two streams is upstream of a culvert under Washer Road (cHOR100) within the growth sector. Both tribHOR01 and the Te Rapa Stream above are incised channels and subject to backwater flooding from the Waikato River. These channels will also be prone to flooding during large storm events.

Key waterway structures in the area of the growth sector have the potential to restrict flow and/or block and create localised flooding or overland flow paths. Culverts on tribHOR01 may restrict flow and cause flooding upstream and/or create an alternative overland flow path, most likely over the road. Culverts cHOR101 and cHOR102 are on the edge of the growth sector and have the potential to create overland flow paths into the growth sector.
