Waikato District Council

Appendix E  
Catchment Management Plan  
Te Kowhai Structure Plan Area

March 2015

T&T Ref: 61814.2000

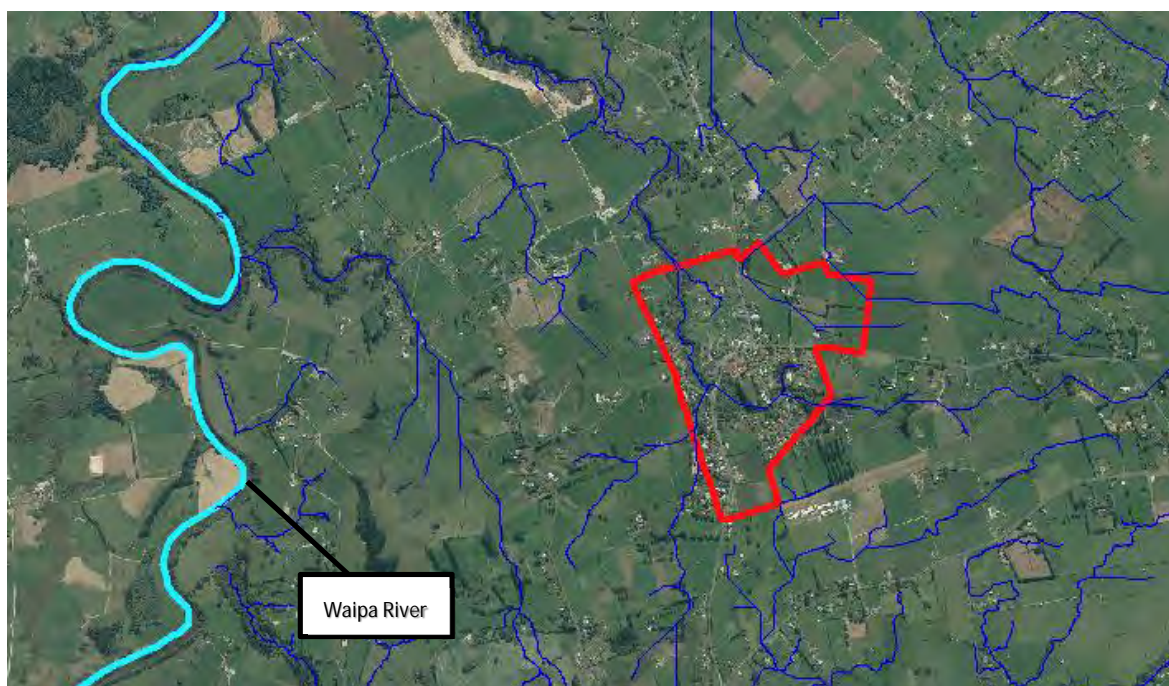
Figure 3. Main water courses (light blue) and tributaries (dark blue) around the SPA (red).

The nearest major watercourse to Te Kowhai is the Waipa River, located approximately 2.5 km west of the town centre. There is a significant unnamed tributary which flows through the Te Kowhai SPA and discharges to the Waipa River in the north. The northern and southern parts of the SPA drain to other unnamed tributaries of the Waipa River.

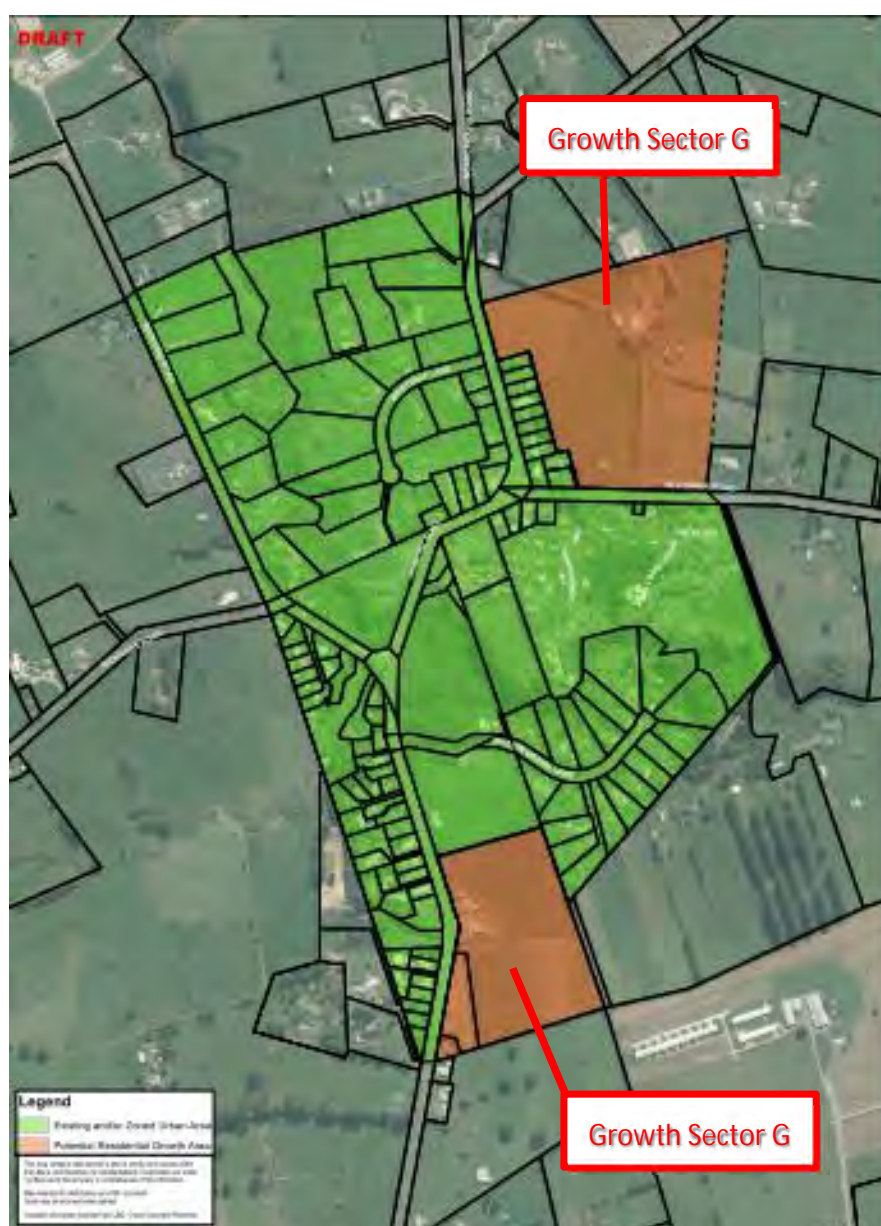
Figure 4. Te Kowhai growth plan provided by WDC and Growth Sectors used for reporting.

Future growth within the SPA has been provided by WDC and is shown in Figure 4 below. The figure shows that the future land use is anticipated to be residential only.

For reporting purposes, the growth areas defined by WDC have been categorised into “Growth Sectors” G and H. These are also presented in Figure 4.

For reporting purposes, each area of potential growth has been broken up into "Growth Sectors". Within the Te Kowhai SPA, there are two Growth Sectors – G and H. The locations of the Growth Sectors are shown in Figure 4 and Figure 262 in Appendix EA. Figure 4 shows that both Growth Sectors contain only proposed residential land.
