**STATEMENT OF REBUTTAL EVIDENCE BY LINCOLN SMITH**

**Terra Firma Resources Limited**

**3 June 2021**

### **High Level Review of Geotechnical Aspects Related to Land Development at Puketirini**

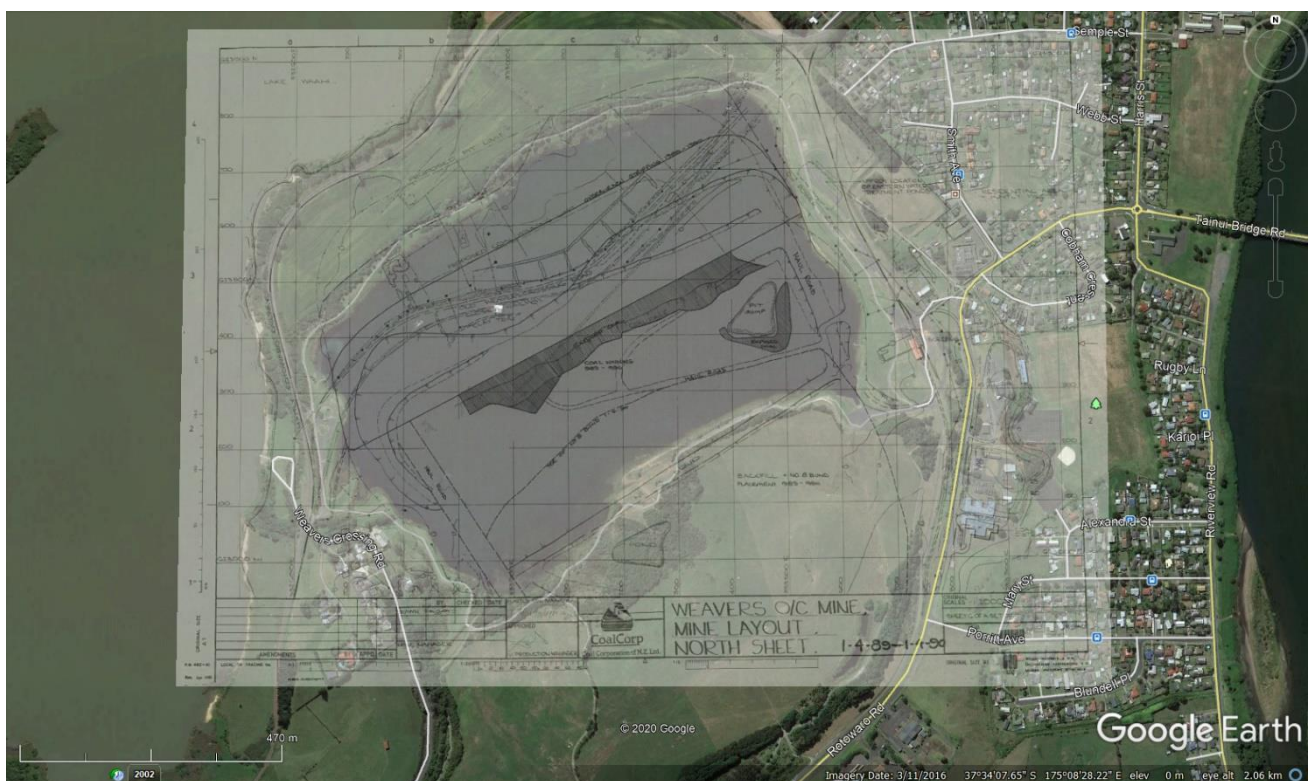
4.5 Figure 4 below is an overlay of an engineering plan on an aerial photo of the subject site, and shows the location of the No. 8 bund wall relative to the lake. Note the toe of the completed No. 8 Bund extending approximately 150m into the southern edge of the lake.

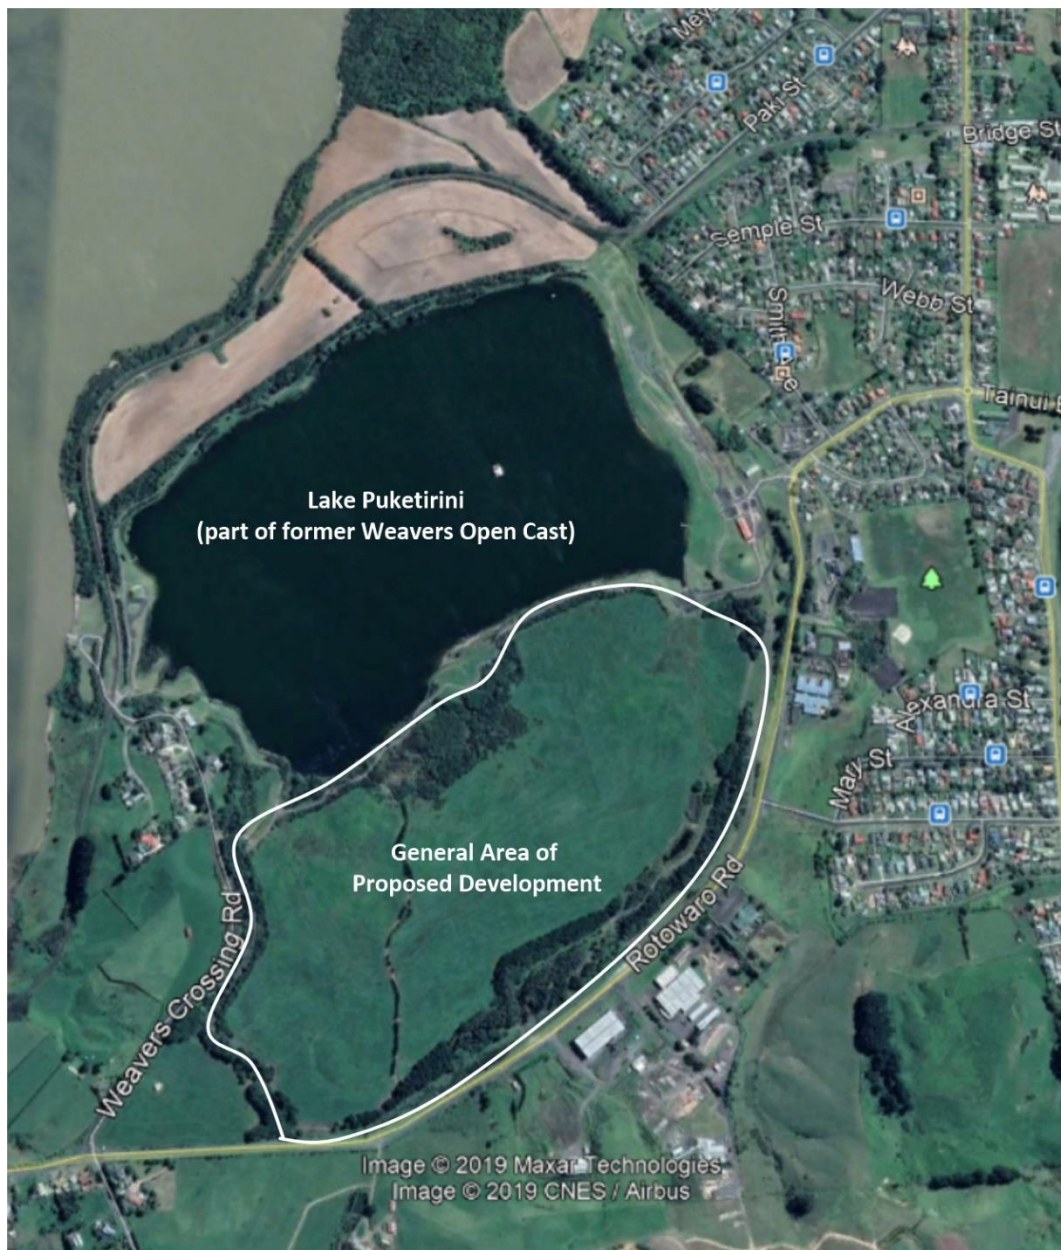
Figure 1 outlines a general location plan of the previous Weavers Open Cast mine (Google Earth imagery 2019) rehabilitated by Coal Corp NZ in the early to mid 1990's, with Lake Puketirini being formed in the northern deep area of the mine and the spoil emplacement area to the south being the proposed residential development area.

**Figure 1: General Location Plan of Proposed Land Development - Puketirini**

The site is located immediately west of the township of Huntly, in a broader area of historic open cut coal mining. The main Rotowaro – Huntly coal mine alignment runs to the north of Lake Puketirini. The naturally formed Lake Waahi is to the west and north of the proposed area (as shown in Figure 1).

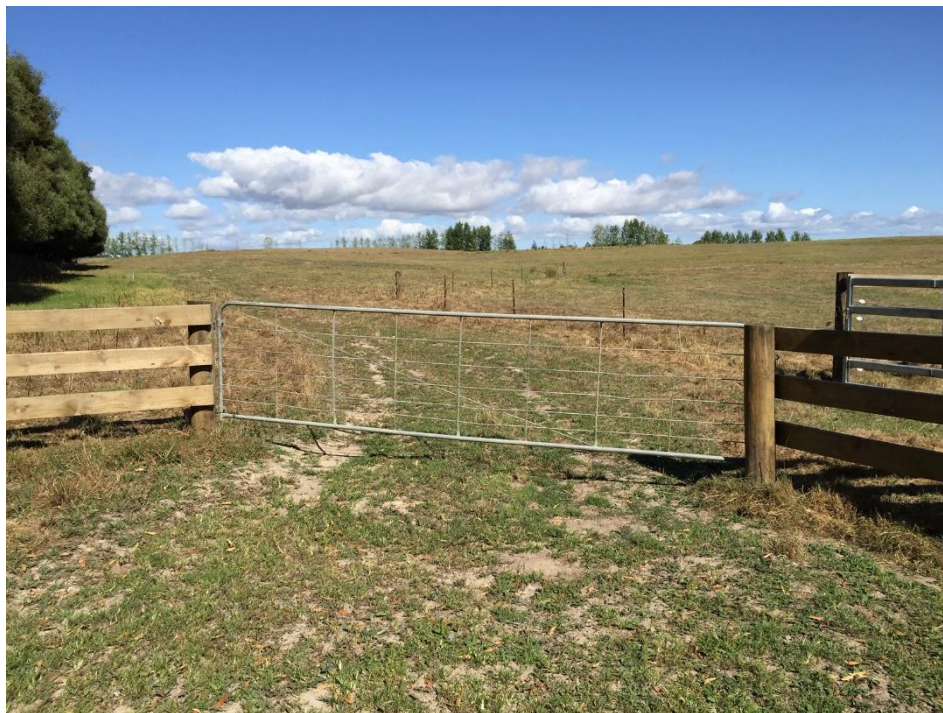
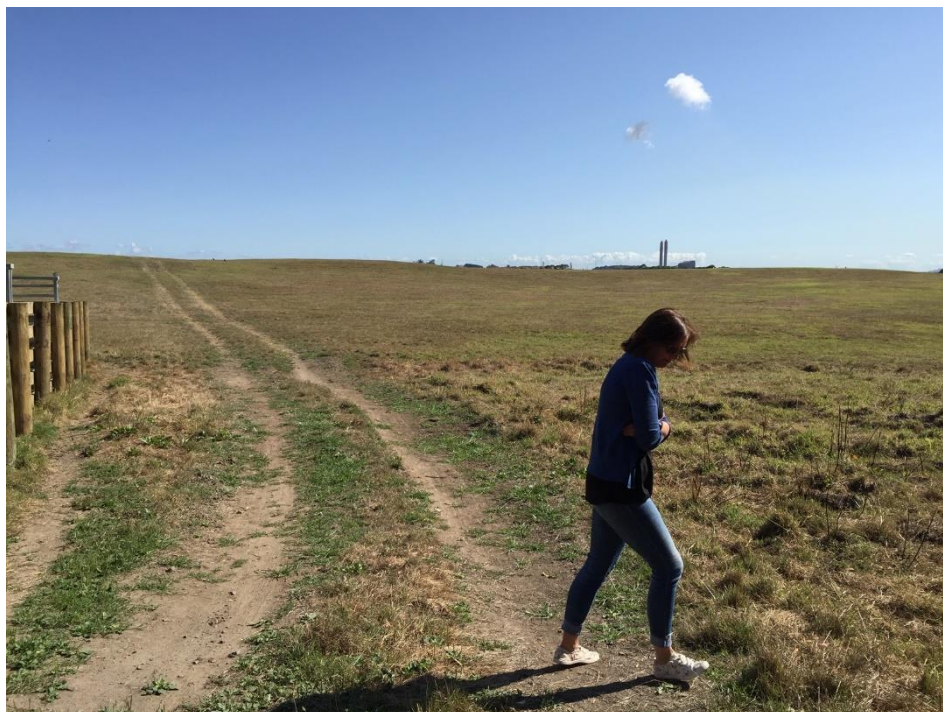
**Figure 2: General images of development area taken February 2019, showing gently undulating pasture.**

Figure 2 provides a general scene of the proposed development area, which is currently subject to general farm grazing and pasture activities.

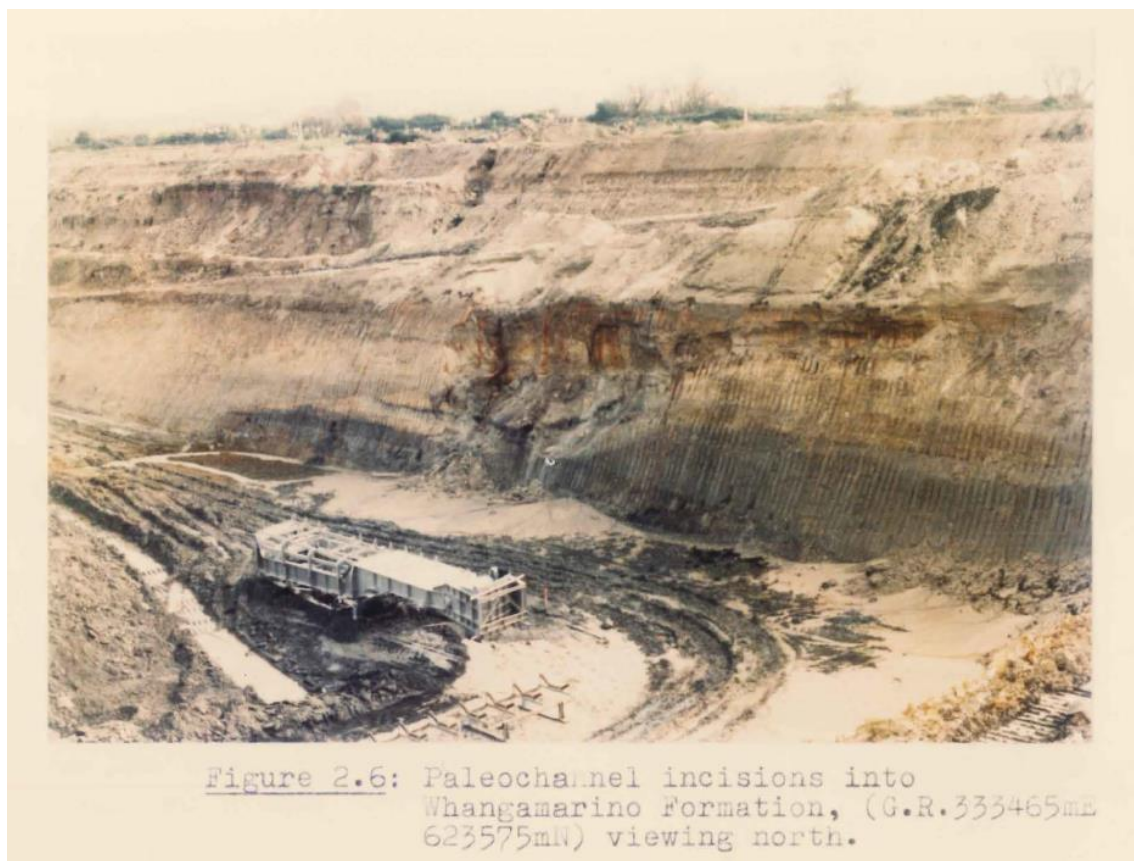
Figure 3 displays a photograph of open cast mine workings taken from Wezenberg's thesis and show the in-pit crusher and mine highwall circa 1987.

**Figure 3: Weavers Open Cast mine workings circa 1987, after Wezenberg (1988).**
