## Review of Coastal Hazards and Coastal Sensitivity Area at Te Akau South

Waikato District Council (“WDC”) have engaged Tonkin & Taylor Ltd. (“T+T”) to undertake a review of the Coastal Hazards and Coastal Sensitivity Area at Te Akau South contained in Appendix 2 of the report titled Waikato District Coastal Hazards - Response to submission on Waikato District Plan Stage 2: Coastal Hazard Area Maps, by Bronwen Gibberd - 4D Environmental Ltd and Jim Dahm - Eco Nomos Ltd (March 2021).

# Appendix 2: Review of Coastal Hazards and Coastal Sensitivity Area at Te Akau South

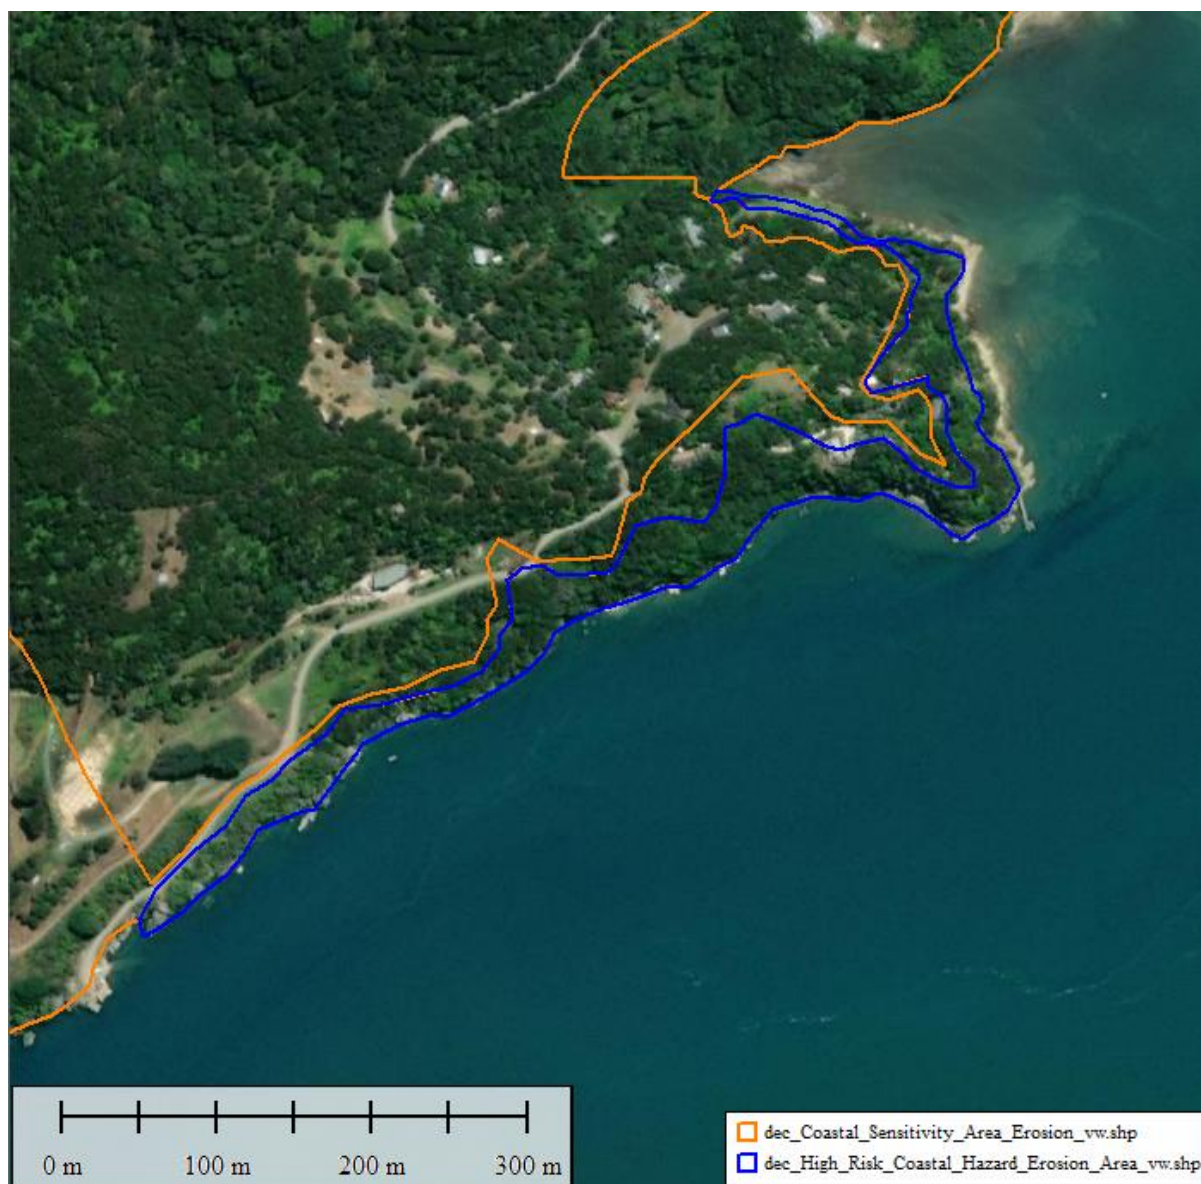
Figure 1 Extent of the mapped high risk coastal erosion hazard area and coastal sensitivity area for Te Akau South

Overall T+T consider that the Focus Resource Management Group assessment is a robust local-scale one, has likely used appropriate values for erosion rates and stable slopes (based on the arguments presented by the authors) and, except for the points noted above, has likely identified appropriate areas susceptible to coastal erosion and instability.

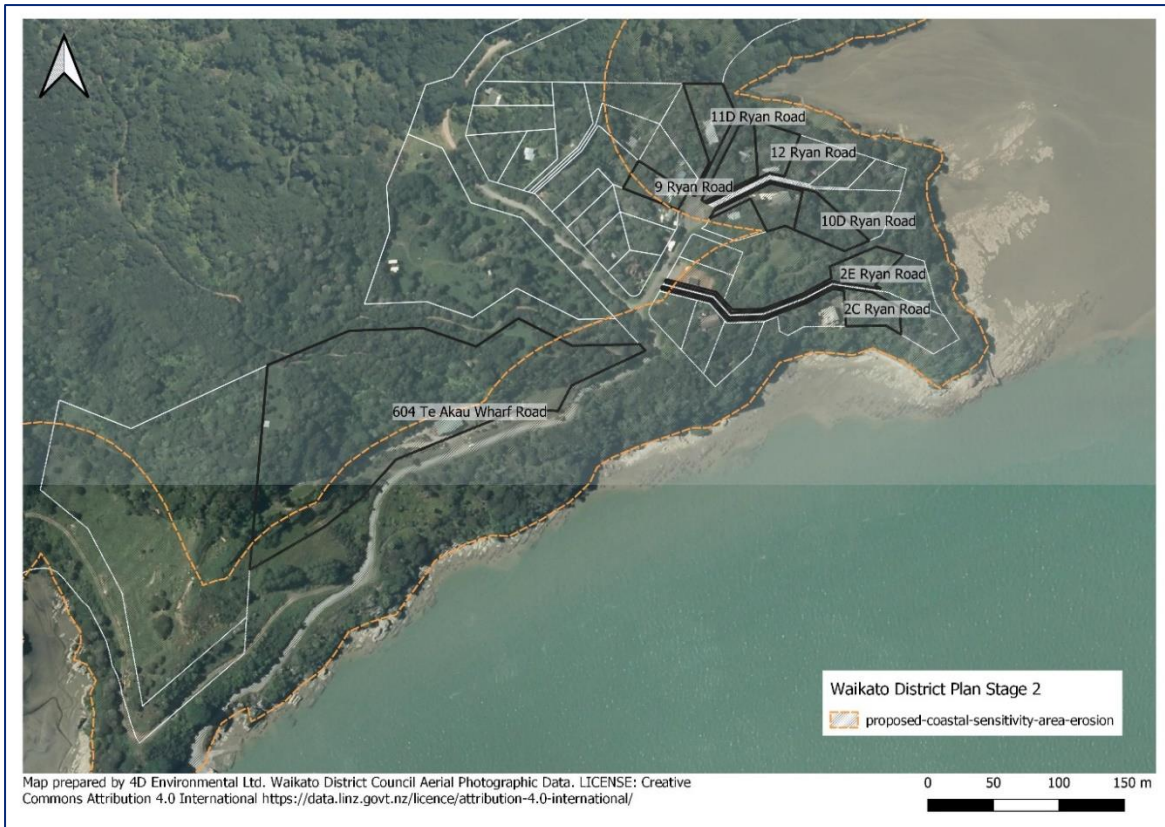
Figure 41: Horongarara Point (Te Akau south) area for revised coastal sensitivity assessment). Properties edged with black indicate submissions received.

The rural Coastal Sensitivity Area (Erosion) overlays the “village” zone area at Te Akau South, on the northern shore of the Raglan Harbour. The Ryan Road subdivision consists of 37 cliff top residential sections located on Horongarara Point, approximately 14 with coastal frontage (cover photo & Figure 41). The area is elevated (10-40 m above sea level) and fronted by near vertical cliffs of varied height and geology.

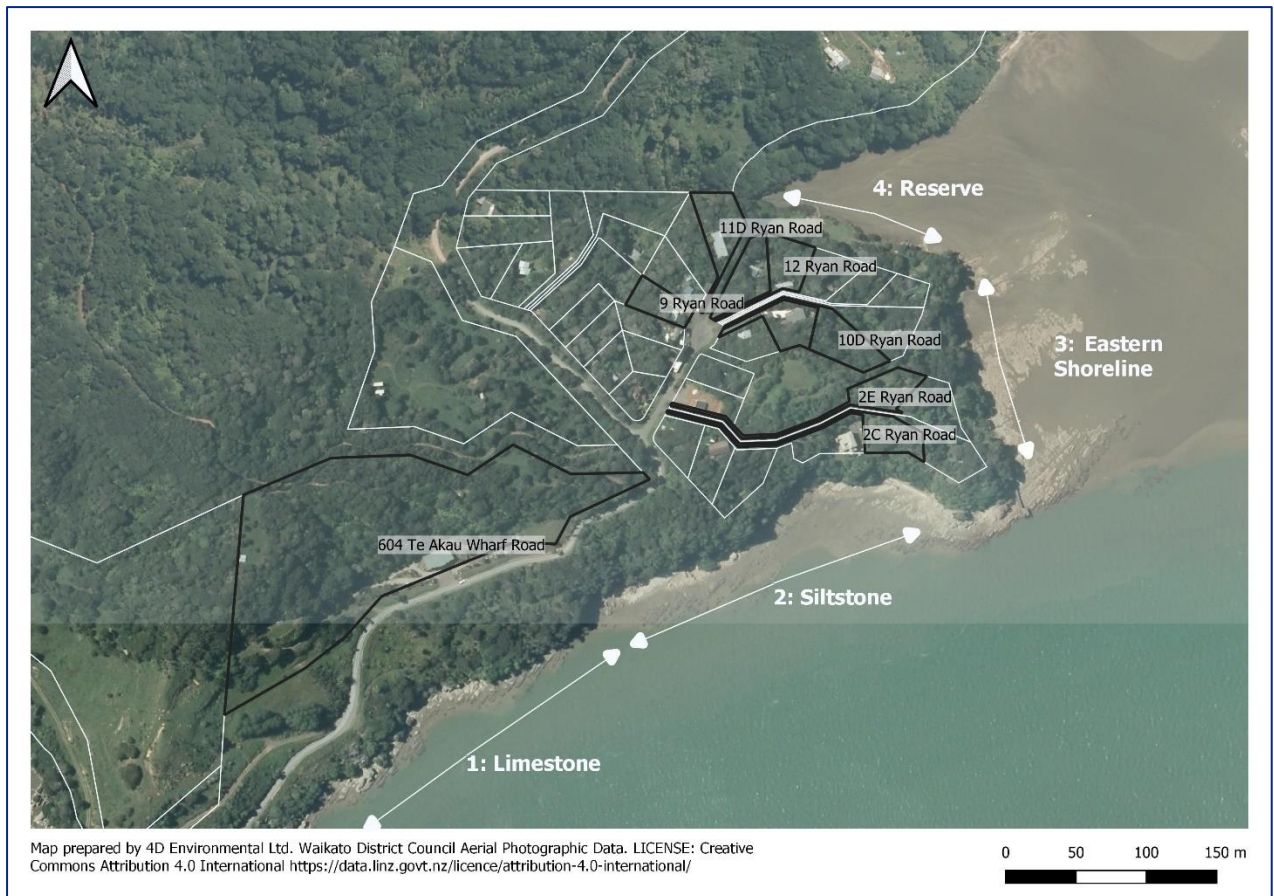
1. South facing limestone shoreline, near vertical cliffs fronted by narrow shore platform and channel. Covers rural area west of Ryan Road subdivision and 604 Te Akau Wharf Road.
2. South facing siltstone cliffs, frontage of 2a-2c Ryan Road.
3. Eastern shoreline, mixed geology, evidence of active failures and some shoreline erosion. Wide shore platform, frontage of 2d, 10d Ryan Road.
4. Low lying coastal reserve (backed by 11d, 12 and 13 Ryan Road).

Figure 42: Te Akau south shoreline, showing sections defined based on cliff geology and topography.

The Te Akau South coastline is backed by steep cliffs of varying geology. For the purposes of this report and for establishing an approach to mapping coastal erosion hazard, this shoreline has divided into four broad sections as described below (Figure 42):

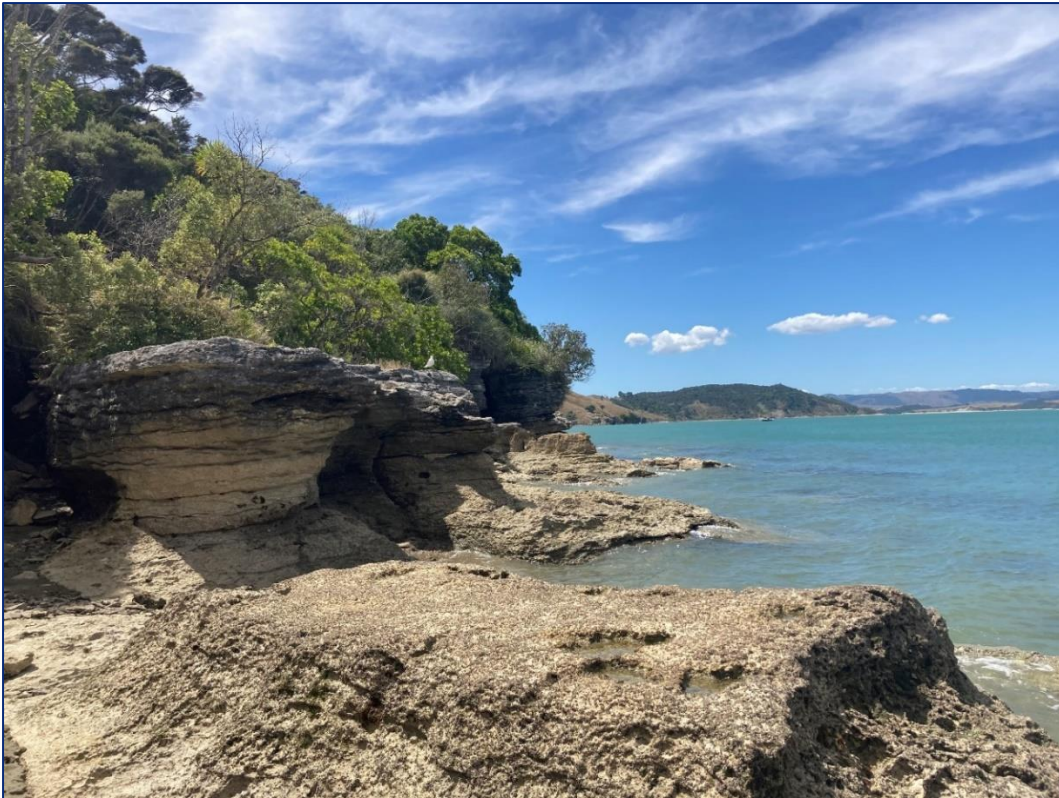
*Figure 43: Limestone shoreline – fronting 604 Te Akau Wharf Road.*

This section of the shoreline faces south and is backed by steep limestone cliffs (Te Akatea Formation – Raglan Limestone). The hard flaggy limestone weathers gradually, which together with very slow shoreline retreat has created “pillars” of rock on the upper shore platform (Figure 43). The steeply sloping coastal cliff is up to 8 m high (near vertical in places), backed by more gentle vegetated slopes (Figure 44 & Figure 45).

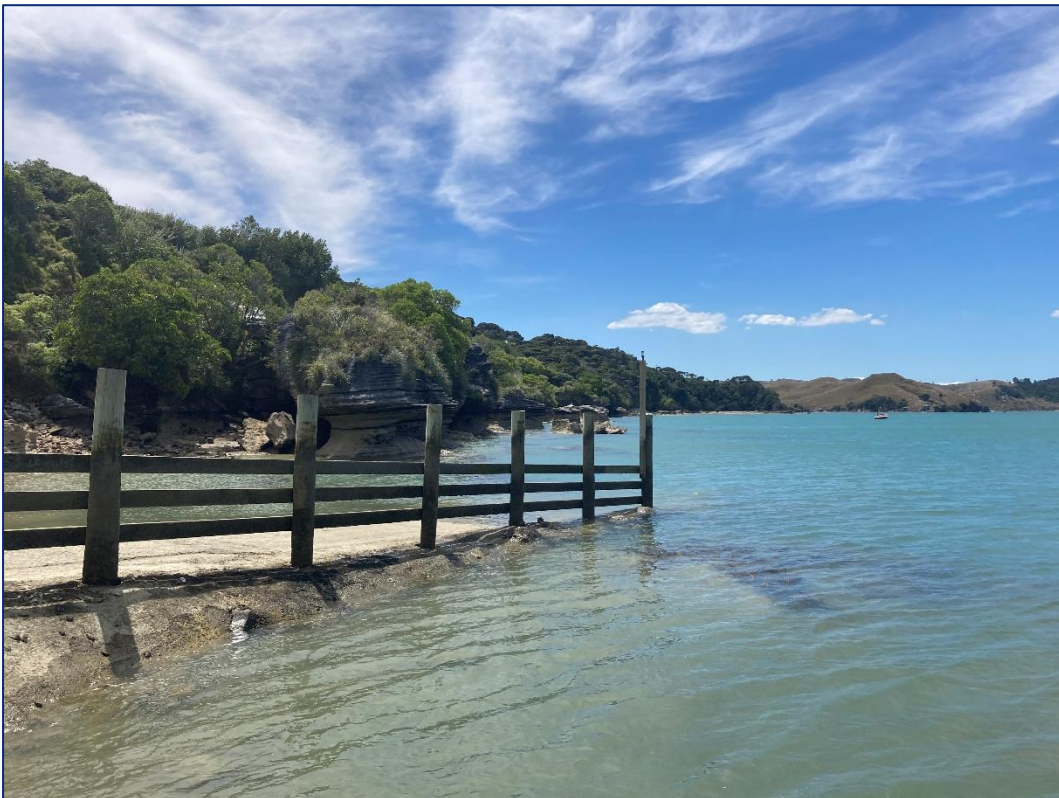
*Figure 44: Limestone shoreline (taken looking east from Te Akau Wharf). Section 2 can be seen in the background.*

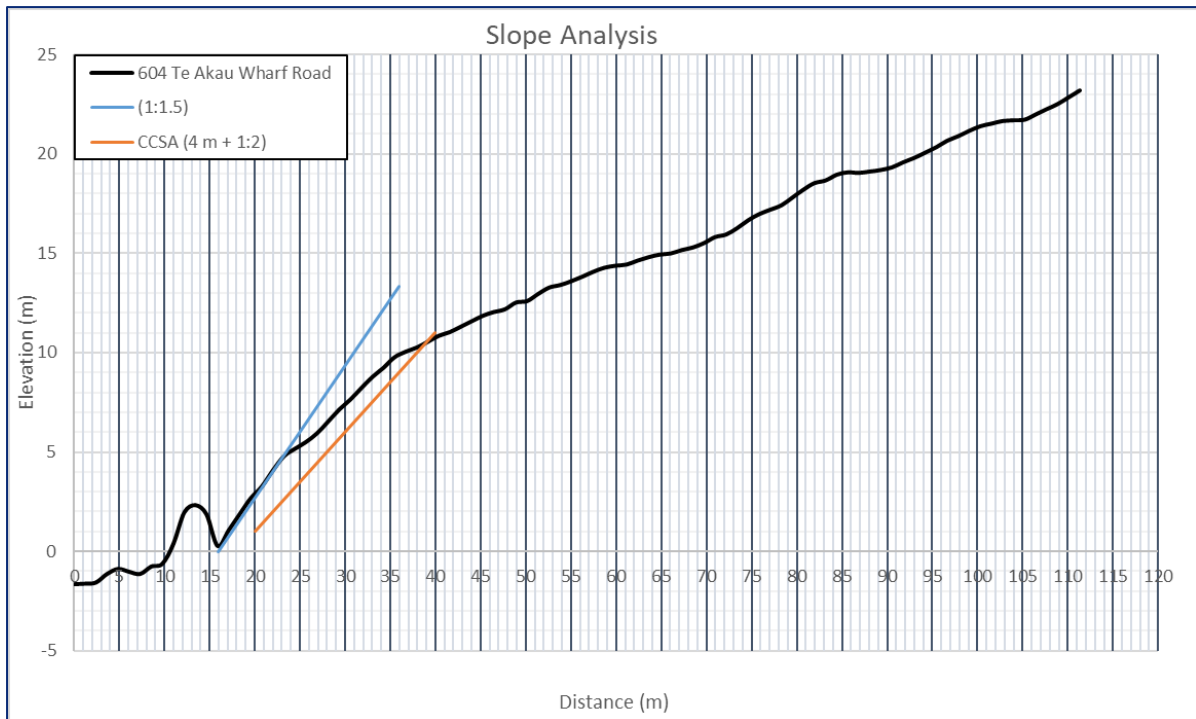
Figure 45: Cross section typical of Section 1 (Limestone Cliffs). Cross section location directly in front of dwelling on 604 Te Akau Wharf Road. Note limestone pillar at shoreline and toe of slope at ~0-1 m. The blue and orange lines indicate the method used to define High Risk Coastal Hazard Area (Erosion) (blue) and Coastal Sensitivity Area (Erosion) (orange).

In terms of potential slope instability associated with the toe erosion, the limestone exposed at sea level holds very steep gradients (near vertical), while the slopes to landward are typically in the order of 1V:1.5H. While the limestone appears to provide an effective buttress to slope failure and will likely remain so with expected sea level rise, we have nonetheless assumed potential for isolated slope instability by way of precaution.

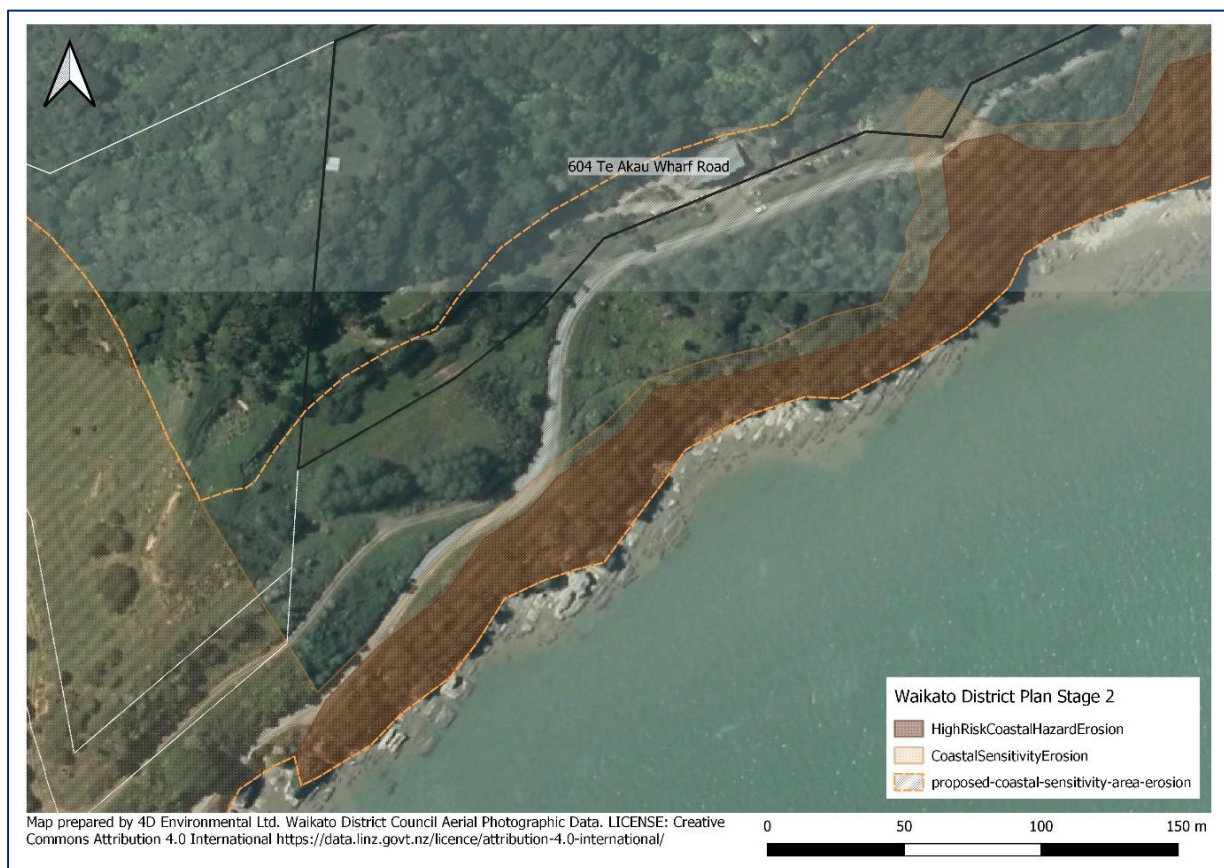
Figure 46: Revised High Risk Coastal Hazard Area (Erosion) and Coastal Sensitivity Area (Erosion) in Section 1 (Limestone Cliffs). The 100 m wide proposed Coastal Sensitivity Area (Erosion) is shown as notified for comparison.

Given the limited potential for significant toe erosion in the short term, we recommend the High Risk Coastal Hazard Area (Erosion) be identified based on a stable slope of 1V:1.5H, measured from the toe of the cliff. This area is entirely within the coastal reserve and simply identifies the margin that may be subject to slope instability in the short term.

We also recommend a Coastal Sensitivity Area (Erosion)<sup>4</sup> that incorporates 2 m of toe erosion and a conservative 1V:2H stable slope. This conservative slope has been applied throughout the study area and reflects the lack of detailed information about the nature and structure of the sub-surface materials. The area overlain by the revised Coastal Sensitivity Area (Erosion) is predominantly coastal reserve (Figure 46). However, the high steep slopes at the eastern end of the 604 Te Akau Wharf Road property result in a wider Coastal Sensitivity Area (Erosion) at this location, which extends across the road and into the property.

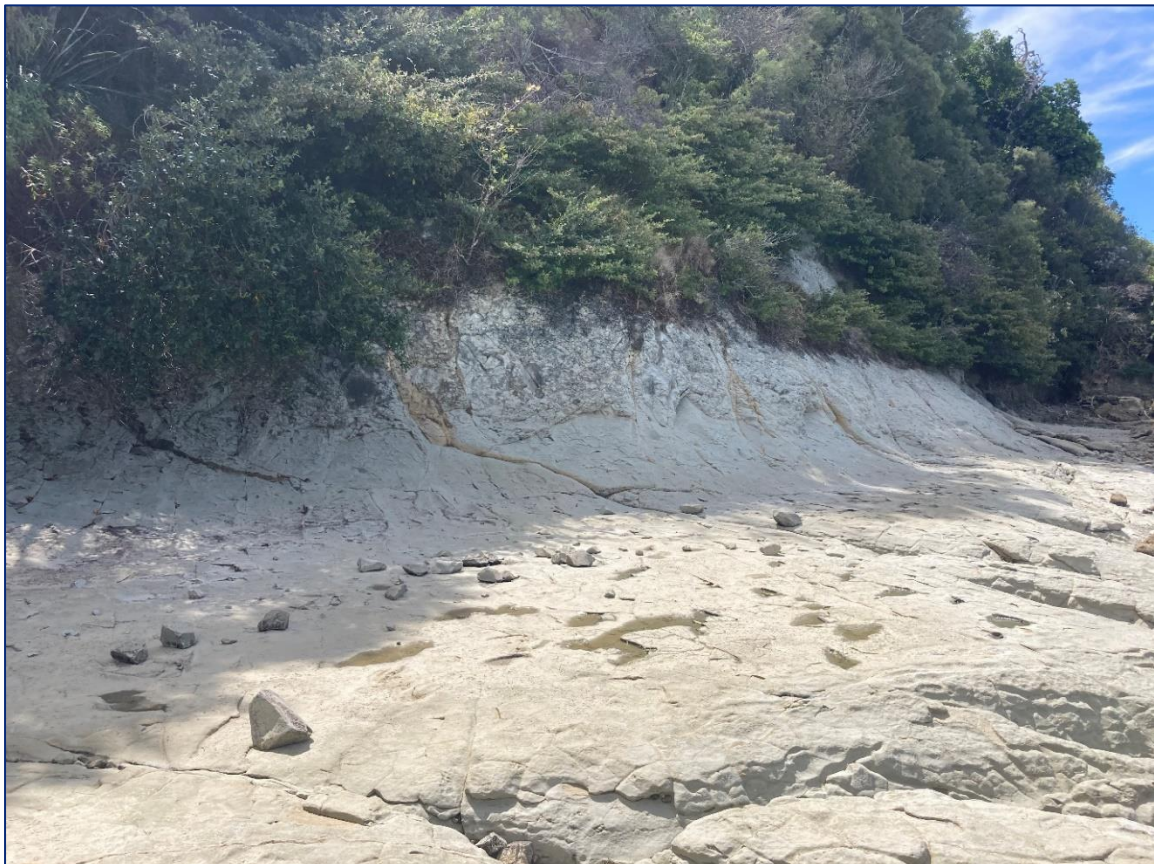
Figure 47: Shoreline near the Western end of Section 2 (west of Ryan Road).

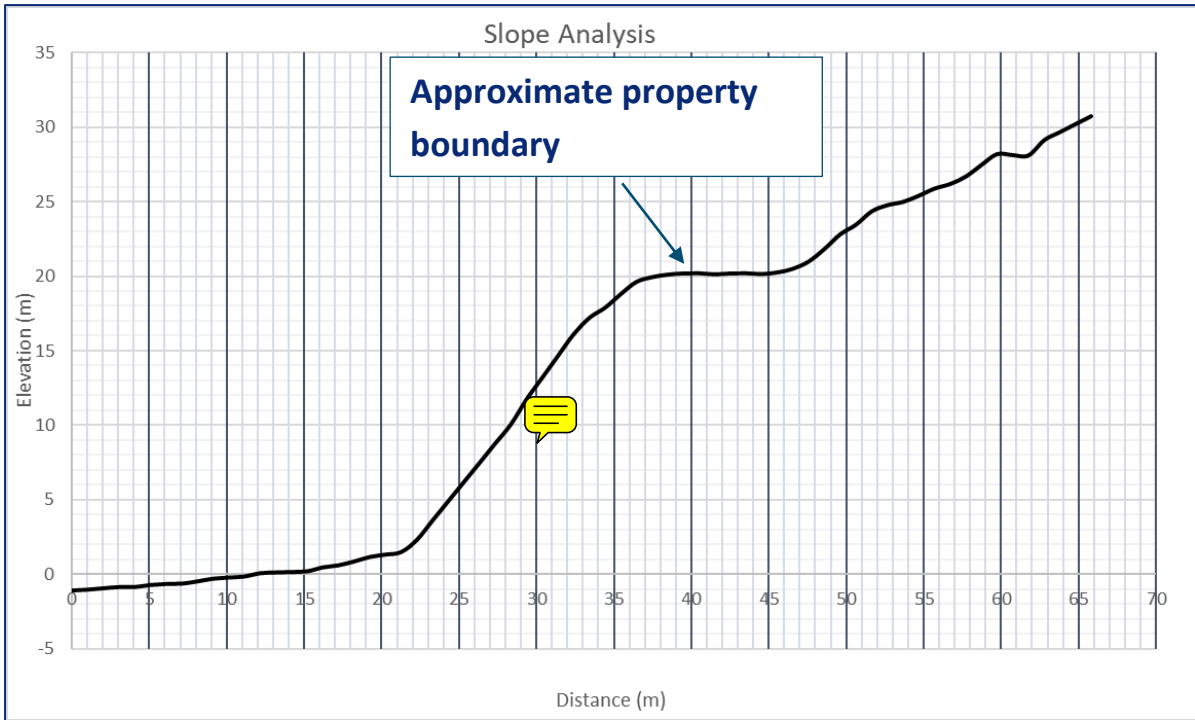
Figure 48: Typical cross section in Section 2.

This section of the shoreline is separated from Section 1 (Limestone) at the location of a known fault, where the geology at the shoreline changes. Materials exposed at the shoreline are varied but the area is broadly characterised by high siltstone cliffs (Figure 47) and a shore platform 30-60 m wide. The grey-white calcareous siltstone cliffs show evidence of recent slope failure in places. Where exposed, the siltstone is weathering and fracturing to pebble sized material through to small and large boulders. Typical cliff slopes in this area are 1V:1H and in some places are near vertical (Figure 48).

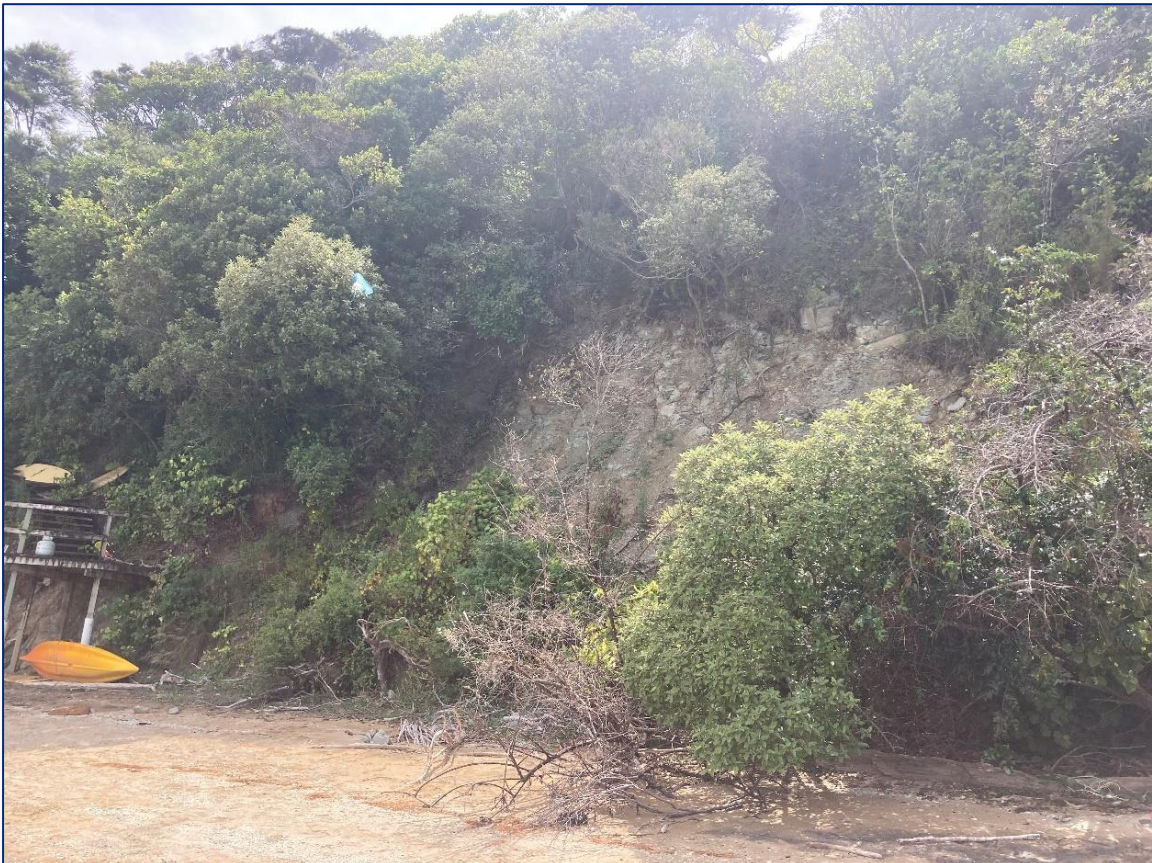
Figure 49: Shoreline in Section 2 (fronting 2c Ryan Road). Note evidence of recent slope failure (slip occurred in 2020).

Relatively recent shallow land slips exist along this section of the coast, indicating that this shoreline is actively eroding (albeit slowly) and potentially vulnerable to slope failure. The top of a recent land slip (2015) fronting 2c Ryan Road is close to the property boundary (Figure 49). It is difficult to accurately map the slope of these failures as they post-date the elevation data available. However, based on field observations and aerial photography, the recent land slips are still generally within a 1V:1H slope.

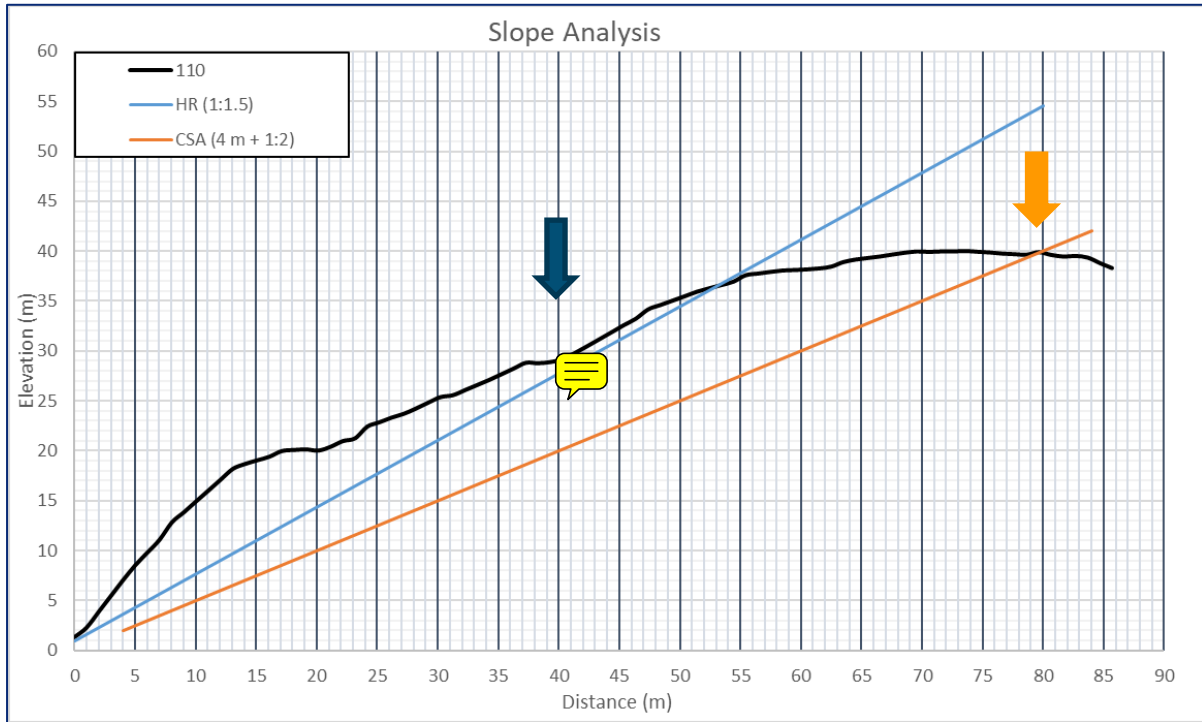
Figure 50: Cross section at Transect 110 (2a Ryan Road). In this location, the High Risk Coastal Hazard Area (Erosion) was limited to a distance of 40 m (blue arrow), based on a frontal cliff height of 20 m, and the closeness of the gradient to the land surface at that distance. The landward limit of the Coastal Sensitivity Area (Erosion) is shown by the orange arrow.

We recommend the identification of a High Risk Coastal Hazard Area (Erosion) based on a stable slope of 1V:2H, measured from the toe of the cliff. Where the topography slopes steeply to landward, strict application of the slope-based approach can generate an unrealistically wide coastal management area. We therefore recommend that the width of the High Risk Coastal Hazard Area (Erosion) is limited to twice the height of the seaward cliff face.

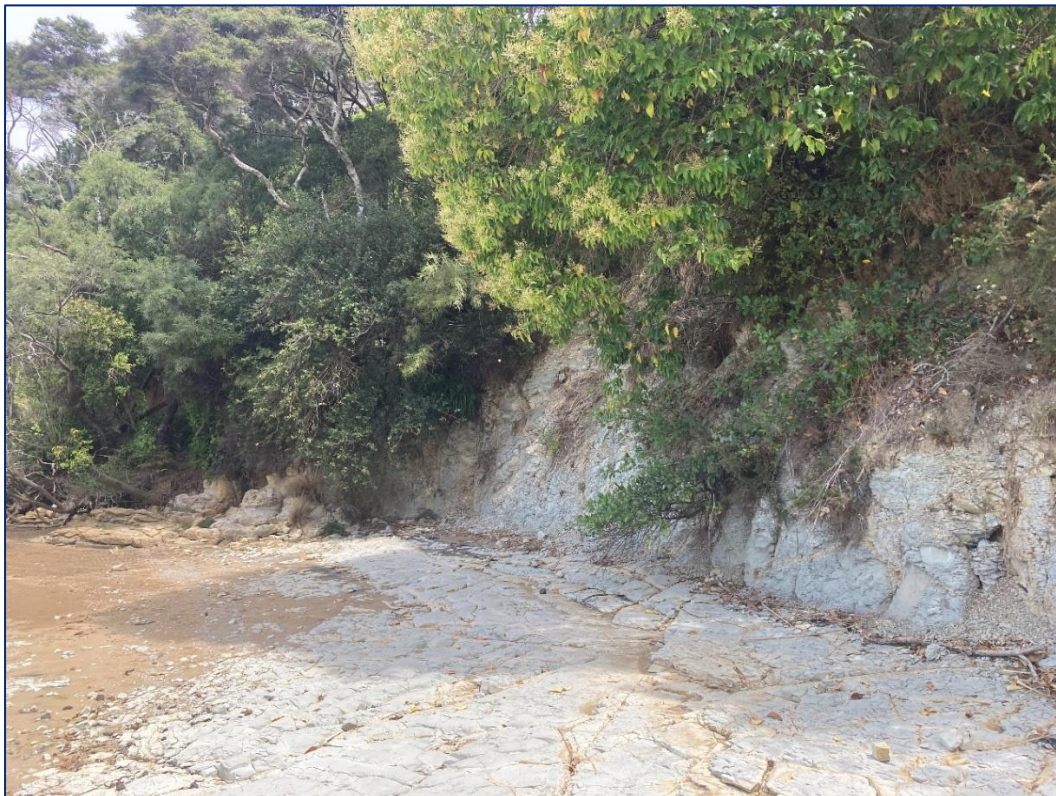
Figure 52: Shoreline at Transect 142 (10d Ryan Road).

Figure 55: Cross shore profile near the northern end of the eastern shoreline at Transect 142 (Figure 52). Blue and orange arrows indicate the landward boundary of the High Risk Coastal Hazard Area (Erosion) and Coastal Sensitivity Area (Erosion) respectively.

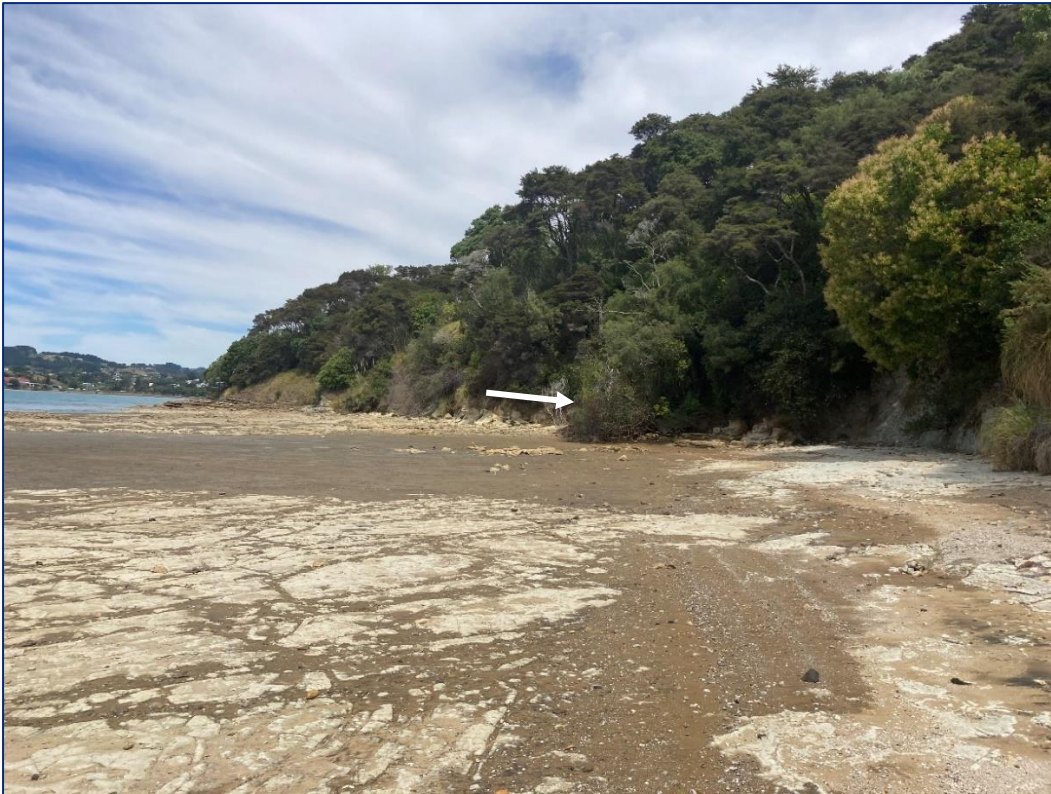
Figure 53: Eastern Shoreline. Approximate location of recent land slip indicated by white arrow.

Cliff slopes in the headland areas at either end vary from 1V:1H to 1V:1.5H but more gentle slopes (typically 1V:1.5H to 1V:2H) are noted in some central areas. A deep-seated landslide was observed on this shoreline fronting 2e Ryan Road (Figure 53). This failure is only 2-3 years old, so occurred since the land elevation data used for his study was collected (2015). Slopes may therefore vary slightly from those measured and reported in this area. Cracks developing on the upper slopes above steep areas near the north end of the Bay indicate further slope failures are likely to occur.

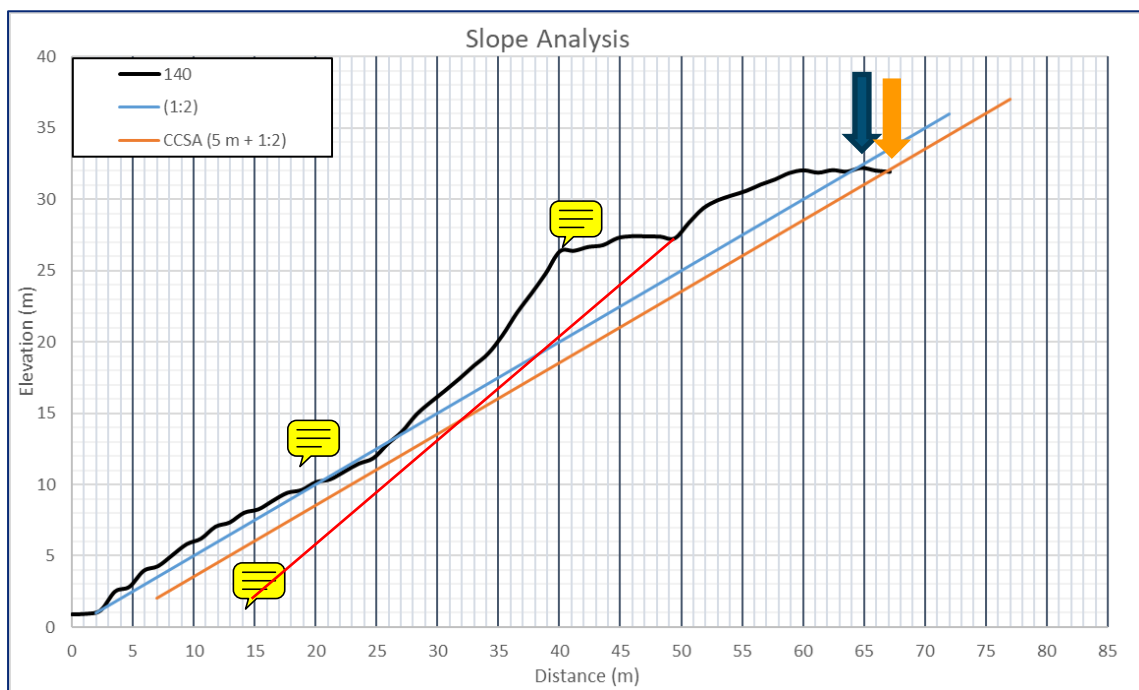
Figure 54: Cross shore profile in the vicinity of the recent land slip (elevation data pre-dates the landslip). Blue and orange arrows indicate the landward boundary of the High Risk Coastal Hazard Area (Erosion) and Coastal Sensitivity Area (Erosion) respectively.

- The coastal edge shown within Figure 54 looks like it may have already experienced an (older) landslip. If so, it could be considered using the same 1(V):1.5(H) slope as adjacent sections but from the location of the assumed rock toe (beneath the landslip).

Given the complex shoreline and evidence of ongoing active slope failures, we recommend that the High Risk Coastal Hazard Area (Erosion) be defined by a 1V:2H stable slope in the more gently sloping areas (e.g. Figure 54). At locations fronted by steep siltstone cliffs, a slope of 1V:1.5H is appropriate, as applied in Section 2 (Figure 55). The highly varied nature of the shoreline makes slope-based mapping complex, and we have also applied minimum width of 20 m and 30 m to the High Risk Coastal Hazard Area (Erosion) and Coastal Sensitivity Area (Erosion) respectively, measured from the toe of the cliff.

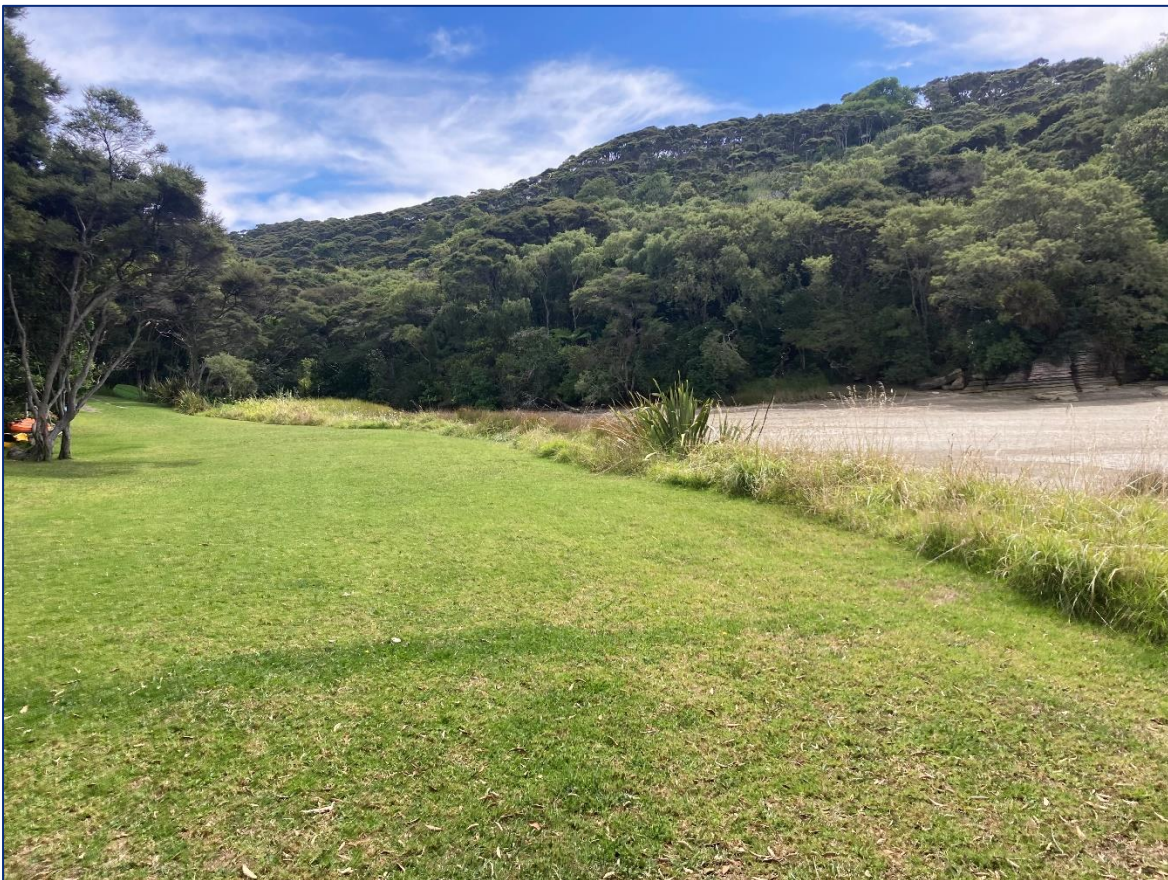
*Figure 57: Coastal reserve at Section 4. The reserve is potentially susceptible to coastal inundation with future sea level rise.*

Section 4 is backed mostly by a low-lying grassed reserve up to 20 m wide (Figure 57). Residential sections are located on the elevated slopes to landward. During the site visit, it was noted by residents that there has been some minor erosion of the frontage over time. Works have been undertaken to stabilise and revegetate some areas. This area is relatively sheltered from wave action. The seaward edge of the reserve is relatively low lying (RL 2-3 m), so is potentially susceptible to occasional coastal inundation during extreme events.

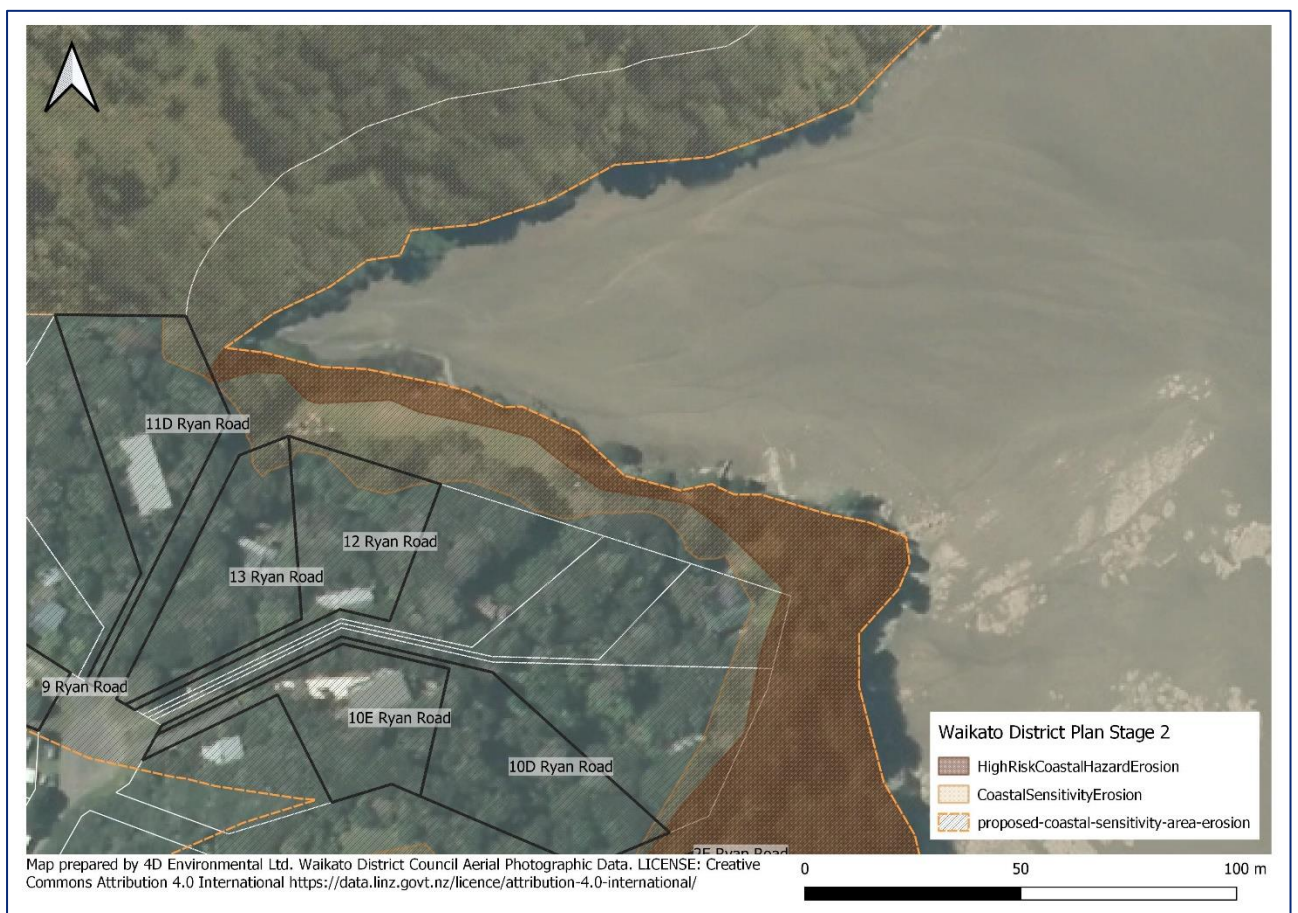
Figure 58: Revised High Risk Coastal Hazard Area (Erosion) and Coastal Sensitivity Area (Erosion) at Te Akau South (Section 4).

We recommend that the 100 m Coastal Sensitivity Area (Erosion) be amended here to produce a High Risk Coastal Hazard Area (Erosion) and a Coastal Sensitivity Area (Erosion) based on a pragmatic approach that reflects the local setting (Figure 58).

In the relatively short term, significant shoreline erosion is unlikely, and will only affect reserve land. We propose a 5.0 m wide High Risk Coastal Hazard Area (Erosion) measured from the toe of the bank.
