# **ECOLOGY REPORT FOR**

## **POKENO WEST STRUCTURE PLAN**

### **Helenslee Road and Munro Road**

FOR: CSR POKENO LIMITED  
BY: JS ECOLOGY LTD  
Jennifer Shanks MSc. Hons

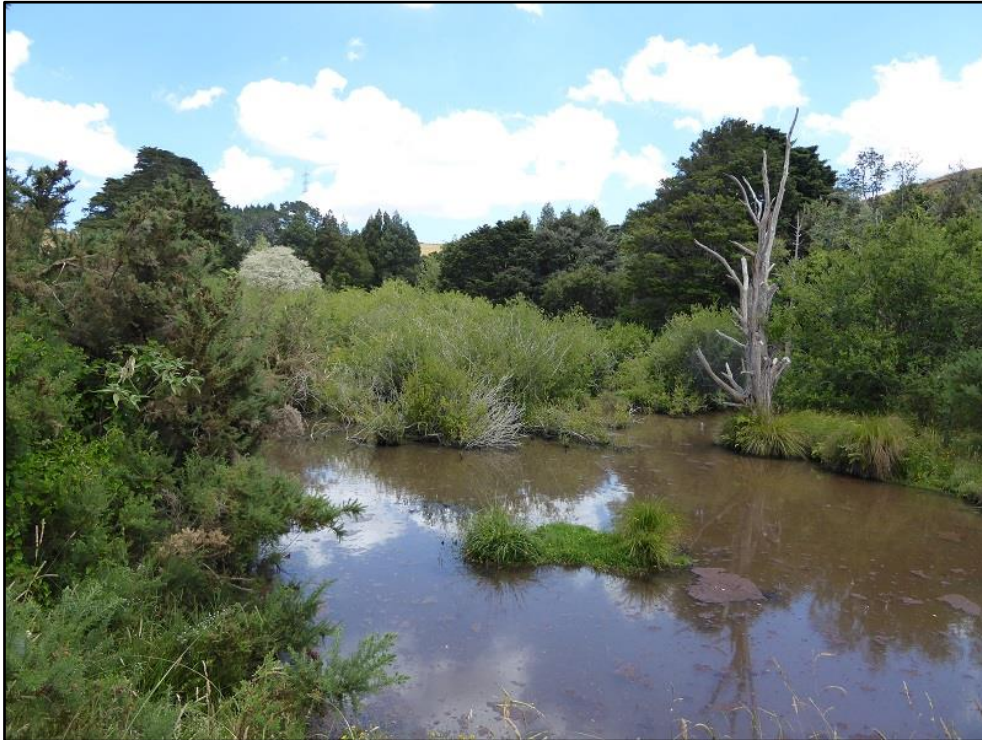
The fenced ISNF is located on stream gully 2 on the southern side of the site. It occupies c. 2.2ha of the lower part of the gully upstream of an artificial pond above the farm track and beside an old barn. The lower part of the ISNF runs on both sides of the stream in a fairly narrow band that is dominated by a wetland in the bottom of the gully that contains mainly grey willow (*Salix cinerea*). Amongst the willows are a few clumps of native sedge (*Carex secta* & *C. virgata*) and kiokio (*Parablechnum novae-zelandiae*) (Plate 1) and the area is fringed with gorse (*Ulex europaeus*) and woolly nightshade (*Solanum mauritianum*). Other exotic weeds include water purslane (*Ludwigia palustris*) in the open water and red algae (*Cylindrocapsa*) on the water surface. Several mature totara (*Podocarpus totara*) stand on the true left bank of the stream with a few karamu (*Coprosma robusta*) and mapou (*Myrsine australis*) under them. There are patches of tree fern forest (*Cyathea medullaris*) here also.

**Plate 1** *Lower ISNF with shallow pond and grey willows. Note patches of algae on the pond surface.*

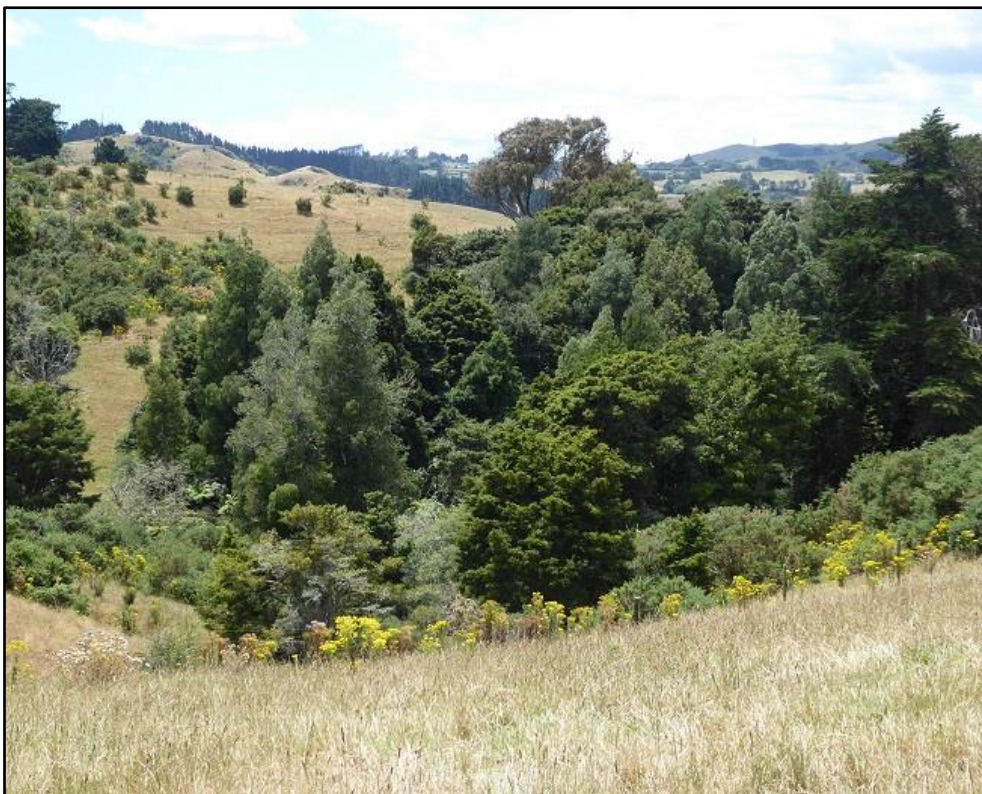
Further up the gully area of native vegetation broadens out with tall kahikatea (*Dacrycarpus dacrydioides*), rimu (*Dacrydium cupressinum*) and totara standing mainly on the true left (northern side) of the gully (Plate 2). A dense stand of more than a dozen exotic macrocarpa (*Cupressus macrocarpa*) stand high up on the southern side of the gully within the fenced ISNF. The ISNF also contains mature tanekaha (*Phyllocladus trichomanoides*), tawa (*Beilschmiedia tawa*) and titoki (*Alectryon excelsa*). Native plants present in the understorey include karamu, putaputaweta (*Carpodetus serratus*), mahoe (*Melicytus ramiflorus*), mapou, and cabbage tree (*Cordyline australis*). The edges of the ISNF are surrounded with gorse and the vegetation along the stream is mainly exotic with grey willow (*Salix cinerea*) and gorse being dominant. Barberry (*Berberis glaucocarpa*), Himalayan honeysuckle (*Leycesteria formosa*), poplar (*Populus alba*) and pampas (*Cortaderia selloana*) also have presence here. Possum sign was noted in several places around the edges of the ISNF.

**Plate 2** *Upper ISNF with mature native trees*

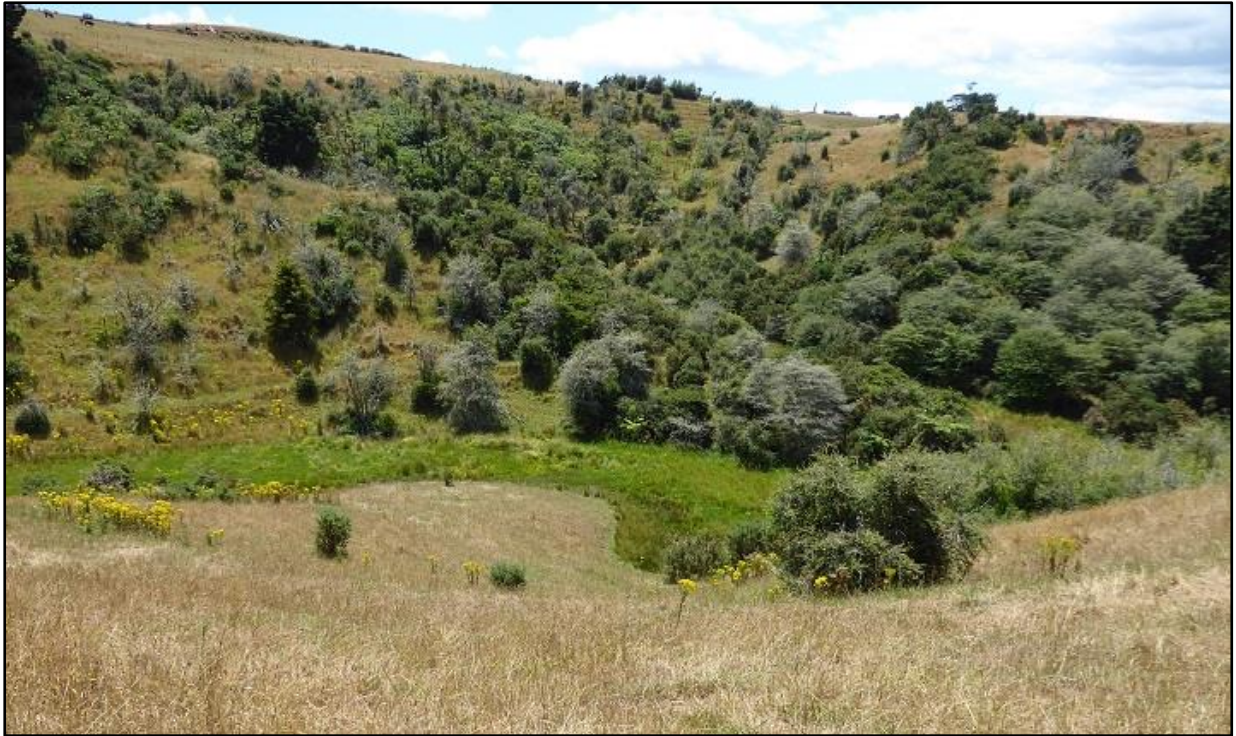
A substantial area of grazed wetland (Plate 3) occurs in the upper gully bottom, mostly containing reed sweet grass (*Glyceria maxima*) with grey willow and barberry lower down. A tributary on the northern side contains a small area of native raupo (*Typha orientalis*) however. The ecological values of this vegetation are generally low.

**Plate 3**      *Area b showing mixed native and exotic scrub and open wetland in the gully bottom*

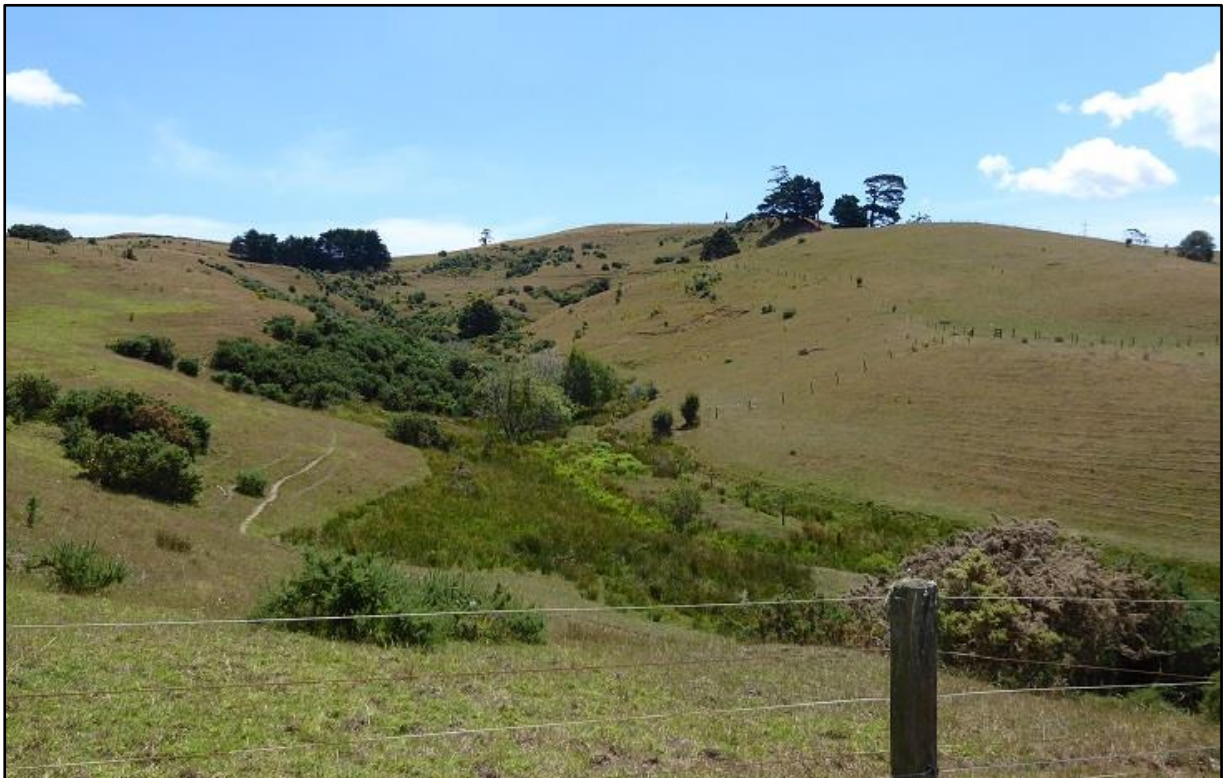
five mature kahikatea in a tight group (Plate 4). In the gully head is gorse and several scattered totara trees. The mature native trees have moderate ecological values as habitat and food for native birds.

**Plate 4**      *Open wetland in the upper gully of Stream 4 with gorse above.*

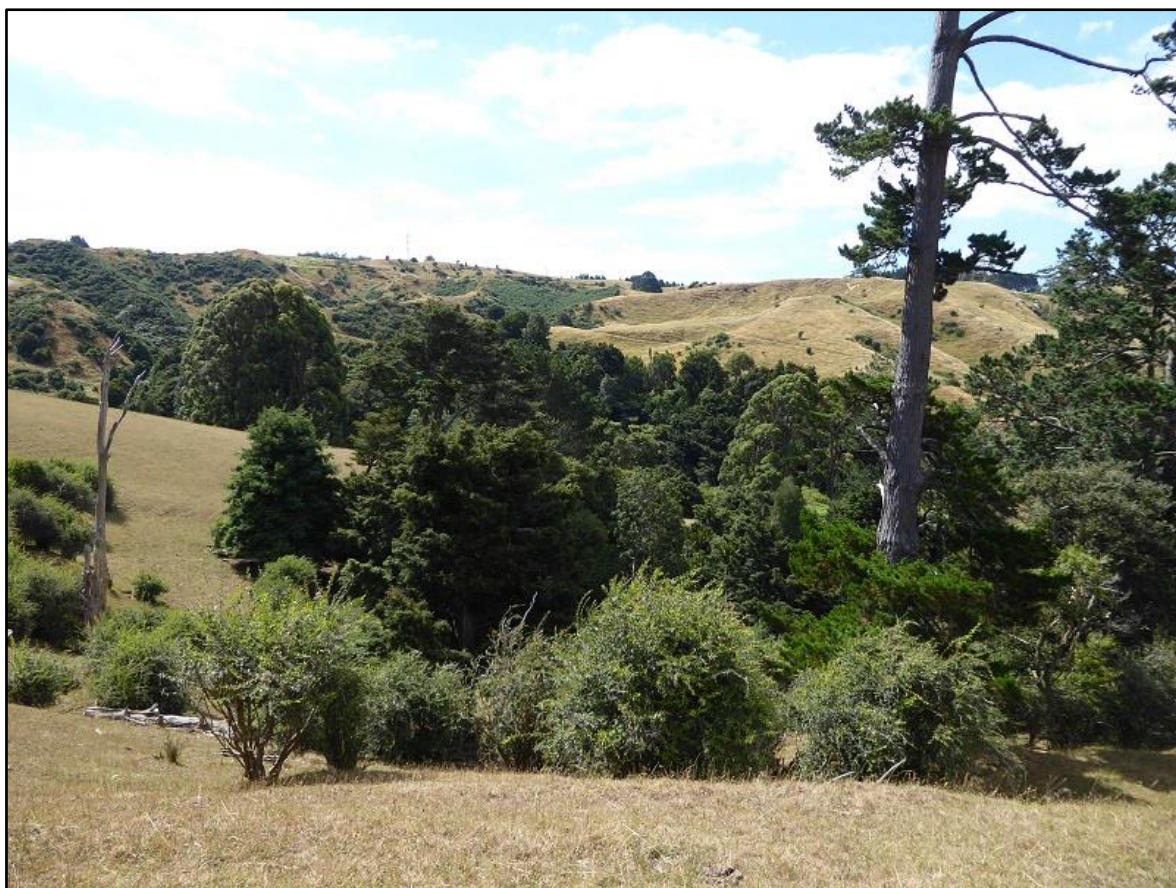
A second small area to the northwest of a farm shed forms a small steep sided basin in a gully head where tall pukatea (*Laurelia novaezelandiae*), totara, kahikatea, and taraire are found (Plate 5). Amongst these larger trees are found nikau (*Rhopalostylis sapida*), silver tree fern (*Cyathea dealbata*), mamaku (*Cyathea medullaris*), titoki, and rewarewa (*Knightia excelsa*). Large eucalypts (*Eucalyptus* sp.) and pines stand around the edges. This small area of native forest appears healthy and intact although parts of it are grazed. It is more or less contiguous with another larger area of regenerating forest on the neighbouring property to the north and its ecological values are moderate.

**Plate 5**      ***Area e with mature totara, kahikatea, pukatea and taraire***

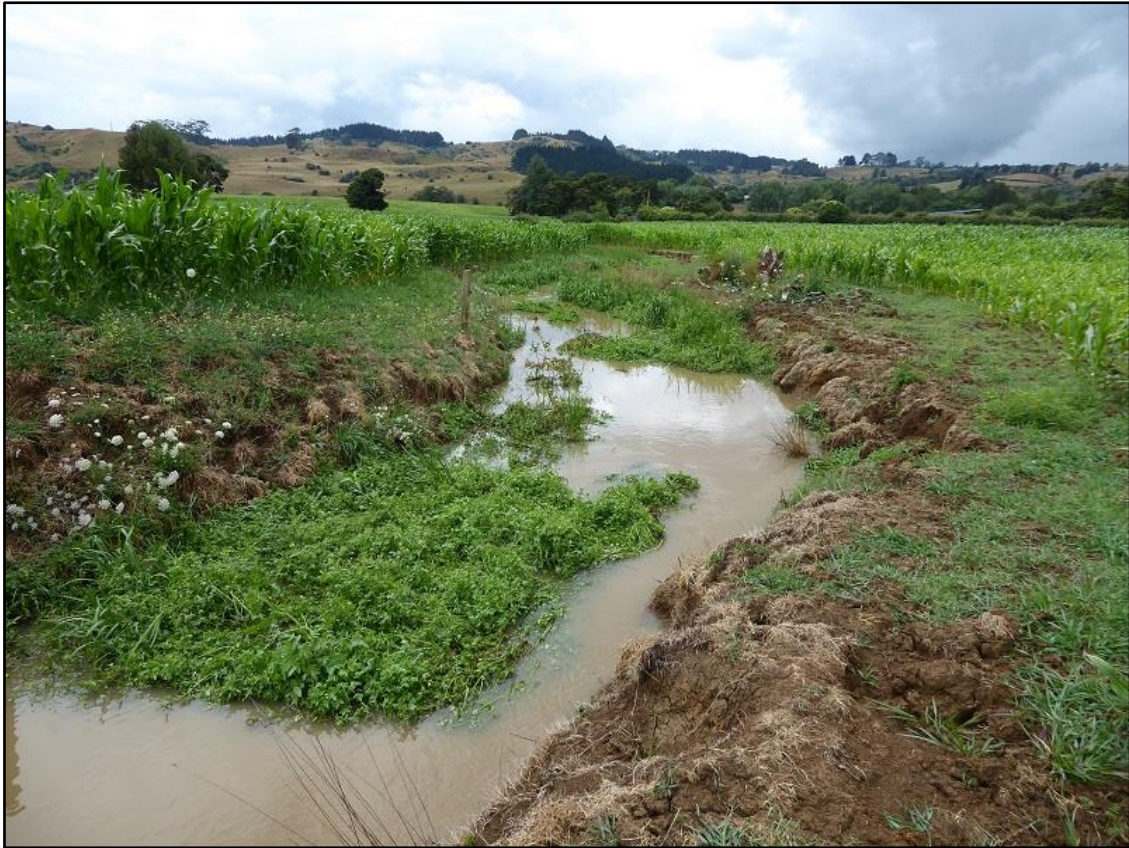
Silt loading and water clarity: Silt loading was observed to be very high in the northern part of the mainstem of the stream particularly in the central part within the cropped area after significant rain. Lower down towards Munro Road Bridge silt loading was lower and this is presumed to be a consequence of inputs from less disturbed side tributaries and the broadening of the stream channel with consequent lessening of the water velocity. After at least 48 hours of fine weather the water clarity was considerably better, however it would still generally be considered poor along most of the mainstem. The western tributary was observed to have moderately good water clarity but the northern tributary has similar

**Plate 7** *View of the Pokeno Stream along the mid-section at the site showing severe bank erosion and low water clarity.*

5. Ensure the riparian areas along permanent streams are kept free of disturbance as far as possible and plant these areas with native trees and shrubs. As a minimum a 20m setback from all permanent streams is recommended. In low lying parts of the site along the lower Pokeno Stream this setback will need to be wider.

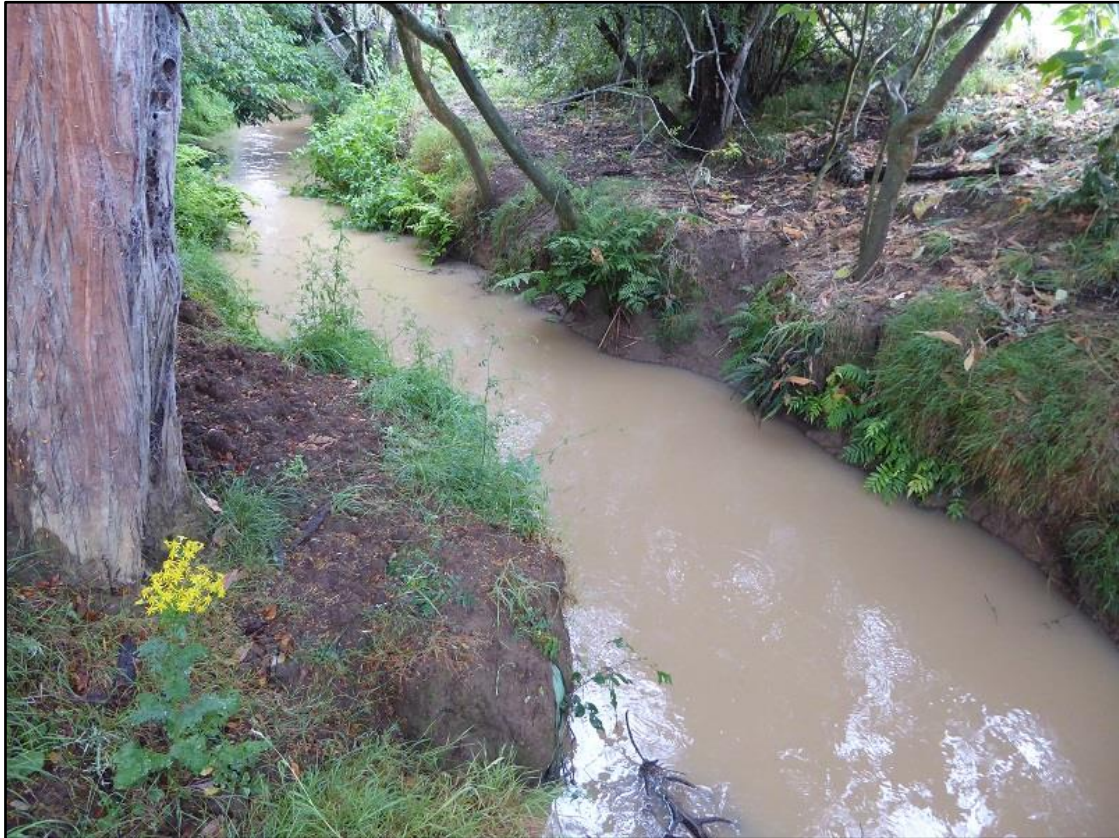
**Plate 8** *View of the upper Pokeno Stream showing partial shading, silty erodible banks and low water clarity.*

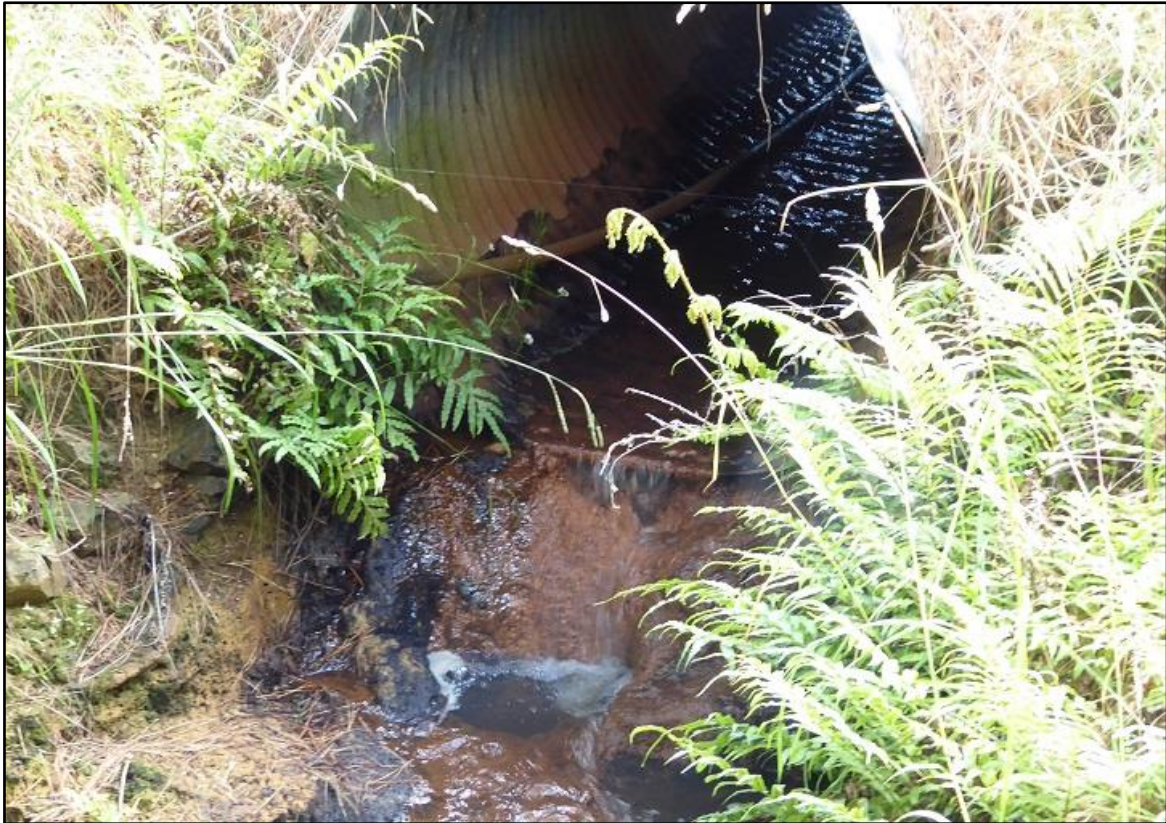
Tributaries 1 – 4 are for the most part, soft-bottomed streams, although small rocks and boulders are evident in some places. Their water clarity appears to be reasonably good in most places except for on-line artificial ponds. Silt loadings appear low to moderate. Iron staining was observed at culverts and downstream of the culverts in Tributary 1 although mats of iron floc bacteria were not observed except in Tributary 3. The iron staining

observed may be due to the corrugated iron culverts that have been used. Stream channels are mainly natural and a range of aquatic habitats are present with pools, runs and wetland areas. Woody debris is present in Tributaries 2 and 3 within the ISNF. The four tributary streams generally have low to moderate aquatic habitat values. Lack of woody riparian vegetation for shading, and pugging of stream banks and channels by livestock are the main contributors to loss of aquatic habitat values for these watercourses. Stock exclusion and riparian restoration planting have the potential to significantly improve both water quality and aquatic habitat values.

**Plate 9**      *Perched iron culvert on Stream 1 with brown, iron-stained water.*

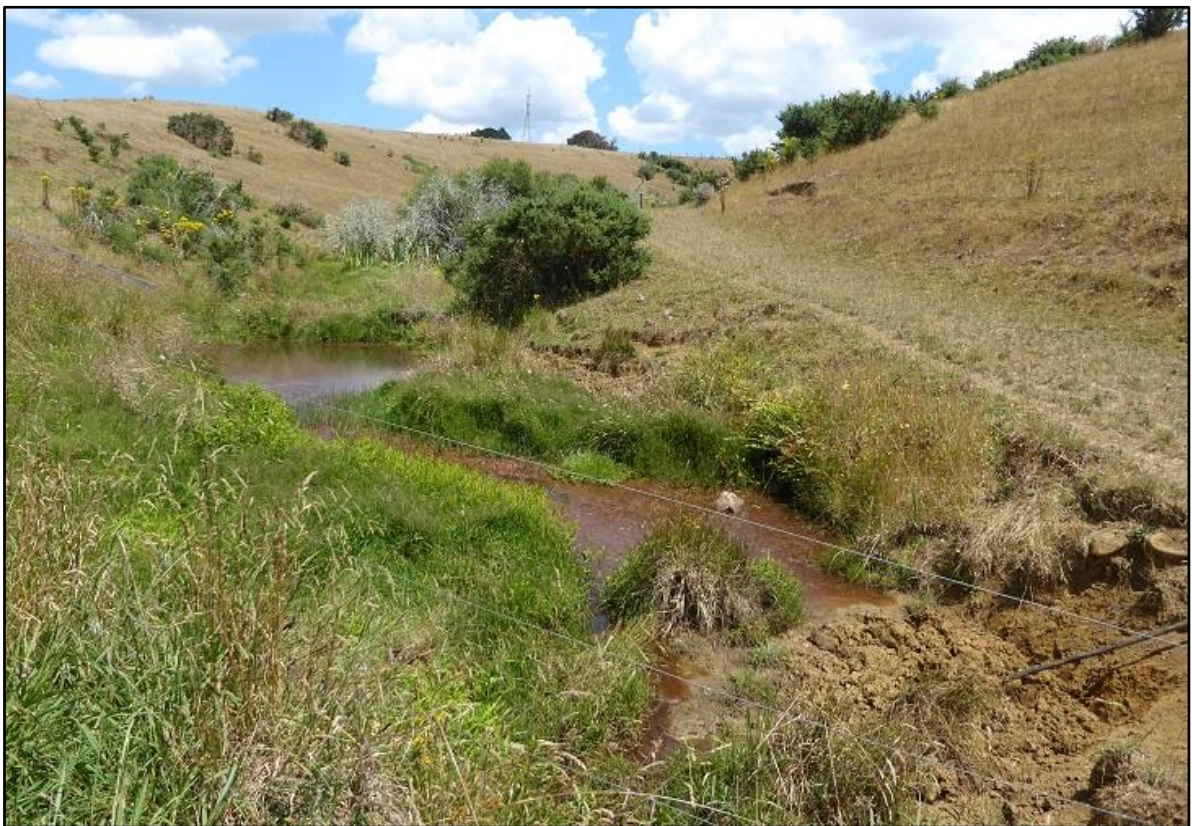
Aquatic values within the shallow ponds found along Tributaries 1, 2 & 3 appeared poor with low water clarity and high levels of algal growth. Due to their openness and shallowness high water temperatures and high diurnal variations in dissolved oxygen levels can be expected particularly over the warmer months. These poor water quality values will also be impacting water quality values downstream of the ponds

**Plate 10**      *Dammed pond on Stream 3 just above the farm crossing. Note bank erosion caused by cattle and algae on the pond surface.*
