Ngaruawahia Structure Plan

Geotechnical Suitability Assessment

Client: Waikato District Council

08-Aug-2014

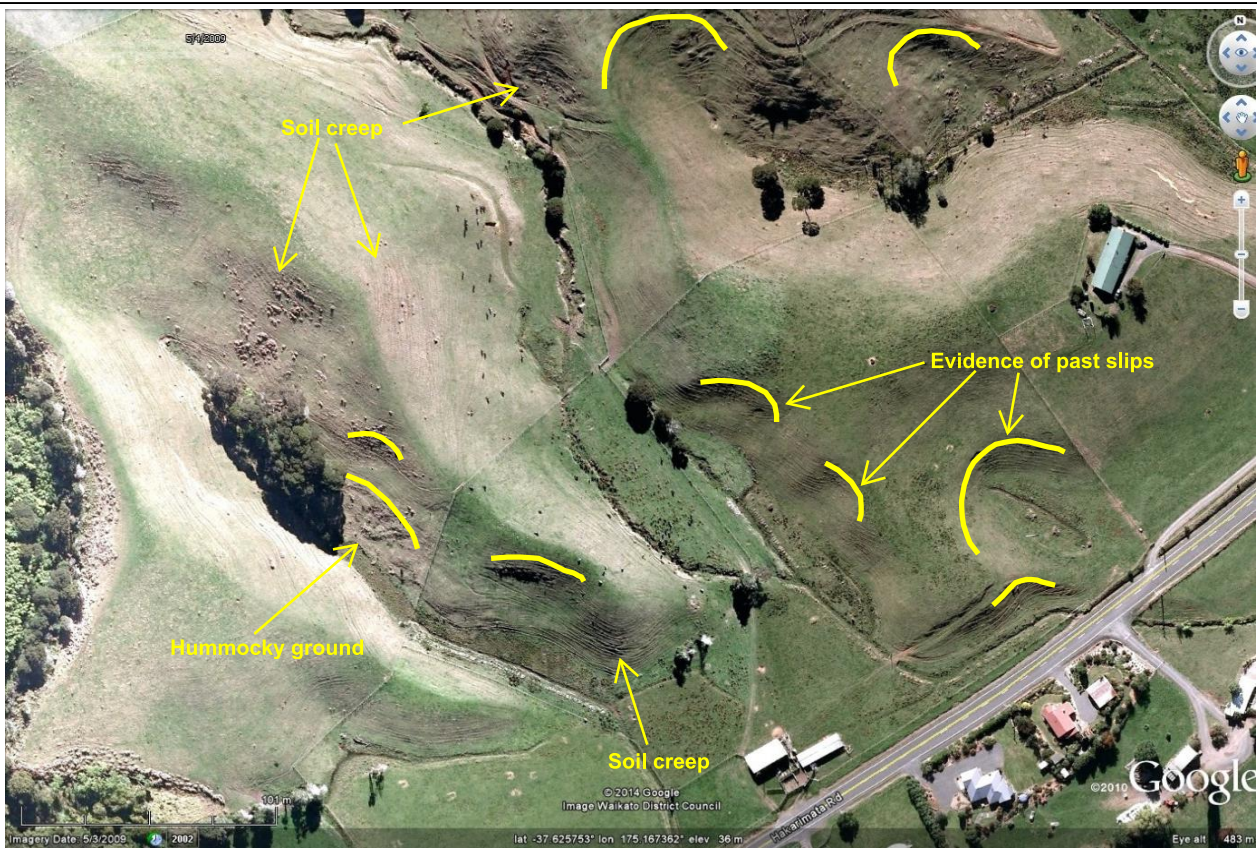
1. This image was taken in May 2009. It shows multiple slips have occurred in the past. Associated with these slips are evidence of hummocky grounds and soil creep.

The 2009 aerial photograph is very clear and shows numerous large slips in the vicinity of the site, indicating that slips of this size and magnitude have happened in this area previously and can be expected to happen in the future. Examination of aerial photographs along Hakarimata Road indicates instability of this size is not unusual, and much larger slips have occurred in the past.

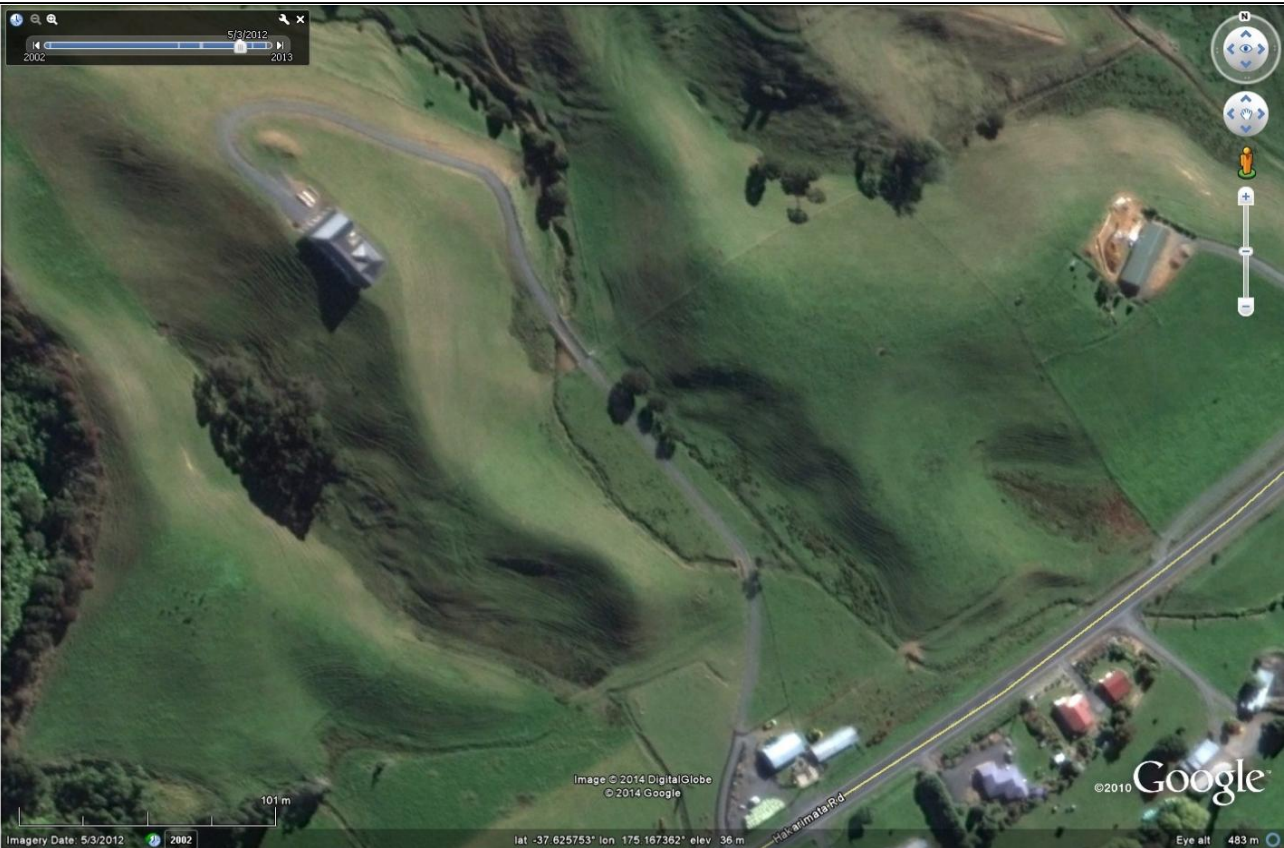
3. By May 2012 a house was relocated to the risge. The image indicates that the driveway did not interfere with the toe of the slope, which subsequently failed in July 2012. The image also indicates that no earthworks were undertaken on the slope.

Had this house been positioned on the slip or in the path of debris flow it would have been destroyed, and any occupants would have been unlikely to survive.

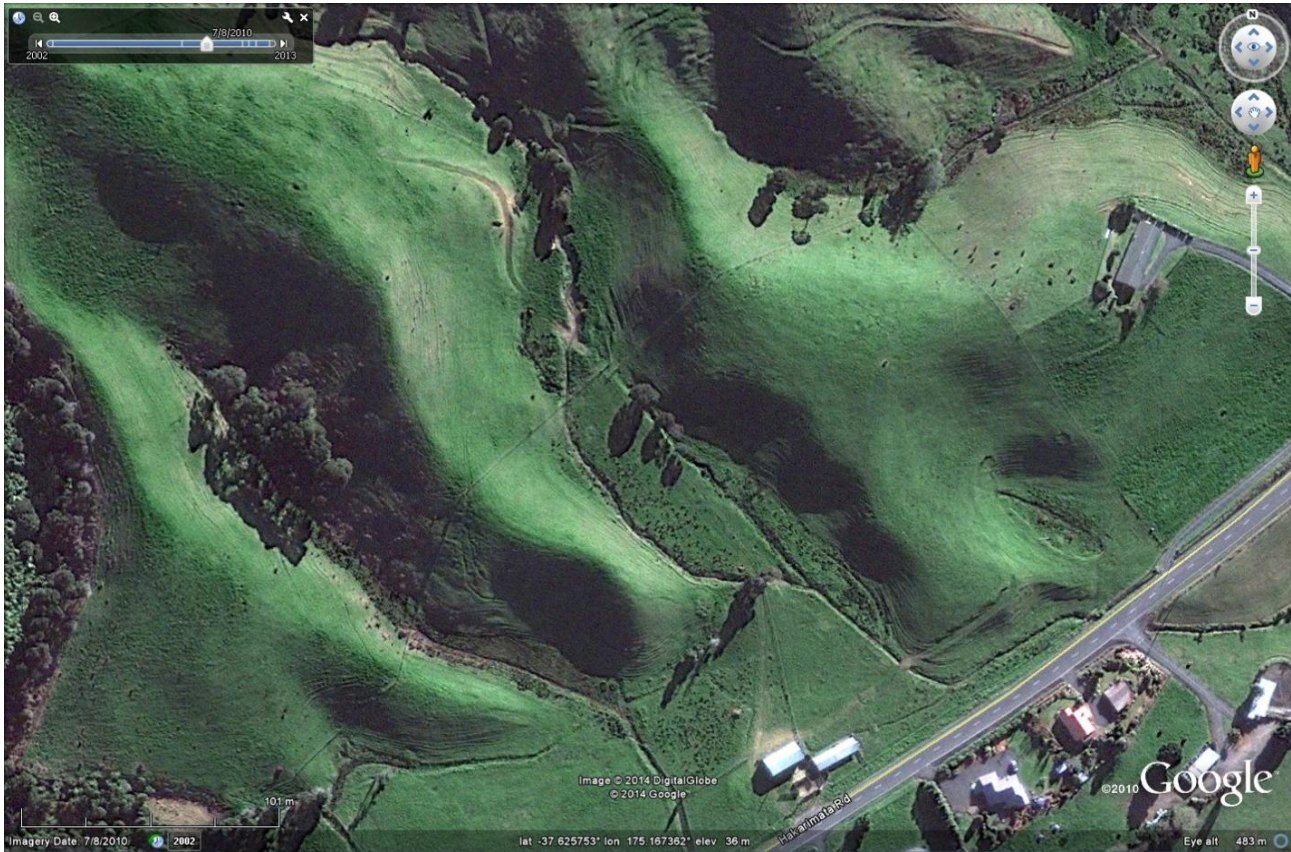
2. This image was taken in July 2010. No major change in slope.

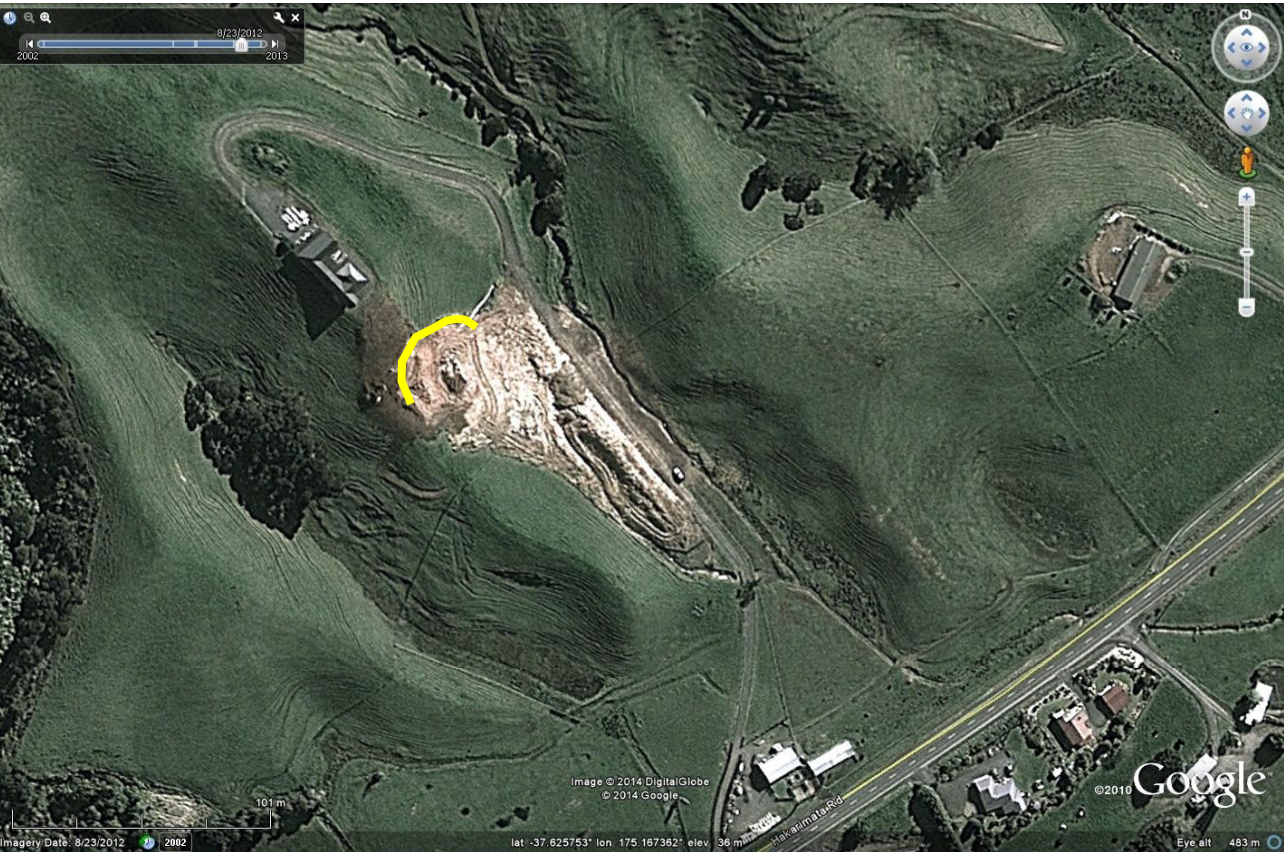
4. This image was taken in August 2012 approximately 6 weeks after the slip occurred. Note the soil has flowed approximately 100 metres from the headscarp. Works have cleared the driveway however surge marks are still visible on the opposite ridge.

Debris from these slips can be fluid and travel a significant distance down slope and across adjacent level ground. Landslide debris from rapid failures poses a significant hazard to property and life. Case Study 2 in Appendix C, discusses a recent slip and debris flow within this area.

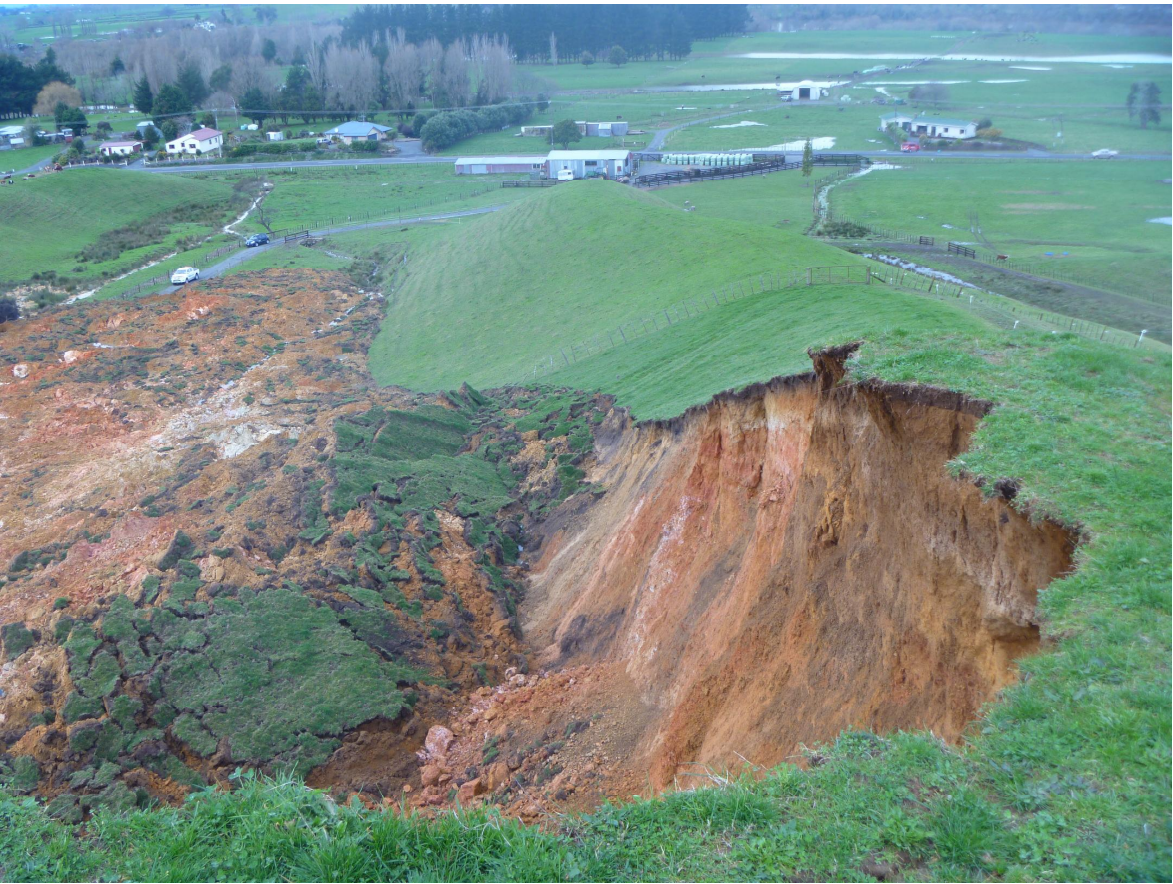
5. Looking across slip backscarp towards Hakarimata Road.

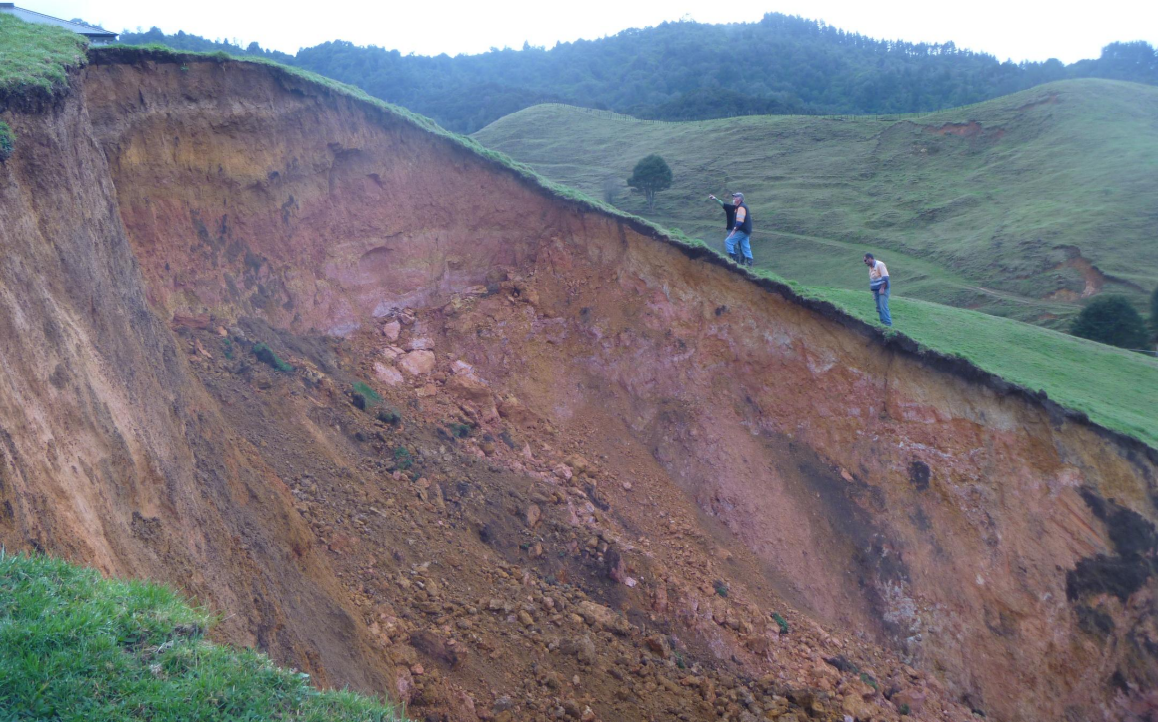
7. The size and depth of back scarp is apparent in this photo

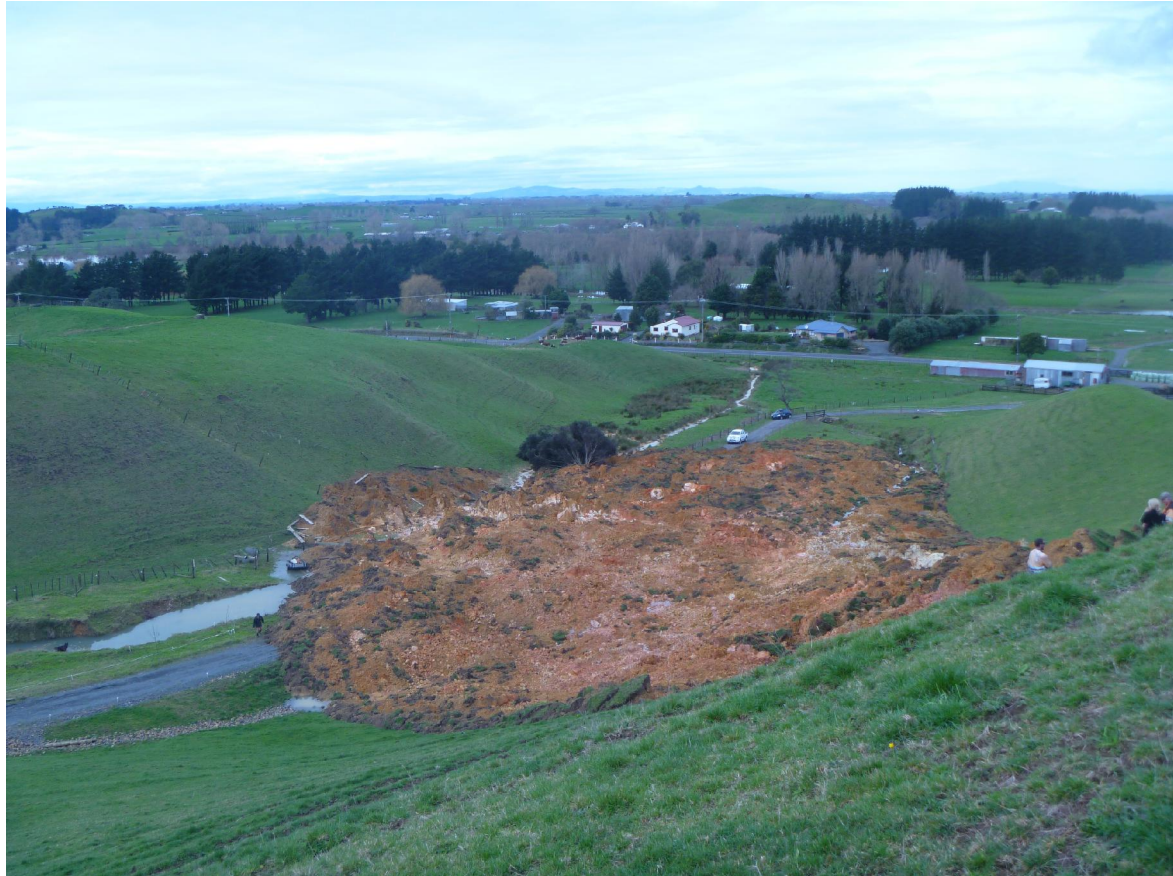
6. Note debris flow had sufficient velocity to travel several metres up adjacent slope and topple mature trees.

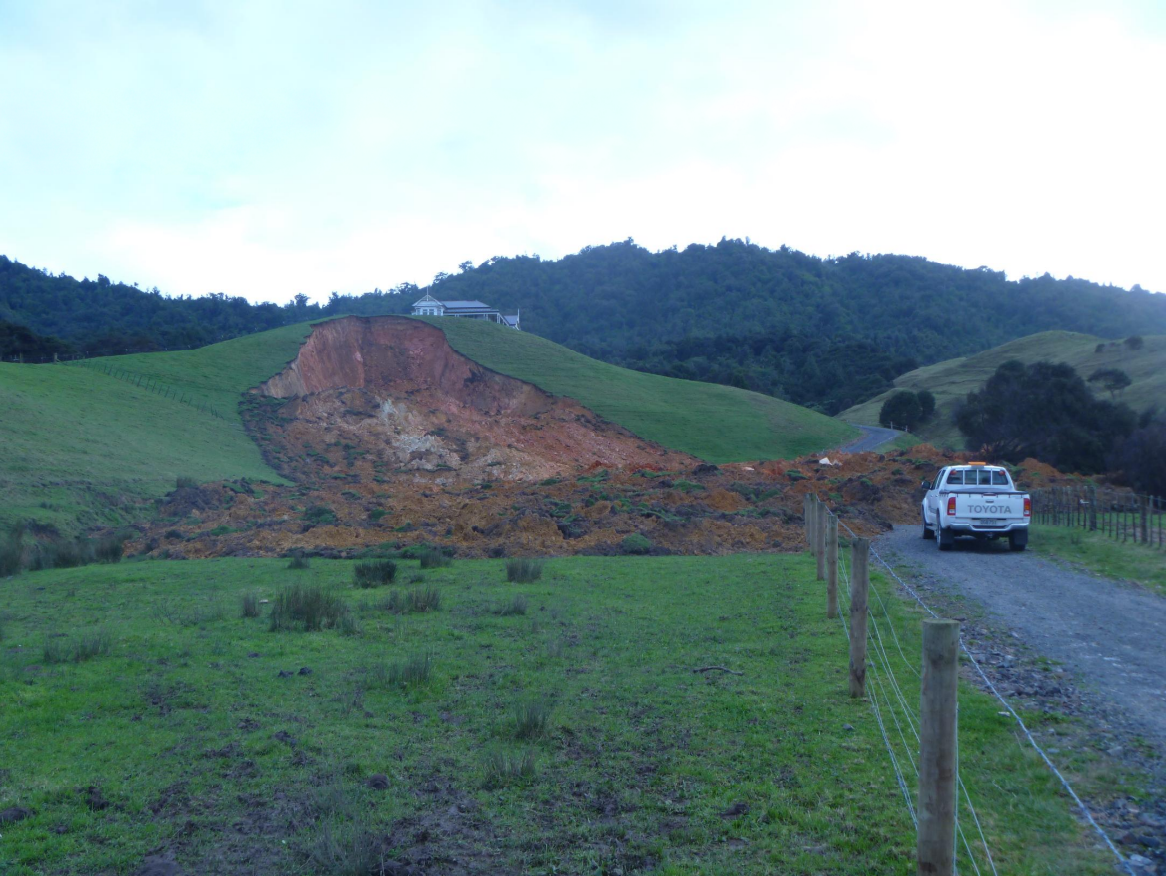
8. View from Hakarimata Road. Note the thickness of the debris 100m from the source.
