Draft - Horotiu West Development

Desktop Preliminary Geotechnical Assessment

Client: Perry Group Limited

AECOM New Zealand Limited

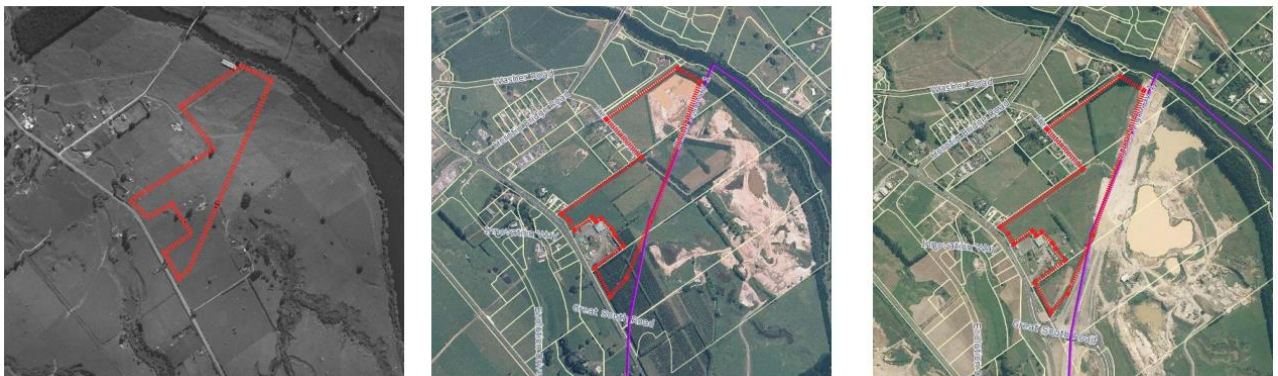
Figure 1 Historic aerial images

Historic aerial photos of the site reveal that the land was previously generally flat pastoral farmland characterised by terraces and paleochannels of the Waikato River. Prior to modification by quarrying and road construction, the property comprised of a broad and near flat upper level with a lower river terrace forming the northern portion of the property. Shallow depressions or channels are typical in these areas and are often described as Maori borrow pits or shallow depressions associated with garden plots.

The land has since been modified by sand mining and by the construction of the Waikato Expressway (directly east and within the north eastern extent). In general, the existing topography slopes gently towards the east with low points adjacent to the expressway embankment. Original ground levels at the site range from RL 16 m to RL 26 m. Excavated sand mine areas are as low as RL 13 m in some locations. Figure 1 below includes google earth images from 1941, 2002 and 2012 showing modification to landform by mining and expressway construction.
