PROPOSED PLAN CHANGE
231 TAHUNA ROAD, OHINEWAI

GEOTECHNICAL ASSESSMENT REPORT

INITIA REF P-000529 REV A

OCTOBER 2019

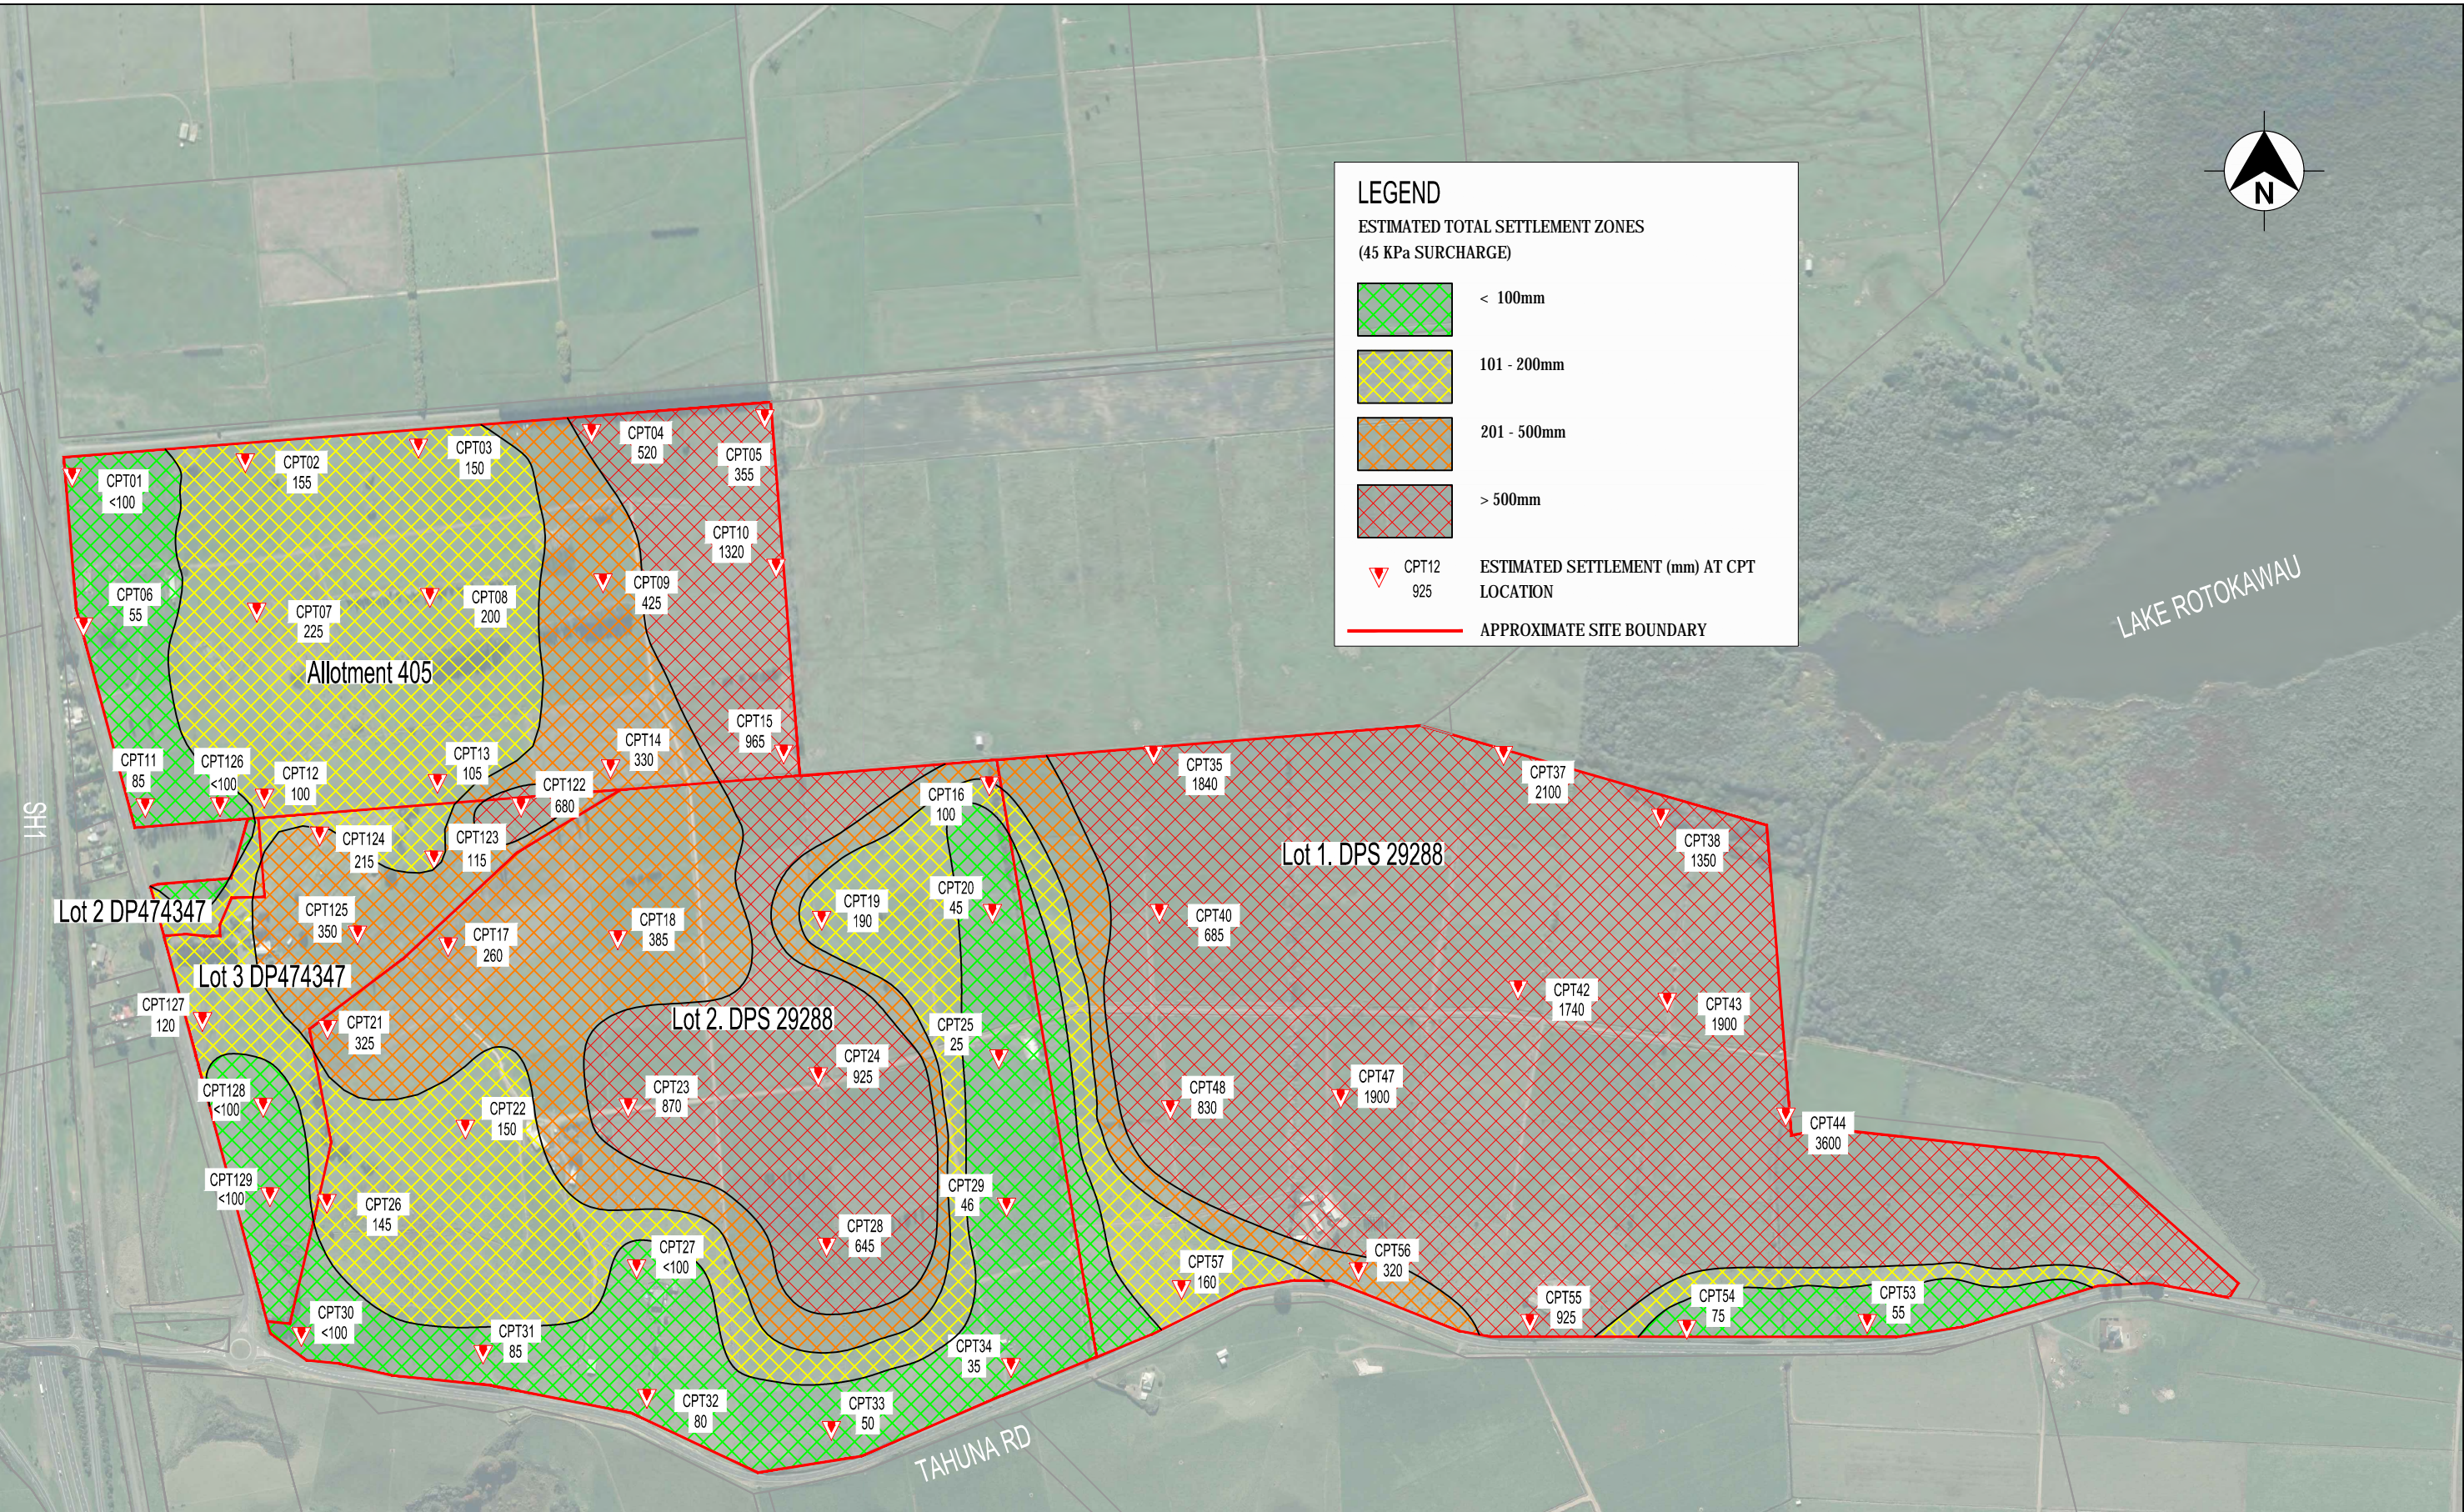
ESTIMATED TOTAL SETTLEMENT ZONES
(45 KPa SURCHARGE)

4.5.2	Settlement	The soils at this site are considered to be highly compressible and could be expected to settle by between 100 mm and 2,000 mm under typical building surcharge pressures of 45 kPa or greater without improvement measures. Low lying areas of the site that are underlain by greater thicknesses of the Rotokawau Formation soils (very soft silts/clays and peat) are at greater risk of settlement. Where, possible future development in these areas should be avoided or minimised. Refer to Figure 529-004 in Appendix A

Consolidation settlement magnitudes within the Rotokawau Formation are expected to range between approximately 50 and 150 mm per 1 m layer thickness (for a 45 kPa surcharge pressure). Similarly, assuming M_v values of 0.1 to $0.3 \text{ m}^2/\text{MN}$ for the Karapiro/Puketoka Formation, settlements are expected to be approximately 5 mm to 15 mm per metre thickness (45 kPa surcharge). Considering, for example, the inferred ground conditions at the location of CPT40 (8 m thickness of Rotokawau Formation and 6 m of Karapiro/Puketoka Formation for a total CPT depth of 14 m), the total consolidation settlement could be expected to be in the range of 450 mm to 1300 mm. This compares well with the predicted total settlement of 700 mm using CPeT-IT. It is noted that the actual settlement at this location could be 100 to 300 mm greater depending on the actual depth of compressible soils within the Karapiro/Puketoka Formation unit extending below the investigation depth.

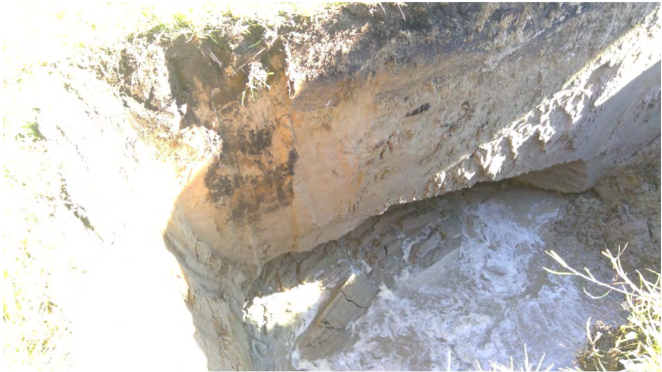
1.4	B			
		1.6	B			
		1.8	B			
SAND; grey. Saturated; sand, fine; some fibrous peat / organics in the base of the excavation. .		2.0	B			
Running sands - pit collapse EOH: 2.00m		2.2

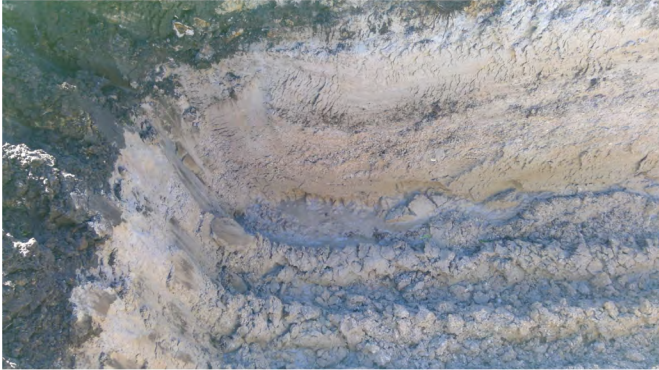
TEST PIT LOG		HOLE NO.: TP02			
	CLIENT: Ambury properties PROJECT: Sleepyhead Ohinewai		JOB NO.: P-000529			
SITE LOCATION: Lumsden Rd Block		START DATE: 31/10/2018				
CO-ORDINATES: 1791213mE, 5849592mN (NZTM)		END DATE: 31/10/2018				
CONTRACTOR: Broughton		LOGGED BY: KND				
RIG: 12t Ex		ELEVATION: 10m				
DRILLER: Heb						
MATERIAL DESCRIPTION (See Classification & Symbology sheet for details)	SAMPLES	DEPTH (m)	LEGEND	SCALA PENETROMETER (Blows / 0mm)	VANE SHEAR STRENGTH (kPa) Vane:	WATER
Topsoil		0.2	TS			
SAND, with trace silt; yellowish brown. Loose; moist; sand, fine to medium.		0.4				
SAND, with some gravel; light brown mottled white. Moist; sand, fine to coarse; gravel, fine to medium; (Pumiceous gravel).		0.6

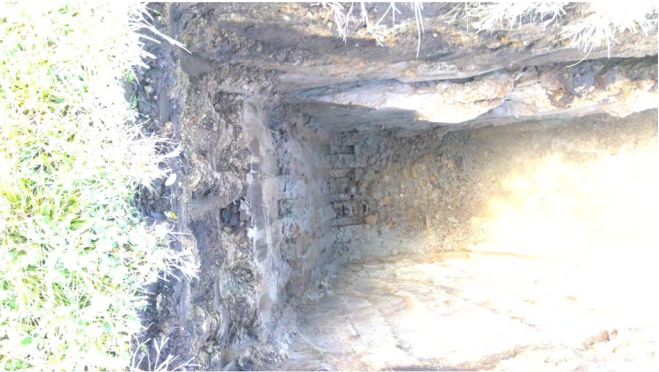
1.0				
		1.2				
	B	1.4				
		1.6				
SAND, with some silt; light grey to light brown. Saturated; sand, fine; Occasional tree roots (up to 50mm dia.).		1.8

2.0				
		2.2				
		2.4				
		2.6				
	2.8					
2.7m: Flowing water						
REMARKS

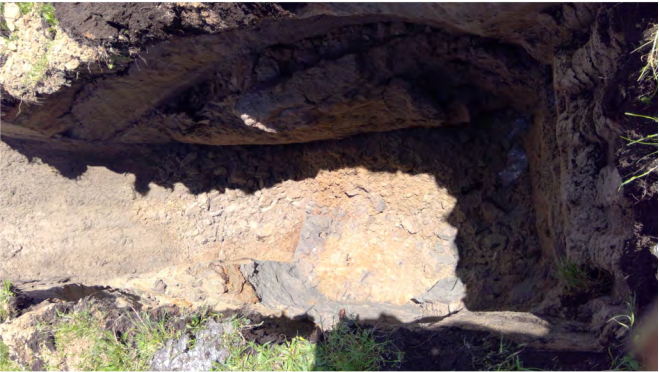
TEST PIT LOG		HOLE NO.: TP04			
	CLIENT: Ambury properties PROJECT: Sleepyhead Ohinewai		JOB NO.: P-000529			
SITE LOCATION: Lumsden Rd Block		START DATE: 31/10/2018				
CO-ORDINATES: 1791766mE, 5849601mN (NZTM)		END DATE: 31/10/2018				
CONTRACTOR: Broughton		LOGGED BY: KND				
RIG: 12t Ex		ELEVATION: 8m				
DRILLER: Heb						
MATERIAL DESCRIPTION (See Classification & Symbolology sheet for details)	SAMPLES	DEPTH (m)	LEGEND	SCALA PENETROMETER (Blows / 0mm)	VANE SHEAR STRENGTH (kPa) Vane:	WATER
Topsoil				2 4 6 8 10 12 14 16 18	50 100 150 200	
SAND, with some gravel; yellowish brown mottled orange white. Sand, fine to coarse; gravel, fine to medium; (Pumiceous Gravel).		0.2 0.4 0.6 0.8 1.0 1.2				
SAND, with minor silt; light grey. Saturated; sand, fine.		1.4 1.6 1.8 2.0 2.2 2.4 2.6 2.8				
EOH: 2.70m

2.7m - 2.7m: large tree roots / stumps in base of hole. Hole collapsed at 2.7m						
REMARKS

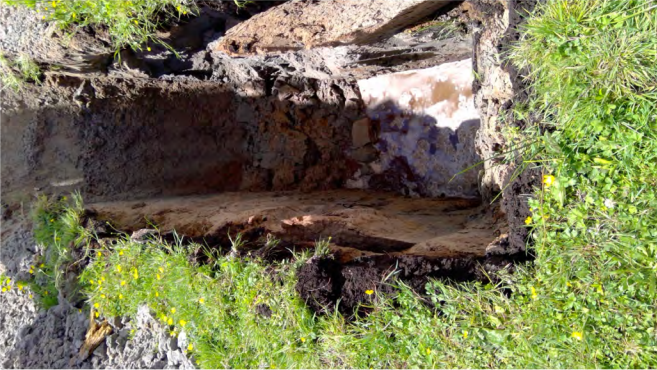
0.4	TS			
SAND; grey. Saturated; sand, fine.		0.6	TS			
		0.8	TS			
		1.0	TS			
		1.2	TS			
		1.4	TS			
		1.6	TS			
		1.8	TS			
		2.0	TS			
		2.2	TS			
		2.4	TS			
SILT; dark brown. Saturated; PEAT. EOH: 2.50m		2.6	TS
