**PRIMARY ECOLOGICAL EVIDENCE OF KELLY MARIE HAYHURST FOR
HARRISVILLE TWENTY THREE LTD**

23 Harrisville Road, Tuakau

NES-F Wetland Assessment

Ecological Management Plan

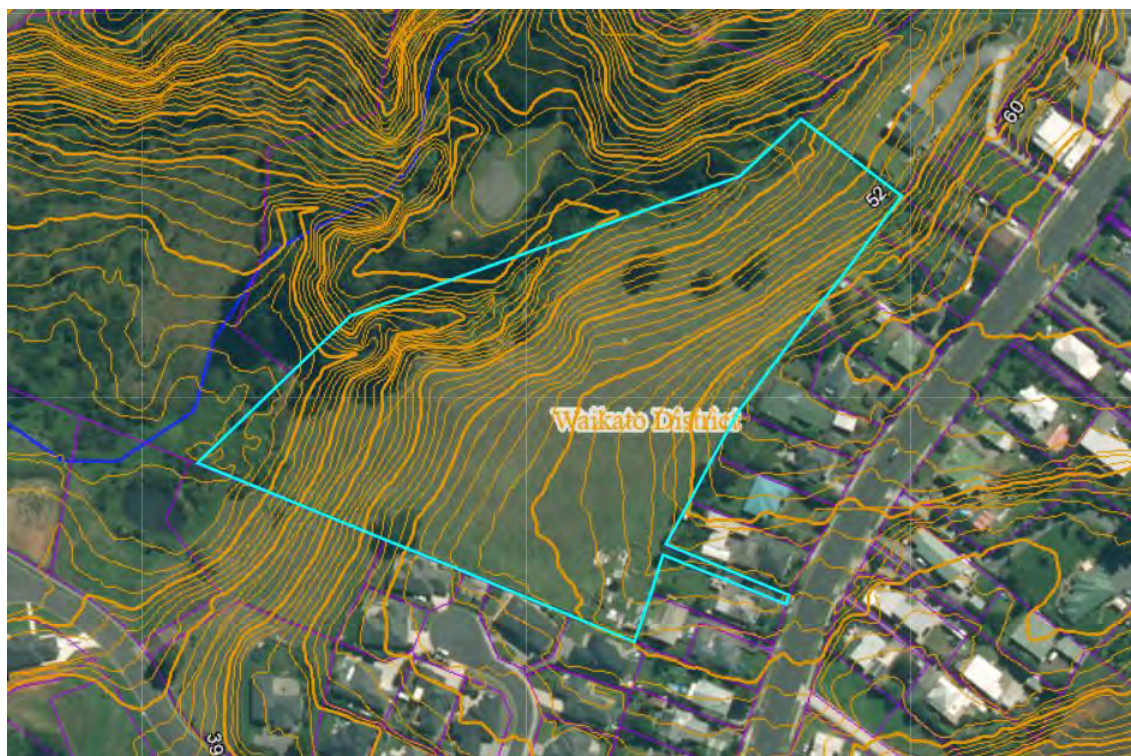
Figure 1: The subject site and Waikato Regional Council overland flow paths and contours layer.

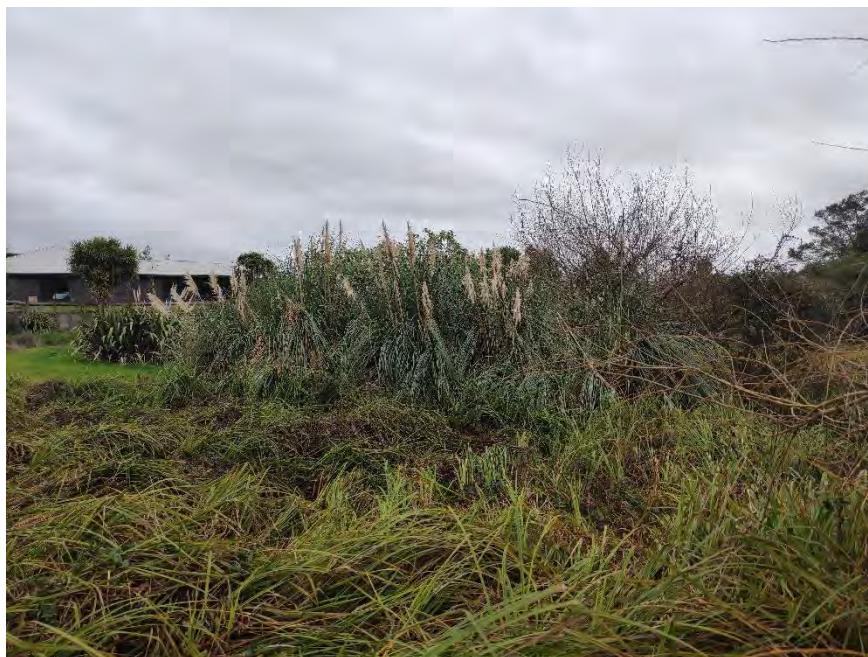
Figure 3: Pampas infestation invading the wetland complex.

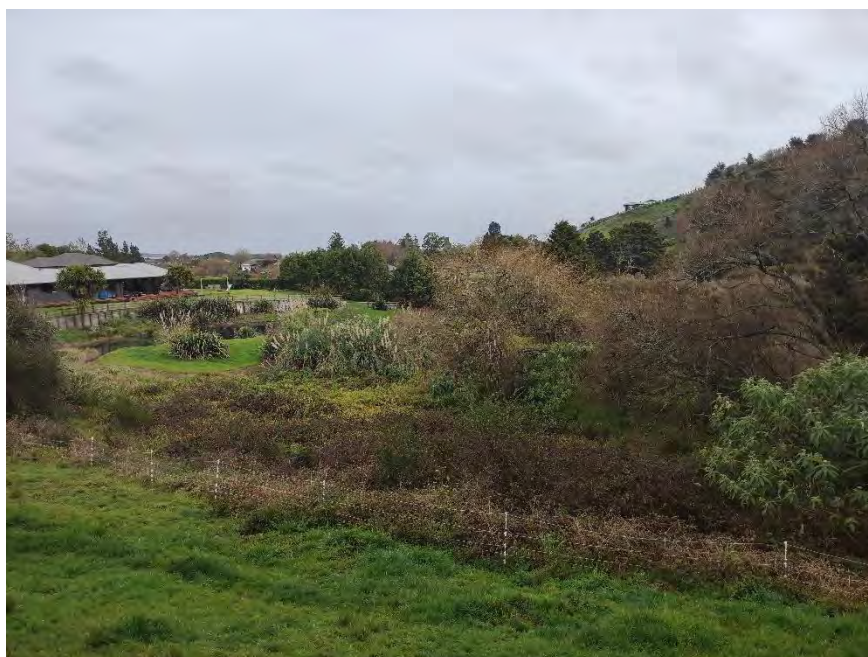
Figure 4: Pest plants including blackberry, woolly nightshade and pampas encroaching on the wetland.

The wetland identified was linked with a permanent section of a stream system and associated overland flow paths at the site. The wider riparian system connects to the main stem of the Waikato River¹³. From the site, the stream system flows south and is generally well vegetated and unmodified with some culverting and online ponds along its reach. The wetland and riparian margins at the site considered by this assessment were well vegetated, although pest plants were prevalent at the time of assessment (Figure 3). Pampas (*Cortaderia selloana*), woolly nightshade (*Solanum mauritianum*), blackberry (*Rubus fruticosus*), Chinese privet (*Ligustrum sinense*), Japanese honeysuckle (*Lonicera japonica*), wandering jew (*Tradescantia fluminensis*), gorse (*Ulex europaeus*), bindweed (*Convolvulus arvensis*), onion weed (*Allium triquetrum*), and wild ginger (*Hedychium gardnerianum*) were present throughout and surrounding the wetland (Figure 4).

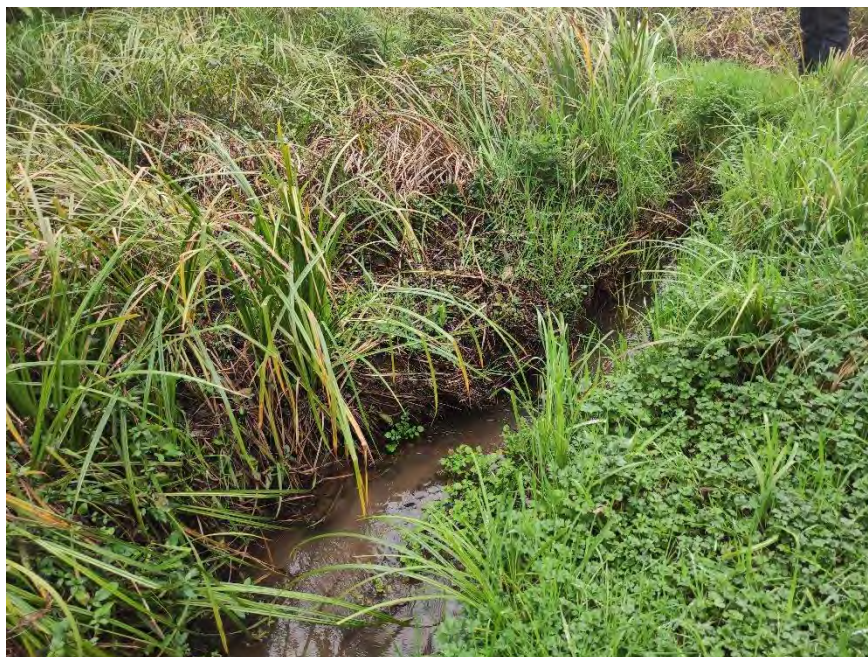
Figure 5: Stream system running through the wetland.

The identified natural wetland contained a channelised stream system flowing through the wetland area to the south-west (Figure 5). There was also a small channel flowing into the wetland from the south-east. The wetland vegetation situated on either side of the channel contained some standing water and had high levels of pest plant impact. There were few indicators of pest animal impact (i.e., grazing damage) and the wetland had been fenced off on the south-east side on-site. When the vegetation was disturbed, the wetland area did not emit sulphurous smell, however, there was evidence of filamentous algae blooms and bacteria in the stream channel flowing through the wetland and additional channel feeding into the wetland from the south-east (Figure 6 and Figure 7). From historical aerial imagery the wetland complex does not appear to have been altered in size.

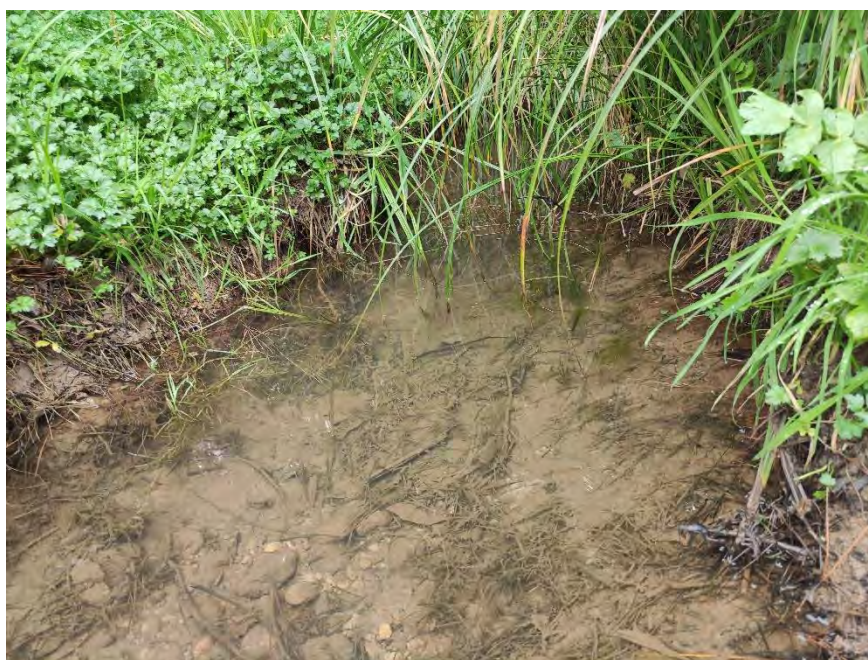
Figure 6: Filamentous algae in the stream system running through the wetland.

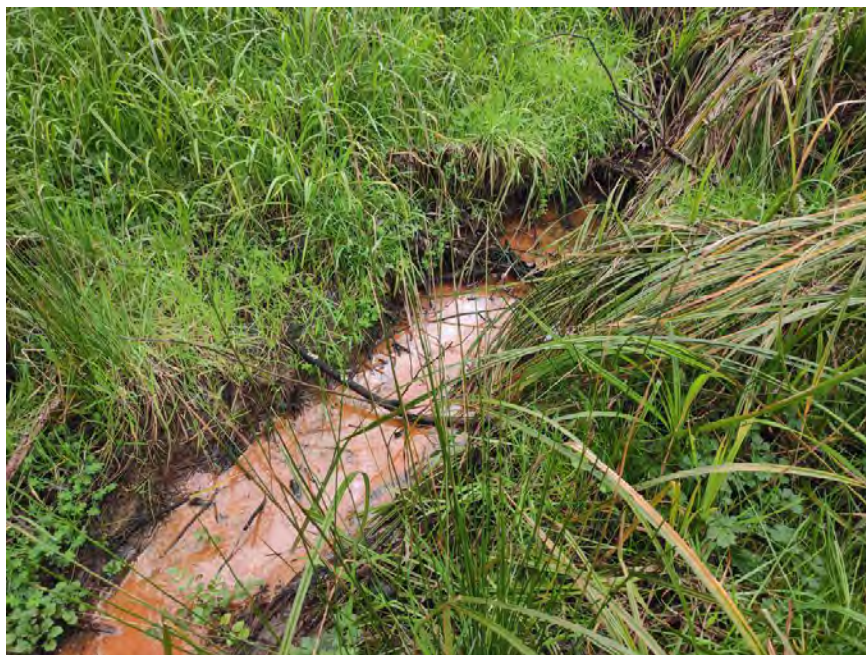
Figure 7: Bacteria in a channel feeding into the wetland.

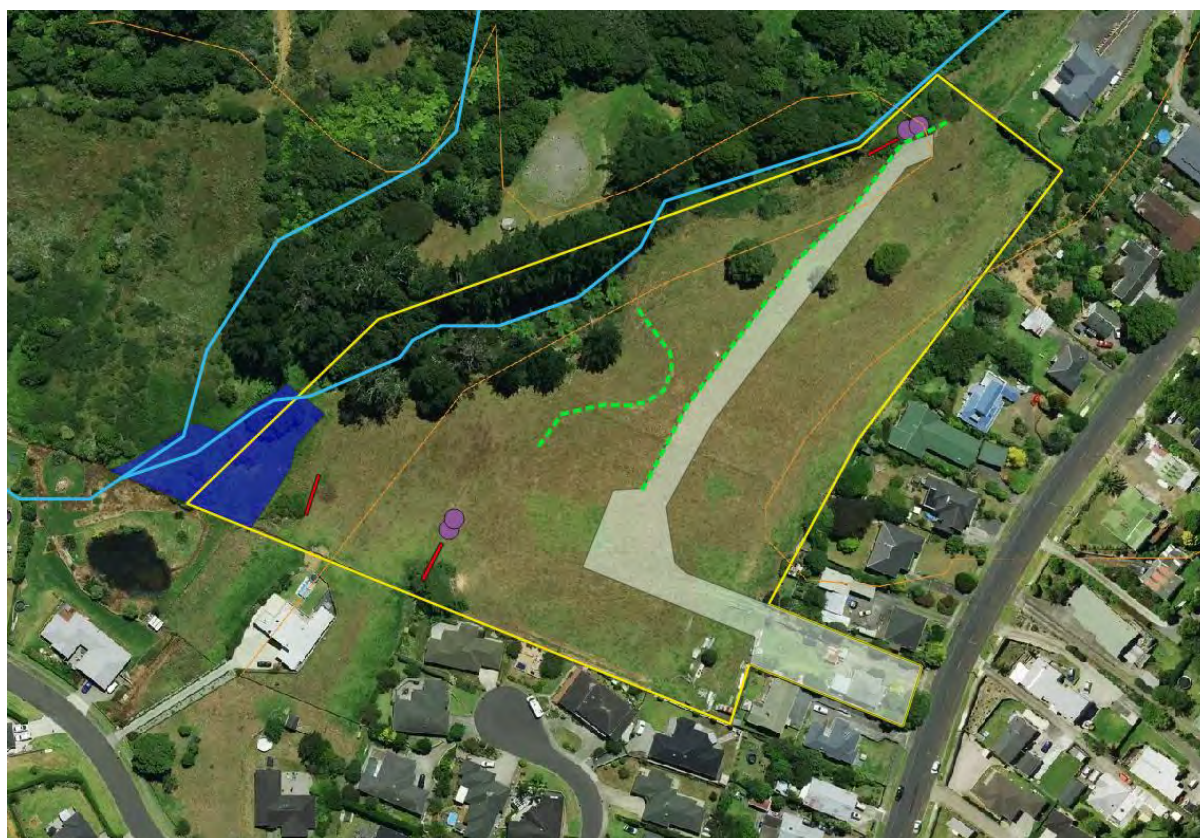
Figure 8: The proposed stormwater spreaders (red), stormwater tanks (purple), earthworks (white), and retaining walls (green), site contours (orange), overland flow paths (blue), pond (light blue) and wetland (dark blue).

The infrastructure for the stormwater trenches and shallow earthworks required to direct an overland flow path to the stormwater tanks at the south-west of the site are proposed to be located at the closest point c. 9m upslope from the identified wetland (Figure 8). The earthworks for the accessway to the subdivision and the retaining walls are proposed to be located upslope at the closest point c. 96m and c. 69m from the identified wetland respectively (Figure 8). At the time of this report, no other earthworks were proposed.

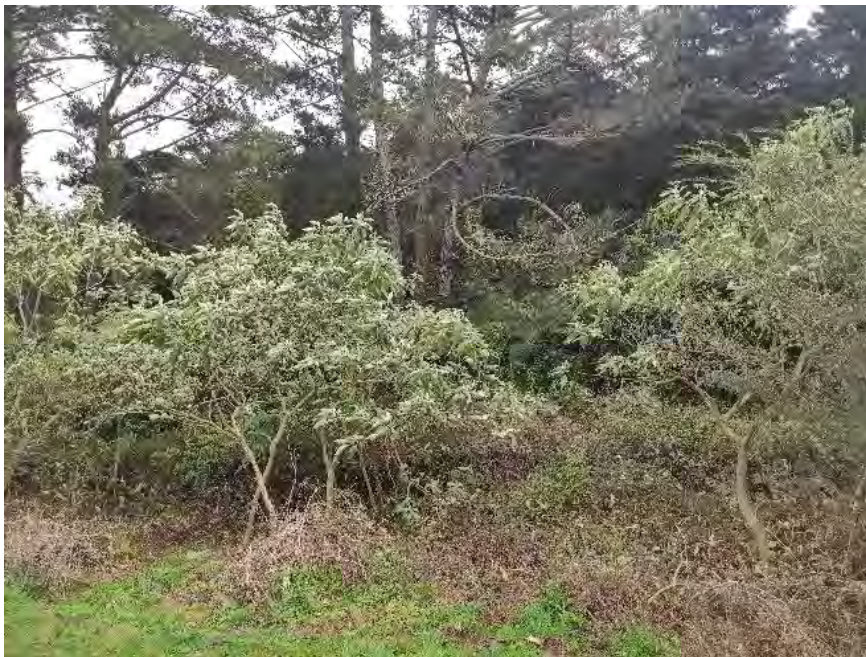
Figure 1: Example of pest plants within the riparian margin.

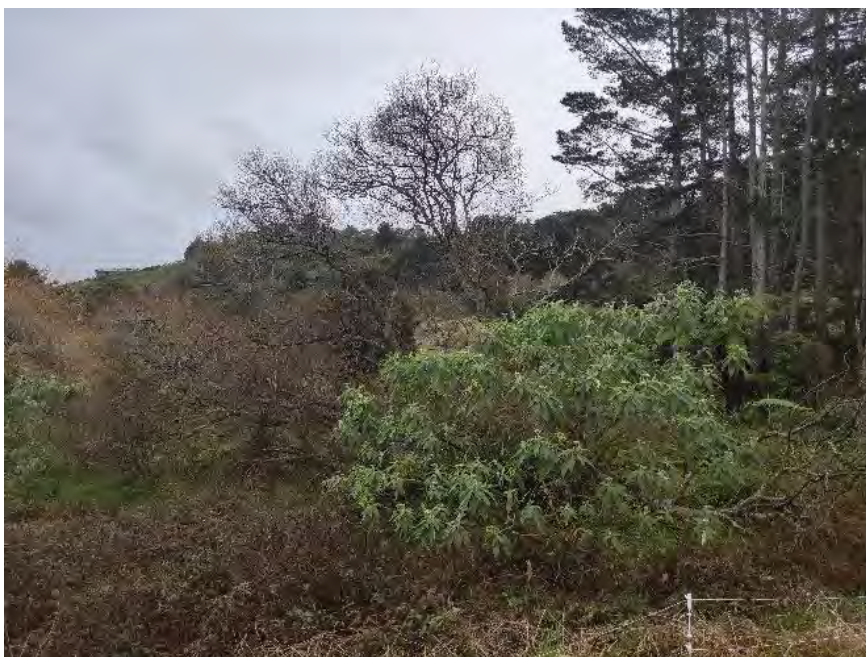
Figure 2: Example of pest plants within the wetland.

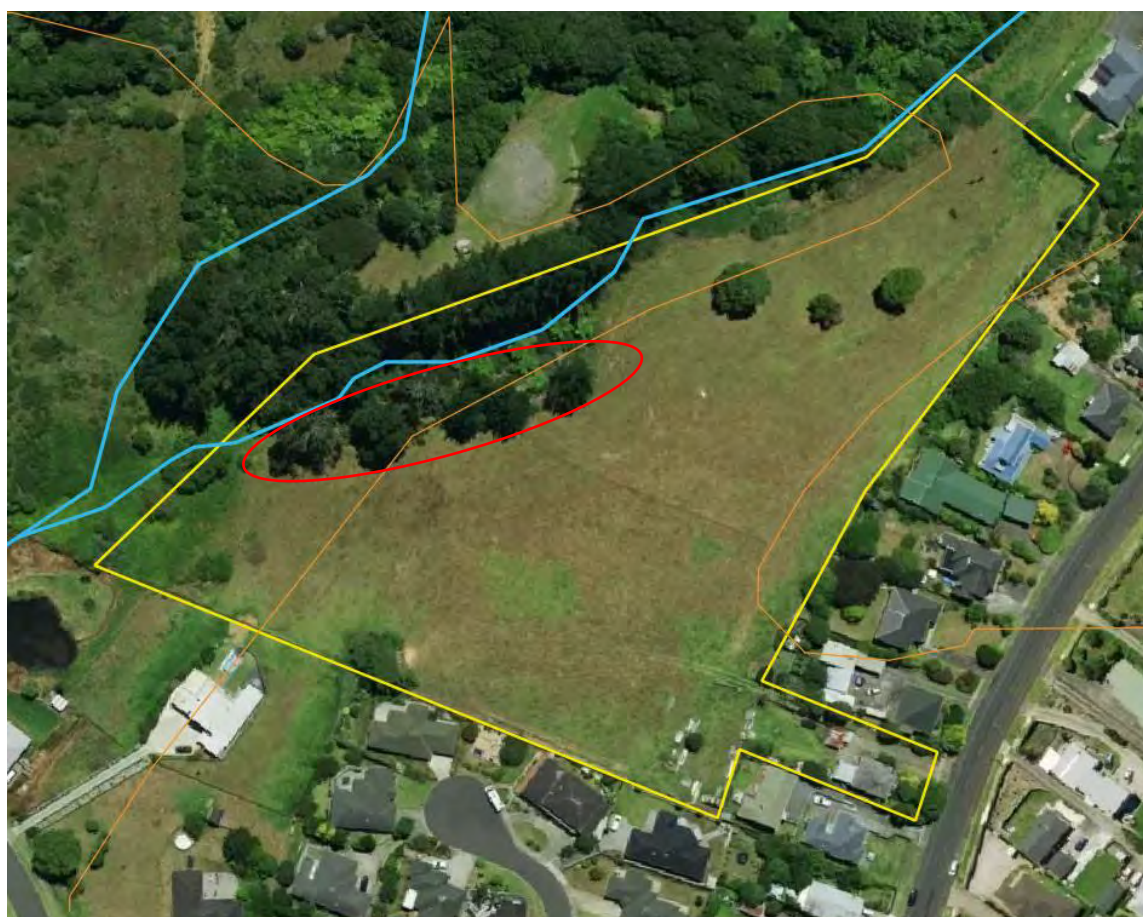
Figure 1: Map of the project site (site boundary in yellow) with overland flow paths (blue), contours (orange) and the indicative area of vegetation removal (red).

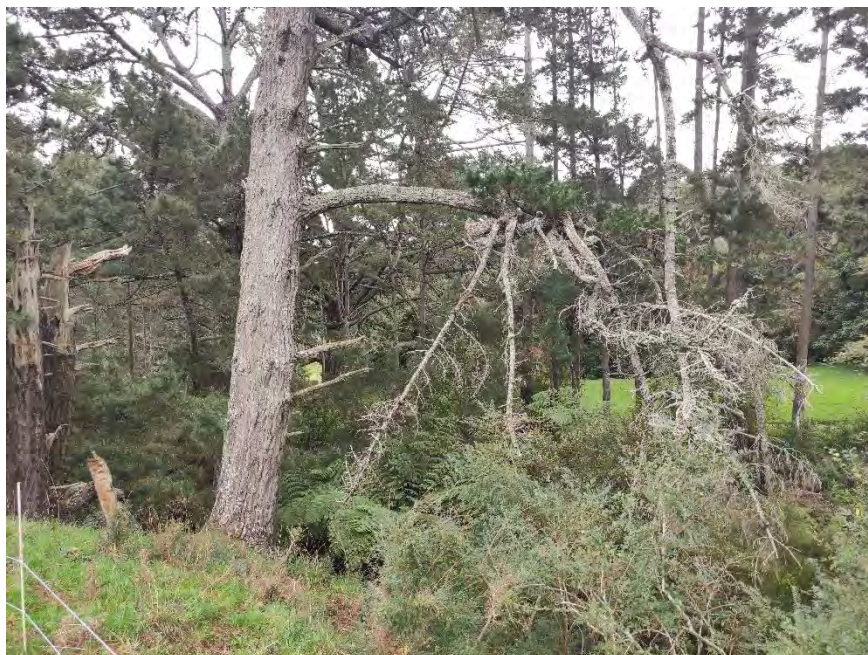
Figure 2: Potential bat habitat in Radiata pine to be removed.
