BEFORE THE WAIKATO DISTRICT COUNCIL INDEPENDENT HEARING PANEL

IN THE MATTER of Proposed Variation 3, under clause 16A of Schedule 1 of the Resource Management Act 1991, to the Proposed District Plan Change

AND
IN THE MATTER of submissions by Greig Developments No 2 Limited and Harrisville Twenty Three Limited, Tuakau.

**PRIMARY GEOTECHNICAL EVIDENCE OF ROBERT TILSLEY FOR
HARRISVILLE TWENTY THREE LTD**

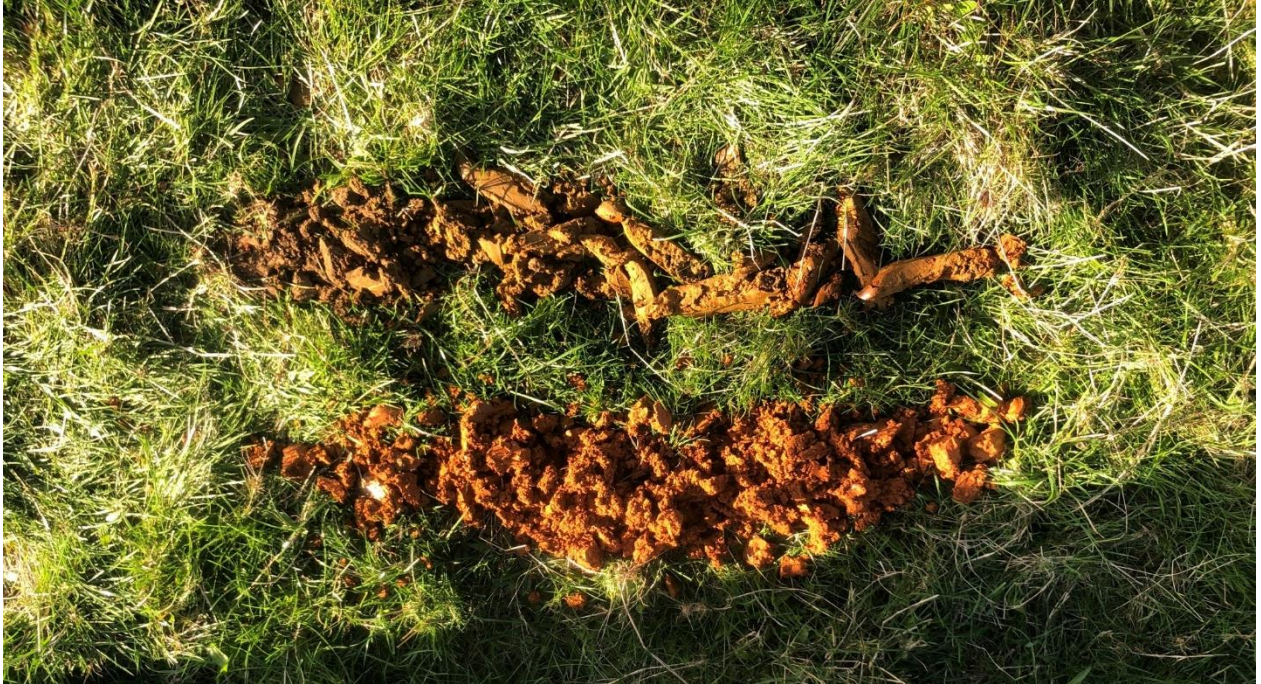
Typical Picture of Subsoil

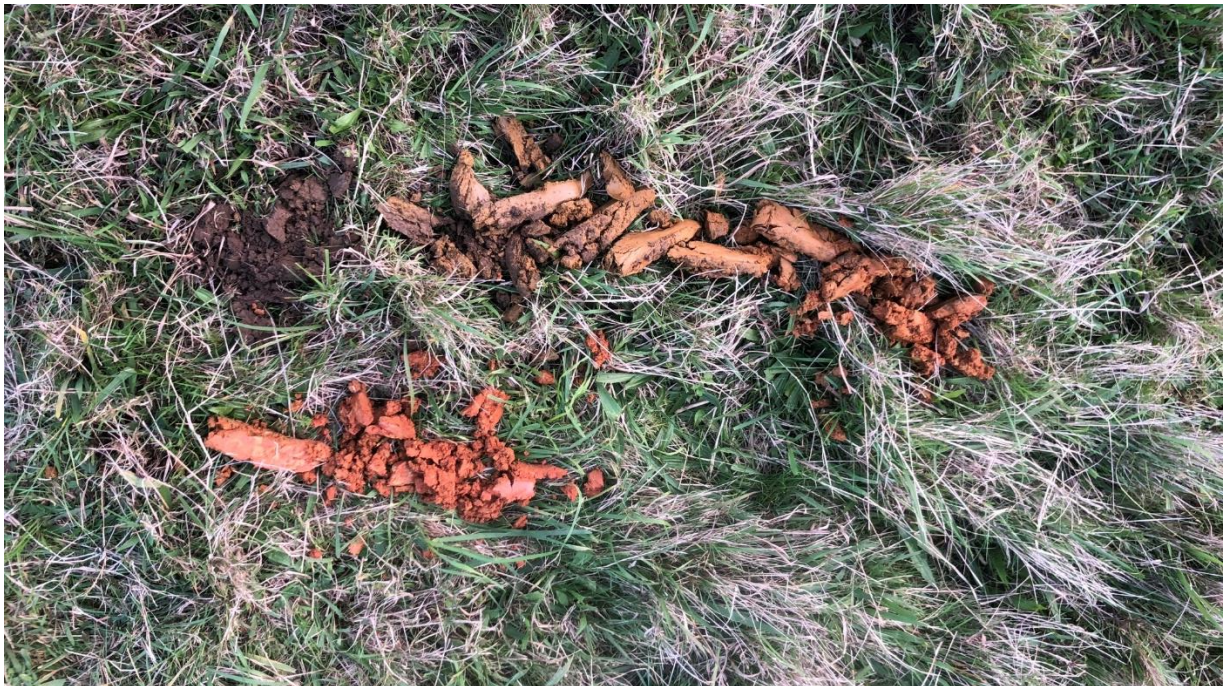
Typical Picture of Subsoil

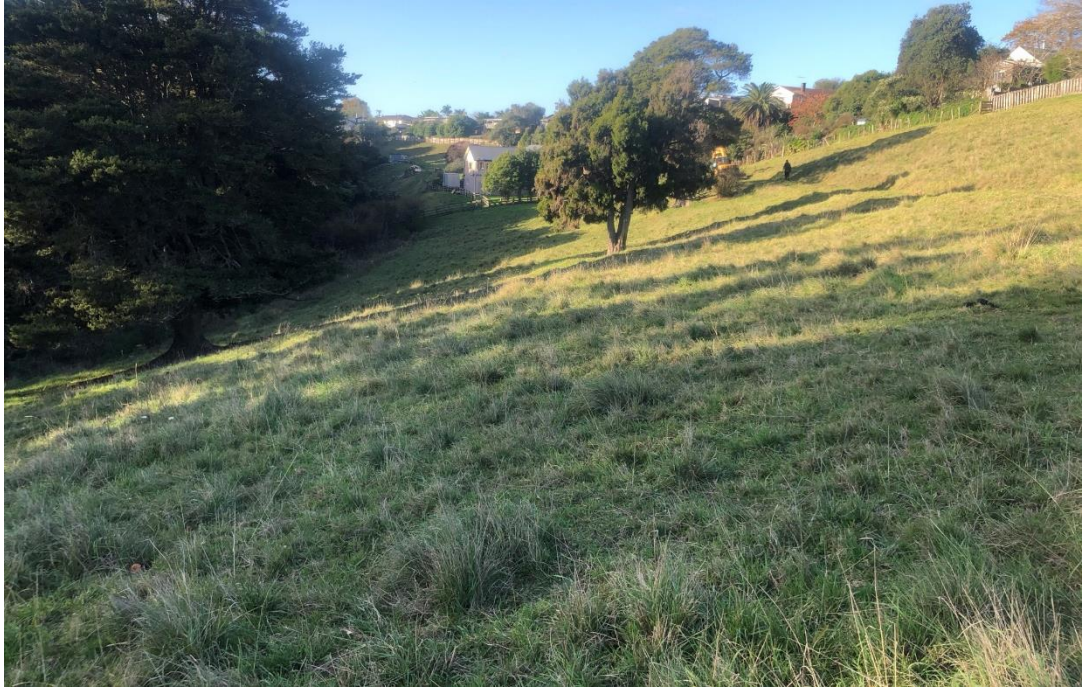
Steep Slopes within Lot

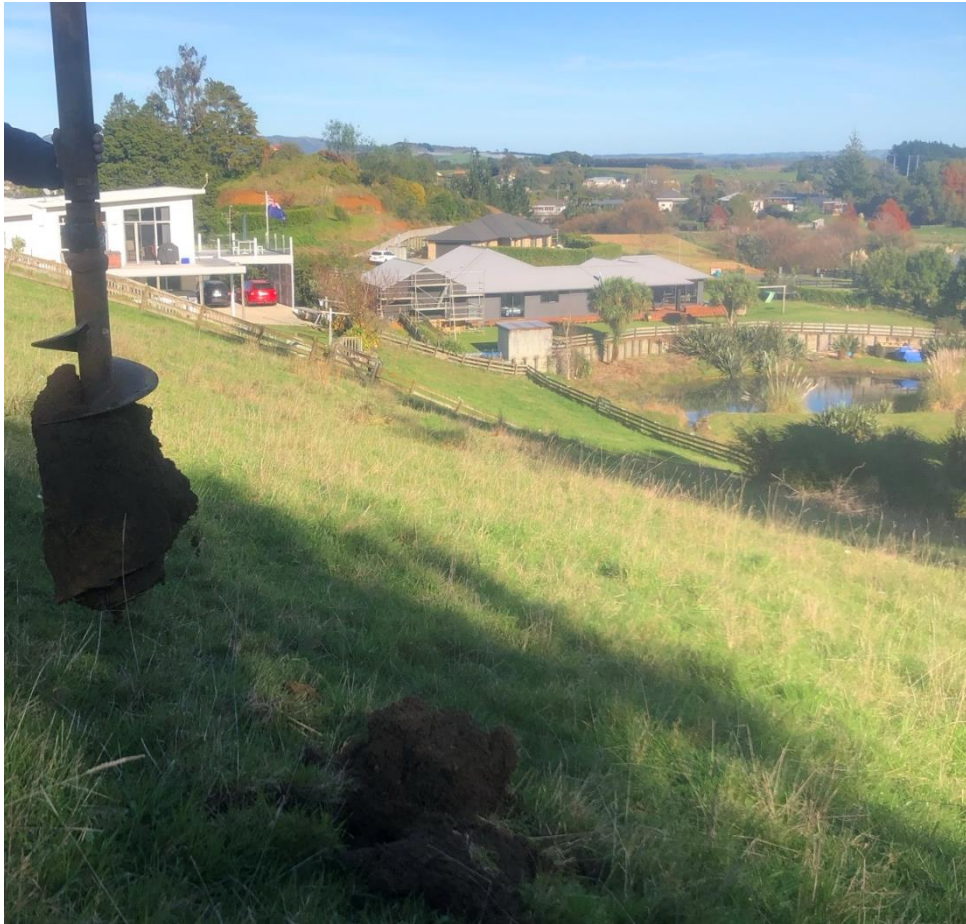
Steep Slopes within Lot

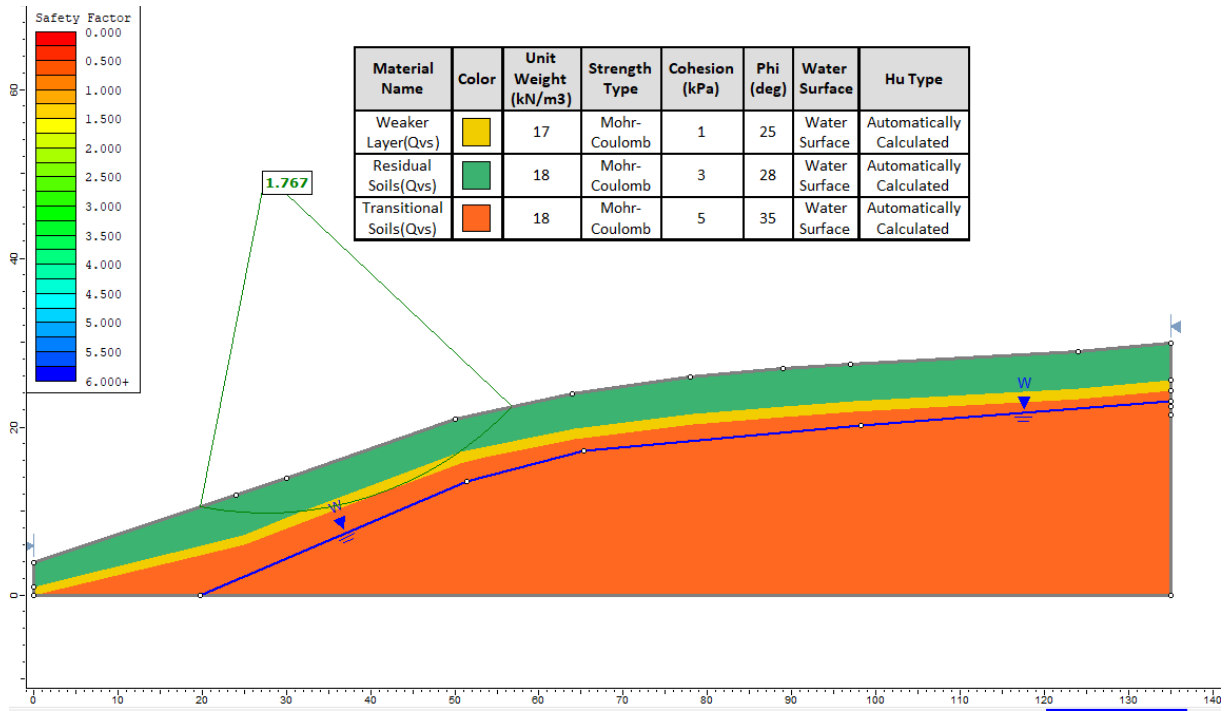
Long Term (Normal Groundwater) Conditions

static, elevated water level, and seismic loading conditions. The cross-sections A-A' and B-B' were drawn through the area to contain the proposed development and are included in the Appendix. These cross-sections are considered to provide a range of representative slope conditions within the subdivision. The cross-sections were analyzed for modes of failure, given the deep soil profiles and the modes of failure associated with the existing instability features. Factors of safety against instability were assessed by worst-case scenario techniques. Worst-case scenarios involve the assessment of the theoretically worst groundwater levels for an existing slope and then using assumed realistic effective stress soil parameters to establish the lowest factor of safety for these conditions.

Conditions of Analysis	Type of Failure	Factor of Safety	Meets Criteria
Cross-section A-A'			
Long Term (Normal Groundwater) Conditions	Circular	1.767	Yes
Short Term (Elevated Groundwater Surface) Conditions	Circular	1.199	No
Seismic Conditions	Circular	1.146	Yes
Cross-section B-B'			
Long Term (Normal Groundwater) Conditions	Circular	1.904	Yes
Short Term (Elevated Groundwater Surface) Conditions	Circular	1.483	Yes
Seismic Conditions	Circular	1.244	Yes
