Waikato District Council

Catchment Management Plan
Ngaruawahia & Surrounds Structure
Plan Area

March 2015

T&T Ref: 61814.2

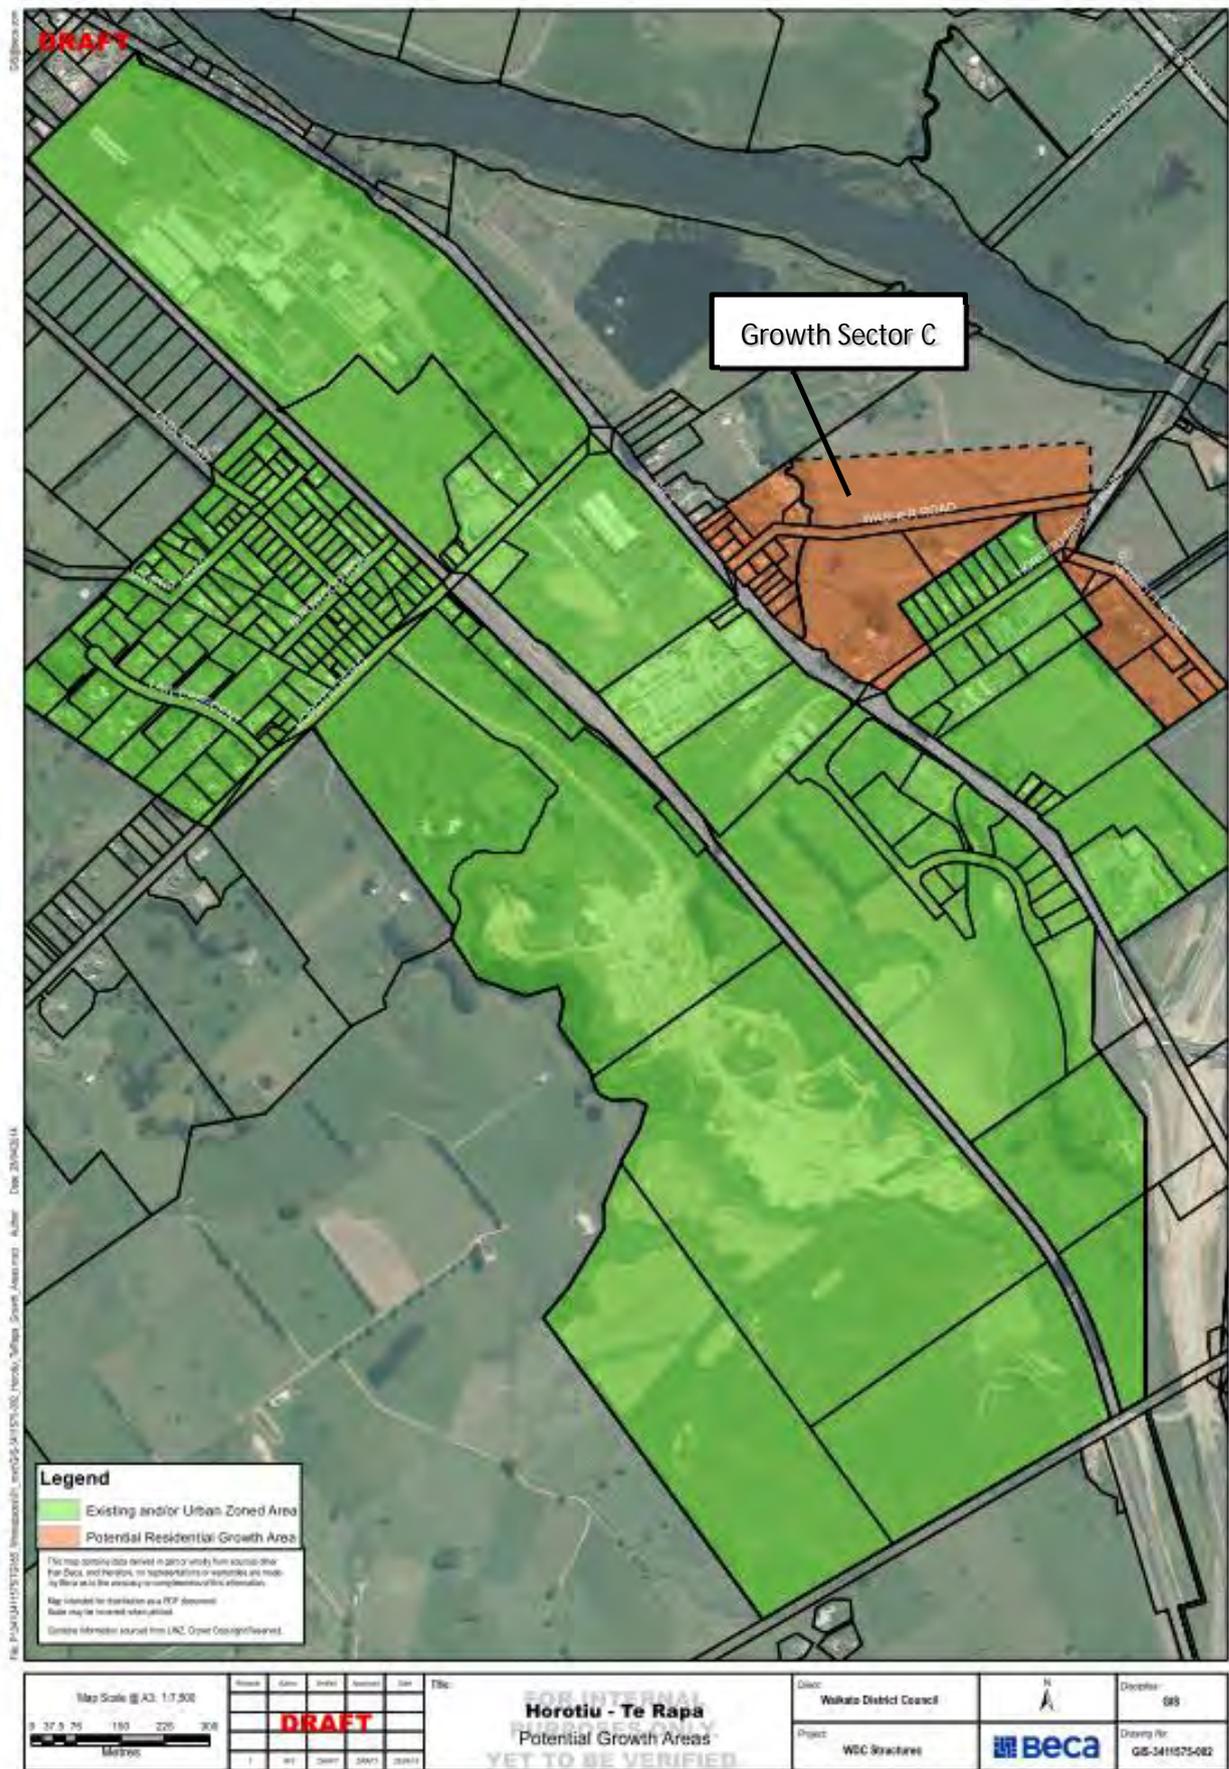
Figure 4. Horotiu growth plan provided by WDC and Growth Sector used for reporting

For reporting purposes, the growth area defined by WDC have been categorised into "Growth Sector" C. This is also presented in Figure 4. It is noted that the growth area provided by WDC and presented in Figure 4 extends beyond the SPA boundary provided by WDC.

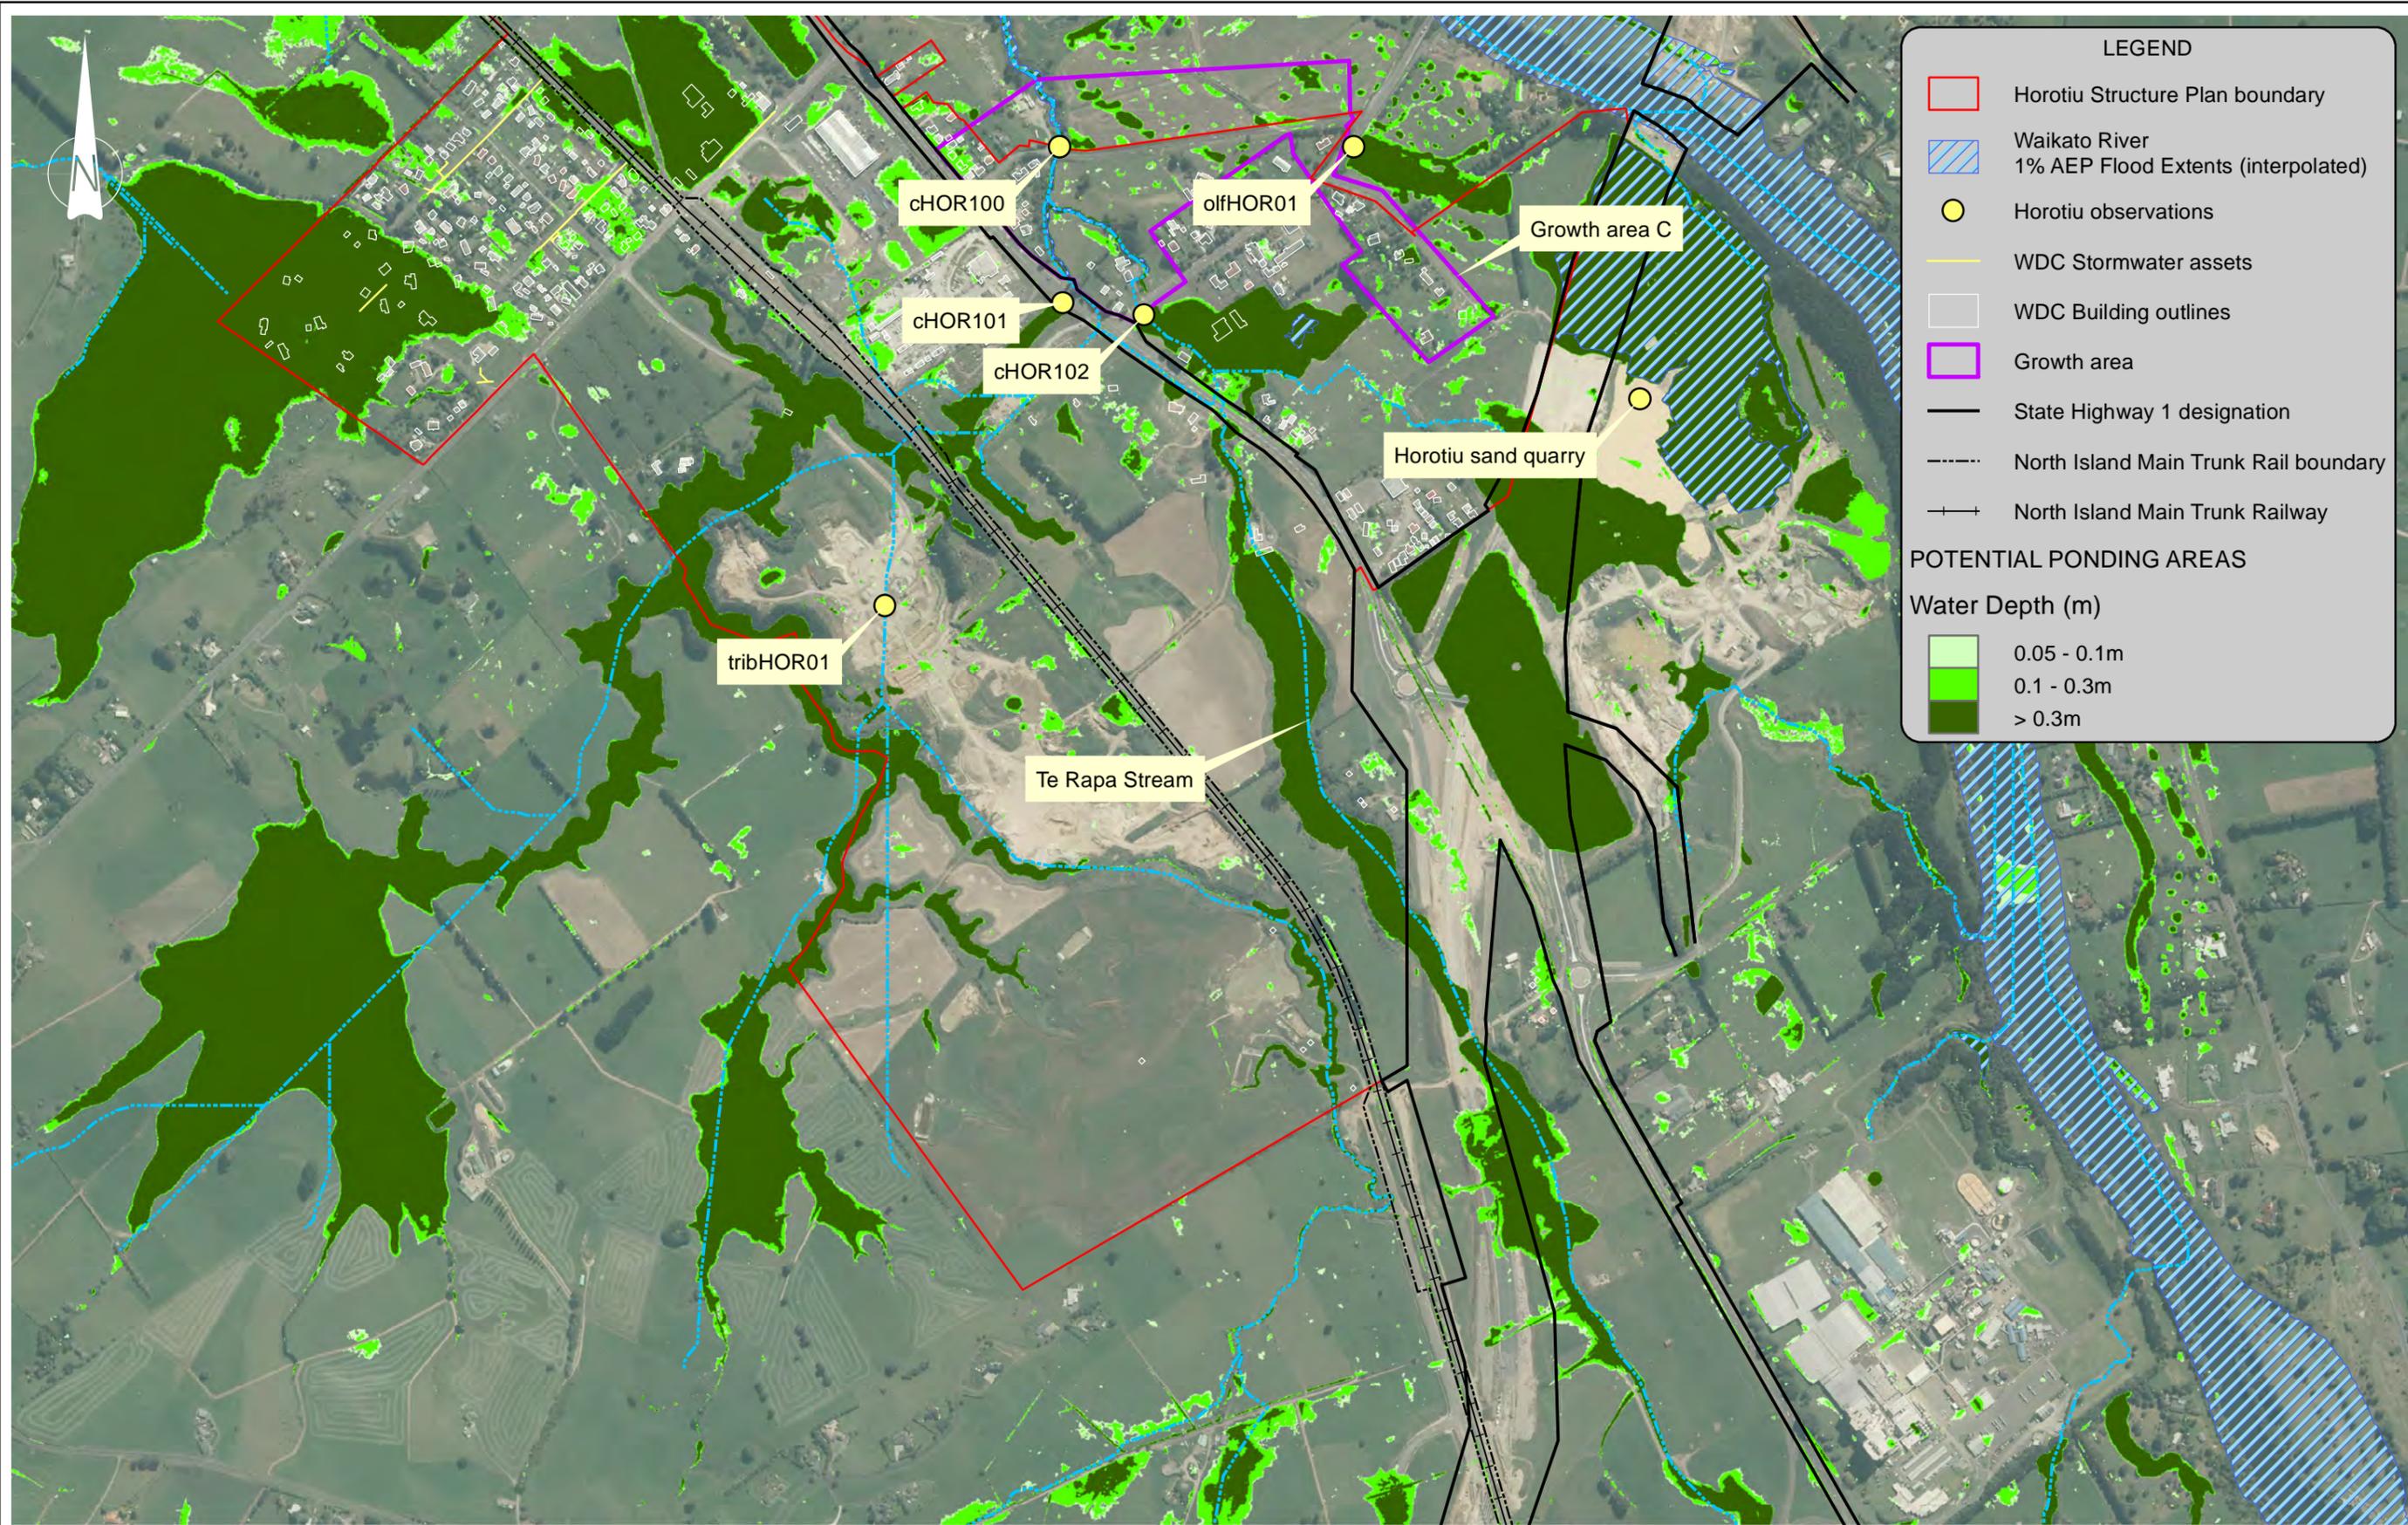
- **Figures 242 & 243 Flooding Maps Sheets 1 & 2**
- **Figure 252 Ecological Map**

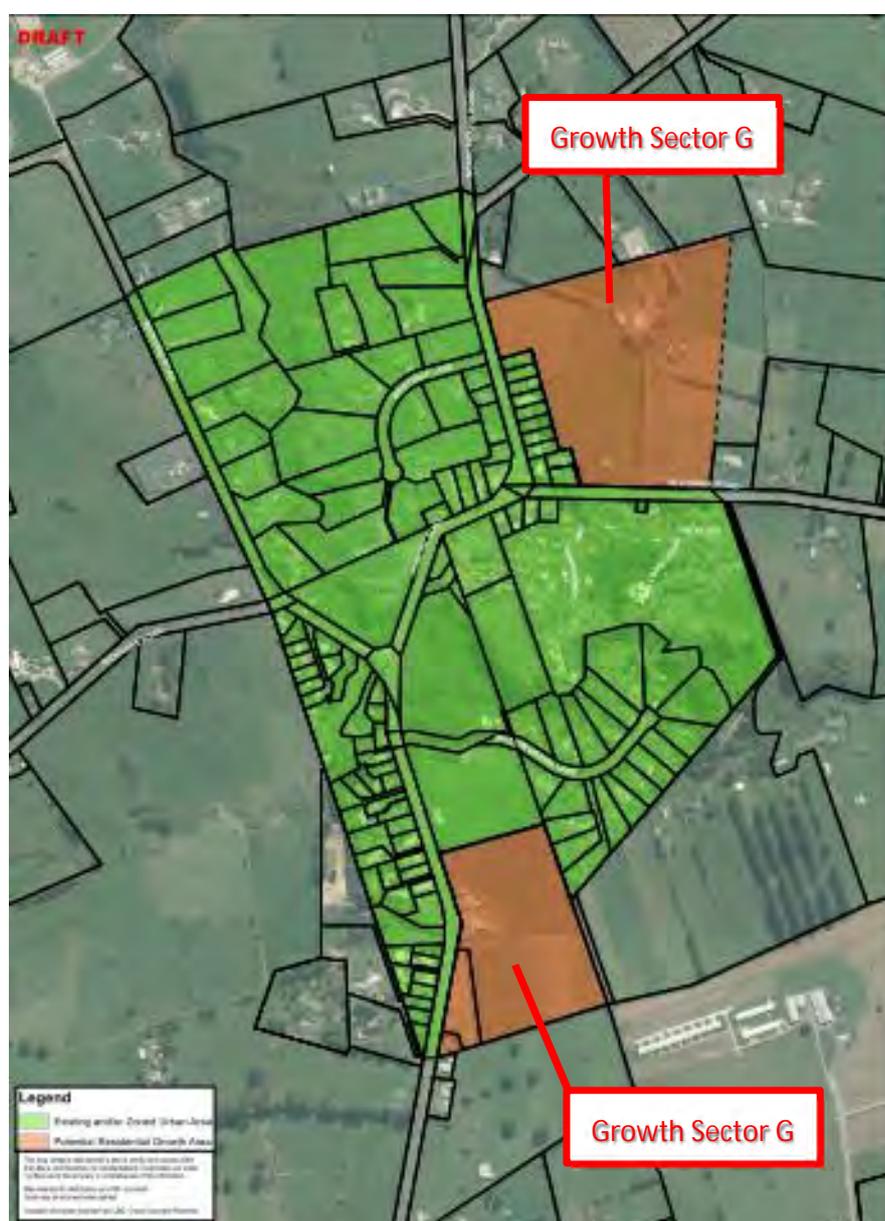
Figure 4. Te Kowhai growth plan provided by WDC and Growth Sectors used for reporting.

For reporting purposes, the growth areas defined by WDC have been categorised into “Growth Sectors” G and H. These are also presented in Figure 4.
