# Tuakau Structure Plan

## Geotechnical Suitability Assessment

Client: Waikato District Council

22-Aug-2014

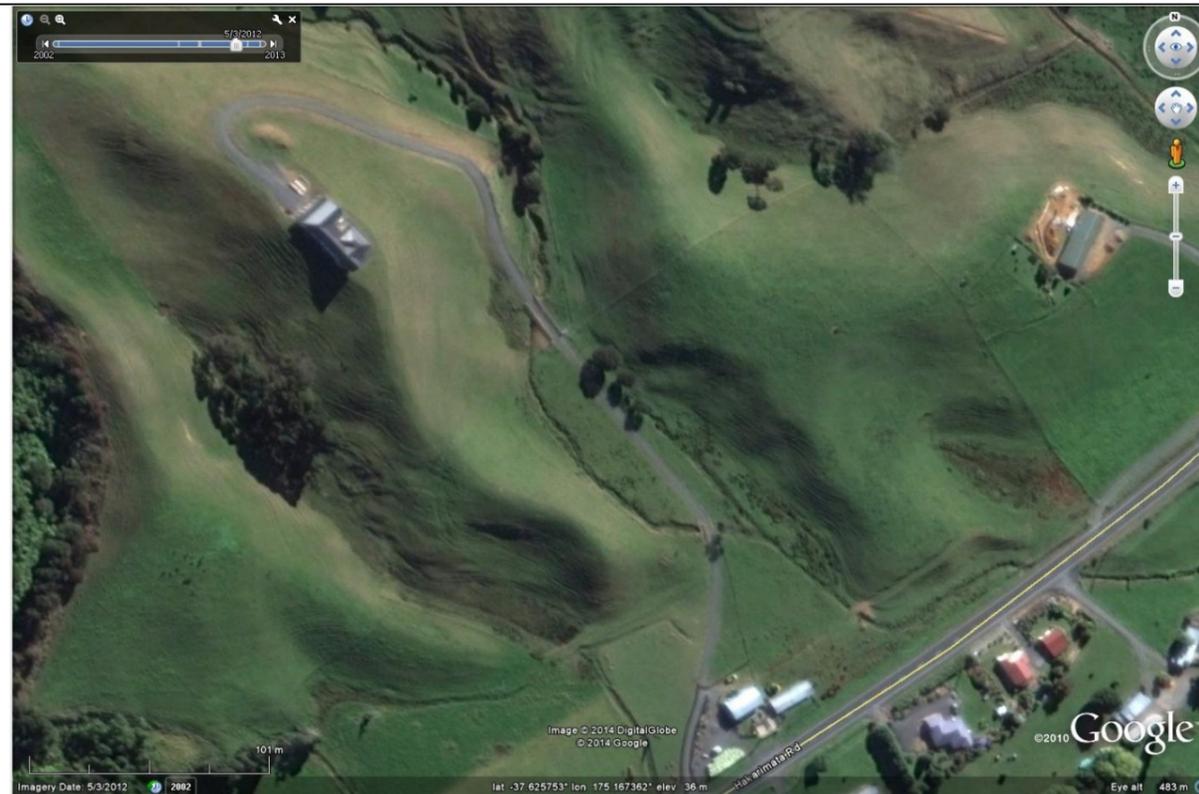
3. By May 2012 a house was relocated to the ridge. The image indicates that the driveway did not interfere with the toe of the slope, which subsequently failed in July 2012. The image also indicates that no earthworks were undertaken on the slope.

Had this house being positioned on the slip or in the path of debris flow it would have been destroyed and any occupants would have been unlikely to survive.

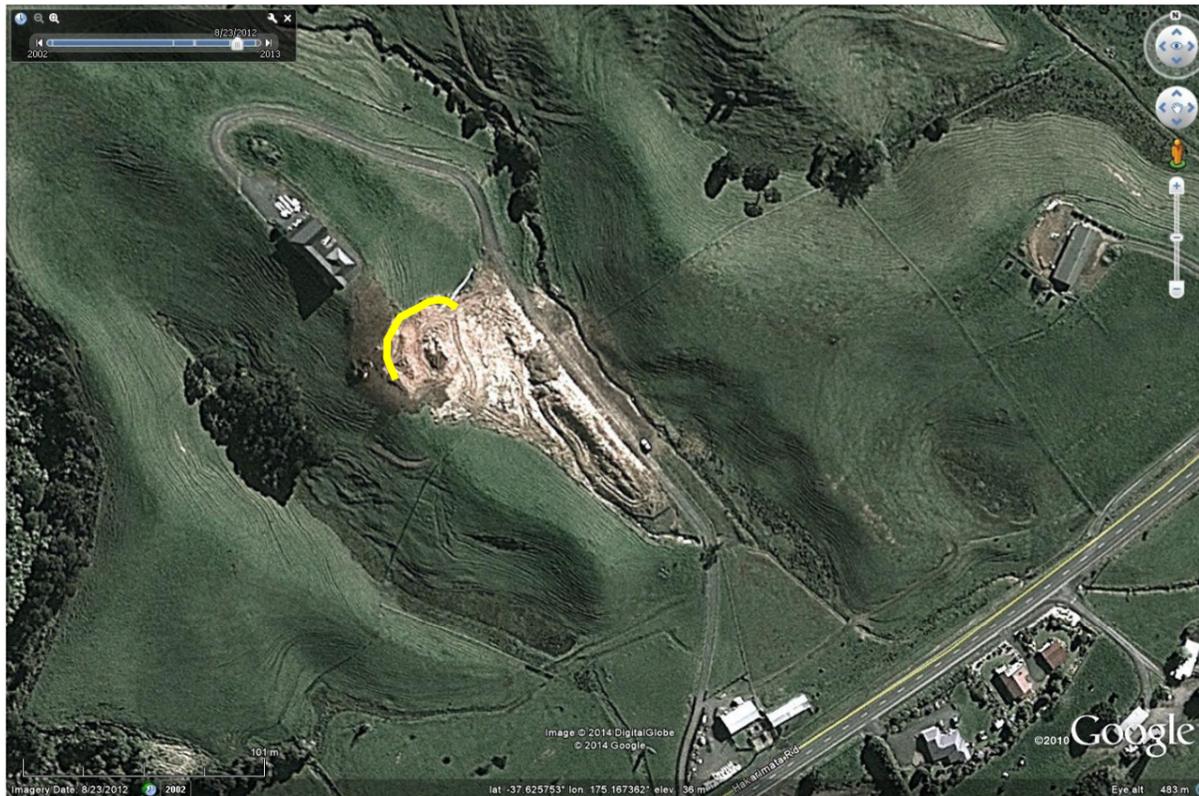
4. This image was taken in August 2012 approximately 6 weeks after the slip occurred. Note the soil has flowed approximately 100 metres from the headscarp. Works have cleared the driveway however surge marks are still visible on the opposite ridge.

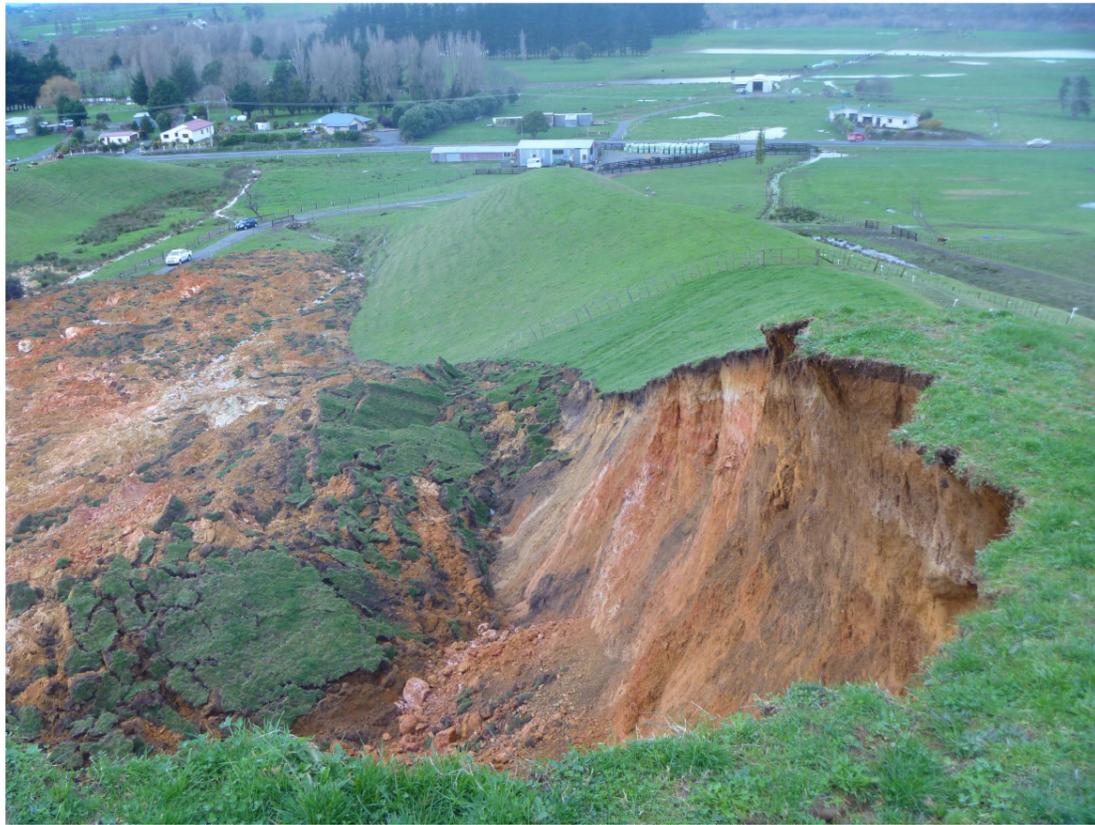
5. Looking across slip backscarp towards Hakarimata Road.

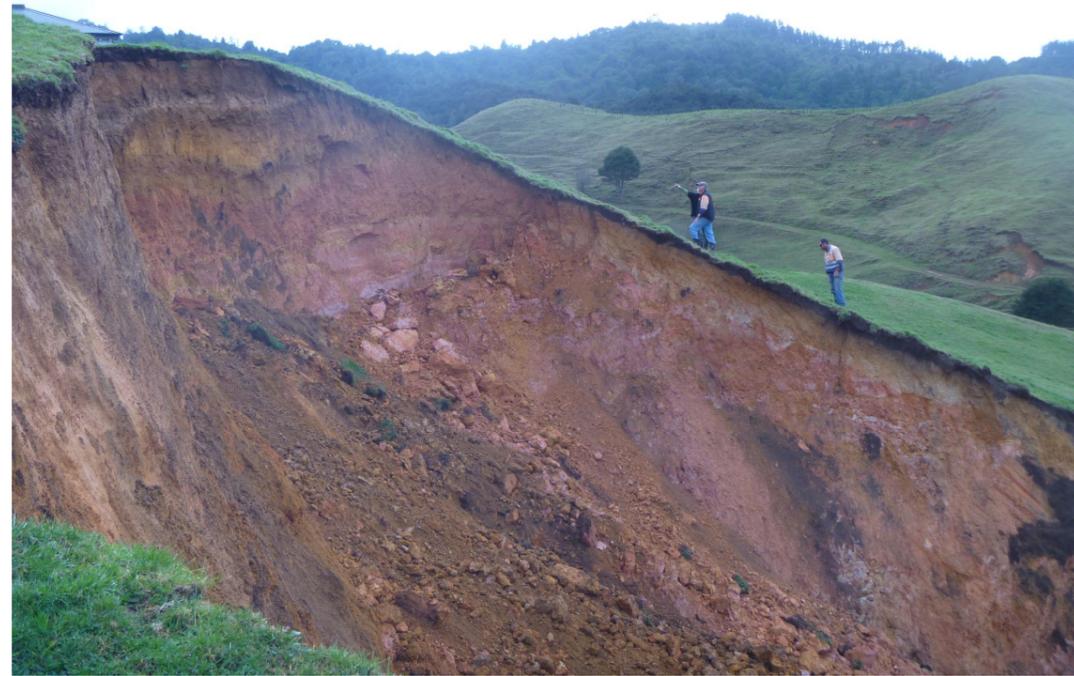
7. The size and depth of back scarp is apparent in this photo

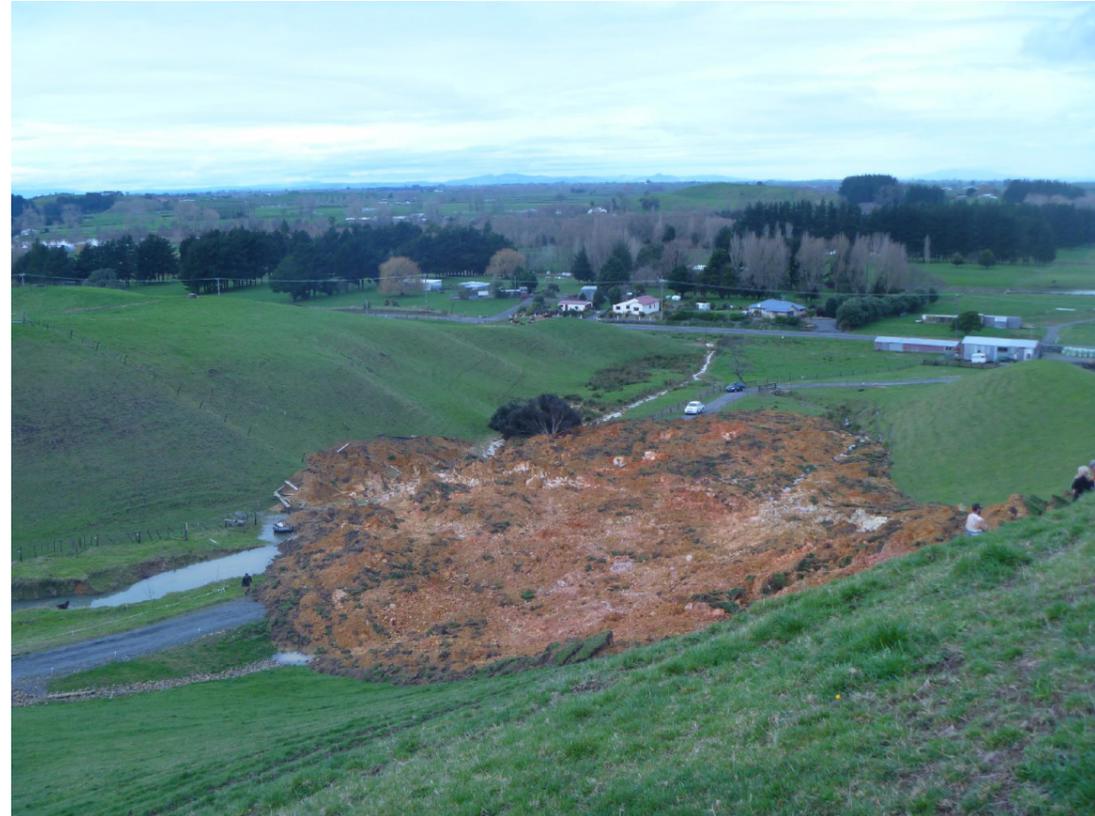
6. Note debris flow had sufficient velocity to travel several metres up adjacent slope and topple mature trees.

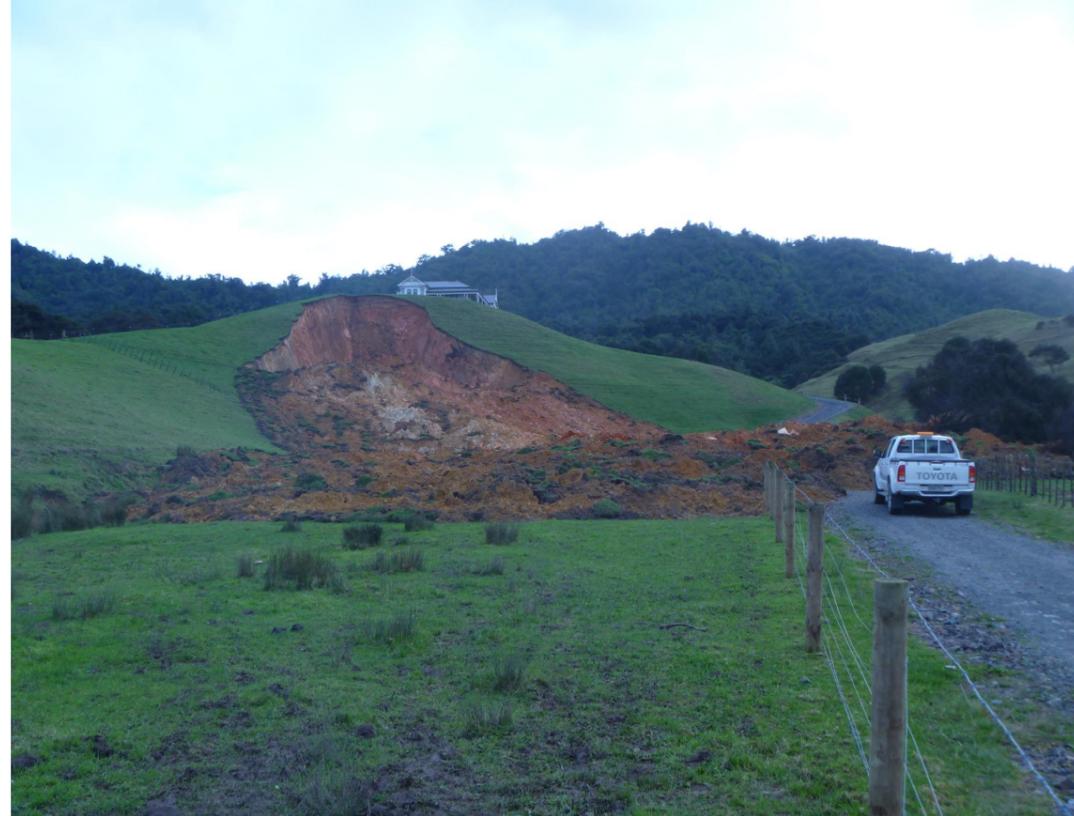
8. View from Hakarimata Road. Note the thickness of the debris 100m from the source.
