# Preliminary Site Investigation at 65-94A Scott Road, Te Kauwhata

Lakeside Developments 2017 Ltd

## **WAIKATO DISTRICT COUNCIL TE KAUWHATA HEAVY VEHICLE BYPASS**

Preliminary Geotechnical Report

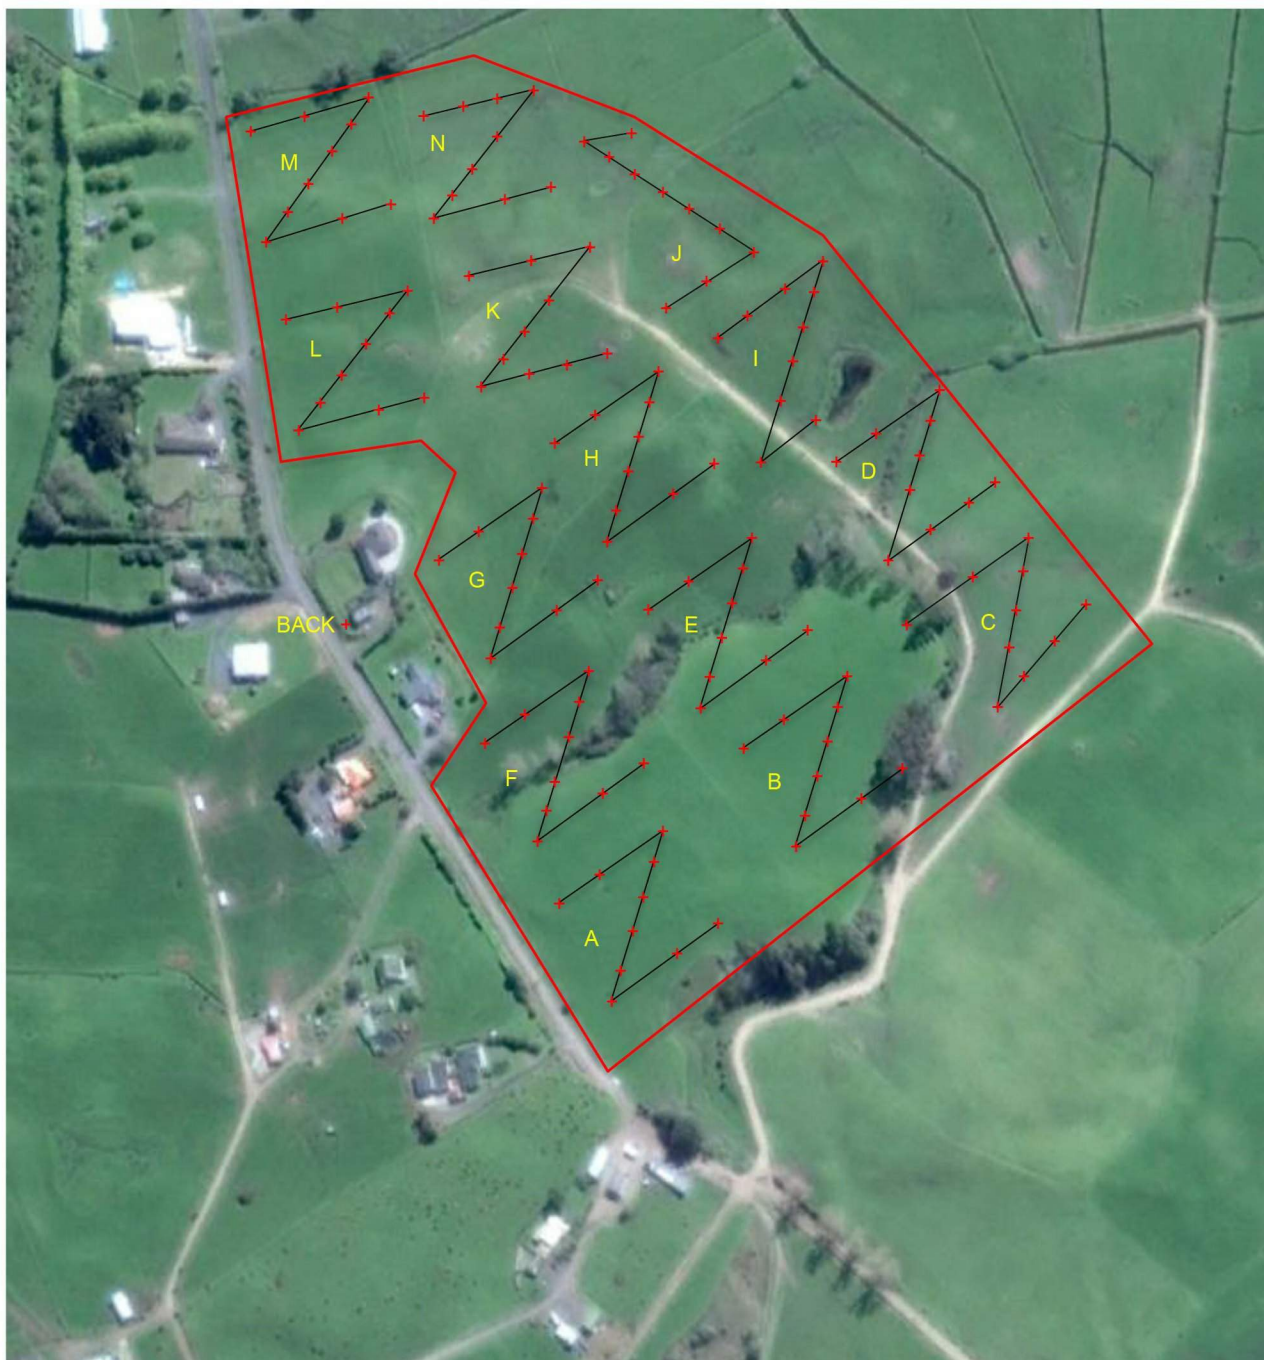
FIGURE 4

SAMPLING PLAN

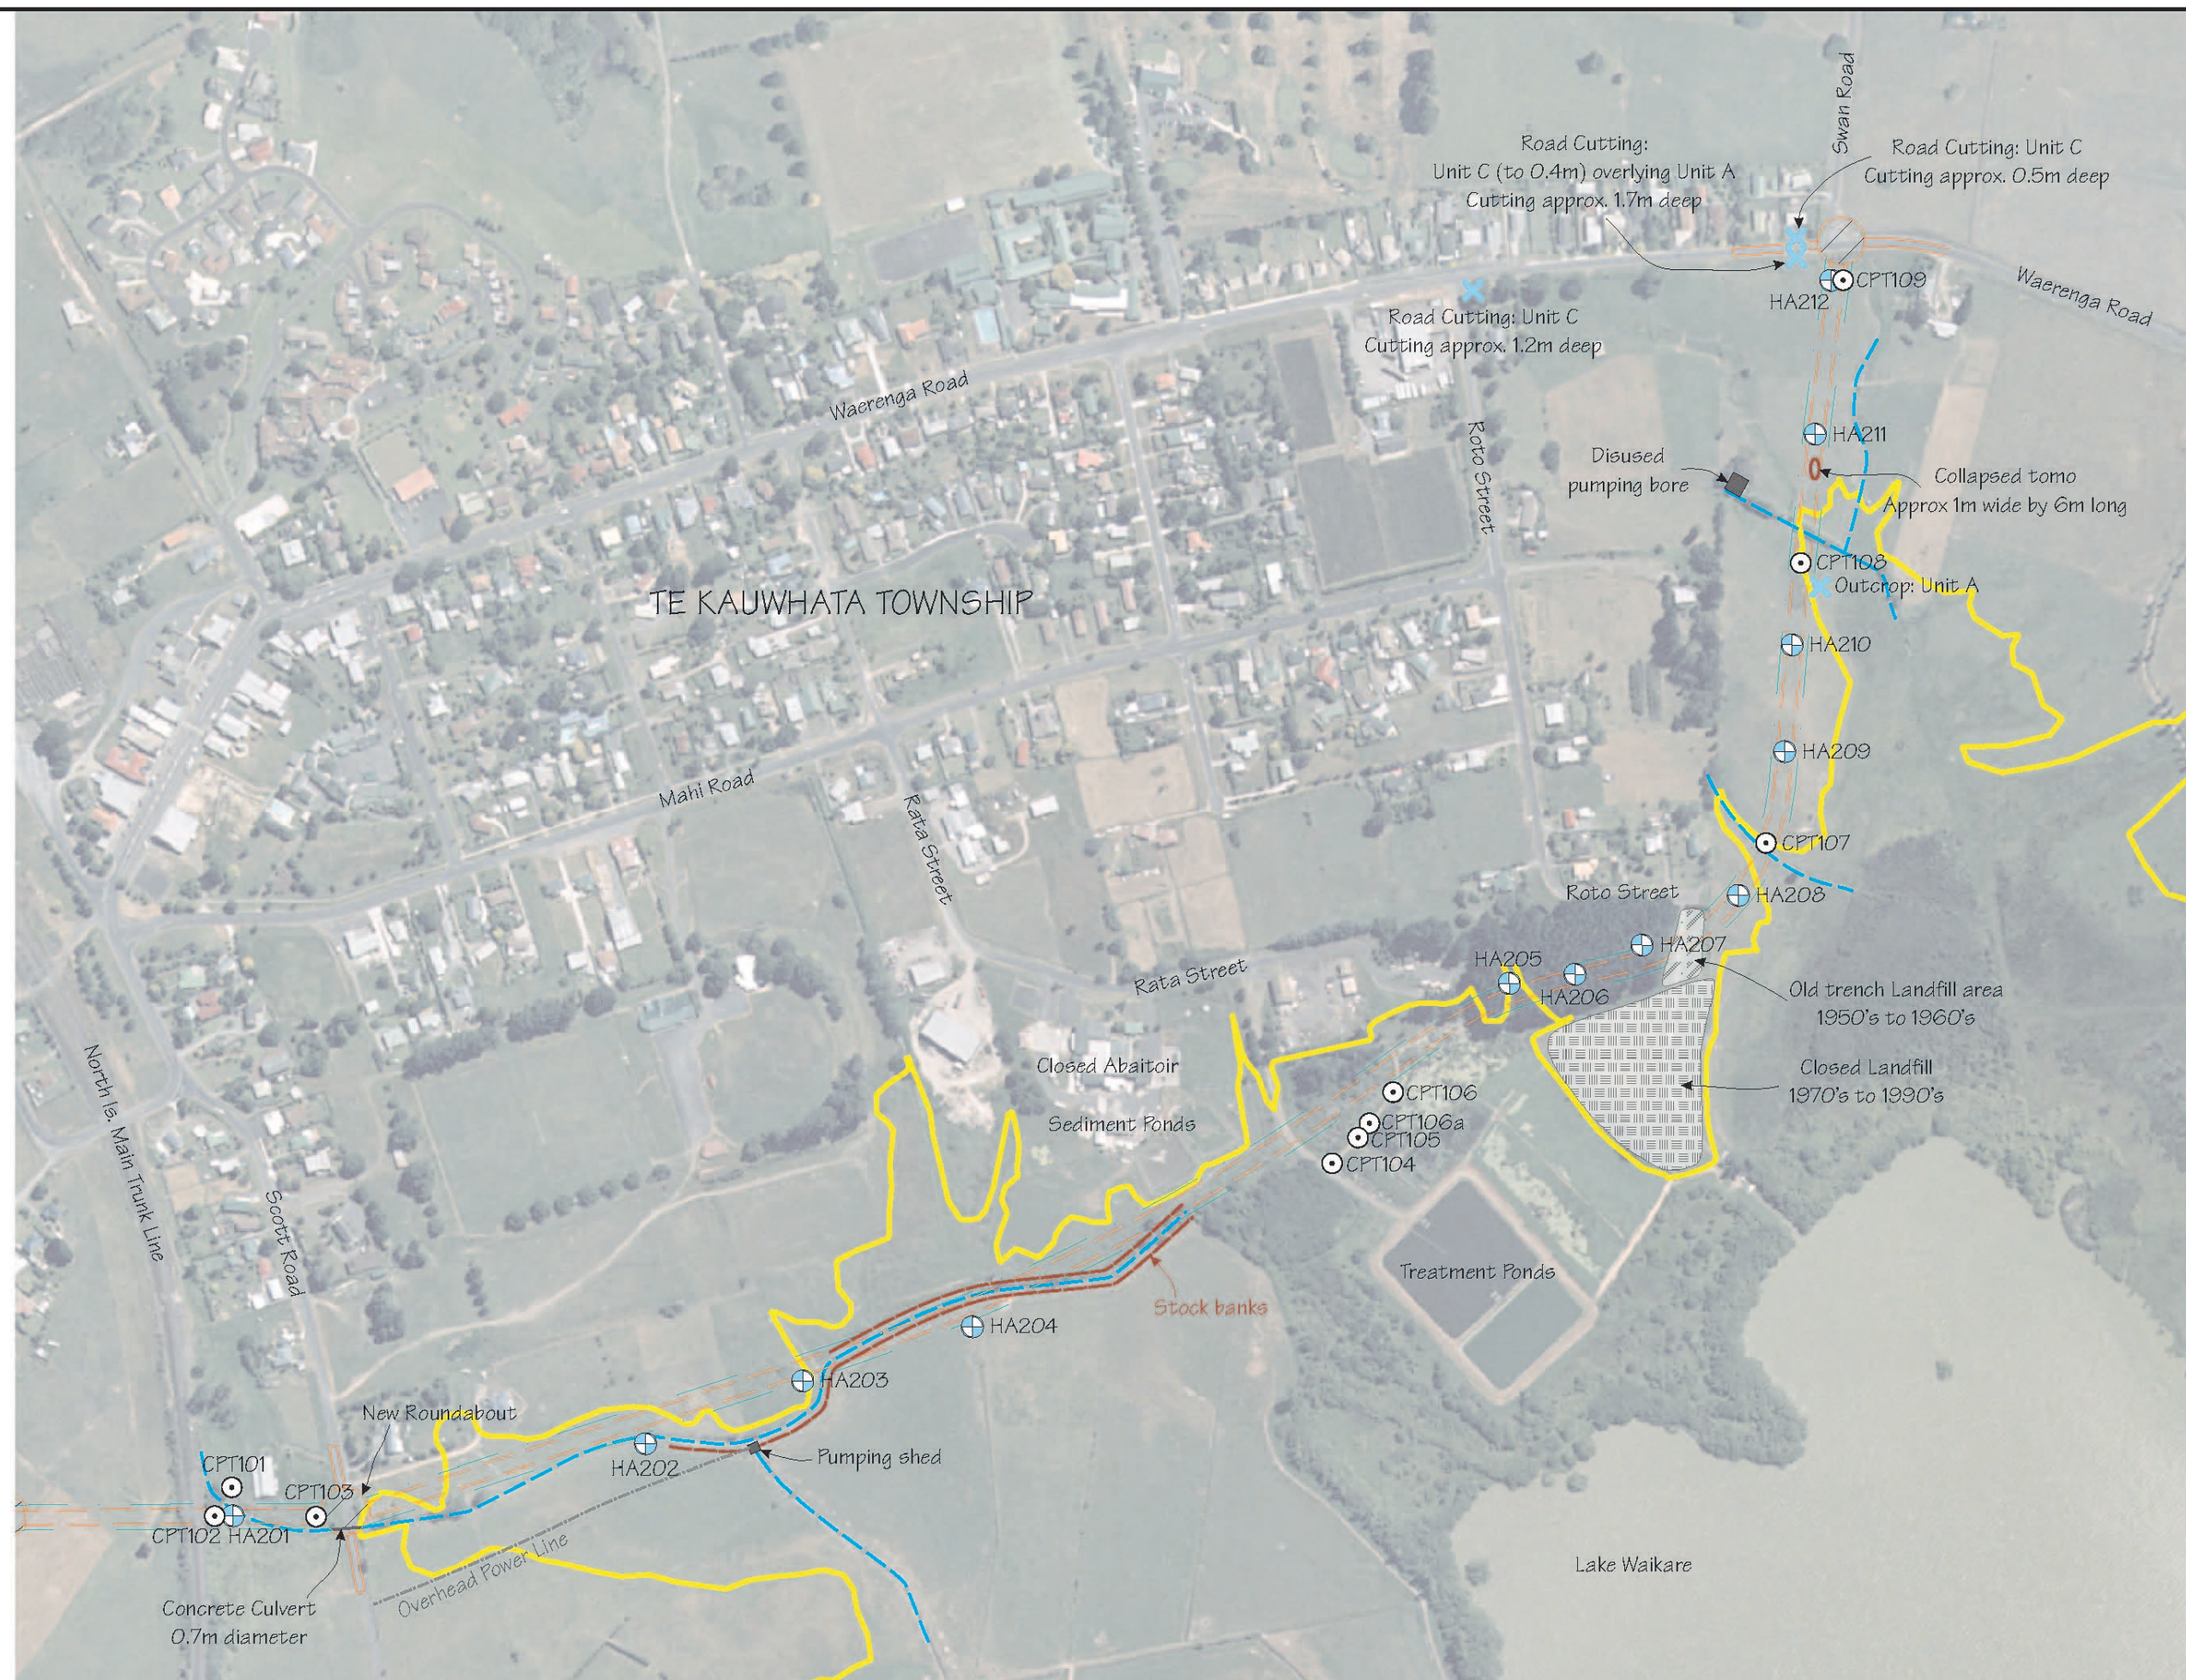
SHEET  
**FIG. 1**  
VERSION **A**  
REF 2760

| FIGURE 1 | TE KAUWHATA HEAVY VEHICLE BYPASS SITE INVESTIGATION<br>PLAN |

Unit A was also observed in an outcrop within 10m of CPT108, and also in road cuttings near the intersection of Waerenga and Swan Roads. Both locations are shown on the site map.
