NGAARUAWAAHIA AND TAUPIRI CPTED ASSESSMENT

Prepared for Waikato City Council

by Beca Ltd (Beca)

28 June 2023

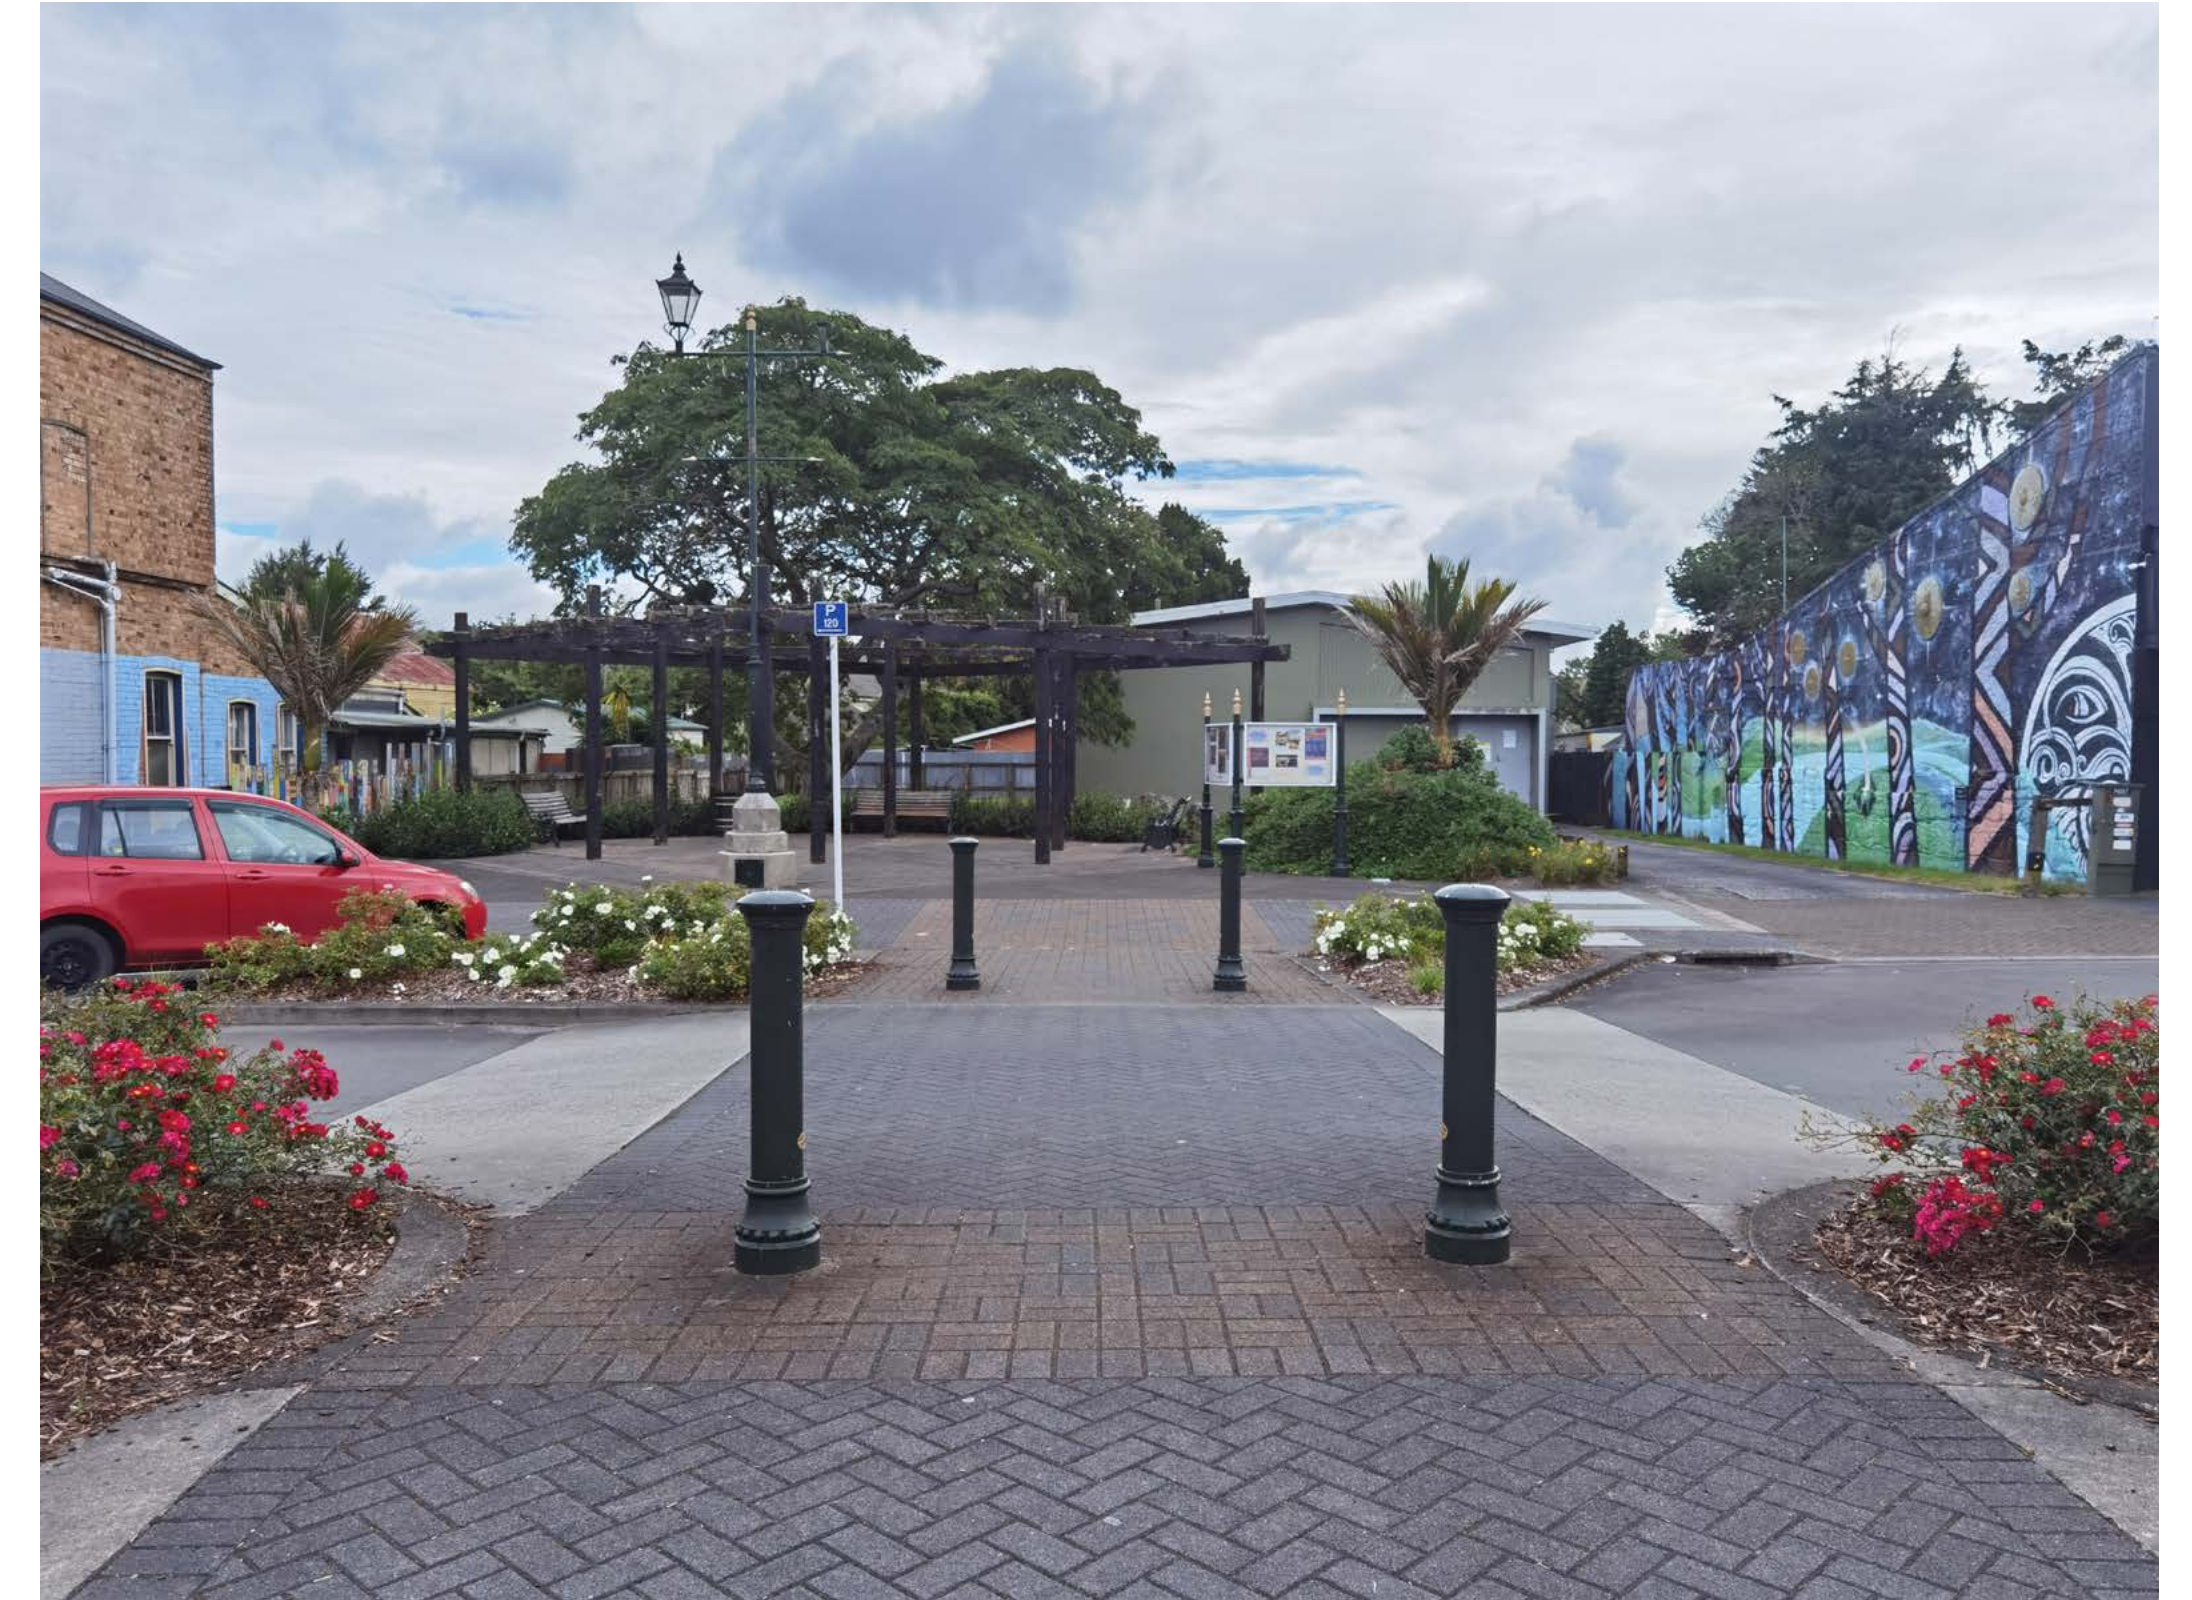
Figure 7. Market area on Jesmond Street

4 Jesmond Road:
 a As a main street there are features that demonstrate a high level of care and maintenance. This includes the quality of the pavers which are a high-cost item and appear to have weathered well, the unified low level and brightly coloured planting along the main street (refer to Figure 7 image on the previous page), quality street furniture (lighting, bins),

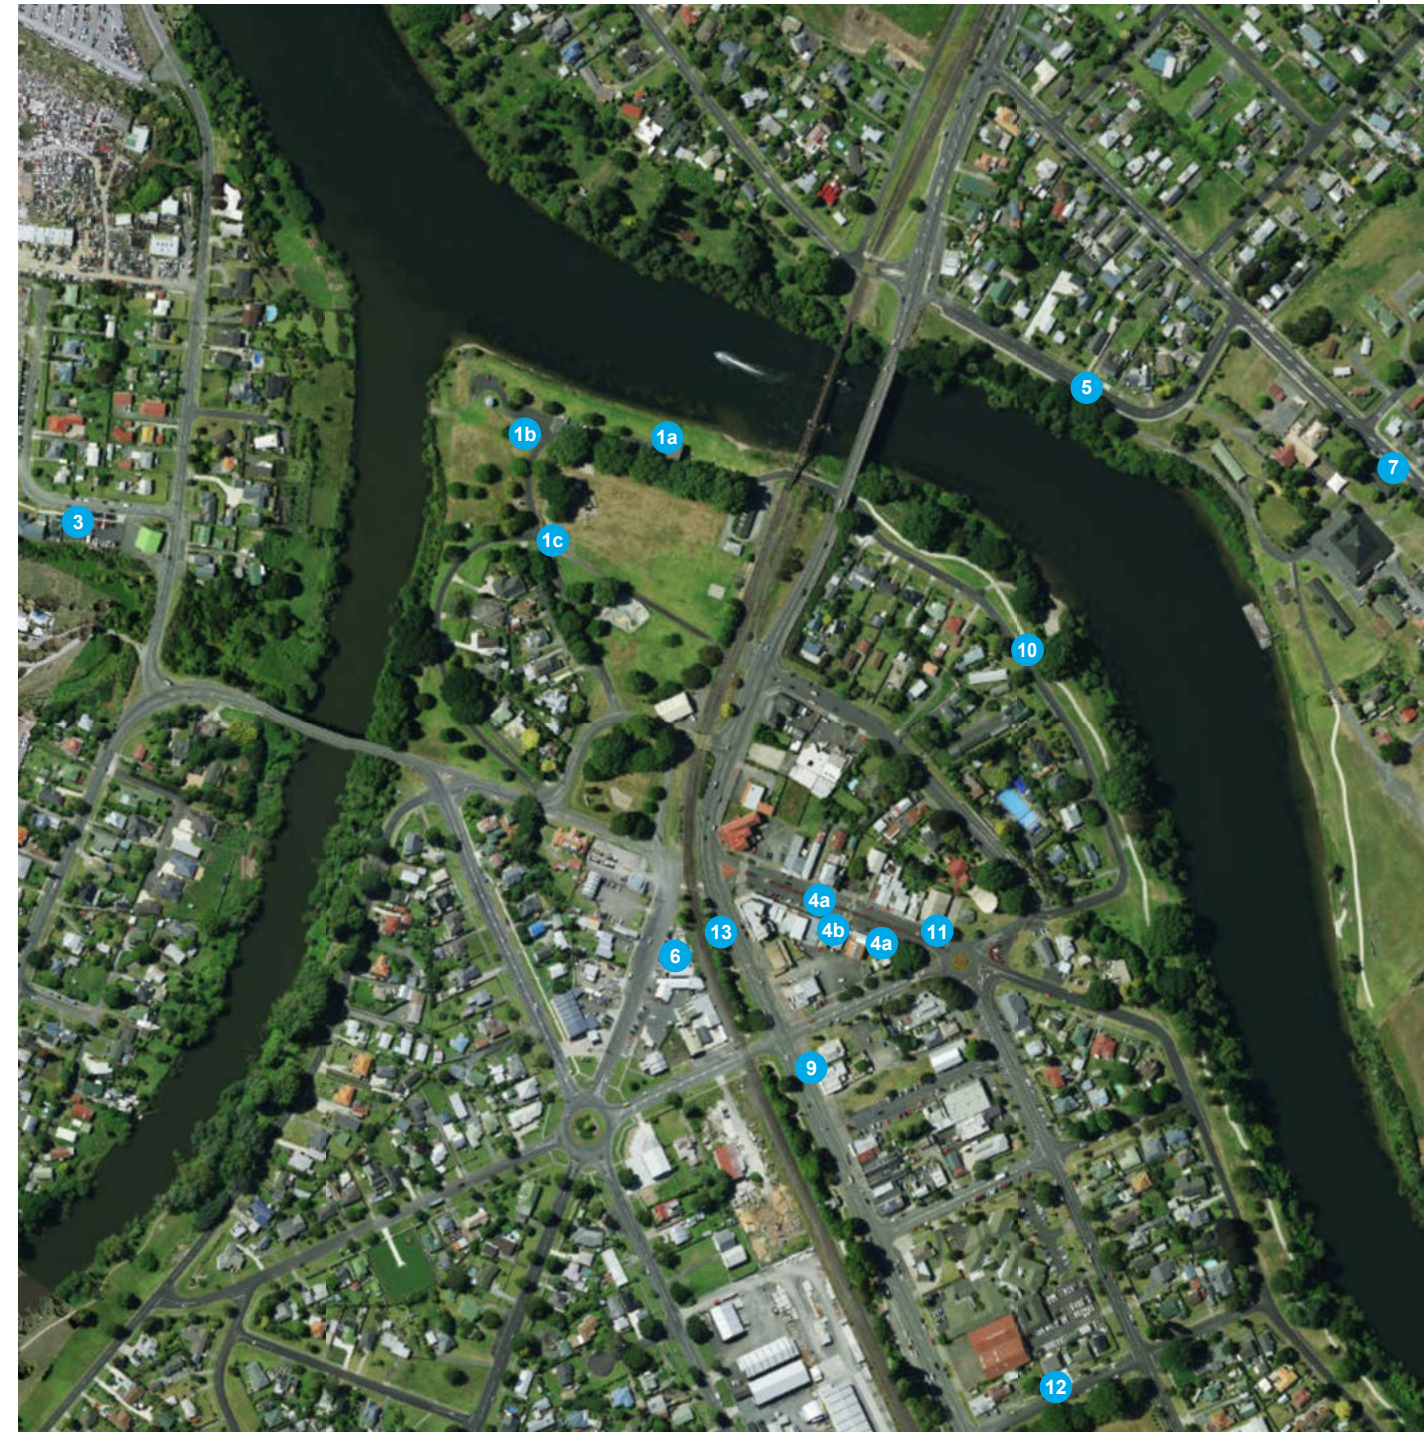
Figure 8. Mapping of positive CPTED features - Ngaaruwaahia

- a The mural on the hall alongside the Waikato River shows little sign of graffiti and is a good strategy for buildings that provide a blank canvas and have little passive surveillance. It is noted that the wall facing the park has been a target of graffiti and has been painted out to a height of approximately 3m. This indicates that this side could be a graffiti target – the only difference being that the western wall is potentially more recent and painted by Graham Hoete.

- b The interpretation panels providing historical context are well located and maintained considering they are over 10 years old. No graffiti was observed on these installations and other locations in the town centre. While general maintenance is required to the facing panels where there has been water ingress, the durable design and materials could be replicated.

- c Landscaping with feature trees being limbed up providing for clear views. This was complimented with lighting located on main access routes. While the luminaires looked to lack maintenance with missing glass panels the lighting was functional at night.

2 Kiingitanga Reserve: Well-lit along Waingaro Road the preferred route. Omission of lighting within the reserve discourages users to take this route at night-time, reducing risks. Some lighting within the Reserve was observed but not working at the time of visit.

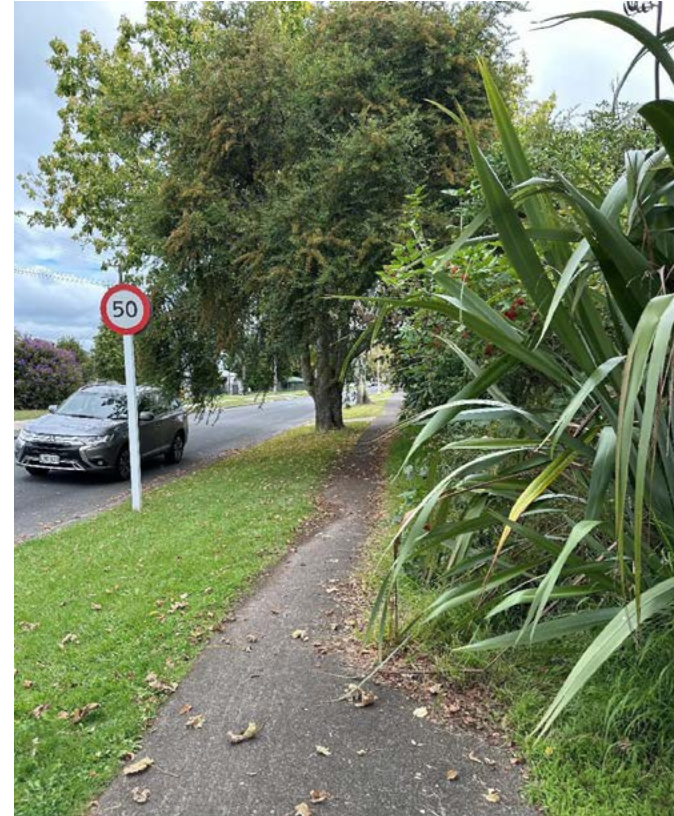
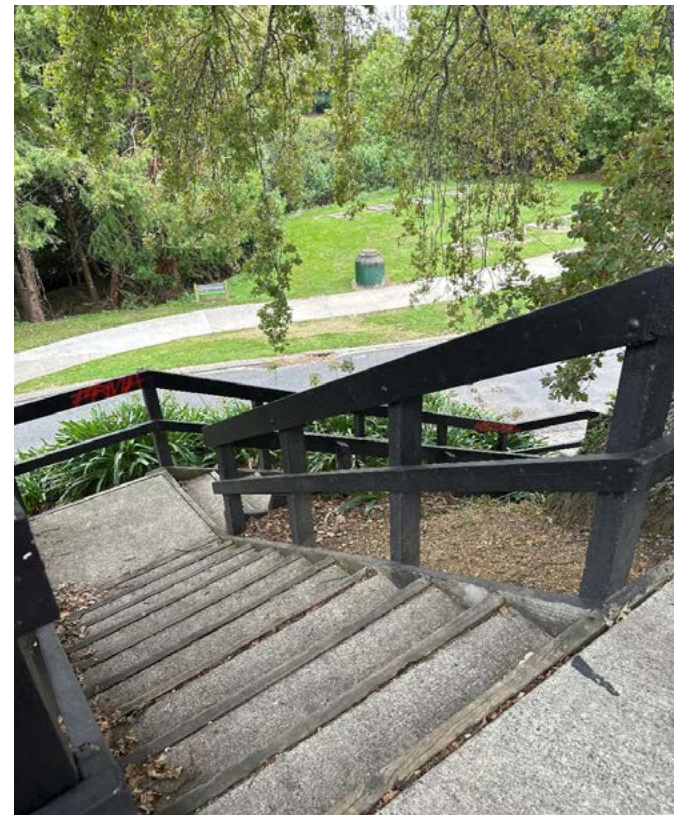
Figure 9. Mapping of CPTED Issues - Ngaaruwaahia

Figure 9 shows the summary of observed issues and contains a photo reference map locating the photos as set out in table form on the following pages and broken down into the following categories:

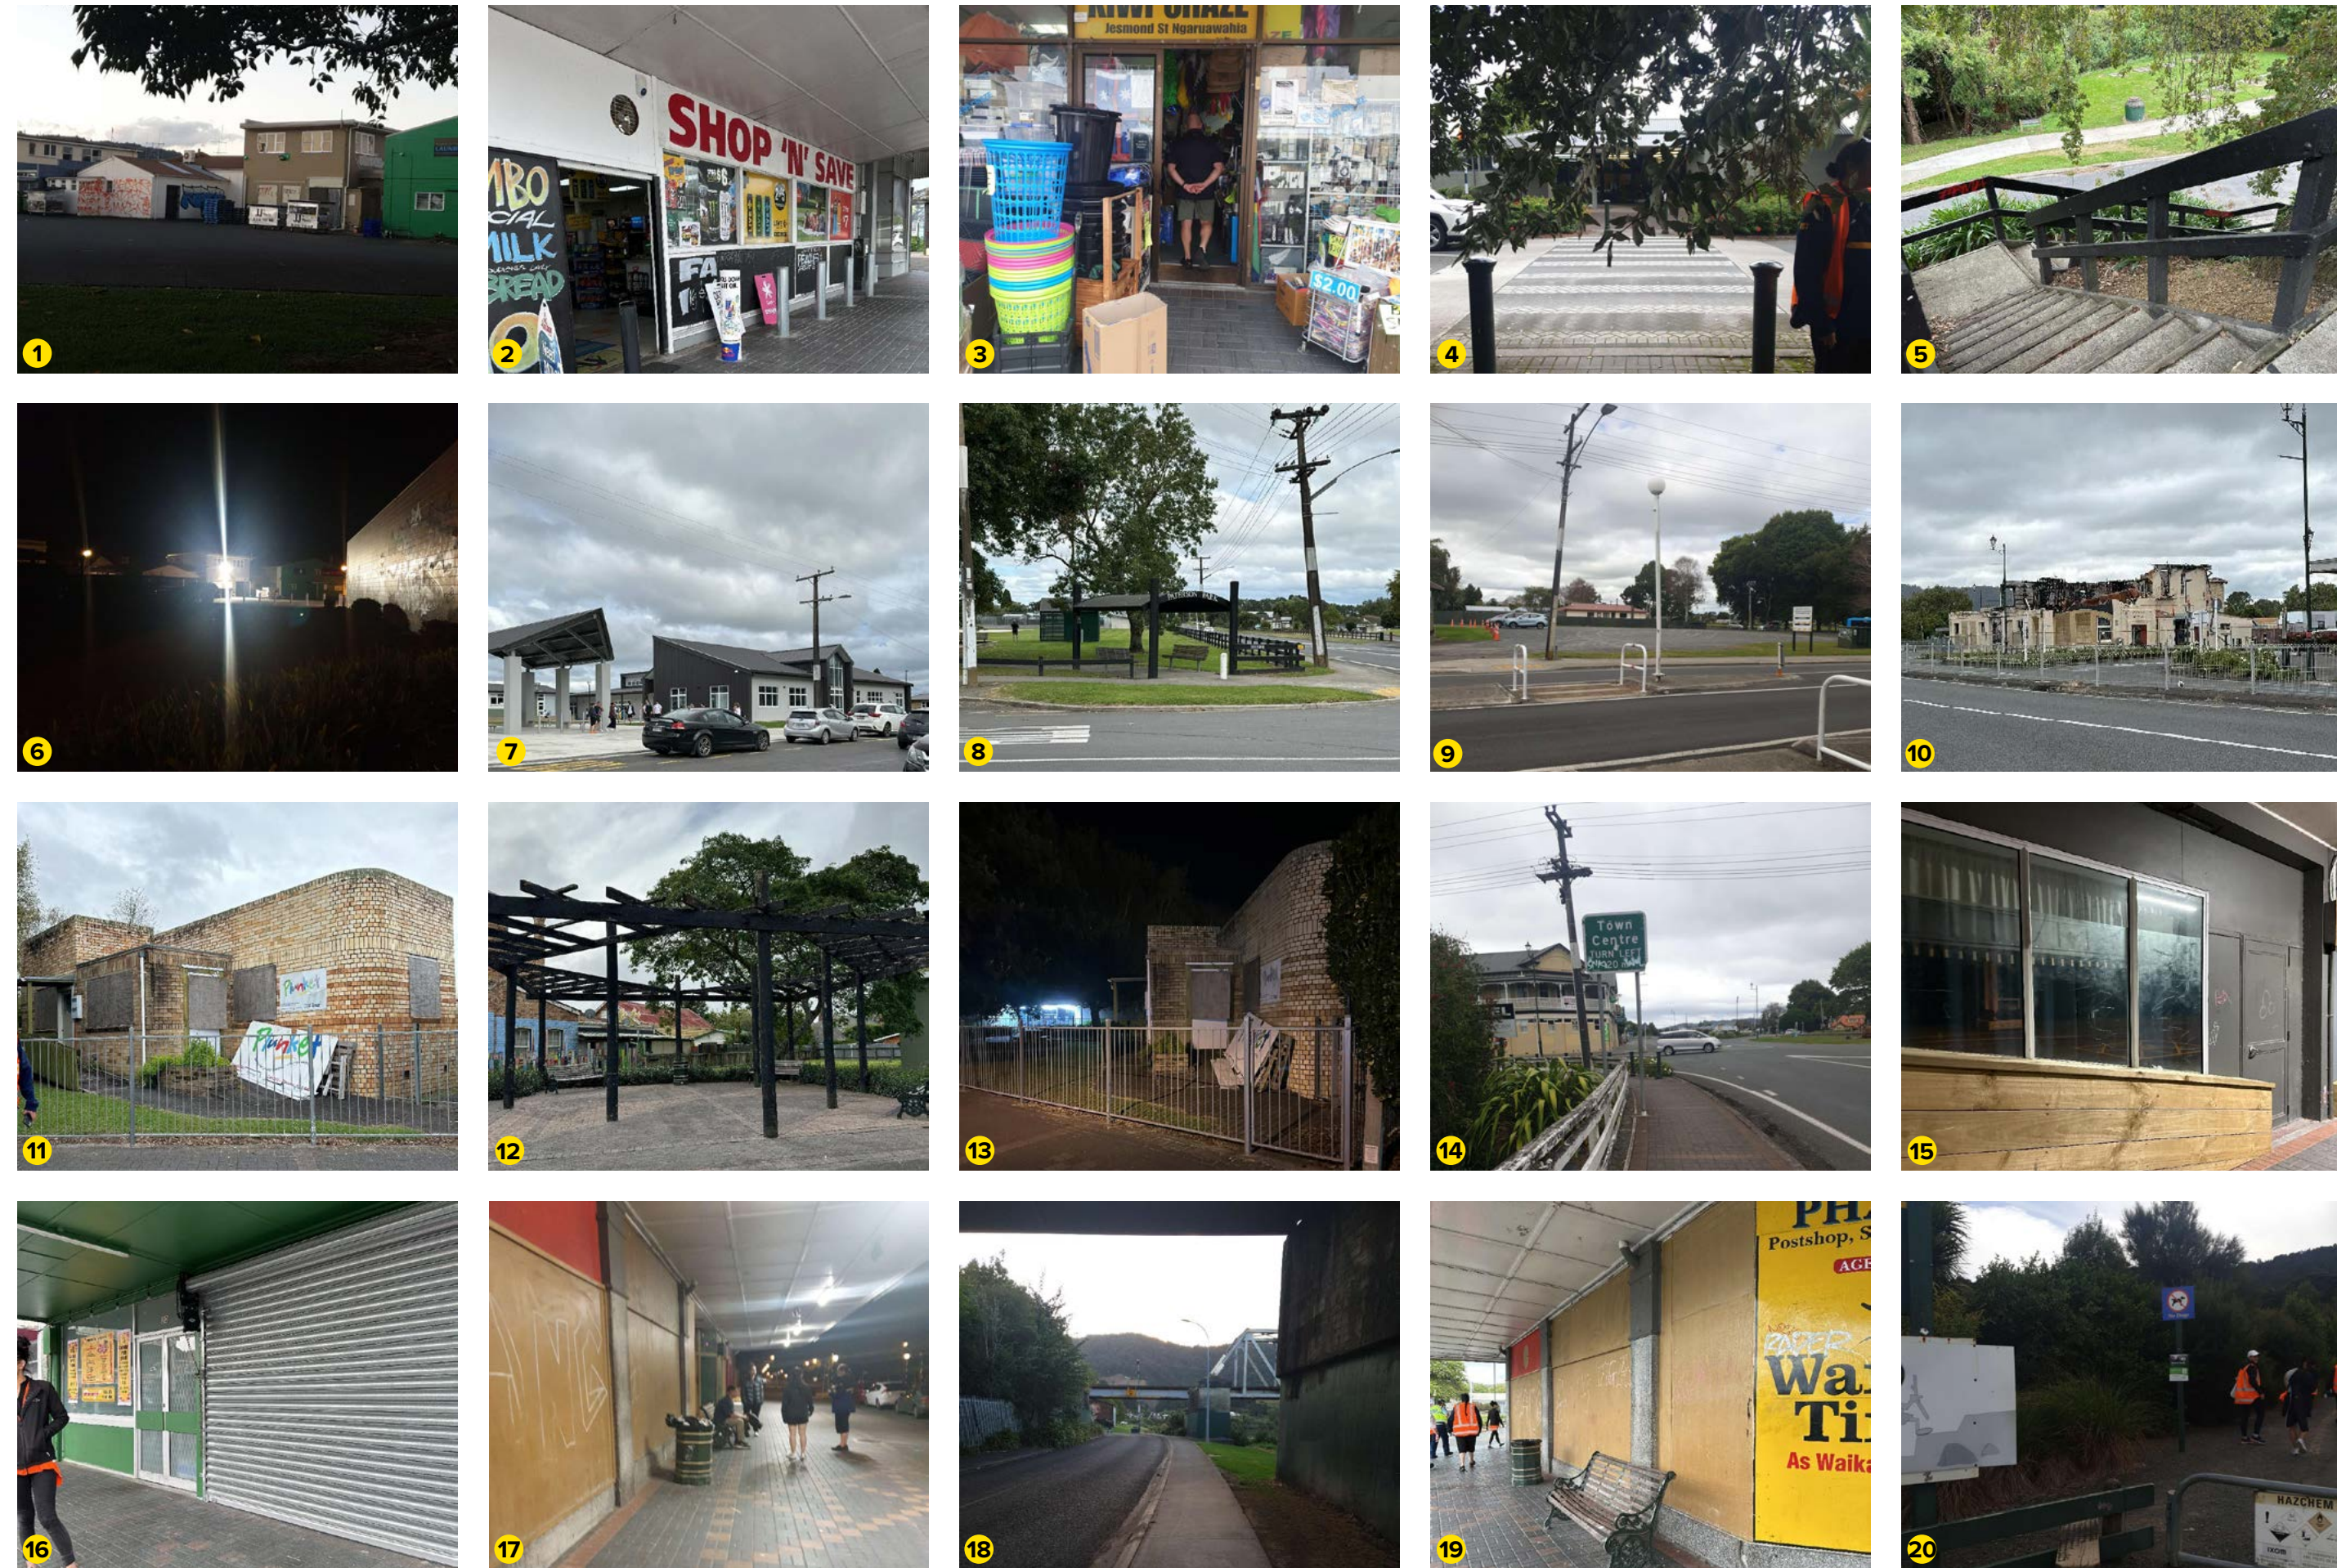
Figure 10. Summary of observed CPTED issues - Ngaaruaahia

ISSUE	LOCATION & PHOTOGRAPH REFERENCE	BEST PRACTICE RESPONSE	PRIORITY
<p>Natural ladders</p> <p>There are natural ladders behind Great South Road - owners to evaluate if this is an issue for access onto rooves etc. The bins can also be a place for people to hide behind at night.</p>

<p>Precedent Image: Hurstmere, Takapuna Auckland</p>	<p>EXTREMELY HIGH</p>
<p>Passive surveillance</p> <p>Shops have posters and screens obstructing views on Jesmond St.</p>

<p>Removal of posters to open sightlines into the shops and provide eyes onto the street.</p> <p>Any roller doors on Great South Rd – suggest could paint in consistent design</p>

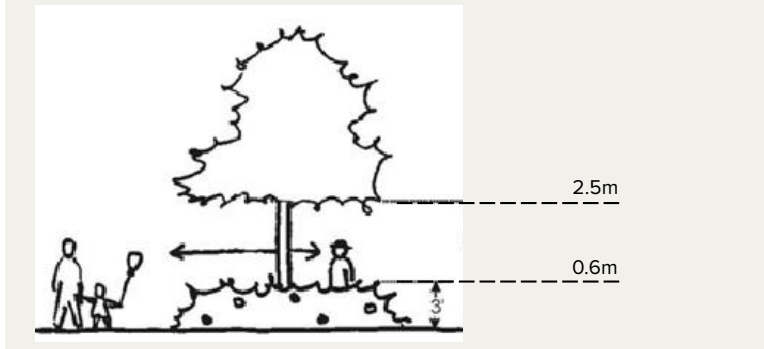
<p>EXTREMELY HIGH</p>
<p>Lighting</p> <p>The space between the buildings along Great South Road has dark unlit areas which leads to a varying pedestrian experience (well lit to no lighting in the gaps). Pedestrian paths alongside the rail line on Great South Road are well lit but obscured by the tree canopy with resulting patchy lighting.</p> <p>Along the rail line and in front of Ngaaruwaahia High School there is no lighting.</p>

<p>Trees (in all areas) should be canopy-lifted, allowing sight lines to be maintained. Trimming of trees surrounding to open sight lines.</p> <p>CPTED best practice stipulates a vegetative clearance between 0.6m to 2.5m (refer diagram below).</p> <p>Trim lower limbs of trees to provide a clear trunk and improve visual connection.</p>

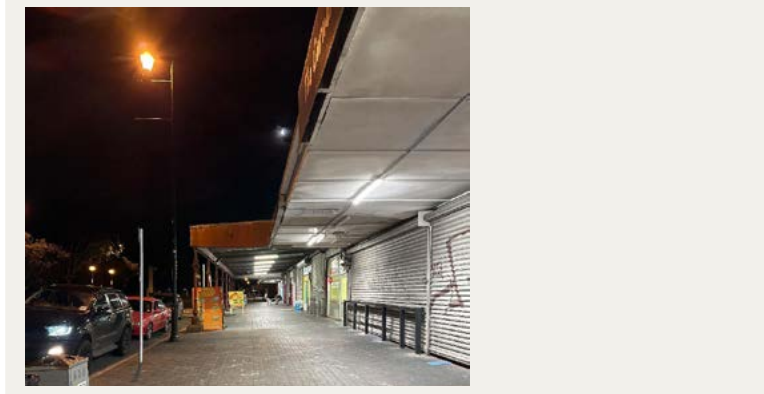
<p>Legibility through wayfinding</p> <p>Lack of signage to connect the town centre to Te Awa Cycle Trail, along the Waikato River edge, bridge and to the Hakarimata Ranges walkway.</p>

<p>Conduct a review of the lighting (on the night of the walkover lights were being replaced) and an arborist review to determine where trees are blocking lighting at ground level.</p> <p>Along the canopies of Great South Road and Jesmond Road shops lighting is effective with no obstruction.</p>

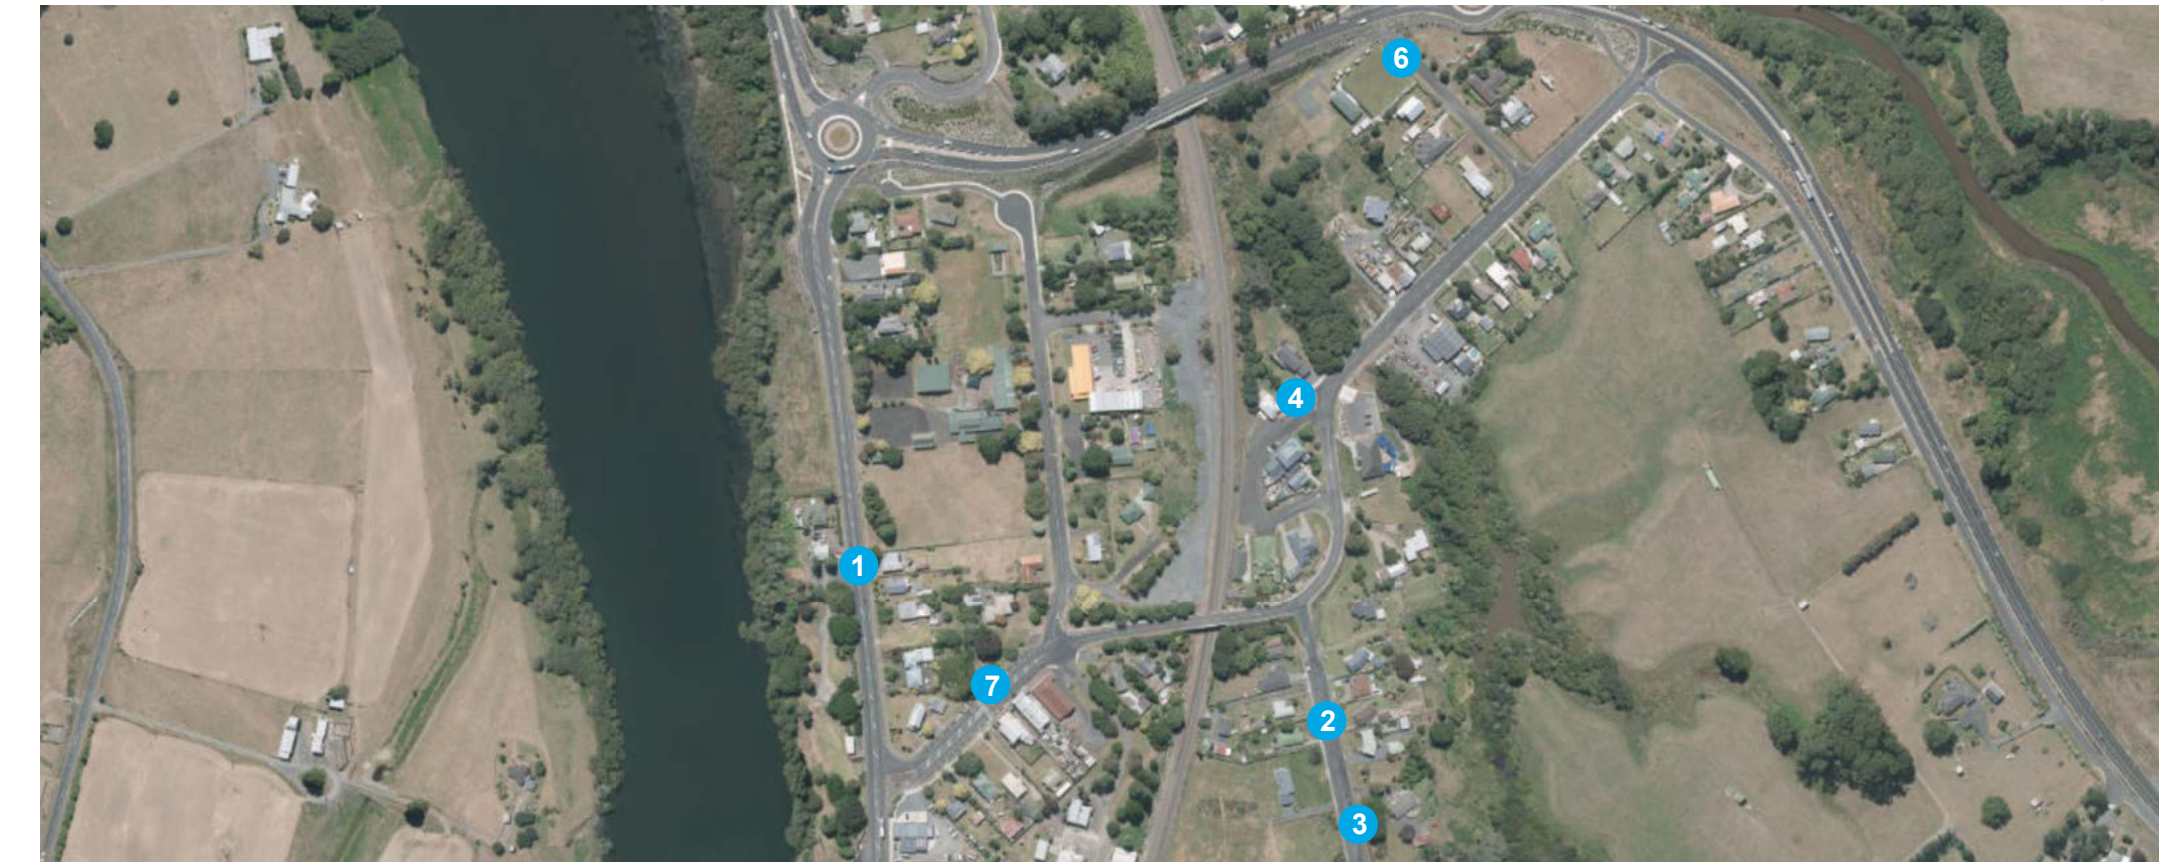
Figure 12. Mapping of positive CPTED features - Taupiri

- 1 Great South Road: Well-maintained hedges and fences with a high level of passive surveillance onto the street.
- 2 Residential streets: The open street frontage and permeable or low fencing supports a community feel with streets observed by residents.

- 6 Community areas - well looked after i.e., Taupiri Bowling Club and sports facilities indicating a high level of community pride and ownership in Taupiri.

- 7 Focus area near the hall and the superette – an opportunity for land use to agglomerate around this area to include health, and other community uses.

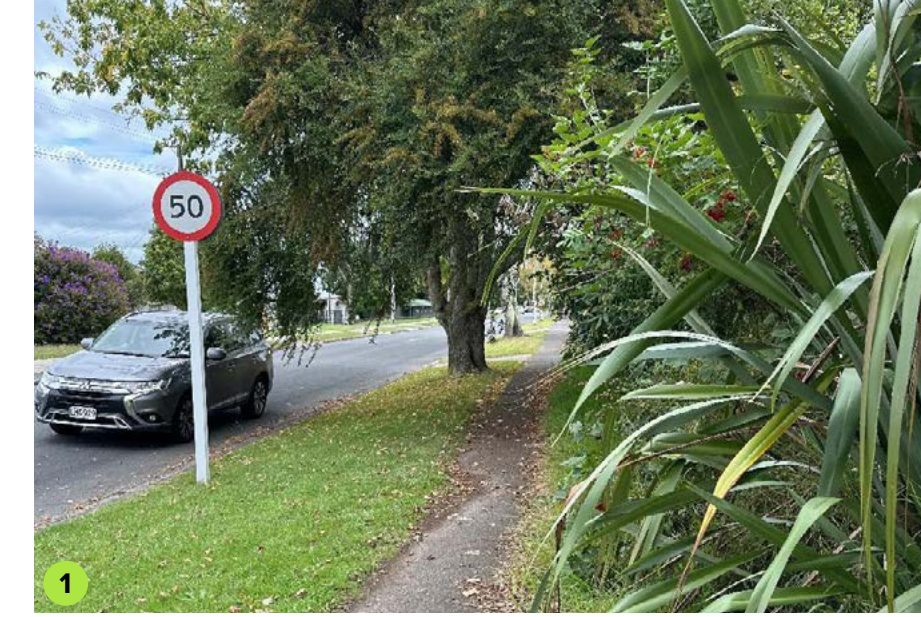
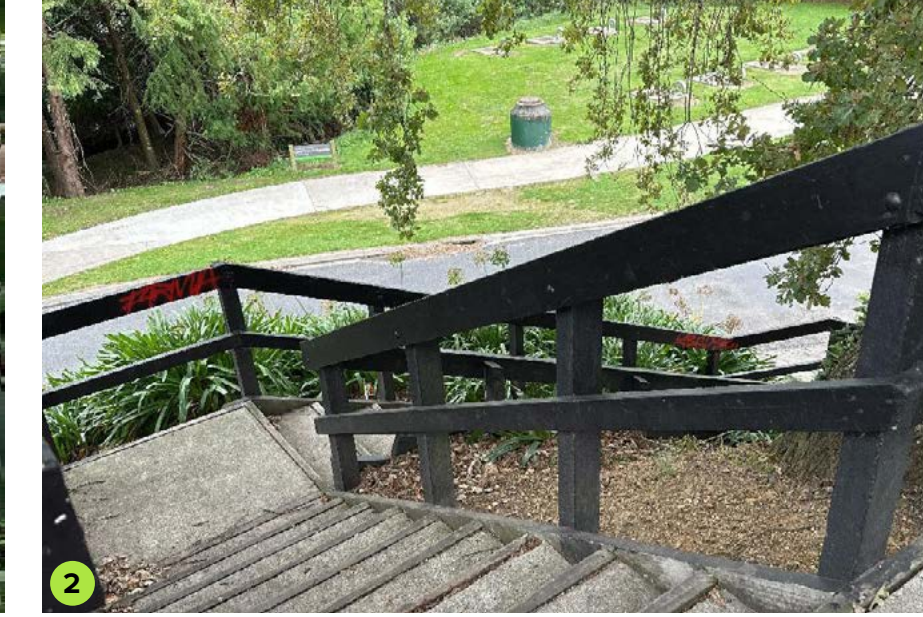
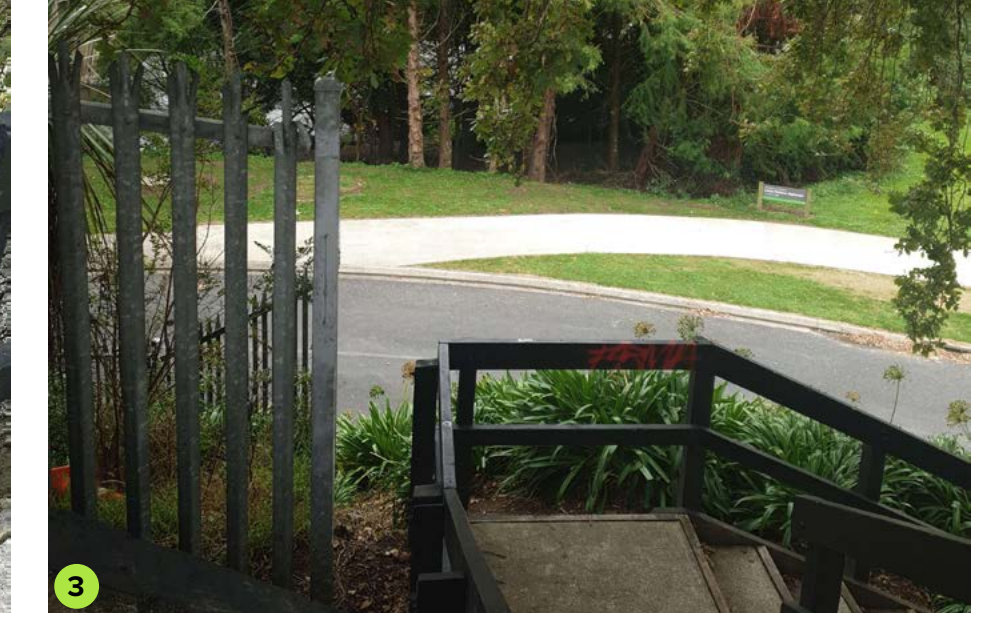
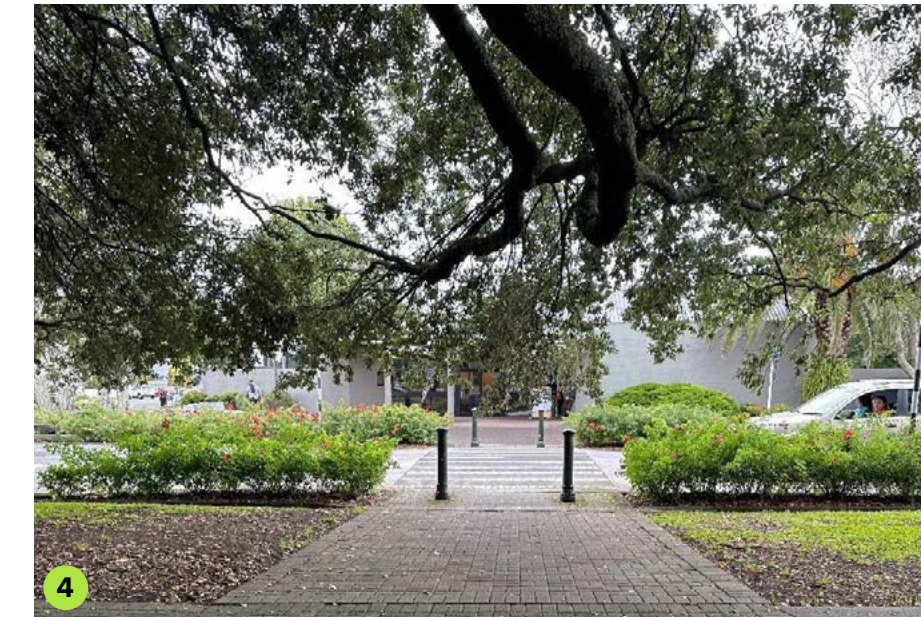
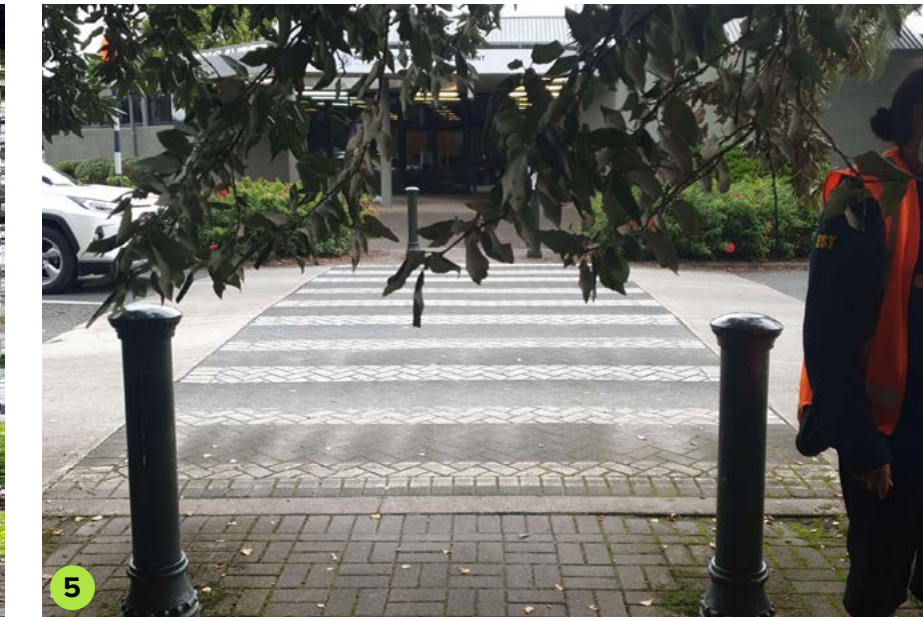
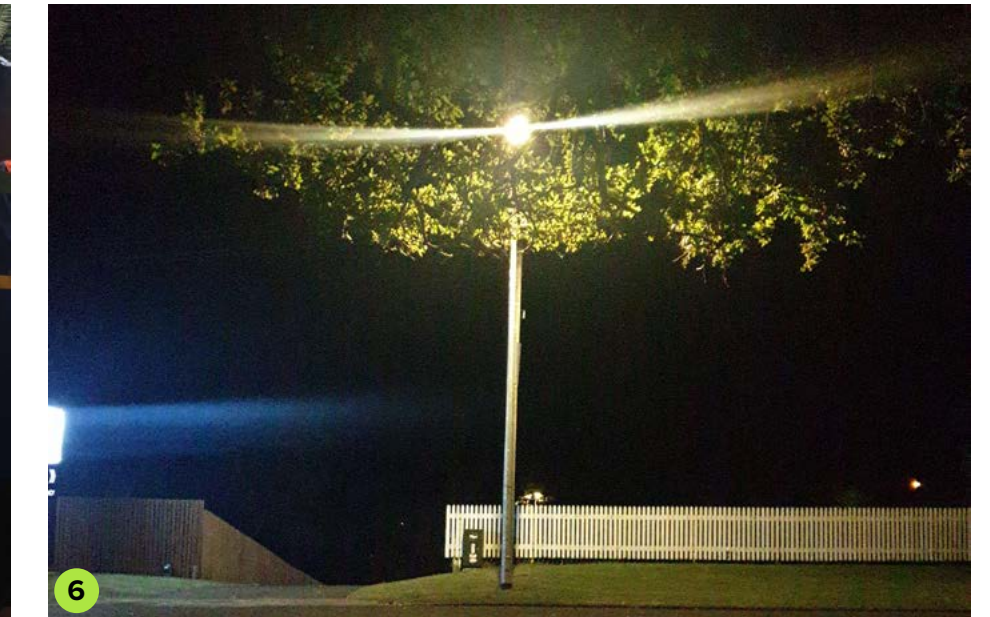
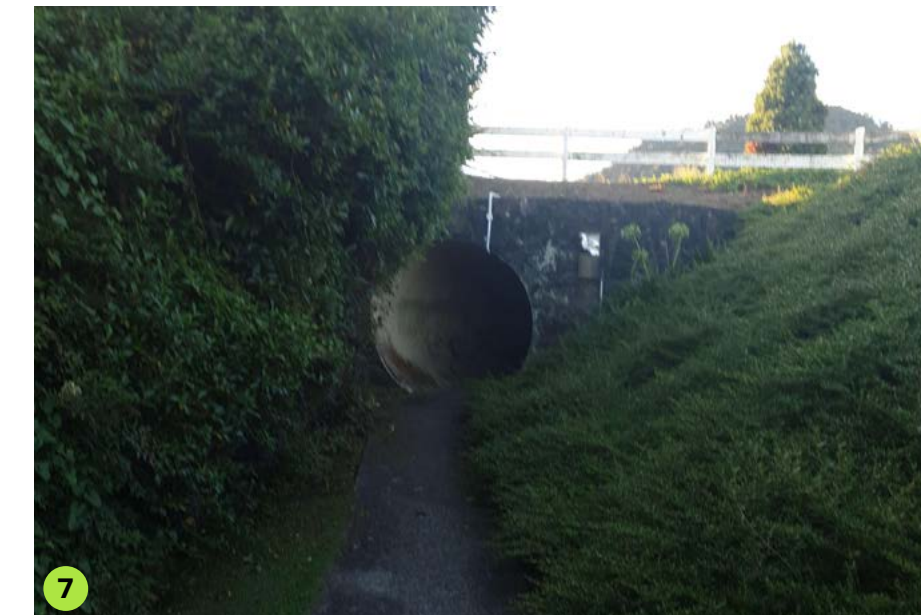
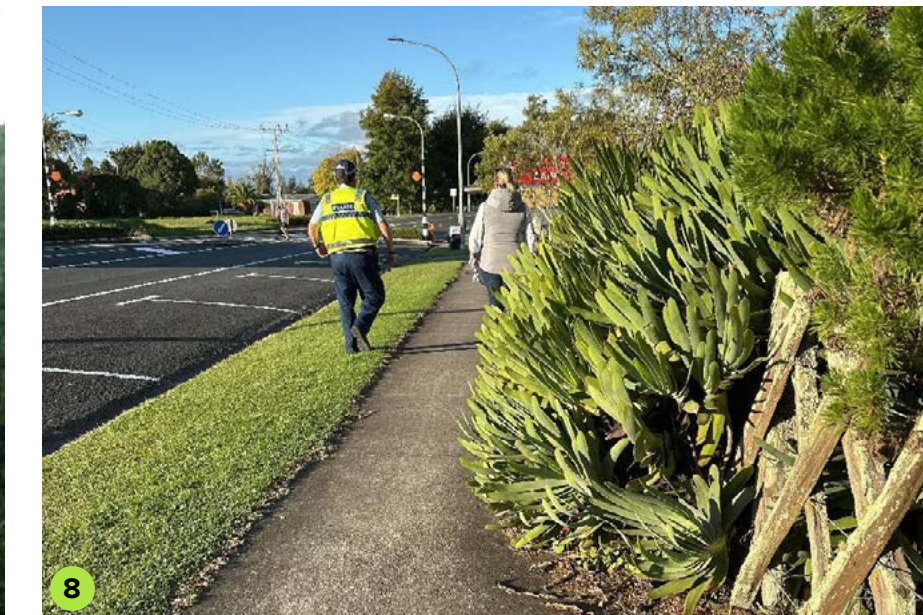
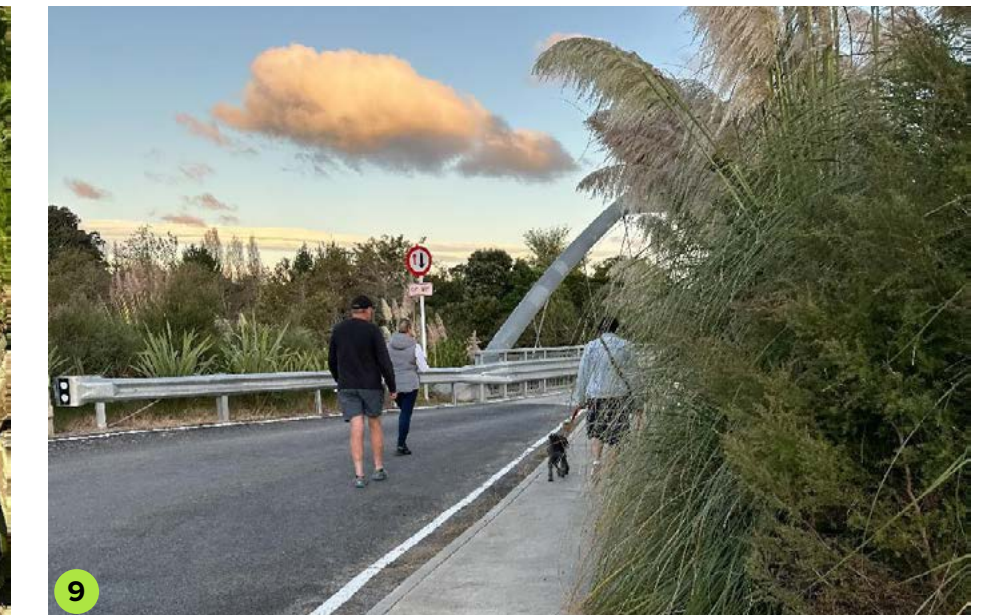
It is recommended to trim vegetation over footpaths and tree canopies as well as that which obscures lighting. This should be included in the maintenance regime to ensure views are not impeded and maximise passive surveillance and safety. Prioritisation should be at higher pedestrian movement areas - The Point, riverside, bridge, Jesmond Street, Great South Road, Market Street, High School, and Turangawaewae Marae.
