## Port Waikato Landslide Assessments

**Prepared for**  
Waikato District Council

**Prepared by**  
Tonkin & Taylor Ltd

**Date**  
June 2023

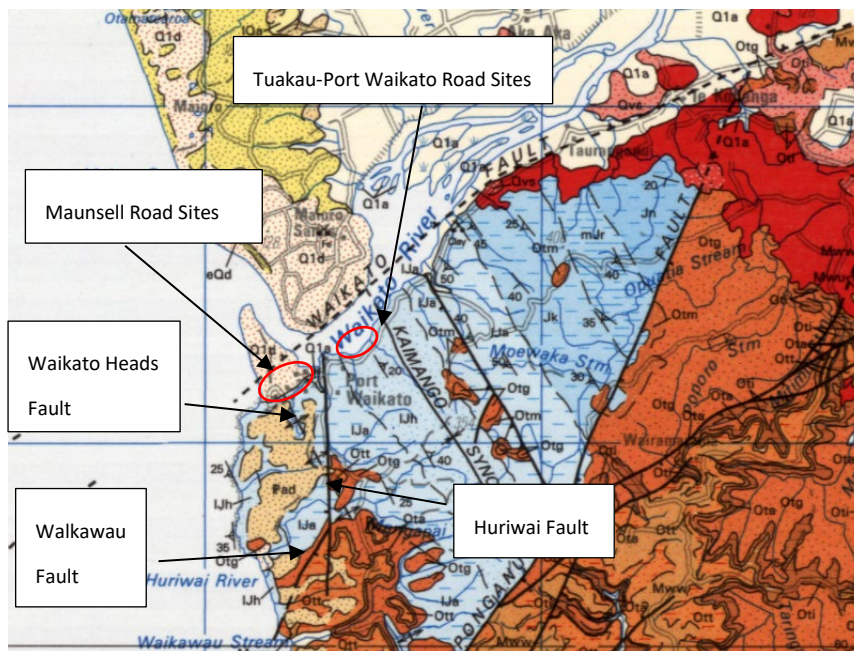
Figure 2.1: Published geological map

Both sites sit within a geological complex system of faulted stratigraphy, which has been subject to structural deformation in the past. The site lies to the south-west of the Kaimango Syncline and several fault lines. The fault lines are presented on the geological map below but the ones closest to the site are the Waikato Fault, the Waikato Heads Fault, the Huriwai Fault, and the Walkawau Fault. These are all considered inactive as no active faults are mapped within this area based on the New Zealand Active Faults Database<sup>3</sup>.

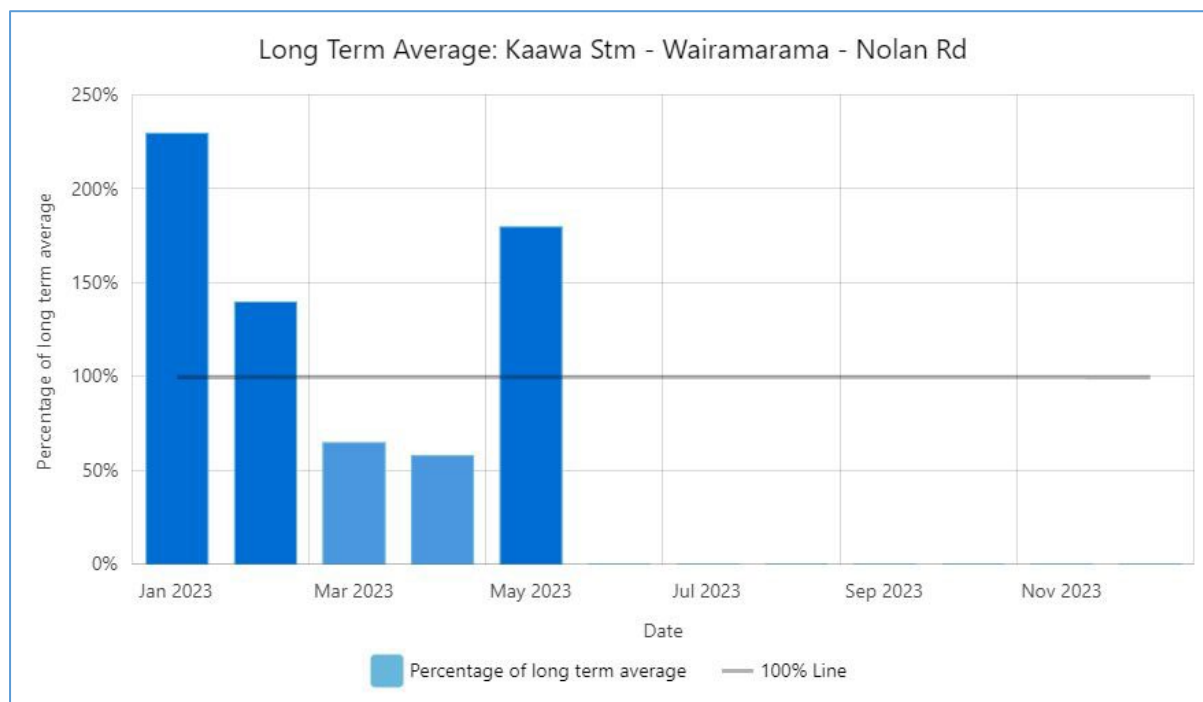
Figure 2.4: Long term average rainfall compared to rainfall during 2023

Figure 2.4 indicates that during January 2023 there was over 200% of the long-term average rainfall, with most of this rain coming towards the end of the month. The ground would have therefore been heavily pre-soaked prior to the Cyclone.

It is worth noting that rainfall in May was also significant (Figure 2.4 and Figure 2.5), where total rainfall over a 24-hour period exceeded the 26 January and Cyclone Gabrielle events with nearly 60 mm of rain depth in one day. No further landslides were noted to have occurred during this month.

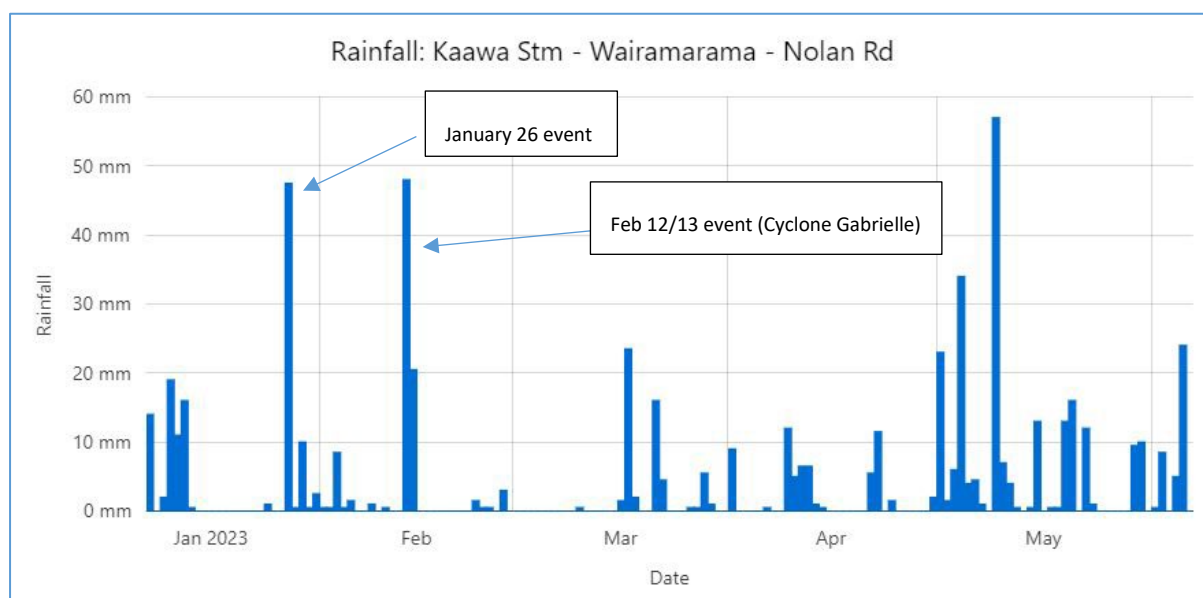
Figure 2.5: Daily rainfall totals during 2023

Figure 2.5 affirms the above conclusions with nearly 50 mm of rainfall occurring during the January 26 event and an additional 60 to 70 mm during Cyclone Gabrielle.

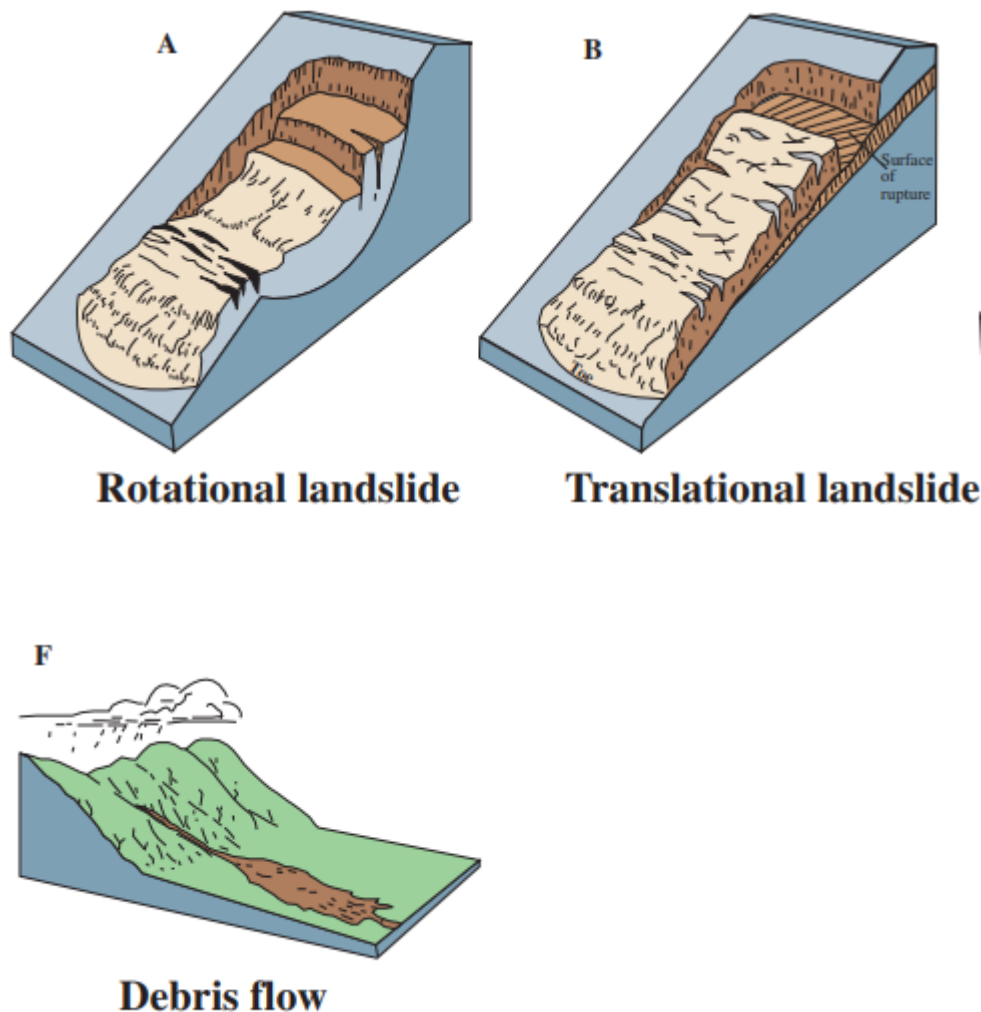
Figure 3.1: USGS Landslide failure modes<sup>6</sup>

- The landslides observed were indicative of shallow rotational failures, debris flows, and translational landslides. Failure surfaces mostly occurred at the interface between the soil veneer or extremely weathered bedrock and the more competent underlying bedrock. Schematic diagrams of the above failure mechanisms are presented in Figure 3.1.
