### Gleeson Quarries Ltd

# Huntly Quarry Disposal Sites – Geotechnical Assessment

Revision C Report Prepared By Gaia Engineers, 5 Carmont Place, Mt Wellington, Auckland 1060, New Zealand

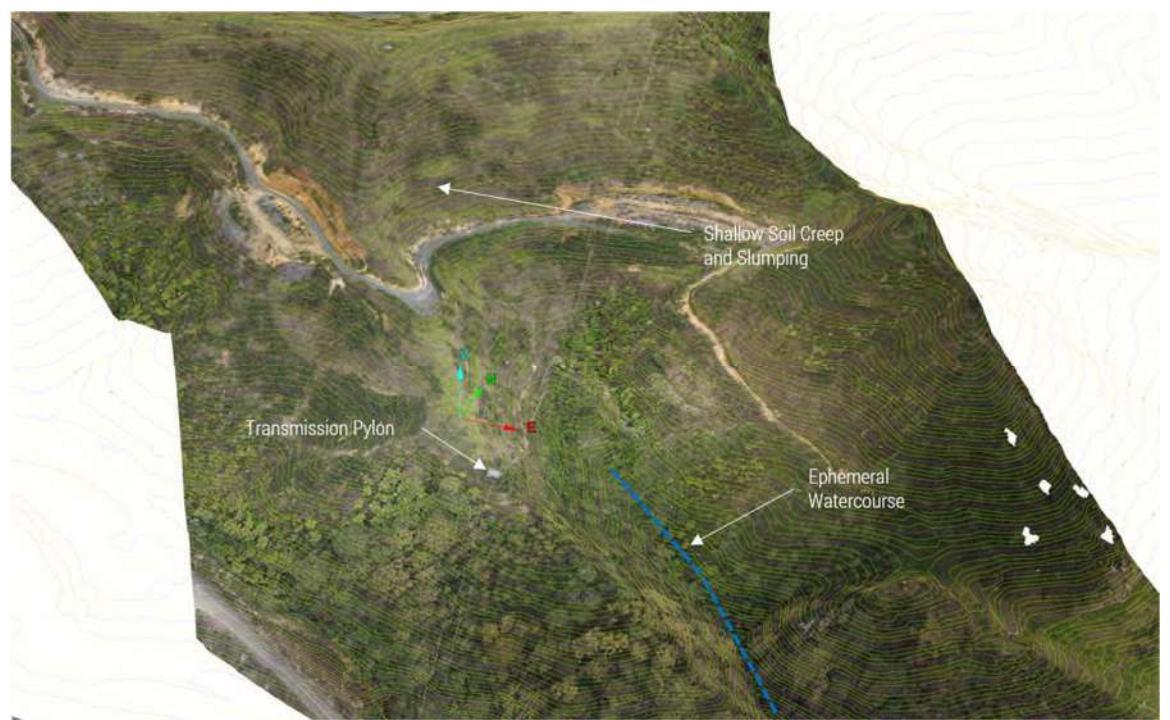
Figure 4: Oblique Image looking North at Fill Site 5 Showing Topographic Features

Electricity transmission pylons are present at the southern end and northern ends of the gully with the transmission lines crossing the gully head near the centre.

The broader ridge area present at the northern end of the Fill 5 Valley exhibits shallow slumping and relatively large creep terracettes. These features are characteristic of the comparatively weak underlying young ash derived soils. Seasonal wetting and drying of these soils cause the soils to creep downslope. At the boundary between the younger soils and the weathered Newcastle Group Greywacke the valley becomes noticeably narrower and steeper. The shape of the valley within this material is more controlled by erosion of the weathered soils and is less affected by slumping and the soil creep depth is much shallower.

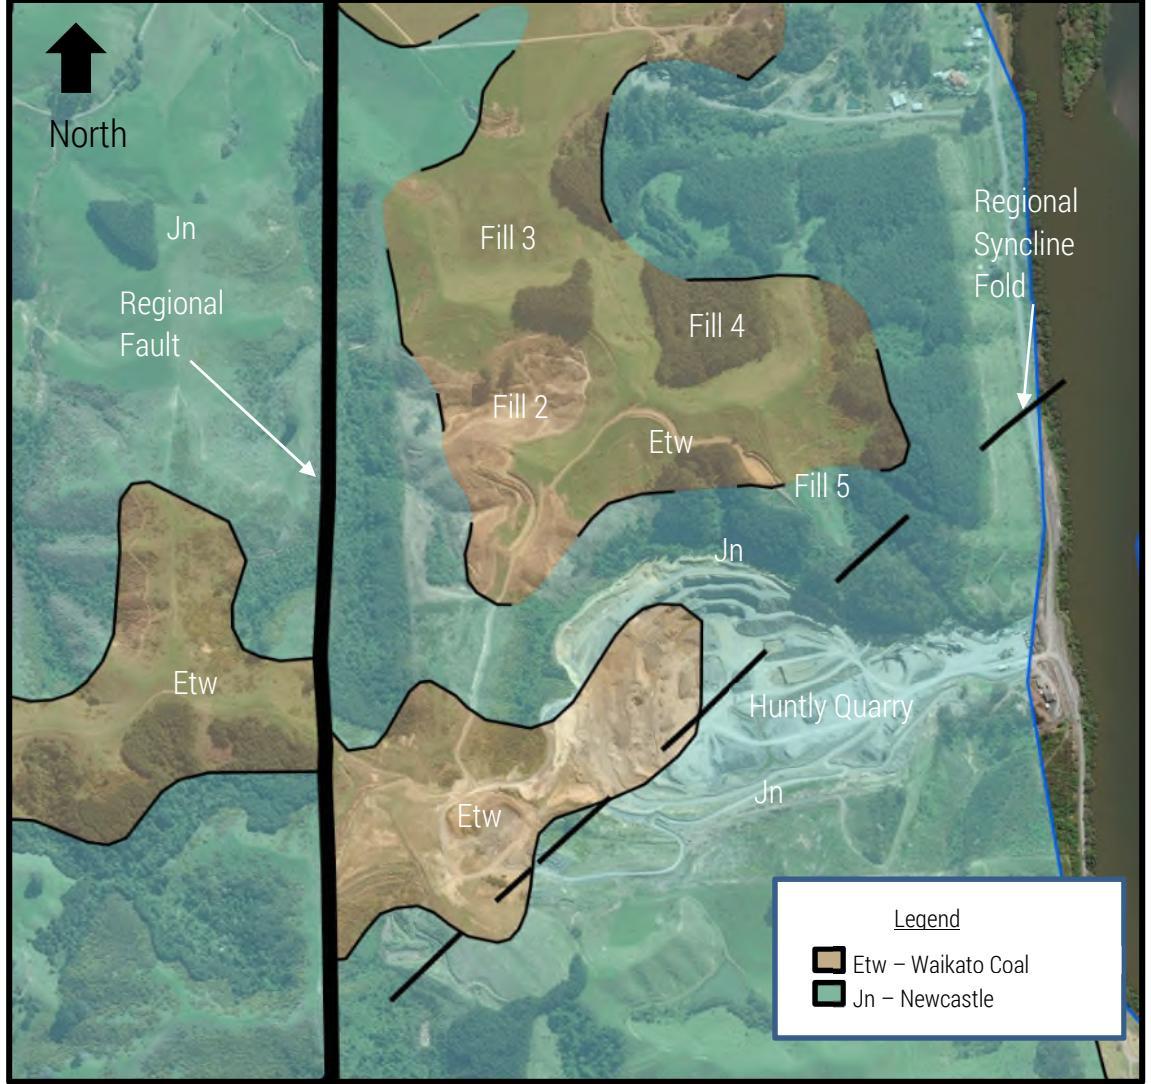
Figure 5: Published Geological Map of the Huntly Quarry and Fill Sites. *Modified from GNS Science Web Map Service Under Creative Commons Licence*

An annotated geological map from the GNS Science New Zealand Geology Web Map is presented below:

The following geological units have been observed or inferred within the project area:
