# AMBURY PROPERTIES

# PROPOSED PLAN CHANGE 231 TAHUNA ROAD, OHINEWAI

# GEOTECHNICAL ASSESSMENT REPORT

INITIA REF P-000529 REV A

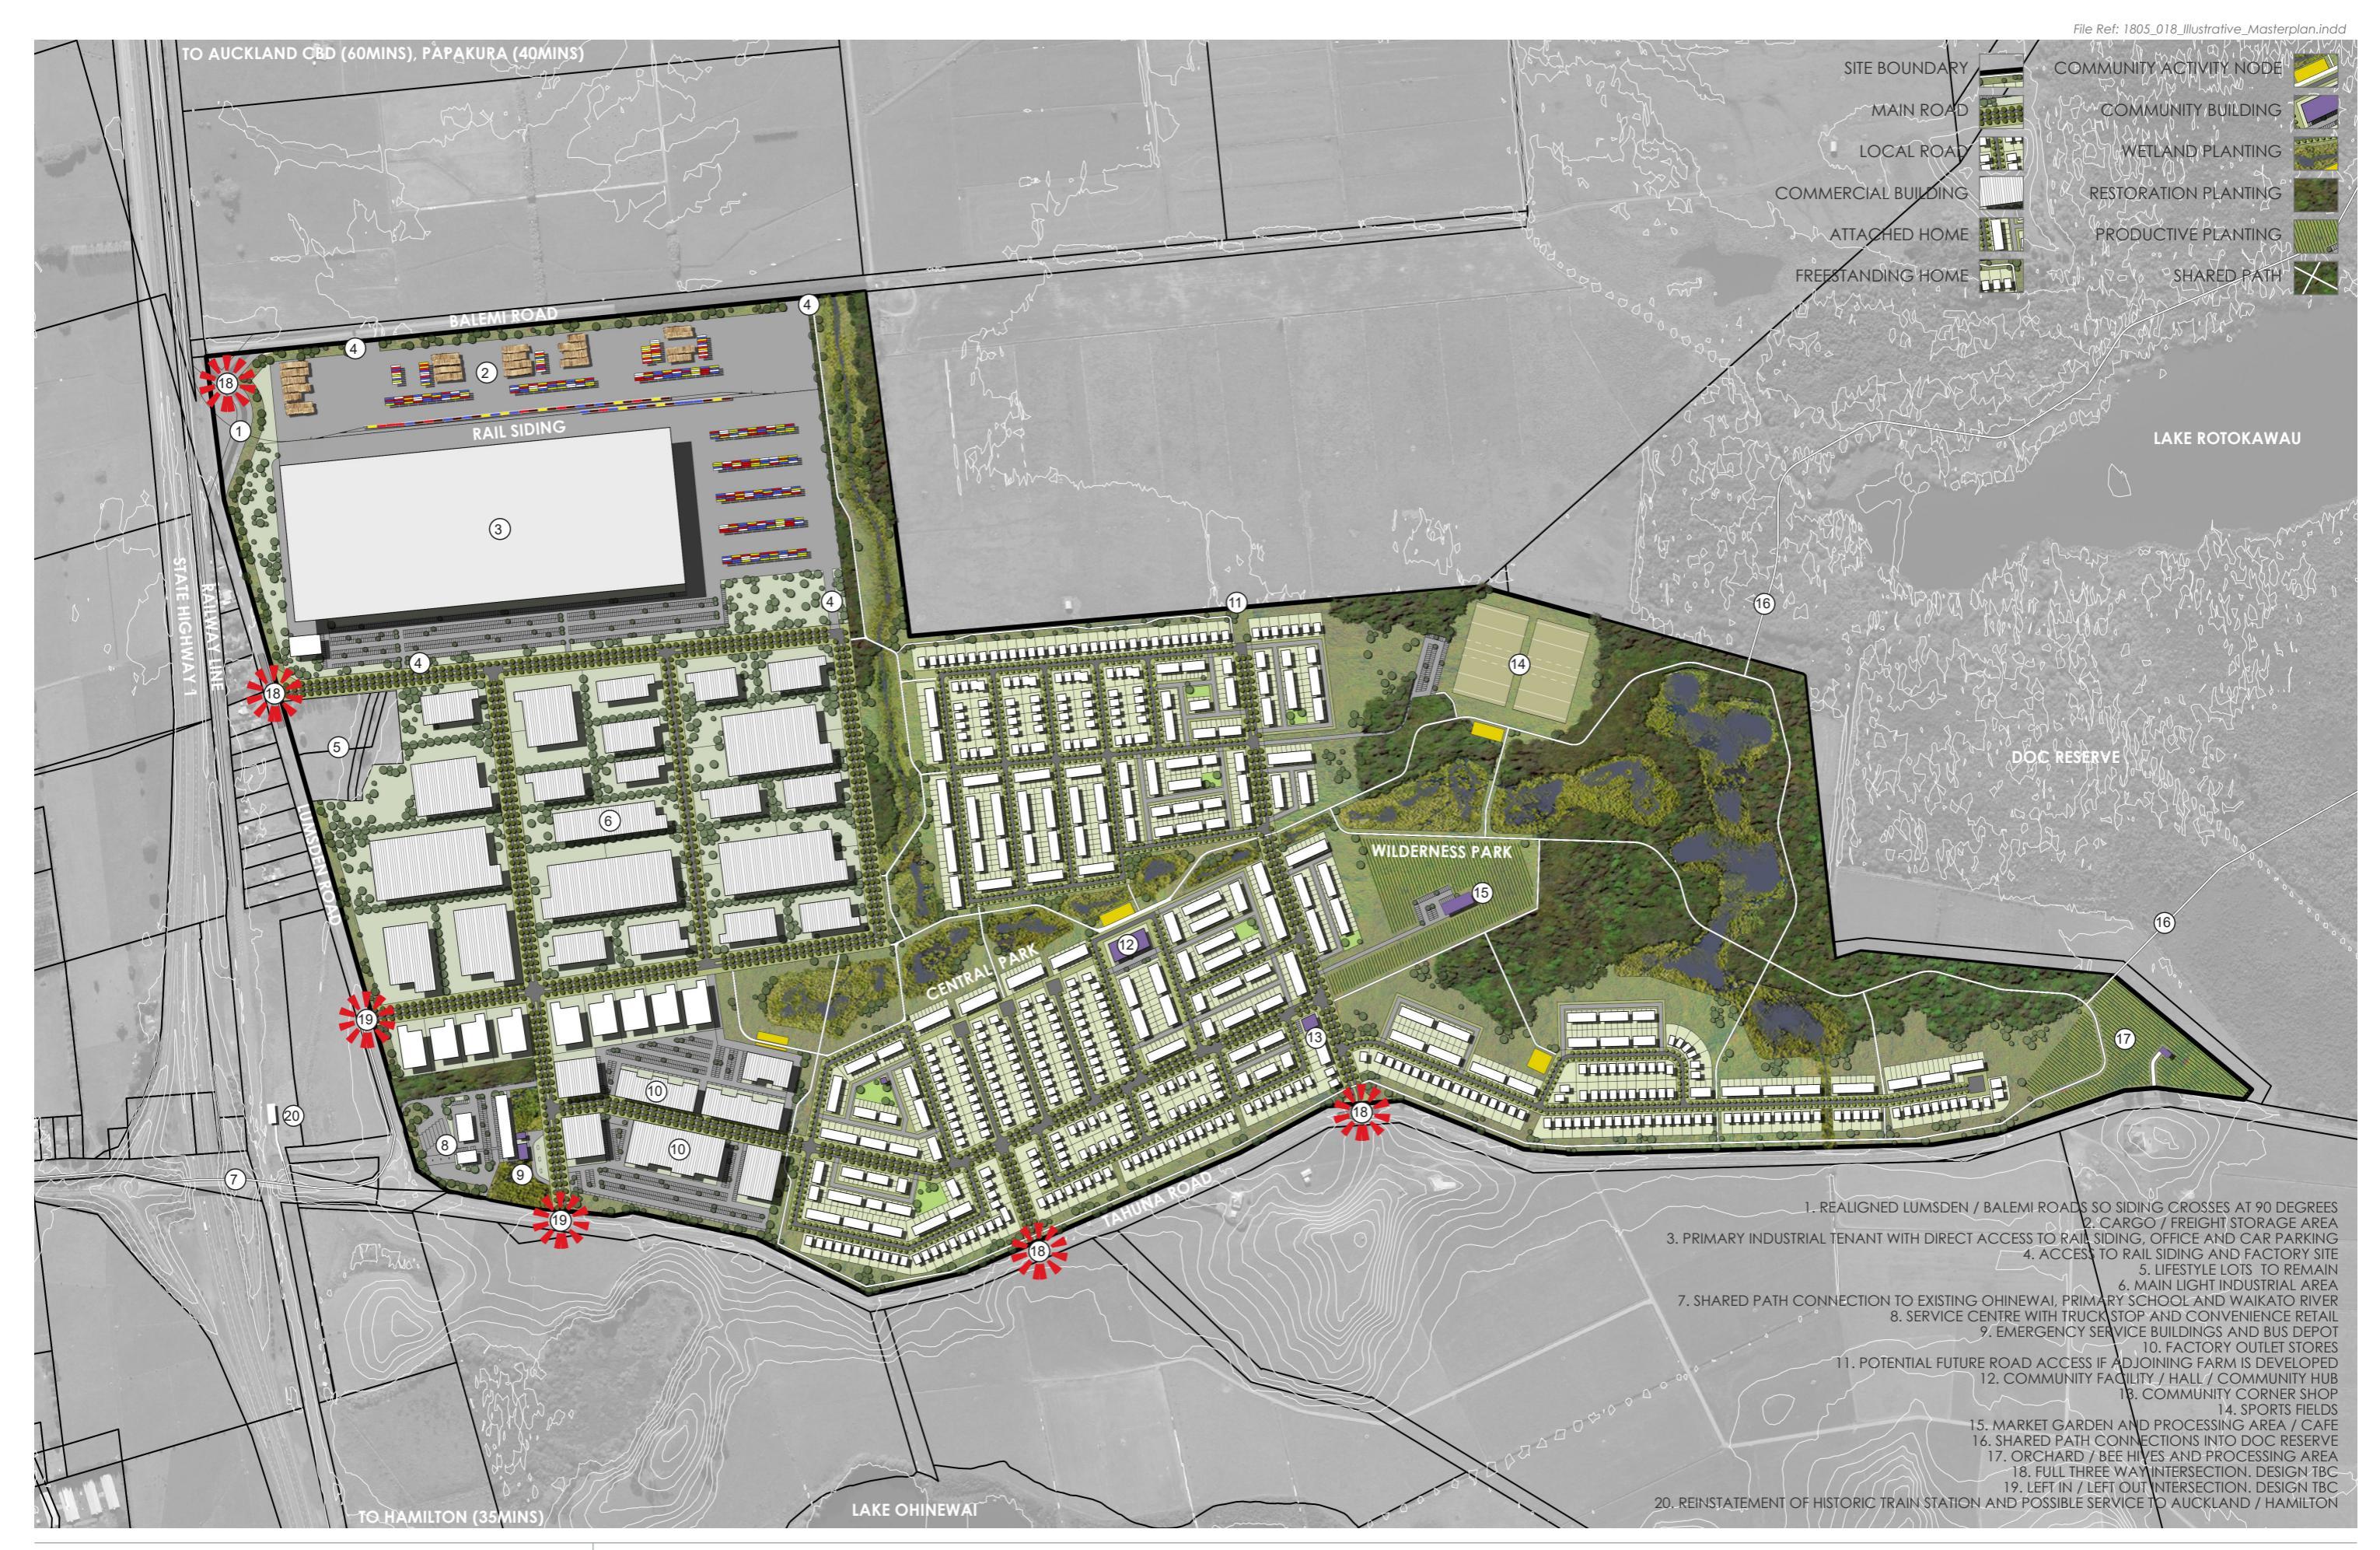
# OHINEWAI STRUCTURE PLAN

Date: 03 October 2019 | Revision J Drawing Number: 1805\_018 Plan prepared by Adapt Studio Ltd for Gaze Property Solutions

From the results of investigations completed to date, several areas of the site have been identified with challenging ground conditions. This is predominantly land that is underlain by significant thicknesses of the Rotokawau Formation (containing highly compressible peat and other very soft soils). Reference should be made to Figure 529-004 in Appendix A which zones land according to 'settlement' magnitudes resulting from an assumed uniform surcharge applied over the entire site. Development over areas of the site zoned red on Figure 529-004 (settlements > 500 mm) will be therefore be highly constrained. For this reason, the Masterplan for the site largely excludes future development in this zone (refer Adapt Studio, Rev J presented in Appendix A).

Based on our understanding of the proposed development detailed in the Illustrative Masterplan (Adapt Studio, Rev J) and our knowledge of the geology and local ground conditions, the principal geotechnical considerations for development of the site are as follows;

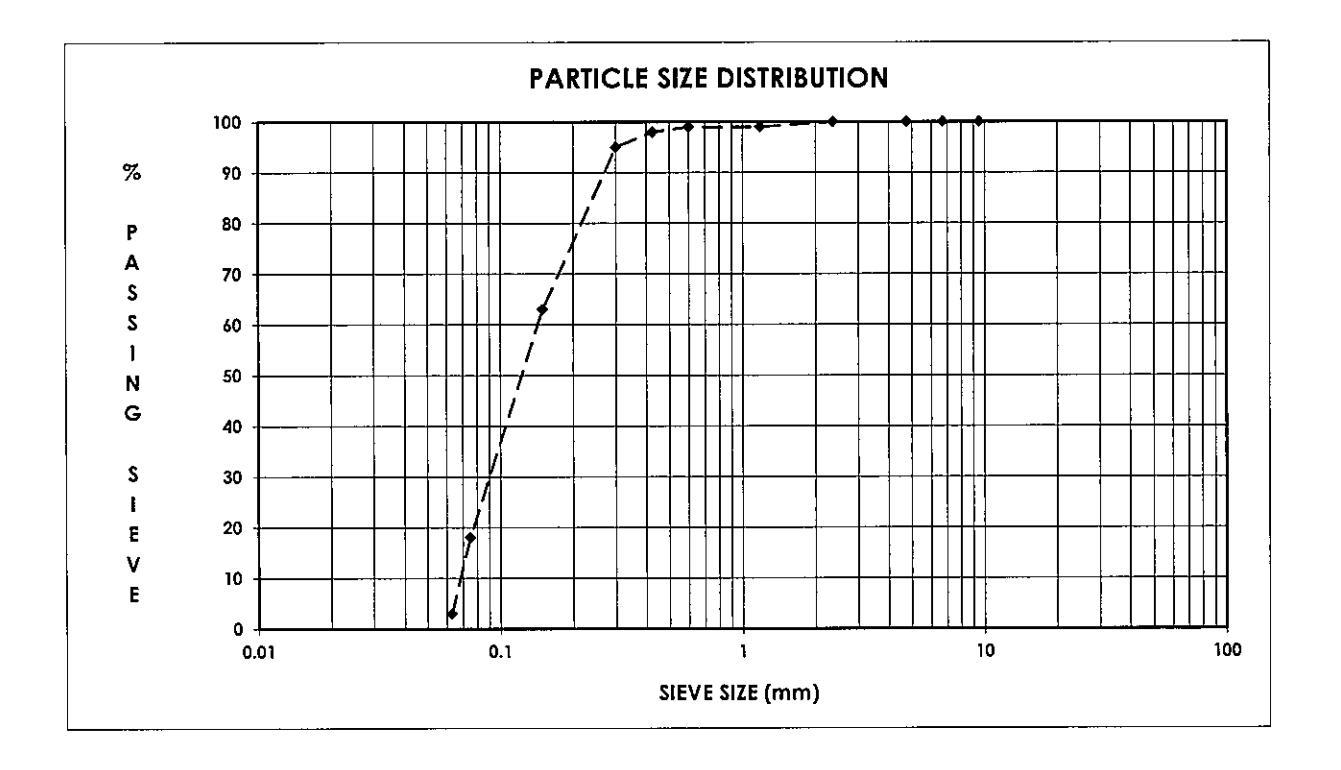
SIEVE SIZE (mm)	37.5	19	13.2	9.5	6.7	4.75	2.36	1.18	.600	.425	.300	.150	.075	.063
% PASSING SIEVE (Wet)	-	-	-	100	100	100	100	99	99	98	95	63	18	3
MAXIMUM SPECIFIED LIMIT	-	-	-	-	-	-	-	-	-	-	-	-	-	-
MINIMUM SPECIFIED LIMIT	-	-	-	-	-	-	-	-	-	-	-	-	-	-
(Dry) = Oven Dried Sample	(Wet	} = % pc	issing fine	st sieve	obtaine	d by diffe	erence		Fine	ness M	odulus:		-

Material:	Sand with Pumice Gravels – TP01 1.3 – 1.6m	Test No:	183103
Source:	Lumsden Road	Date Sampled:	31st October 2018
Job:	Block Trail Pits	Reference No.:	P-000529

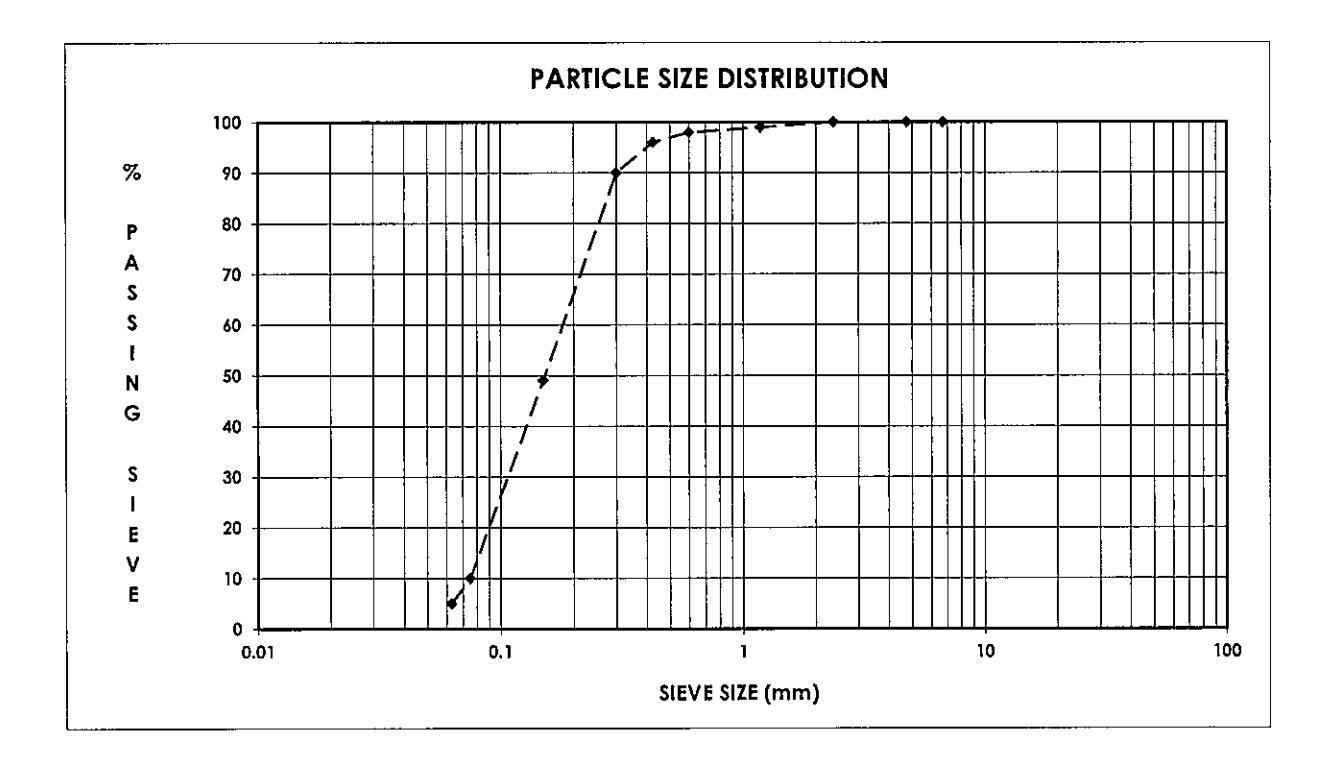
SIEVE SIZE (mm)	37.5	19	13.2	9.5	6.7	4.75	2.36	1.18	.600	.425	.300	.150	.075	.063
% PASSING SIEVE (Wet)	-	-	-	-	100	100	100	99	<del>9</del> 8	96	90	49	10	5
MAXIMUM SPECIFIED LIMIT	-	-	-	-	-	-	-	-	-	-	-	-	-	-
MINIMUM SPECIFIED LIMIT	-	-	-	-	-	-	-	-	-	-	-	-	-	-
(Dry) = Oven Dried Sample	(Wet	) = % pc	assing fine	st sieve	obtaine	d by diff	erence		Fine	ness M	odulus:		-

Material:	Sand Yellow Brown with Orange Bands – TP01 0.5 – 1.0m	Test No:	183102
Source:	Lumsden Road	Date Sampled:	31 <sup>st</sup> October 2018
Job:	Block Trail Pits	Reference No.:	P-000529

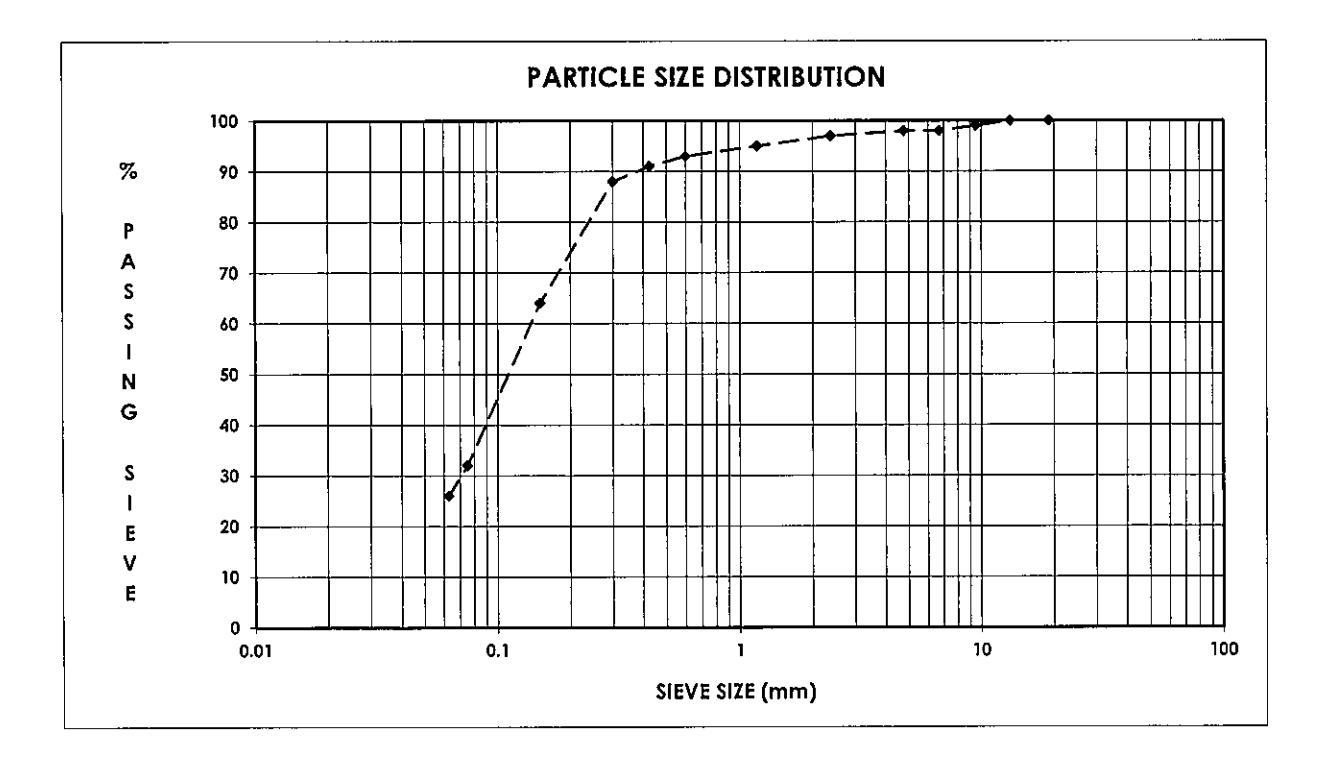
SIEVE SIZE (mm)	37.5	19	13.2	9.5	6.7	4.75	2.36	1.18	.600	.425	.300	.150	.075	.063
% PASSING SIEVE (Wet)	-	100	100	99	98	98	97	95	93	91	88	64	32	26
MAXIMUM SPECIFIED LIMIT	-	-	-	-	-	-	-	-	-	-	-	-	-	-
MINIMUM SPECIFIED LIMIT	-	-	-	-	-	-	-	-	-	-	-	-	-	-
(Dry) = Oven Dried Sample	(Wet	) = % pa	ssing fine	st sieve	obtaine	d by diffe	erence		Fine	ness M	odulus:		-

Material:	Sand with Pumice Gravels – TP02 2.0 – 2.5m	Test No:	183104
Source:	Lumsden Road	Date Sampled:	31 <sup>st</sup> October 2018
Job:	Block Trail Pits	Reference No.:	P-000529

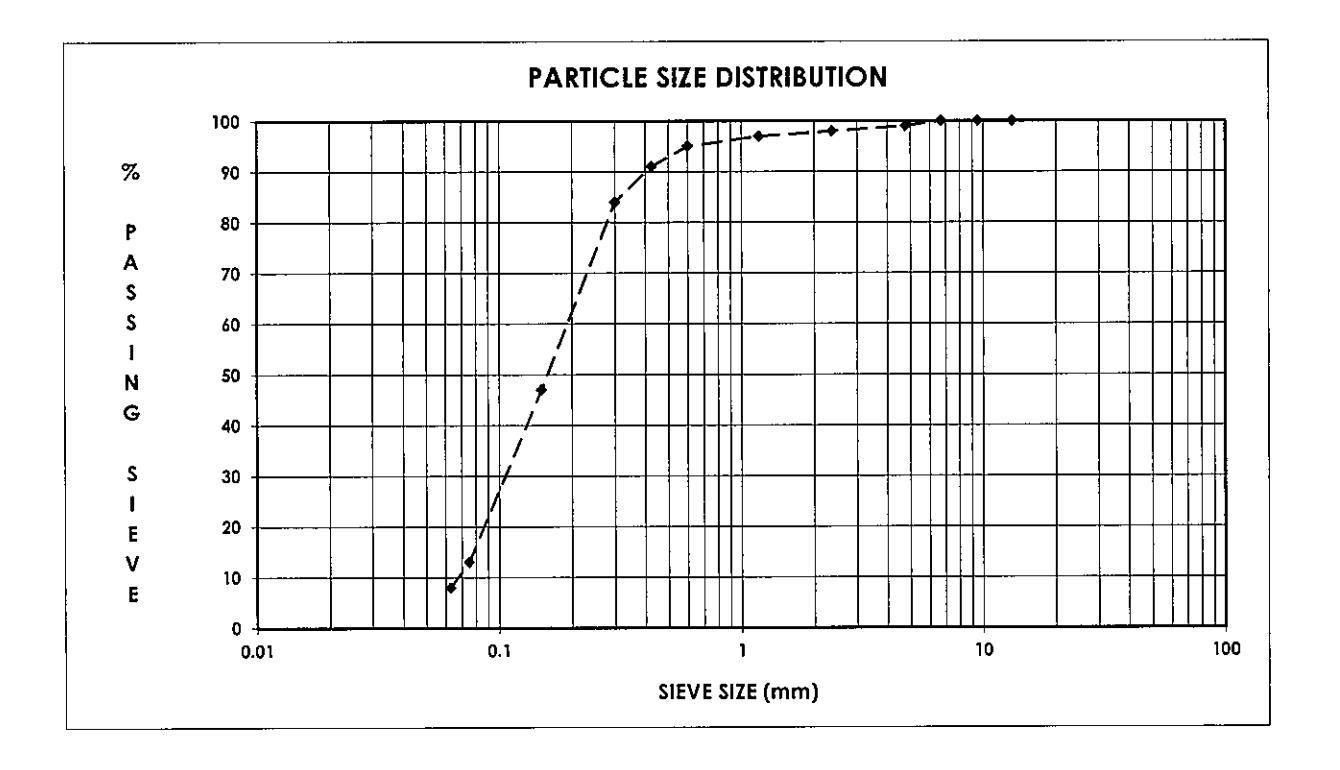
SIEVE SIZE (mm)	37.5	19	13.2	9.5	6.7	4.75	2.36	1.18	.600	.425	.300	.150	.075	.063
% PASSING SIEVE (Wet)	-	-	100	100	100	99	98	97	95	91	84	47	13	8
MAXIMUM SPECIFIED LIMIT	-	-	-	-	-	-	-	-	-	-	-	-	-	-
MINIMUM SPECIFIED LIMIT	-	-	-	-	-	-	-	-	-	-	-	-	-	-
(Dry) = Oven Dried Sample	(Wet	)=%pc	assing fine	est sieve	obtaine	d by diff	erence		Fine	ness M	odulus:		-

Material:	Sand Yellow Brown with Orange Bands – TP05 0.5 – 0.8m	Test No:	183105
Source:	Lumsden Road	Date Sampled:	31st October 2018
Job:	Block Trail Pits	Reference No.:	P-000529

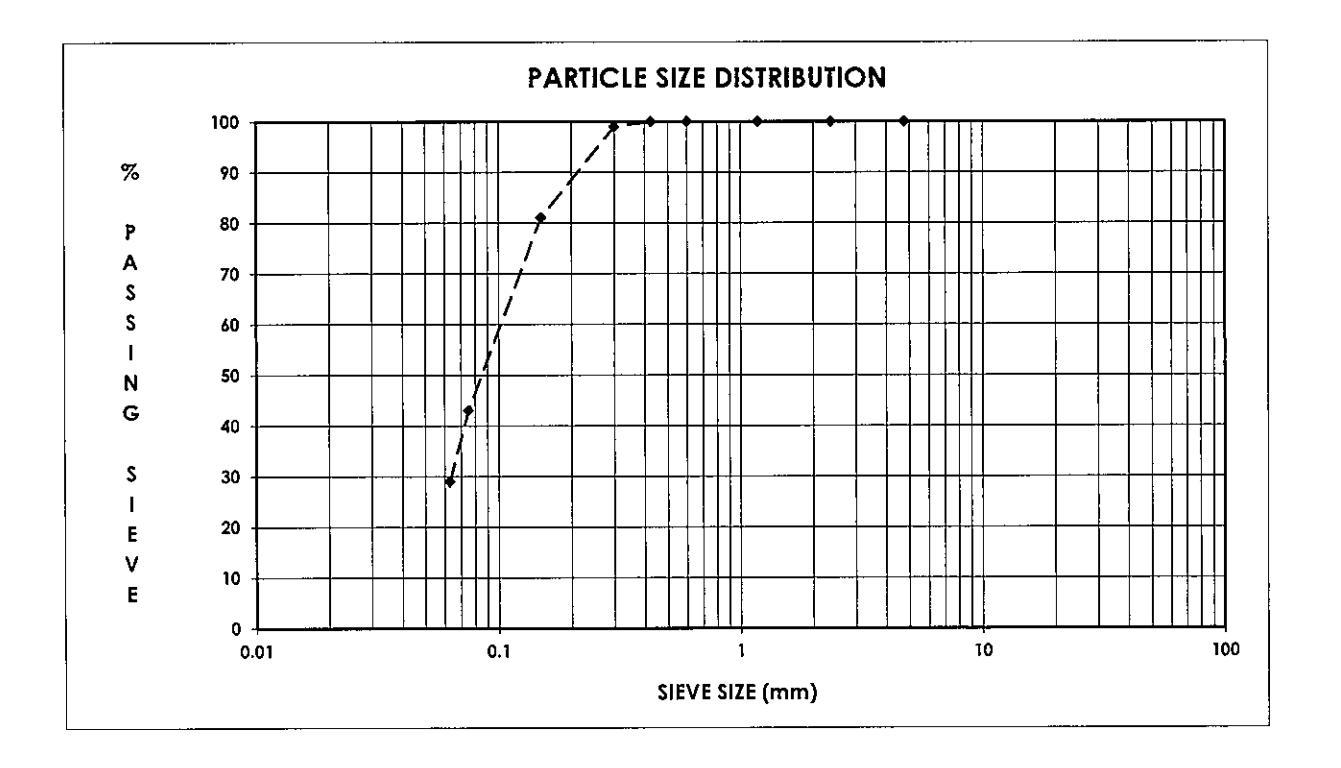
SIEVE SIZE (mm)	37.5	19	13.2	9.5	6.7	4.75	2.36	1.18	.600	.425	.300	.150	.075	.063
% PASSING SIEVE (Wet)	-	-	-	-	-	100	100	100	100	100	99	81	43	29
MAXIMUM SPECIFIED LIMIT	-	-	-	-	-	-	-	-	-	-	-	-	-	-
MINIMUM SPECIFIED LIMIT	-	-	-	-	-	-	-	-	-	-	-	-	-	-
(Dry) = Oven Dried Sample	(Wet	) = % pc	issing fine	st sieve	obtaine	d by diffe	erence		Fine	ness M	odulus:		-

Material:	Sand – Grey Wet – TP03 1.3 – 1.6m	Test No:	183106
Source:	Lumsden Road	Date Sampled:	31 <sup>st</sup> October 2018
Job:	Block Trail Pits	Reference No.:	P-000529

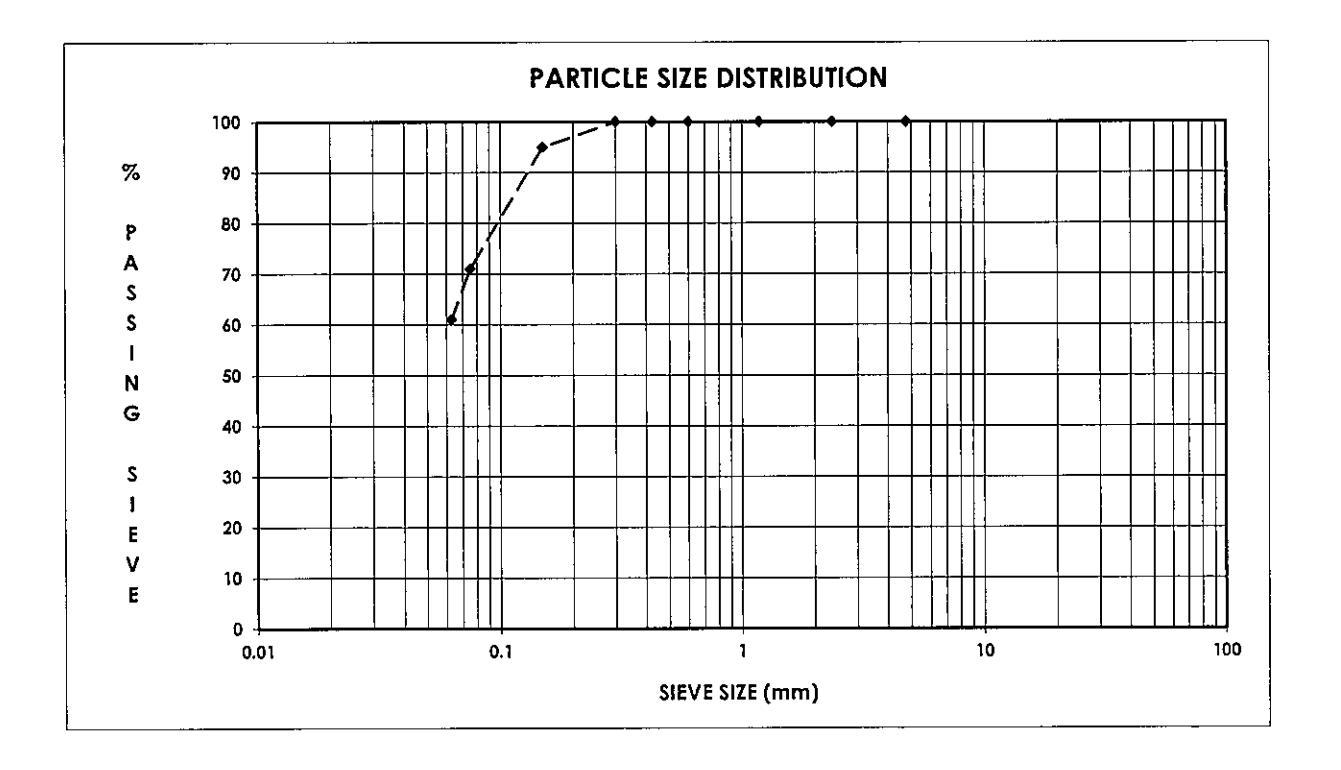
SIEVE SIZE (mm)	37.5	19	13.2	9.5	6.7	4.75	2.36	1.18	.600	.425	.300	.150	.075	.063
% PASSING SIEVE (Weł)	-	-	-	-	-	100	100	100	100	100	100	95	71	61
MAXIMUM SPECIFIED LIMIT	-	-	-	-	-	-	-	-	-	-	-	-	-	-
MINIMUM SPECIFIED LIMIT	-	-	-	-	-	-	-	-	-	-	-	-	-	-
(Dry) = Oven Dried Sample	(Wet	) = % pc	assing fine	est sieve	obtaine	d by diffe	erence		Fine	ness M	odulus:

Material:	Sand – Grey Light Brown – TP03 3.1m	Test No:	183107
Source:	Lumsden Road	Date Sampled:	31st October 2018
Job:	Block Trail Pits	Reference No.:	P-000529

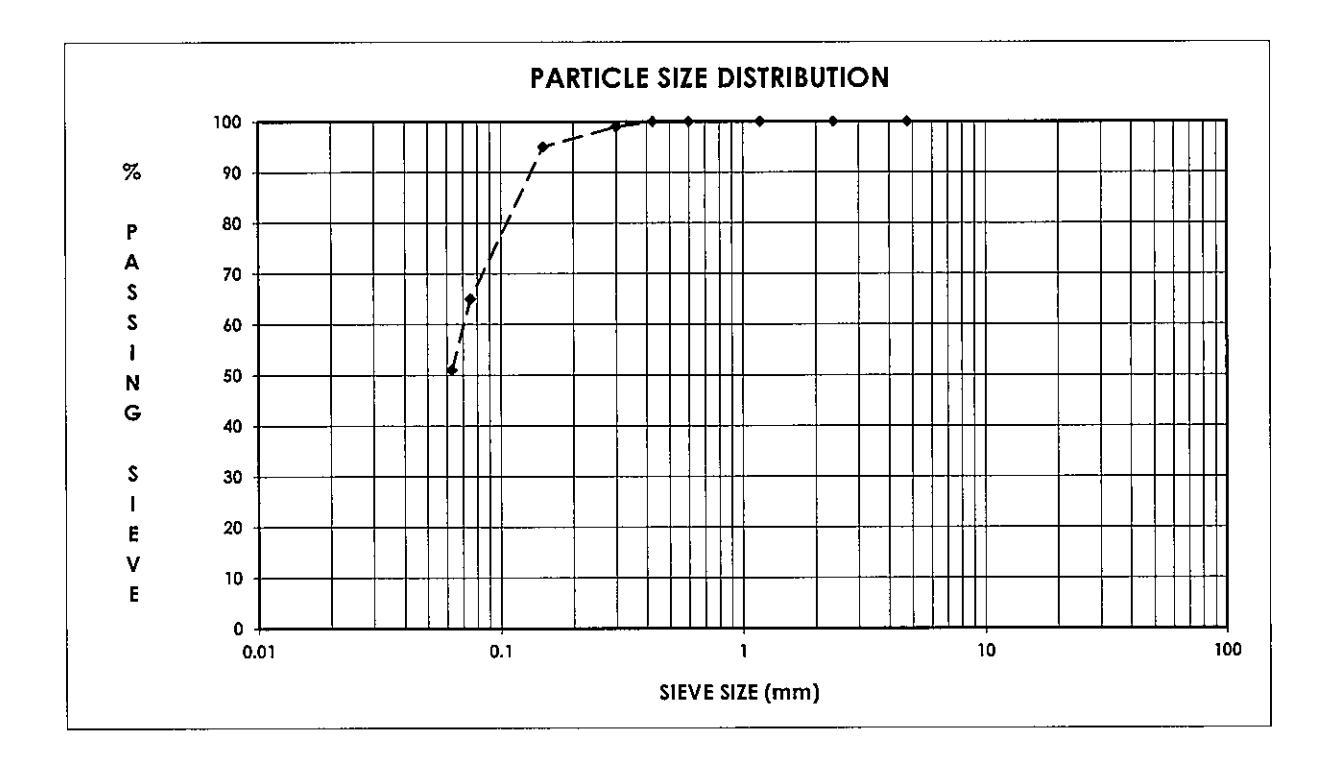
SIEVE SIZE (mm)	37.5	19	13.2	9.5	6.7	4.75	2.36	1.18	.600	.425	.300	.150	.075	.063
% PASSING SIEVE (Wet)	-	-	-	-	-	100	100	100	100	100	9 <b>9</b>	95	65	51
MAXIMUM SPECIFIED LIMIT	-	-	-	-	-	-	-	-	-	-	-	-	-	-
MINIMUM SPECIFIED LIMIT	-	-	-	-	-	-	-	-	-	-	-	-	-	-
(Dry) = Oven Dried Sample	(Wet	Wet) = % passing finest sieve obtained by difference							Fine	ness M	odulus:		-

Material:	Sand – Grey – TP05 2.5 – 2.8m	Test No:	183108
Source:	Lumsden Road	Date Sampled:	31 <sup>st</sup> October 2018
Job:	Block Trail Pits	Reference No.:	P-000529
