IN THE MATTER of the Resource Management Act 1991

IN THE MATTER of the hearing (Stage 1) by the Waikato District Council on the Proposed Waikato District Plan

# EVIDENCE BY CRAIG SMITH Terra Firma Resources Limited

**Integrated Transportation Assessment**

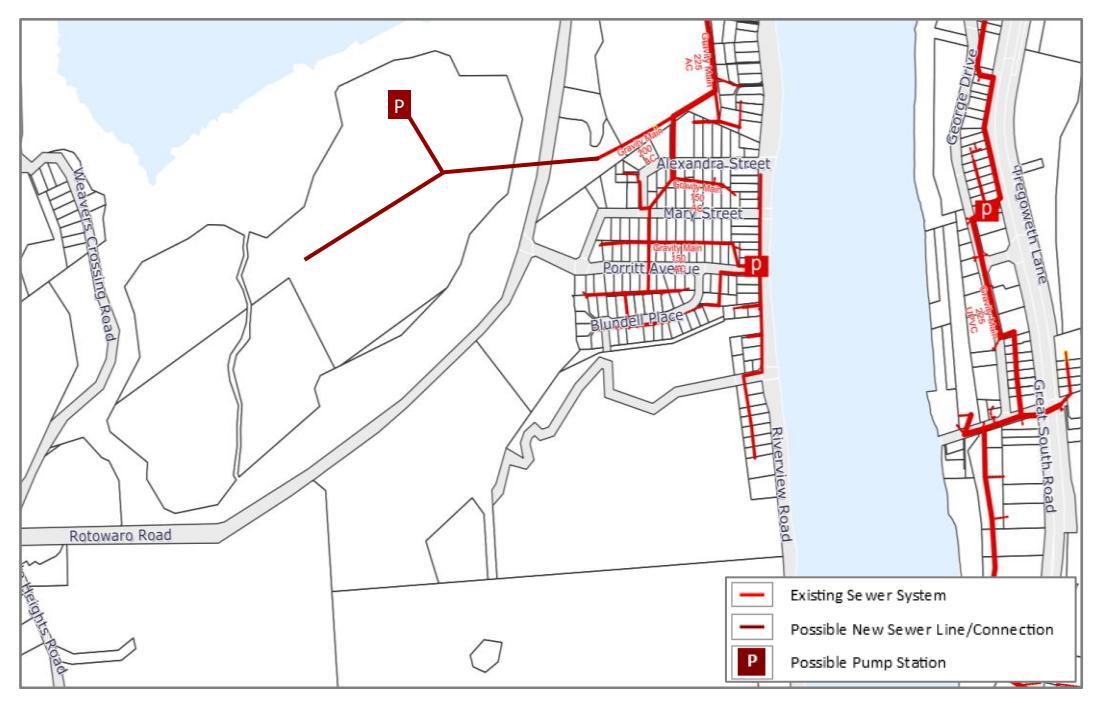
Potential wastewater servicing option.

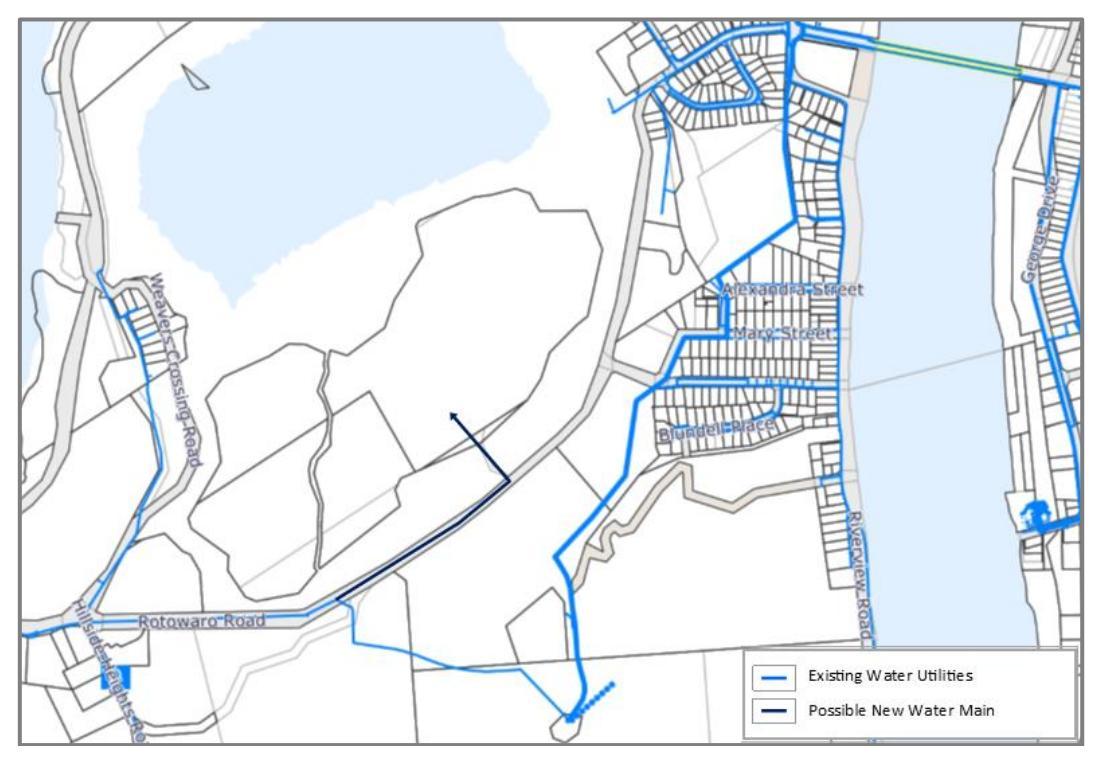
Potential water servicing option.

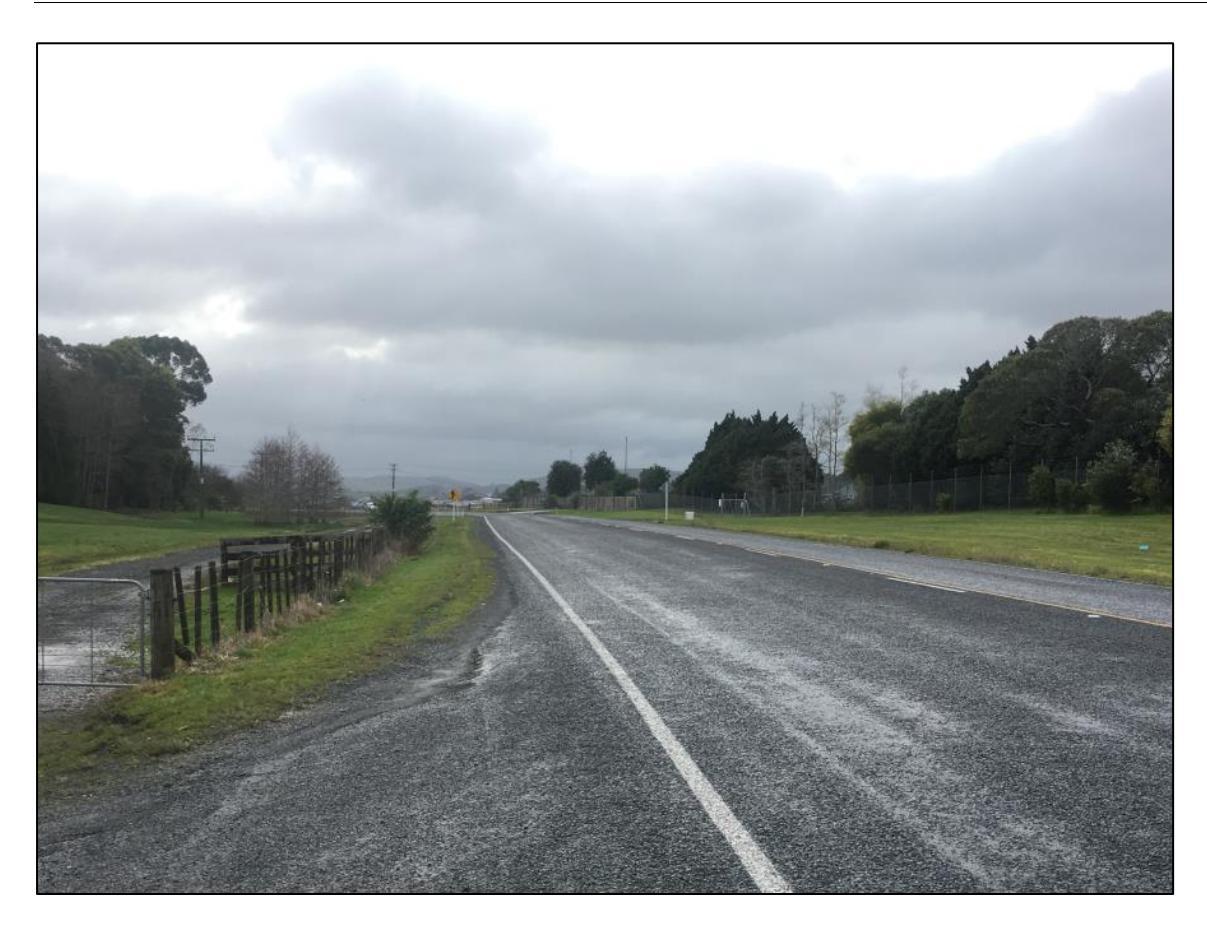
Figure 4: Rotowaro Road (Looking East)

- 3.1.1 Rotowaro Road is classified as a Collector Road in the ODP road hierarchy between Harris Street and Waikokowai Road. Under the PDP, this classification is retained and extended over the full length from Harris Street to Waingaro Road.
- 3.1.2 Near the site, Rotowaro Road is generally flat and curves around the southern boundary of the property. It provides one 3.7m wide traffic lane in each direction and a painted centreline and edgelines. There are sealed shoulders of varying width (typically around 0.5m) on both sides of the road. The existing form of Rotowaro Road is shown as Figure 4.

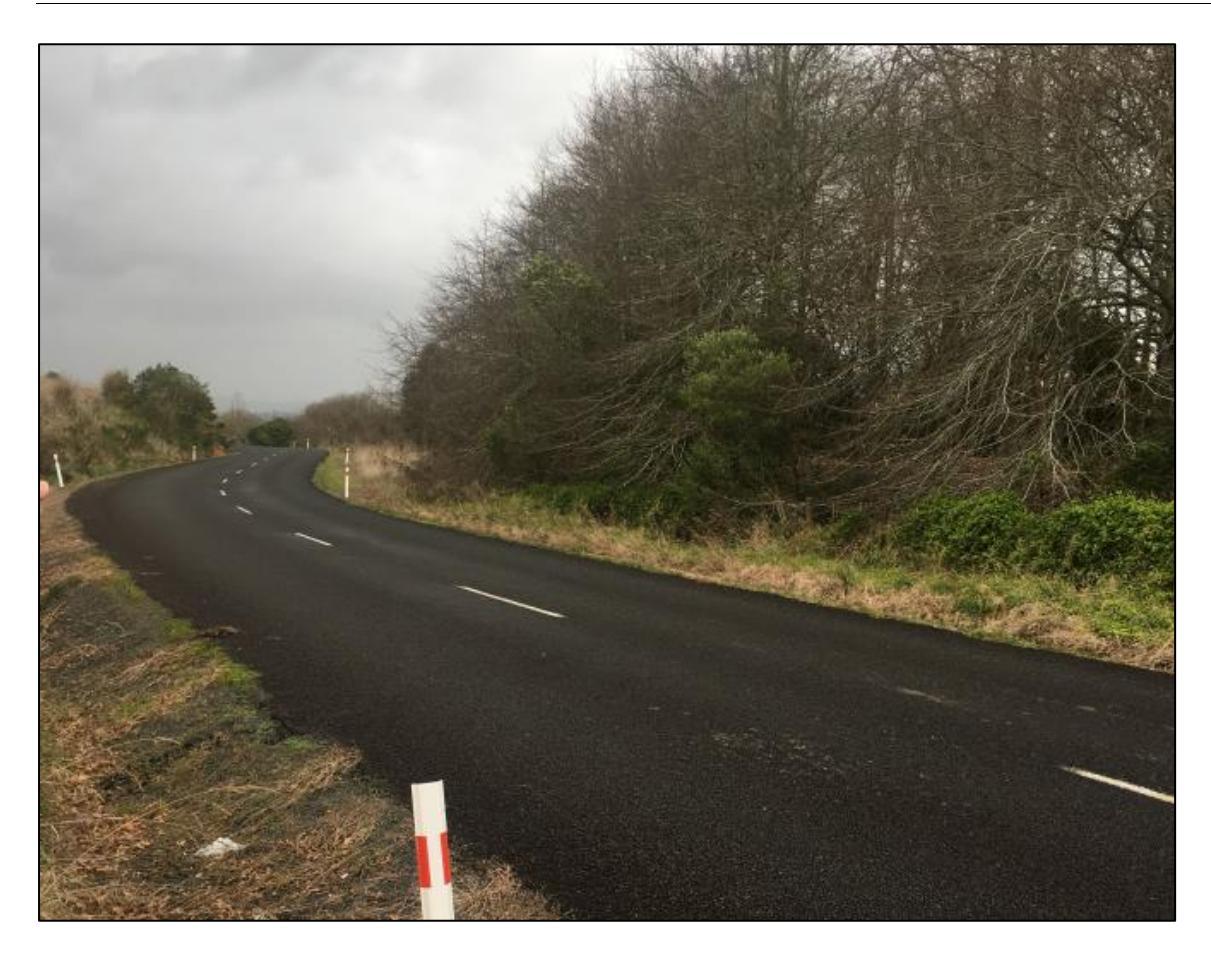
Figure 5: Weavers Crossing Road Cross Section (Looking North)

- 3.1.6 Weavers Crossing Road provides access to both Lake Puketirini and adjacent Lake Waahi. It also services a small community of approximately 14 dwellings. There is a level crossing over the Huntly/Glen Afton Branch Railway. Weavers Crossing Road is shown as Figure 5.

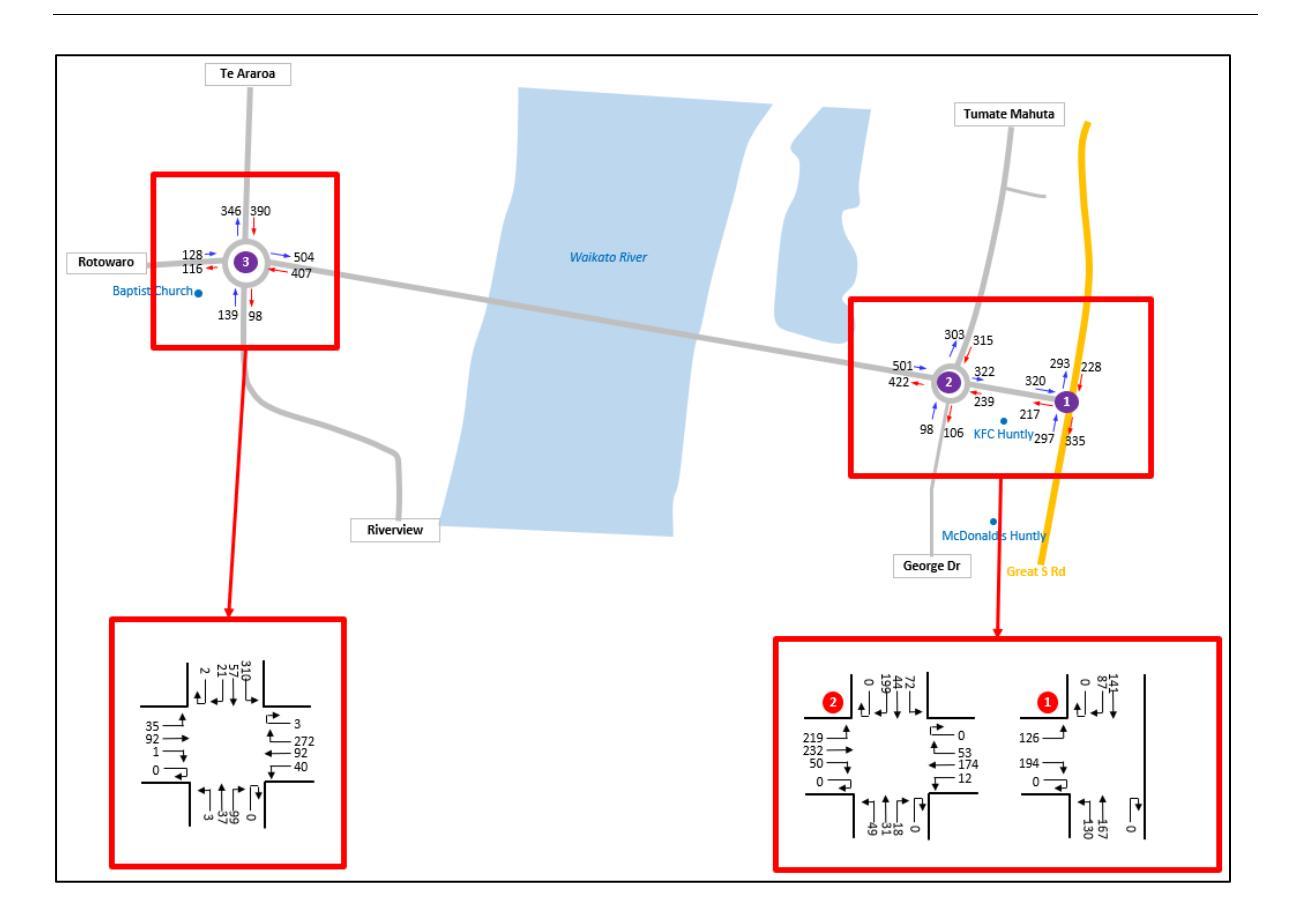
#### Figure 6: AM Peak Hour (8:00-9:00am) Intersection Counts

- 3.2.1 Data published by WDC shows that Rotowaro Road carries an average daily traffic volume (ADT) of 2,920 vehicles per day (vpd) near the Riverview Road roundabout. Past the site, between Porritt Avenue and Weavers Crossing Road, the ADT is 2,070 vpd. The volume reduces further to 1,690 vpd beyond Weavers Crossing Road. Heavy commercial vehicles (HCVs) make up 8% of the flow on Rotowaro Road in Huntly, 9% past the site, and 4% beyond Weavers Crossing Road. Weavers Crossing Road. Weavers Crossing Road has a daily volume of 160 vpd, including 4% HCV.
- 3.2.2 Intersection counts were arranged at three intersections along the route between the subject land and Great South Road, in September 2020. The recorded peak hour volumes during the weekday morning, weekday evening and Saturday midday peaks are shown as Figure 6, Figure 7 and Figure 8.

- 3.2.3 The Figures show that Tainui Bridge Road carried approximately 920-938 vehicles per hour (vph)(two-way) during the weekday morning and evening peaks. On Saturday, it carried up to 690 vph.
- 3.2.4 Until the Huntly Section of the Waikato Expressway was opened in early 2020, Great South Road carried an average daily volume of around 24,300 vpd<sup>1</sup> and peak hour volumes of up to 1,900 vph<sup>2</sup>, two-way. Volumes on Great South Road have reduced significantly since the new route was opened.
- 3.2.5 The survey data recorded Great South Road as carrying peak hour volumes of 630 vph during the morning, 800 vph during the evening and 620 vph on Saturday. This indicates that traffic

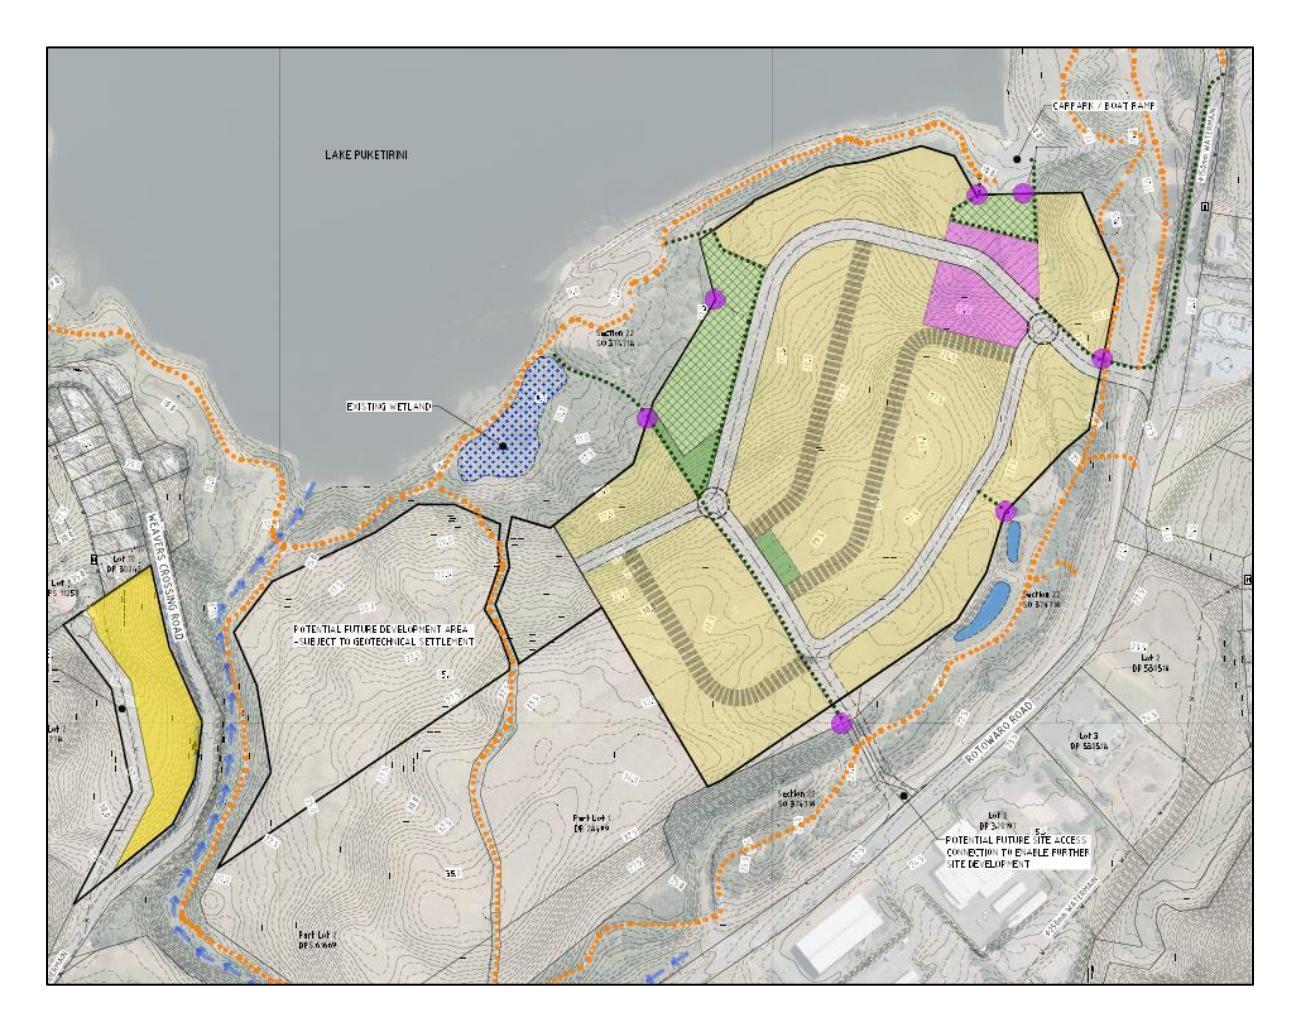
Figure 10: Subdivision Concept Plan (Prepared by Wainui Environmental)

6.1.1 A subdivision concept plan for the site is shown as Figure 10 below.

- 6.1.2 It is noted that the western area of the site is not currently being proposed as a part of the plan change due to geotechnical constraints. However, consideration of this area being developed into residential activities has been included and assessed within this ITA as it would be accessed via the proposed new Residential Zone.
- 6.1.3 Vehicle access for the rezoned area is proposed to be via a new T-intersection with Rotowaro Road (known as the 'east access'). There is an existing west access. This is currently a 9m wide right of way over WDC Reserve land which provides access to the TFR and neighbouring land. This access is currently unsealed and is to an agricultural standard. It is anticipated that

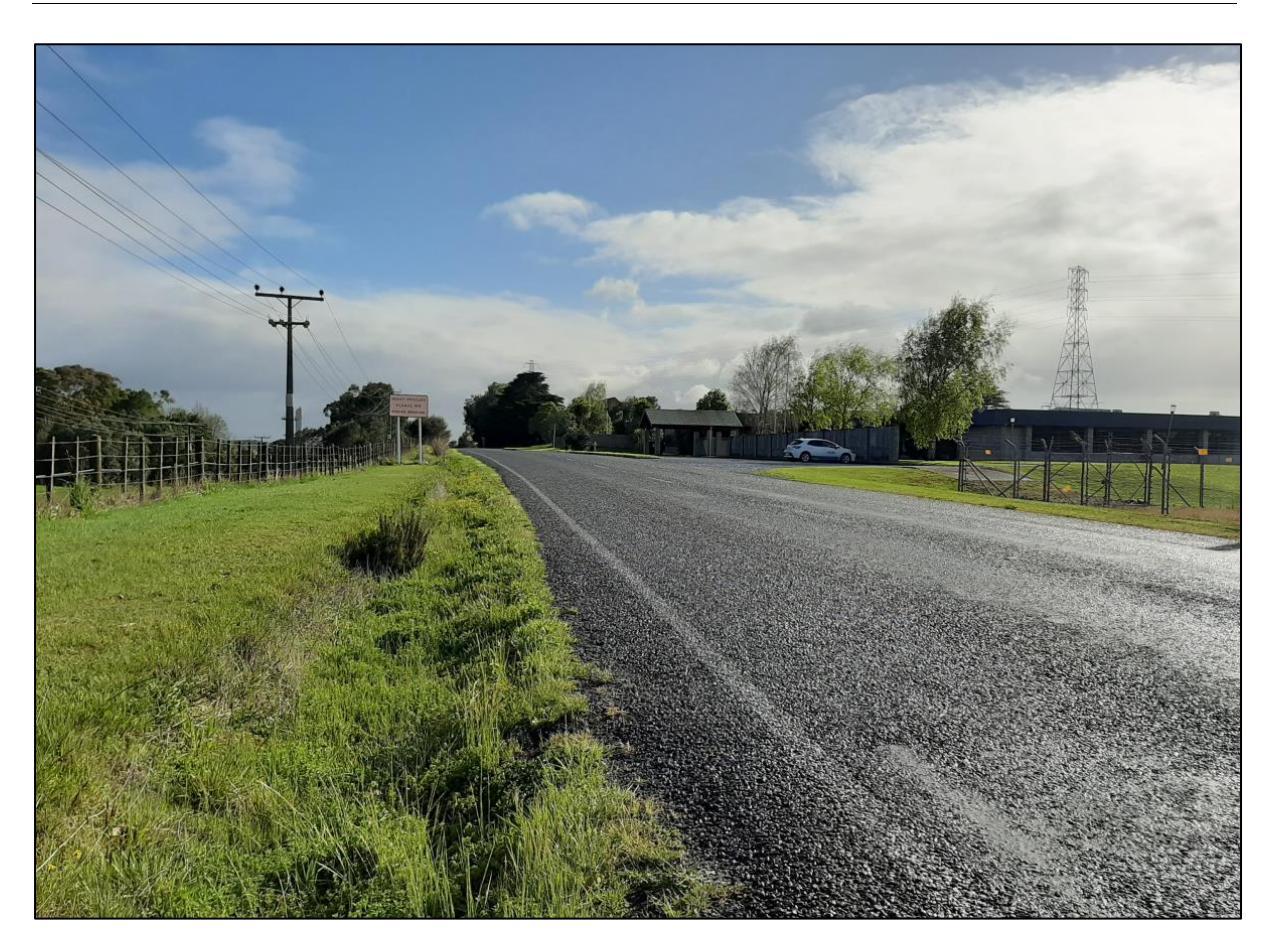
Figure 11: Sight Distance from Rotowaro Road Eastern Access to North

- 6.3.1 Three access points are potentially available to connect the subject land to the existing transport network, two on Rotowaro Road (one being an emergency/future stage access) and one on Weavers Crossing Road.
- 6.3.2 The easternmost access to Rotowaro Road is currently shown approximately 110m north of Porritt Avenue, approximately 30m west opposite the carpark at Te Wananga o Aotearoa. The available sight distance at this location is 200m to the north, towards Huntly and 175m to the south. These views are shown as Figure 11 and Figure 12.

- 6.3.3 These distances meet the requirements for either an 80km/h speed zone (175m) or a 50km/h speed zone (90m), as discussed further later in this report. It has been noted that a change in speed limit at this location is supported from WDC. Further details of WDC consultation are included in Section 8 of this report.

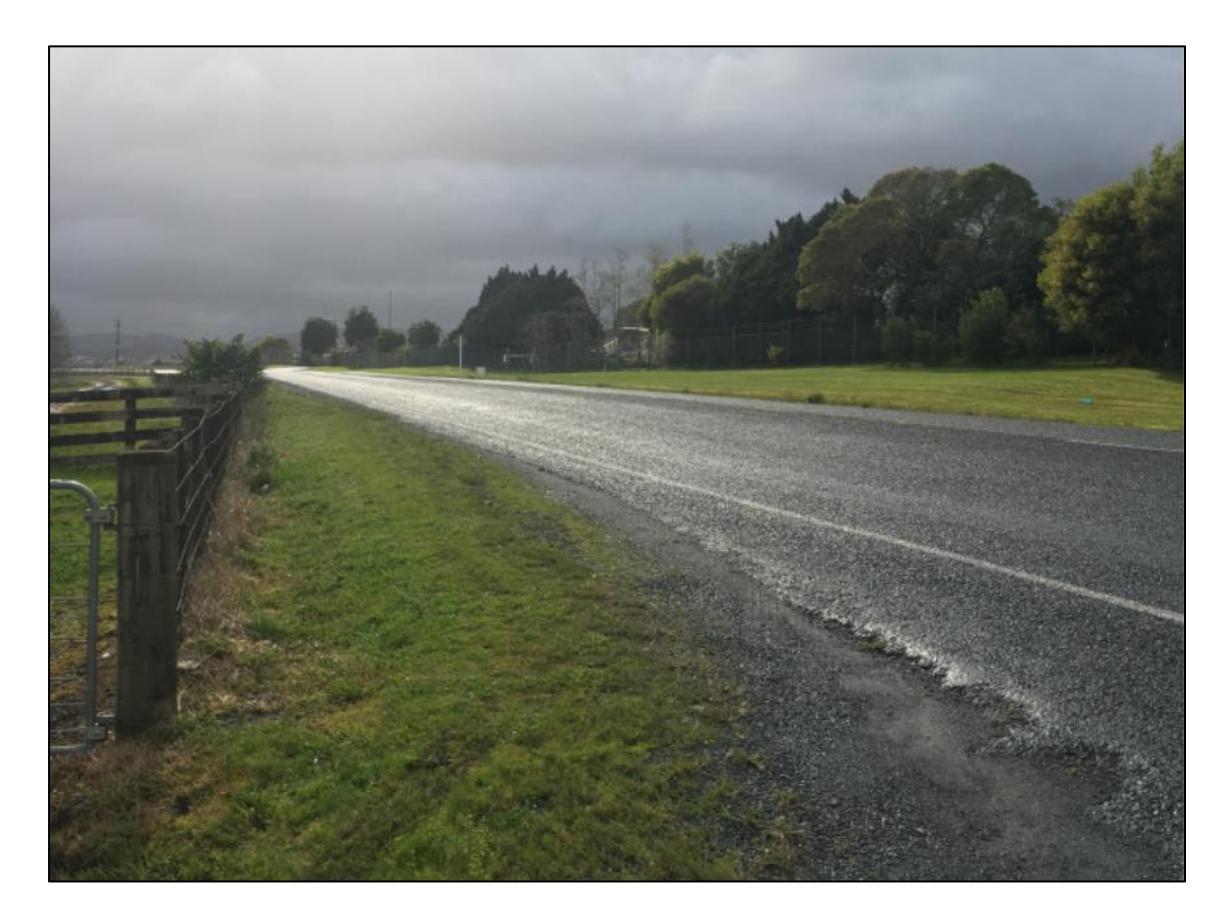
Figure 13: Sight Distance from Rotowaro Road Western Access to East

- 6.3.4 The westernmost emergency/future stage access to Rotowaro Road is proposed to be located approximately 340m south of Porritt Avenue, opposite the Huntly Coal Screening Plant. The available sight distance at this location is 150m to the east, towards Huntly and 250m to the west away from Huntly. The available sight distance to the west satisfies the requirements of either an 80km/h or 50km/h speed zone. The distance to the east falls short of the 80km/h requirement but satisfies the 50km/h requirement. Views east and west from this location are shown as Figure 13 and Figure 14. It is anticipated that this crossing will be used for emergency purposes for initial stages of development. It may be formed as a second point of access subject to details assessed at the time of a future subdivision application once details of a specific development is known.

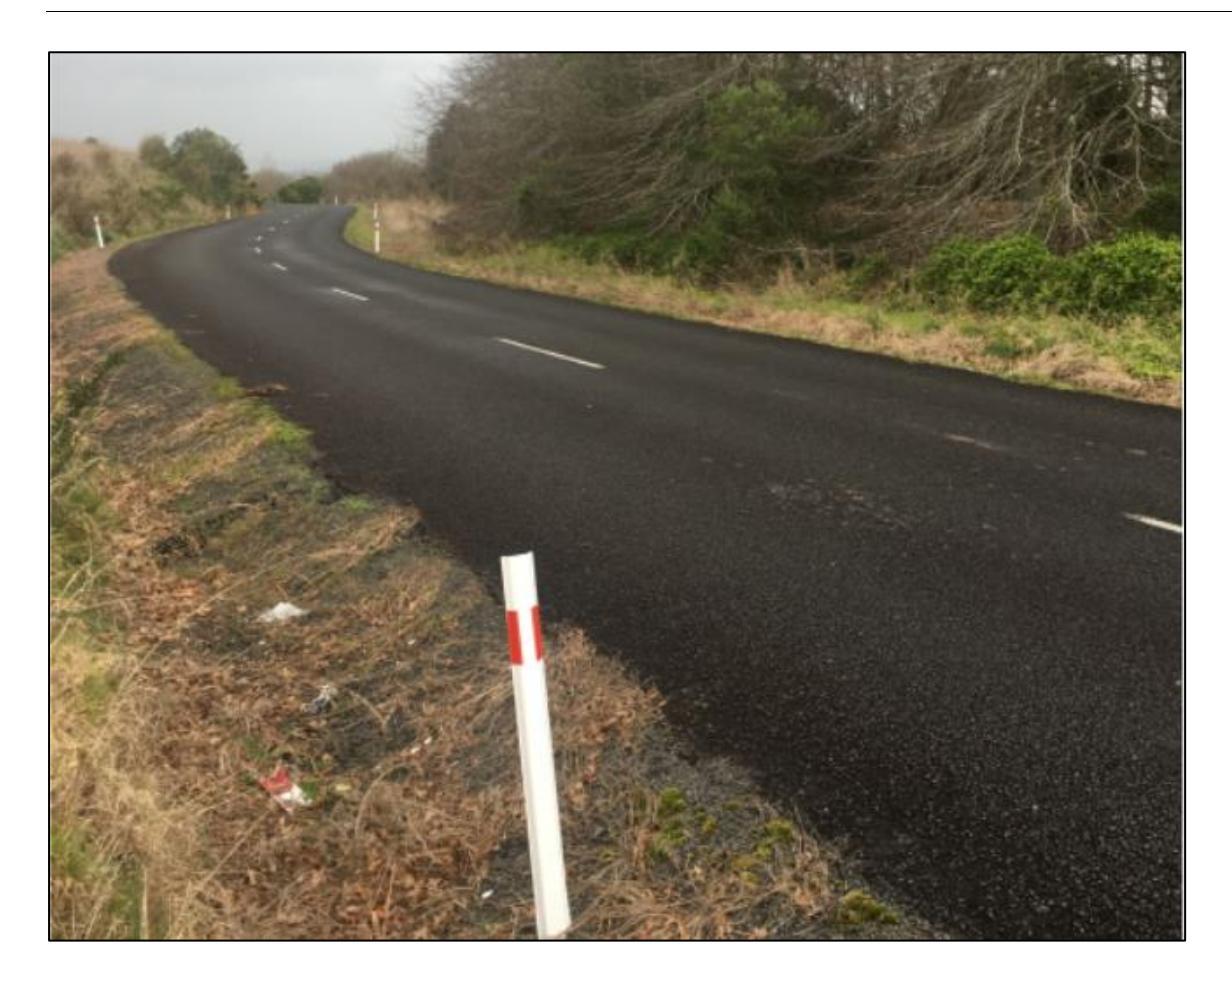
Figure 15: Sight Distance from Weavers Crossing Road to Left (North)

The available sight distances from the paper road serving 63 Weavers Crossing Road were 115m to the north and 170m to the south. Views from this location are shown as Figure 15 and Figure 16.

6.3.5 Given the posted speed limit of 100km/h, 250m of sight distance is technically required for entrances along Weavers Crossing Road. In practice, the operating speed in this area is lower due to the existing topography and road alignment. The available distances of 115m and 170m are appropriate for up to 60km/h and 78km/h, respectively. This is assessed as adequate for the proposed land use and the existing operating environment.

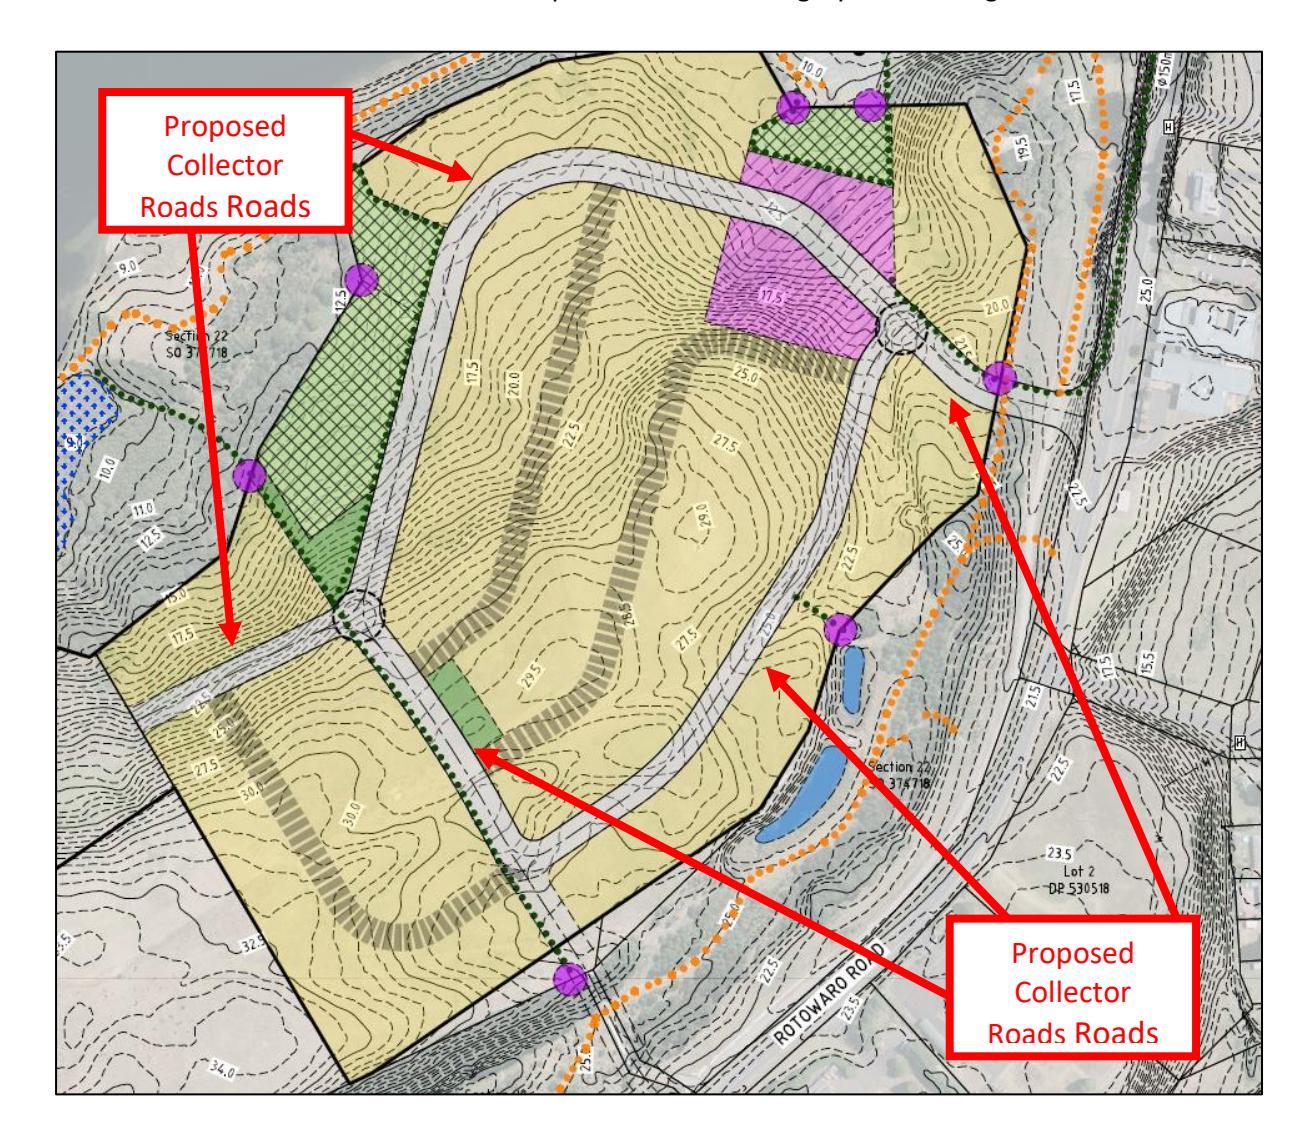
## Figure 17: Proposed Collector Roads (In Grey)

7.4.2 The collector roads for the development are shown in grey below in Figure 17.

- 7.4.3 The ODP<sup>5</sup> and the PDP<sup>6</sup> require accesses catering for more than 40 vpd in 80km/h speed rural environments to provide at least 175m of sight distance. This can be achieved in both directions at the eastern access, and to the west from the future possible (western) access. Only 150m is available from the western access to the east. Removal of vegetation may make compliant sight distance available.
- 7.4.4 If the recommended change in speed limit is adopted and the area is classed as urban, required sight distance reduces to 80m and both accesses can comply.

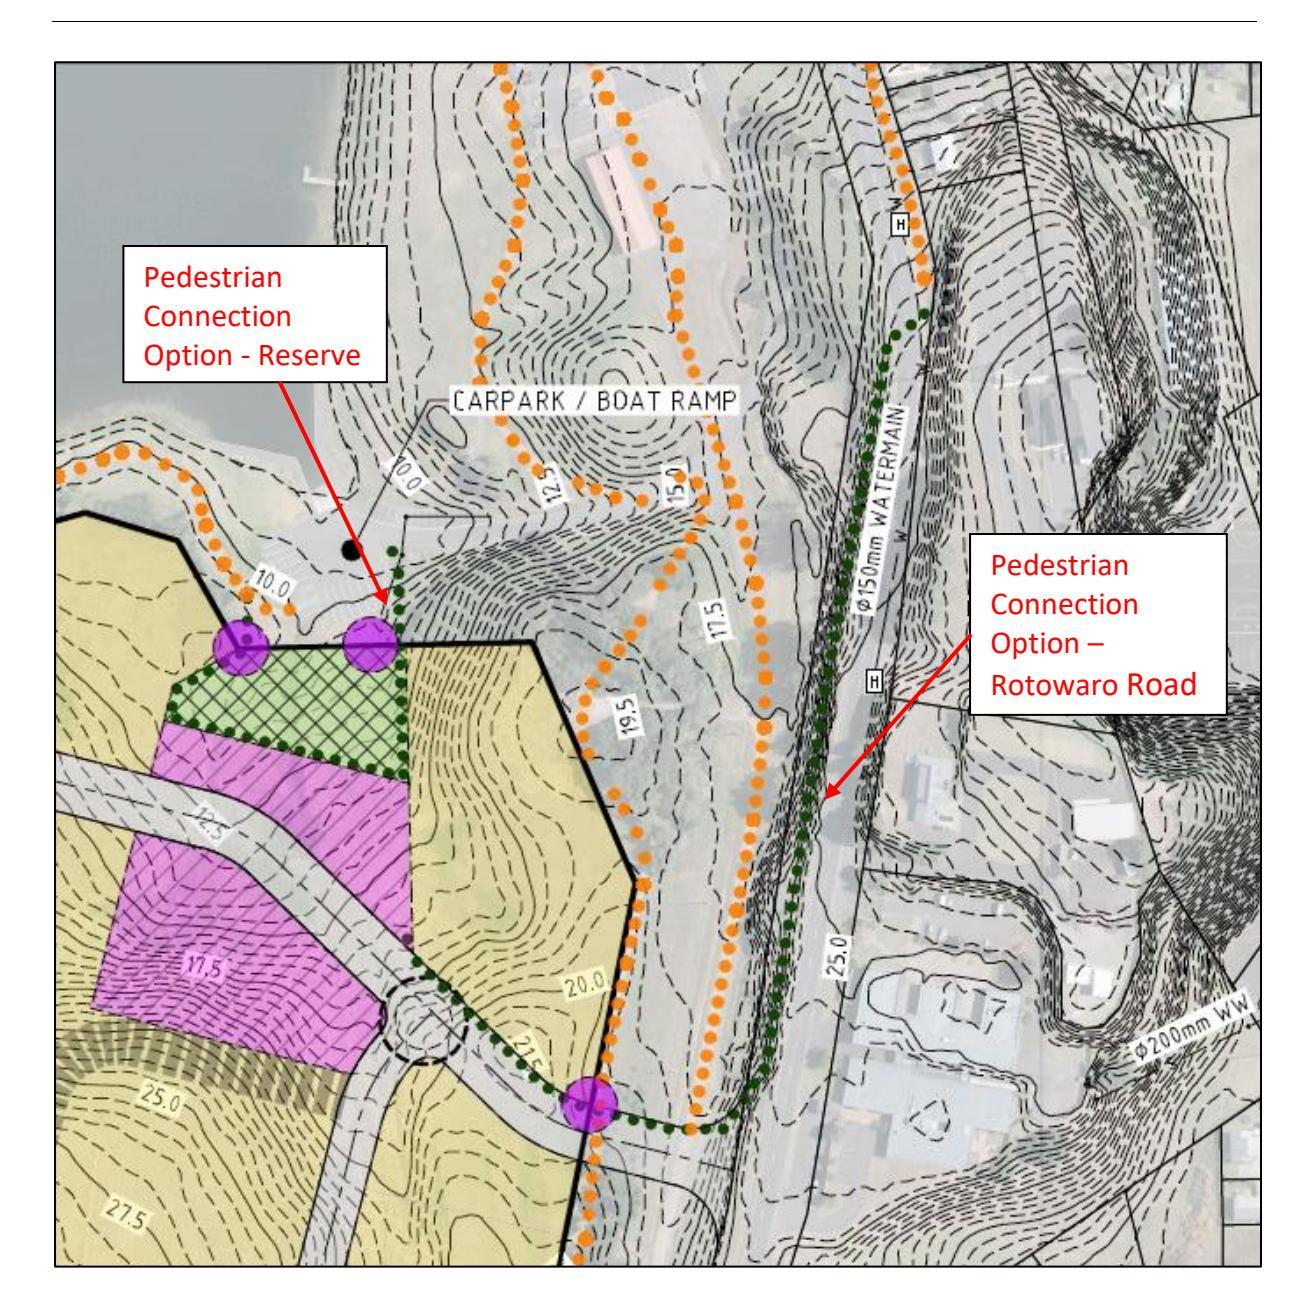
Figure 18: Recommended Footpath Extension

- 7.5.3 It is recommended that integration with the existing on-street footpath network in Huntly is completed by either constructing a footpath on the western side of Rotowaro Road from the existing termination point west of Smith Avenue to the eastern site access road or by providing a connection through to the Lake Puketirini reserve. The suggested options are shown on Figure 18. The final form of pedestrian access can be confirmed at subdivision stage.

7.5.4 Future pedestrian and cycling paths are recommended to be built in accordance with District Plan standards. The design and location of these facilities can be confirmed at the subdivision stage once a particular development is proposed.
