GEOTECHNICAL FEASIBILITY ASSESSMENT FOR A PROPOSED SUBDIVISION

REF: R3726-1A DATE: 20 DECEMBER 2017

CHENSHUI 53 MUNRO ROAD, POKENO LOCATION PLAN

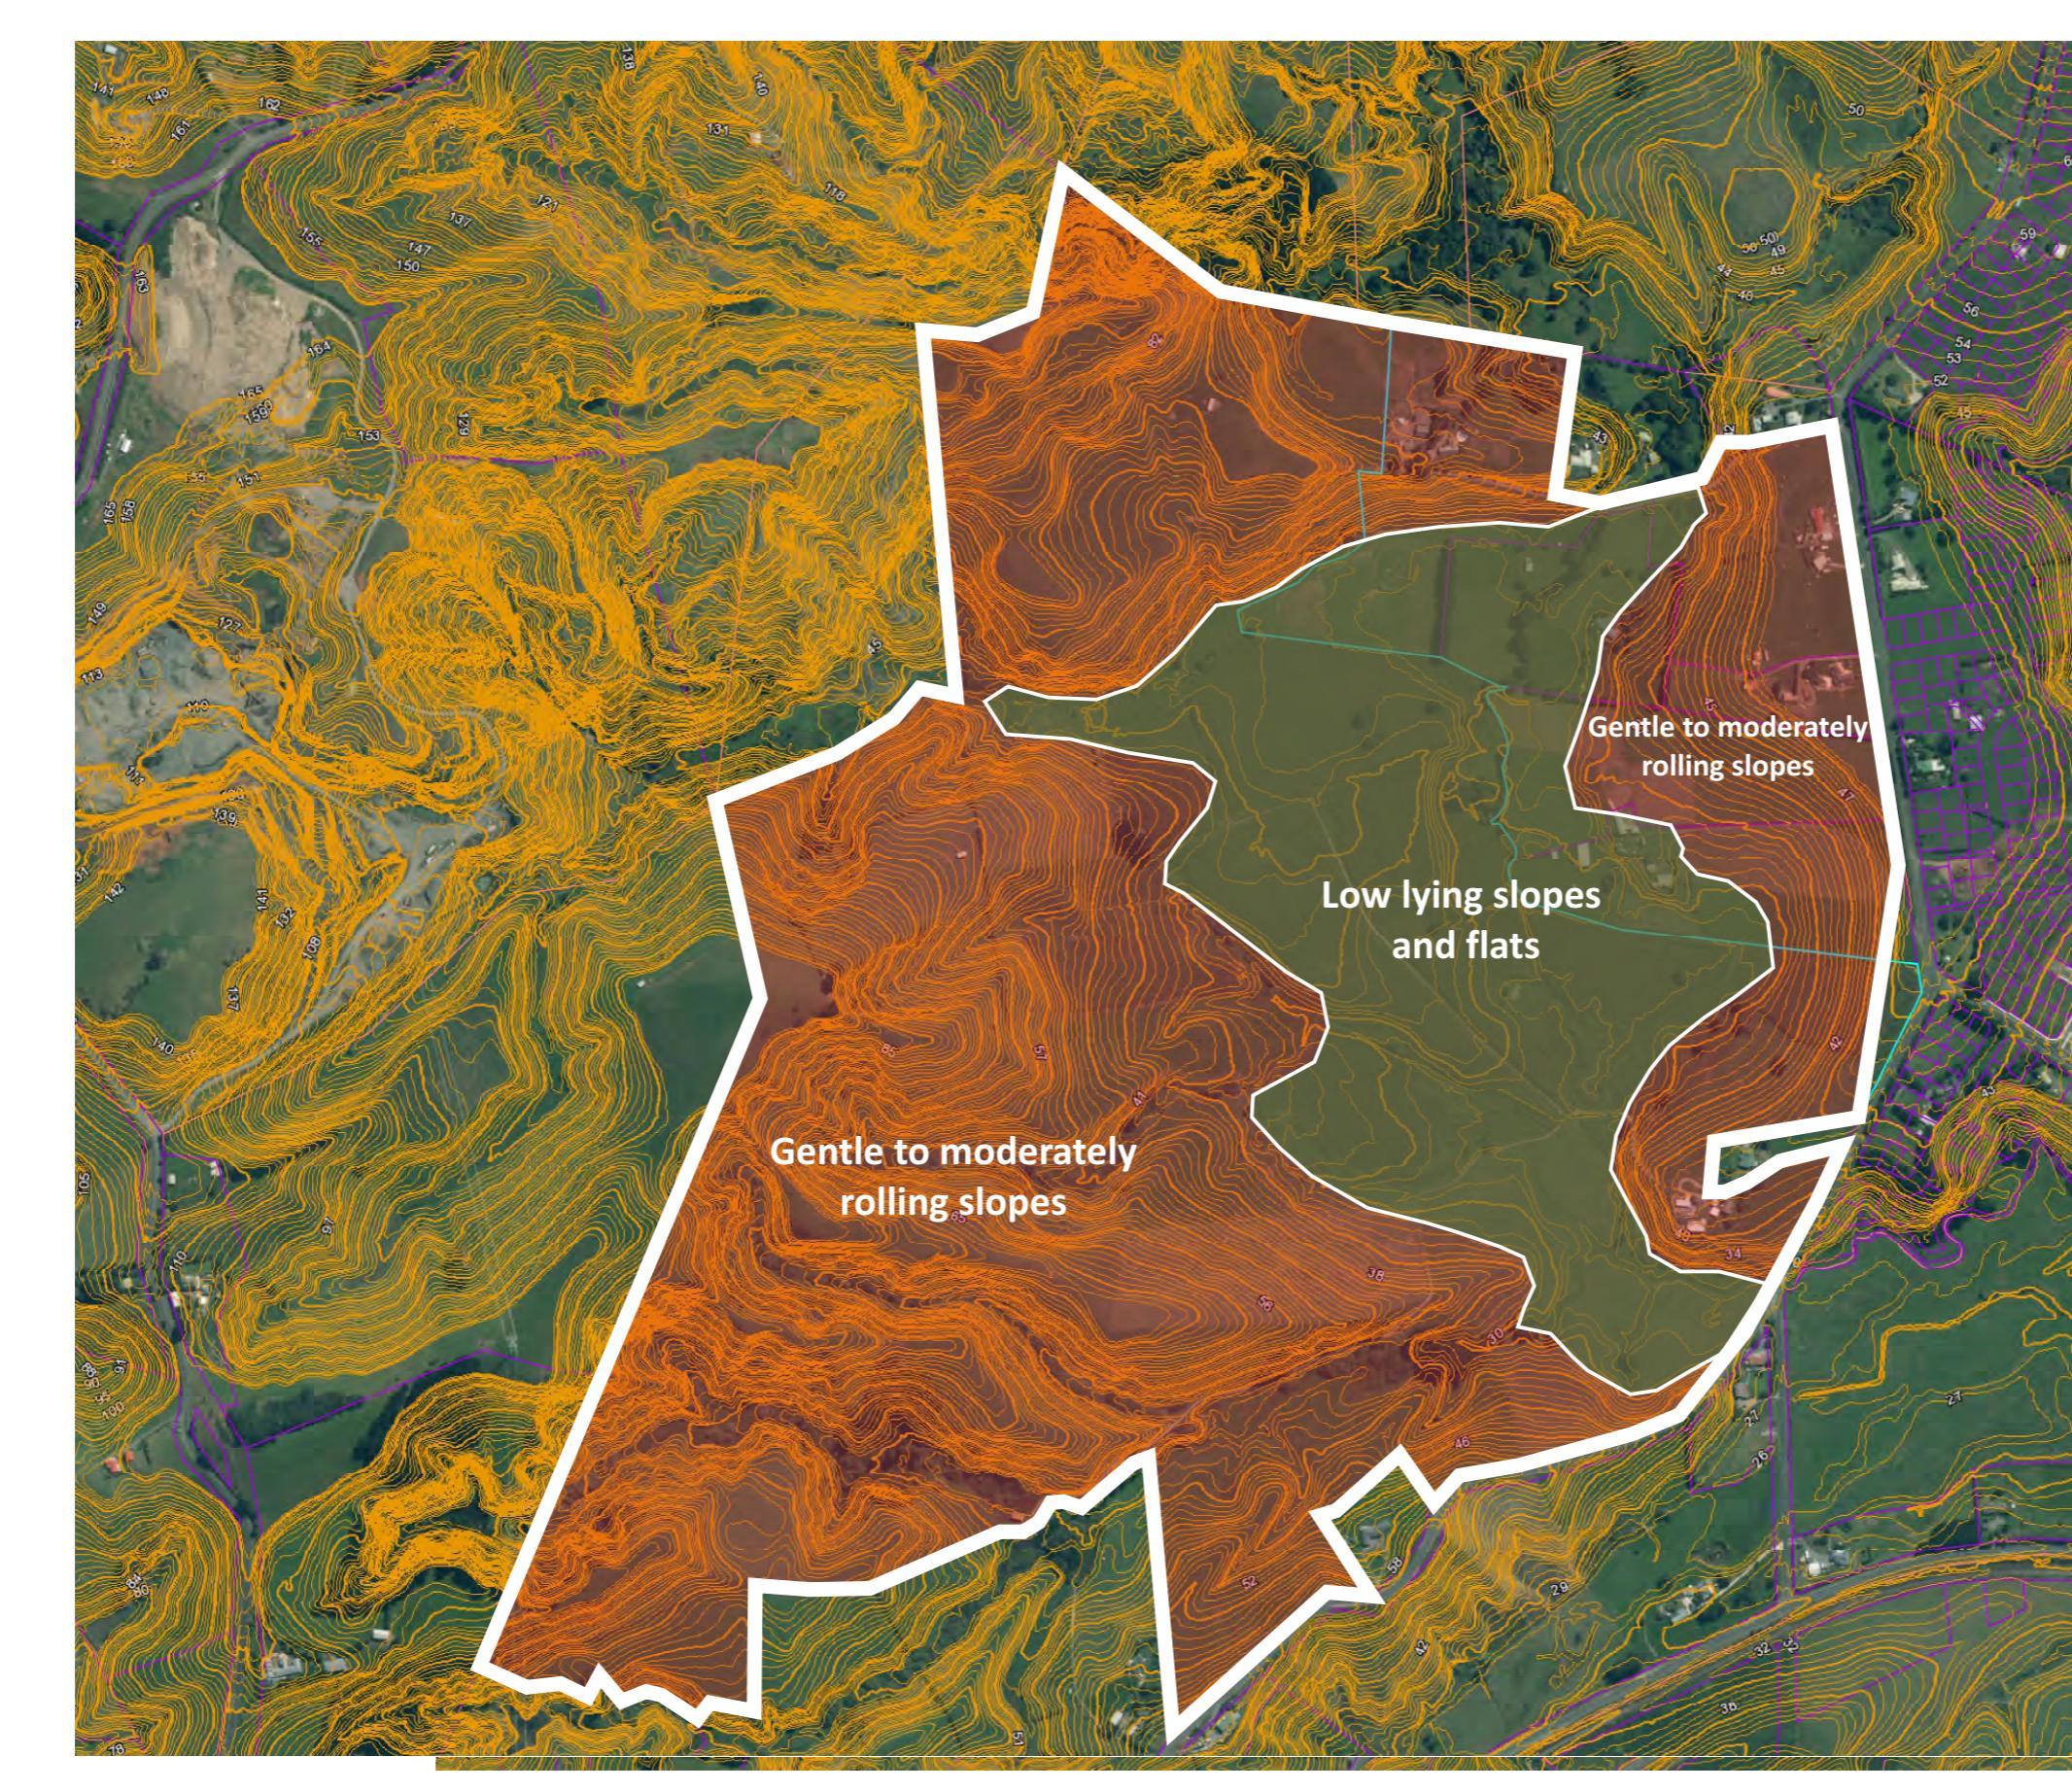
CHENSHUI 53 MUNRO ROAD, POKENO SITE PLAN: LANDFORMS

The subdivision is located on two predominant landforms as shown on Drawing 002. The landforms are described as follows:

Extensive low lying slopes and flats are located within the central and eastern portion of the subdivision. The flats are utilized for cropping and pastureland and are drained via. a series of ditch drains and overland flowpaths.

The majority of the subdivision contains gentle to moderately rolling slopes forming a series of ridge crests and intermediary gullies which extend down to the flow lying flats. The ridge crests are typically gently sloping and utilized as pastureland. The gullies and gully side slopes are typically moderately steep and utilized as pastureland. The gully bases contain swampy ground in places.

The steeper portions of the moderately steep gully side slopes and ridge crest side slopes contain regolith type slope instability features associated with shallow soil creep and slumping ground. The steeper slopes also contain semi-circular shaped gully head formations in places which may represent the remnants of old highly eroded landslides. Further investigation of these features is warranted for subdivision consent given the potential impact on subdivision development. Otherwise, the moderately steep slopes do not contain any deep-seated and/or large-scale slope instability features.

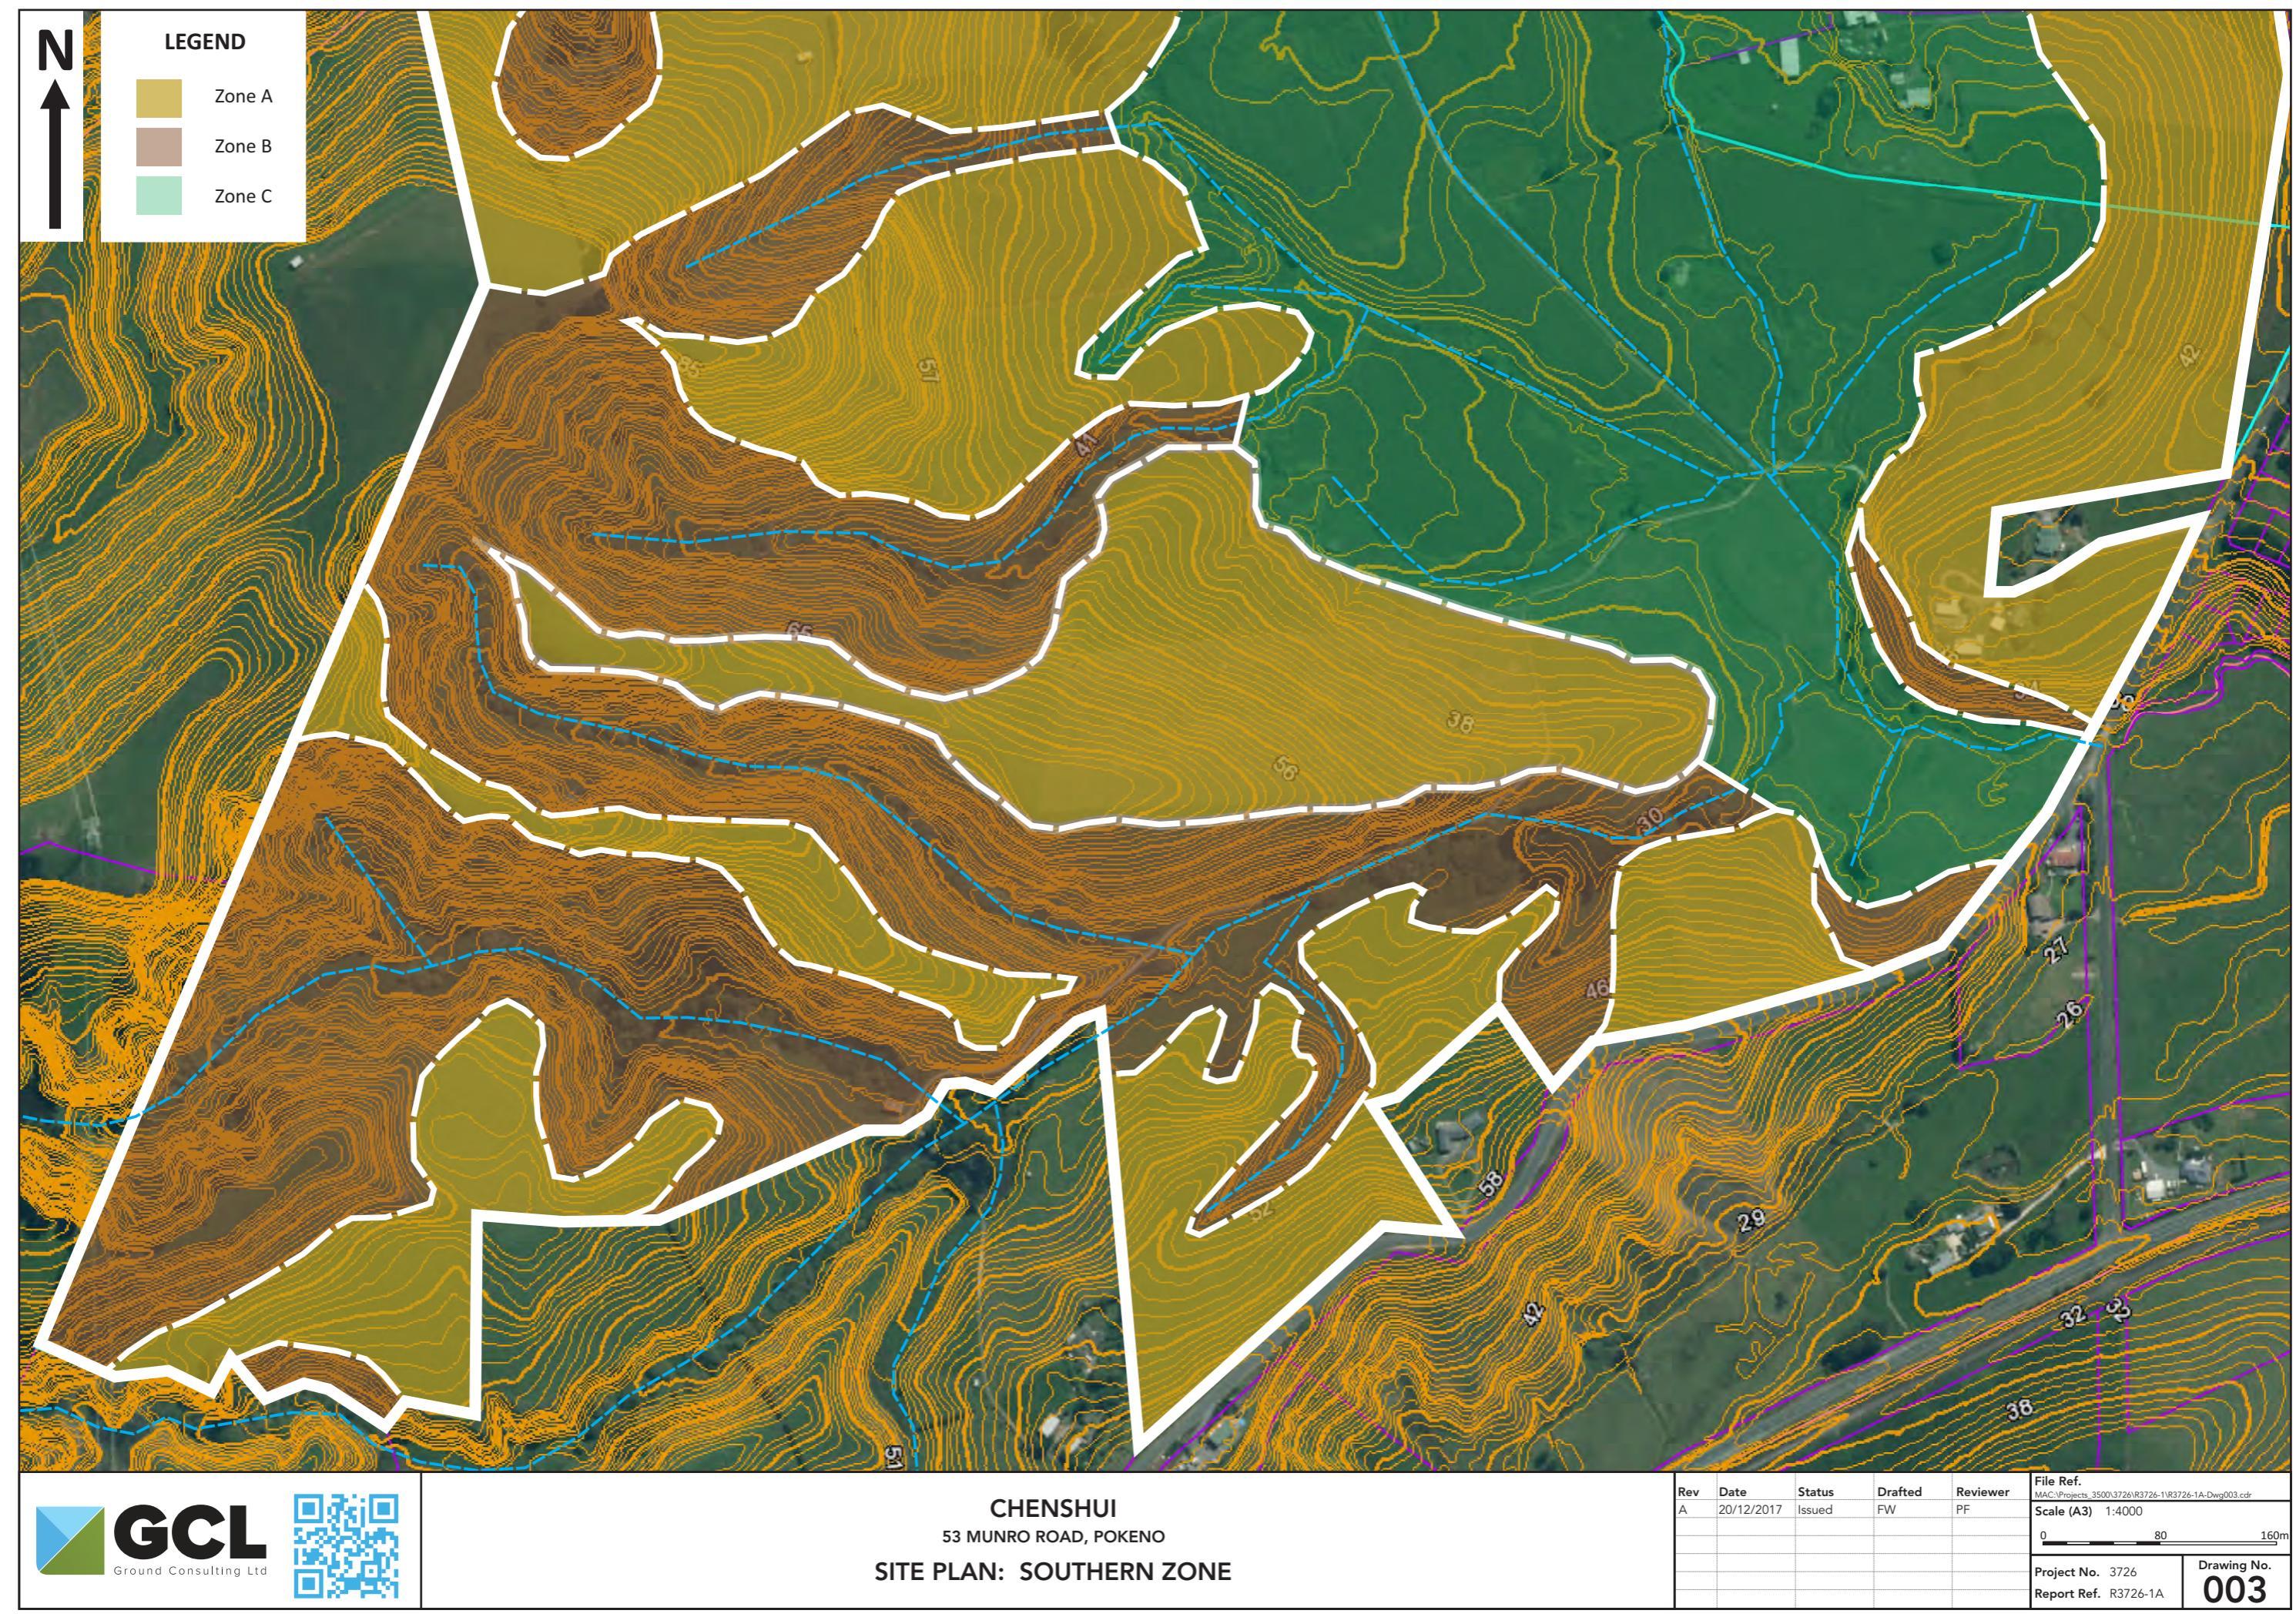
The subdivision has been divided into subdivision development zones as shown on Drawings 003 & 004. The subdivision development zones are based on the site mapping undertaken. The subdivision development zones provide general recommendations on allowable subdivision development and constraints which can be utilised to provide a subdivision scheme plan. The subdivision development zones are summarized as follows:

Zone A is land is considered to be suitable for residential development and should provide safe and stable conditions. Zone A land is typically associated with:

- Gently sloping topography with slope angles of no steeper than 1(v) on 4(h).
- Topography which is not associated with high groundwater levels.
- Topography which is not associated with surface water flows and/or ponding.

The extent of Zone A land is shown on Drawings 003 & 004.

Zone B land is not suitable for residential development under existing conditions and includes the steeper portions of the gentle to moderately rolling slopes. Zone B land, however, can provide suitable subdivision development conditions with appropriate remedial measures. Zone B land is typically associated with:

The extent of Zone B land is shown on Drawings 003 & 004.

Zone C land may not be suitable for residential development under existing conditions and includes the low lying slopes and flats. The suitability of building within Zone C is dependant on the strength and saturation of the alluvial deposits which likely underlie this zone. Zone C land, however, can provide suitable subdivision development conditions with appropriate remedial measures.

The extent of Zone C land is shown on Drawings 003 & 004.
