Port Waikato Coastal Hazards

Prepared for the Waikato District Council By Jim Dahm Bronwen Gibberd Focus Resource Management Group

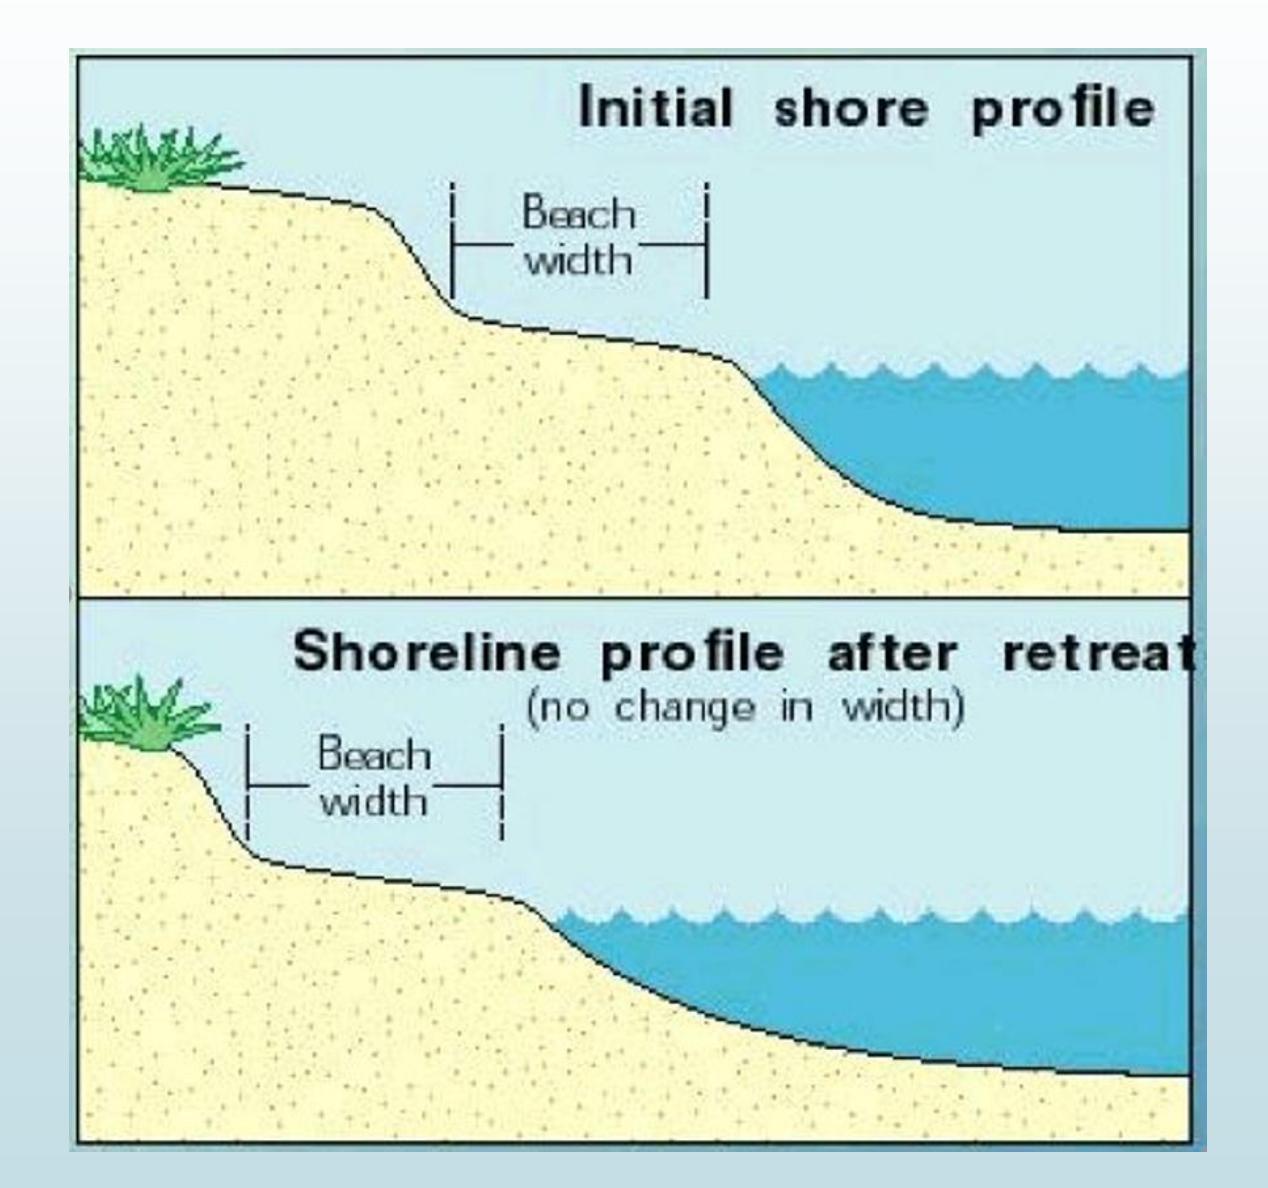
Coastal Structures – why a last resort?

- When erosion occurs on a natural beach, the whole profile moves landward
- A wide high tide beach will reestablish after erosion
- Erosion does not destroy beaches as long as the erosion encounters sand

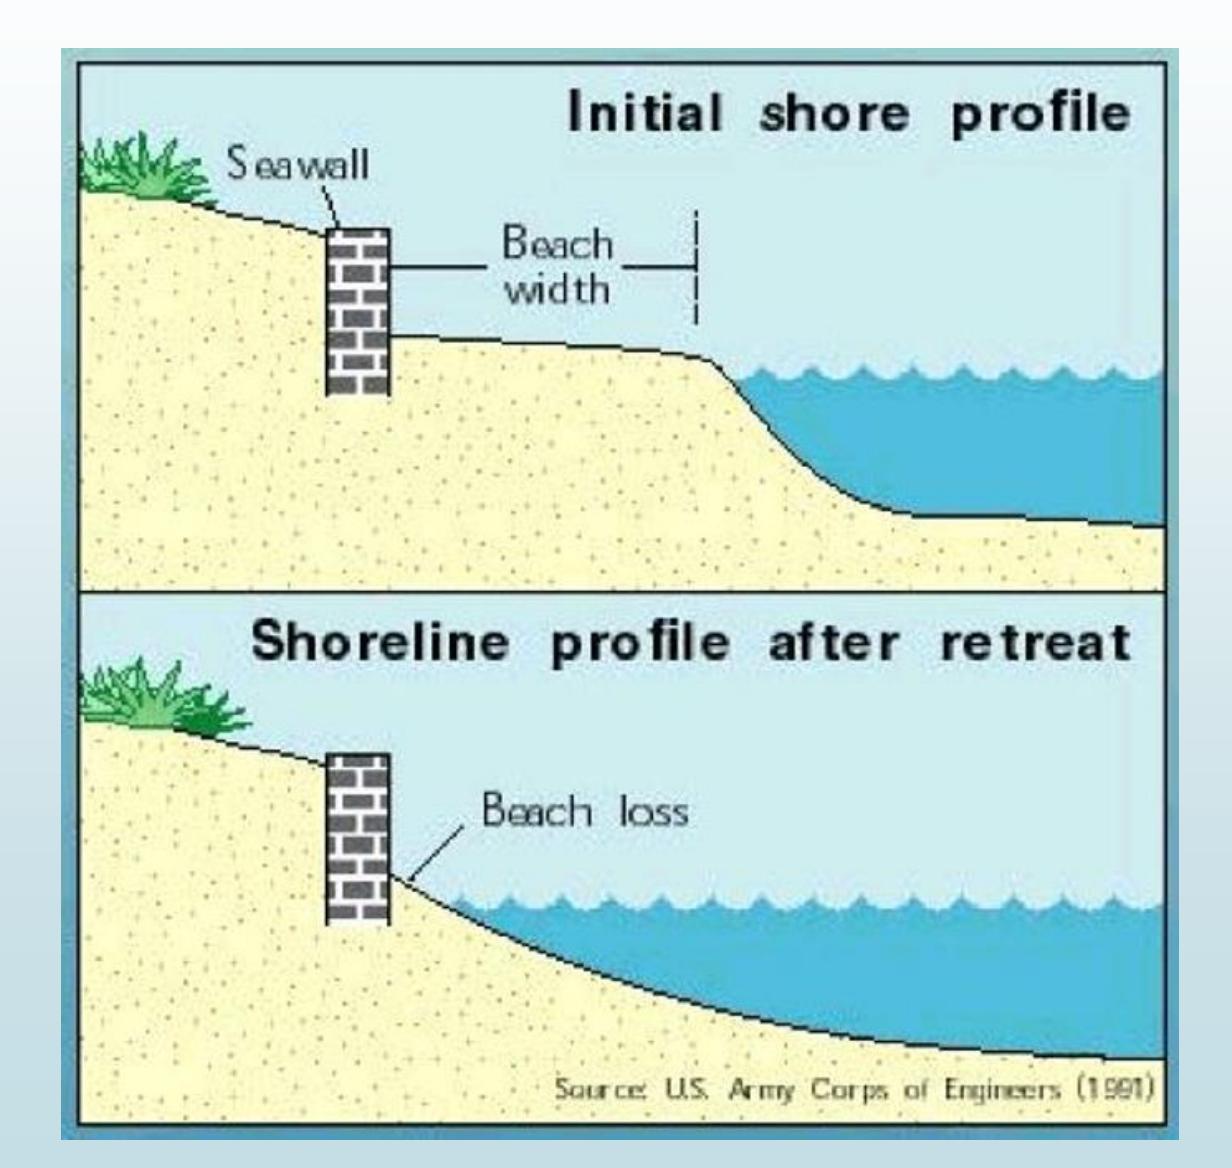
Coastal Structures – Effect on beaches

- Building an effective seawall protects the land behind the wall
- A seawall does not stop the processes driving erosion in front of the wall
- The beach continues to erode, and over time the beach disappears
- Recreational values are lost and public access alongshore also adversely affected
- So, generally not an acceptable long-term solution on sandy shorelines.

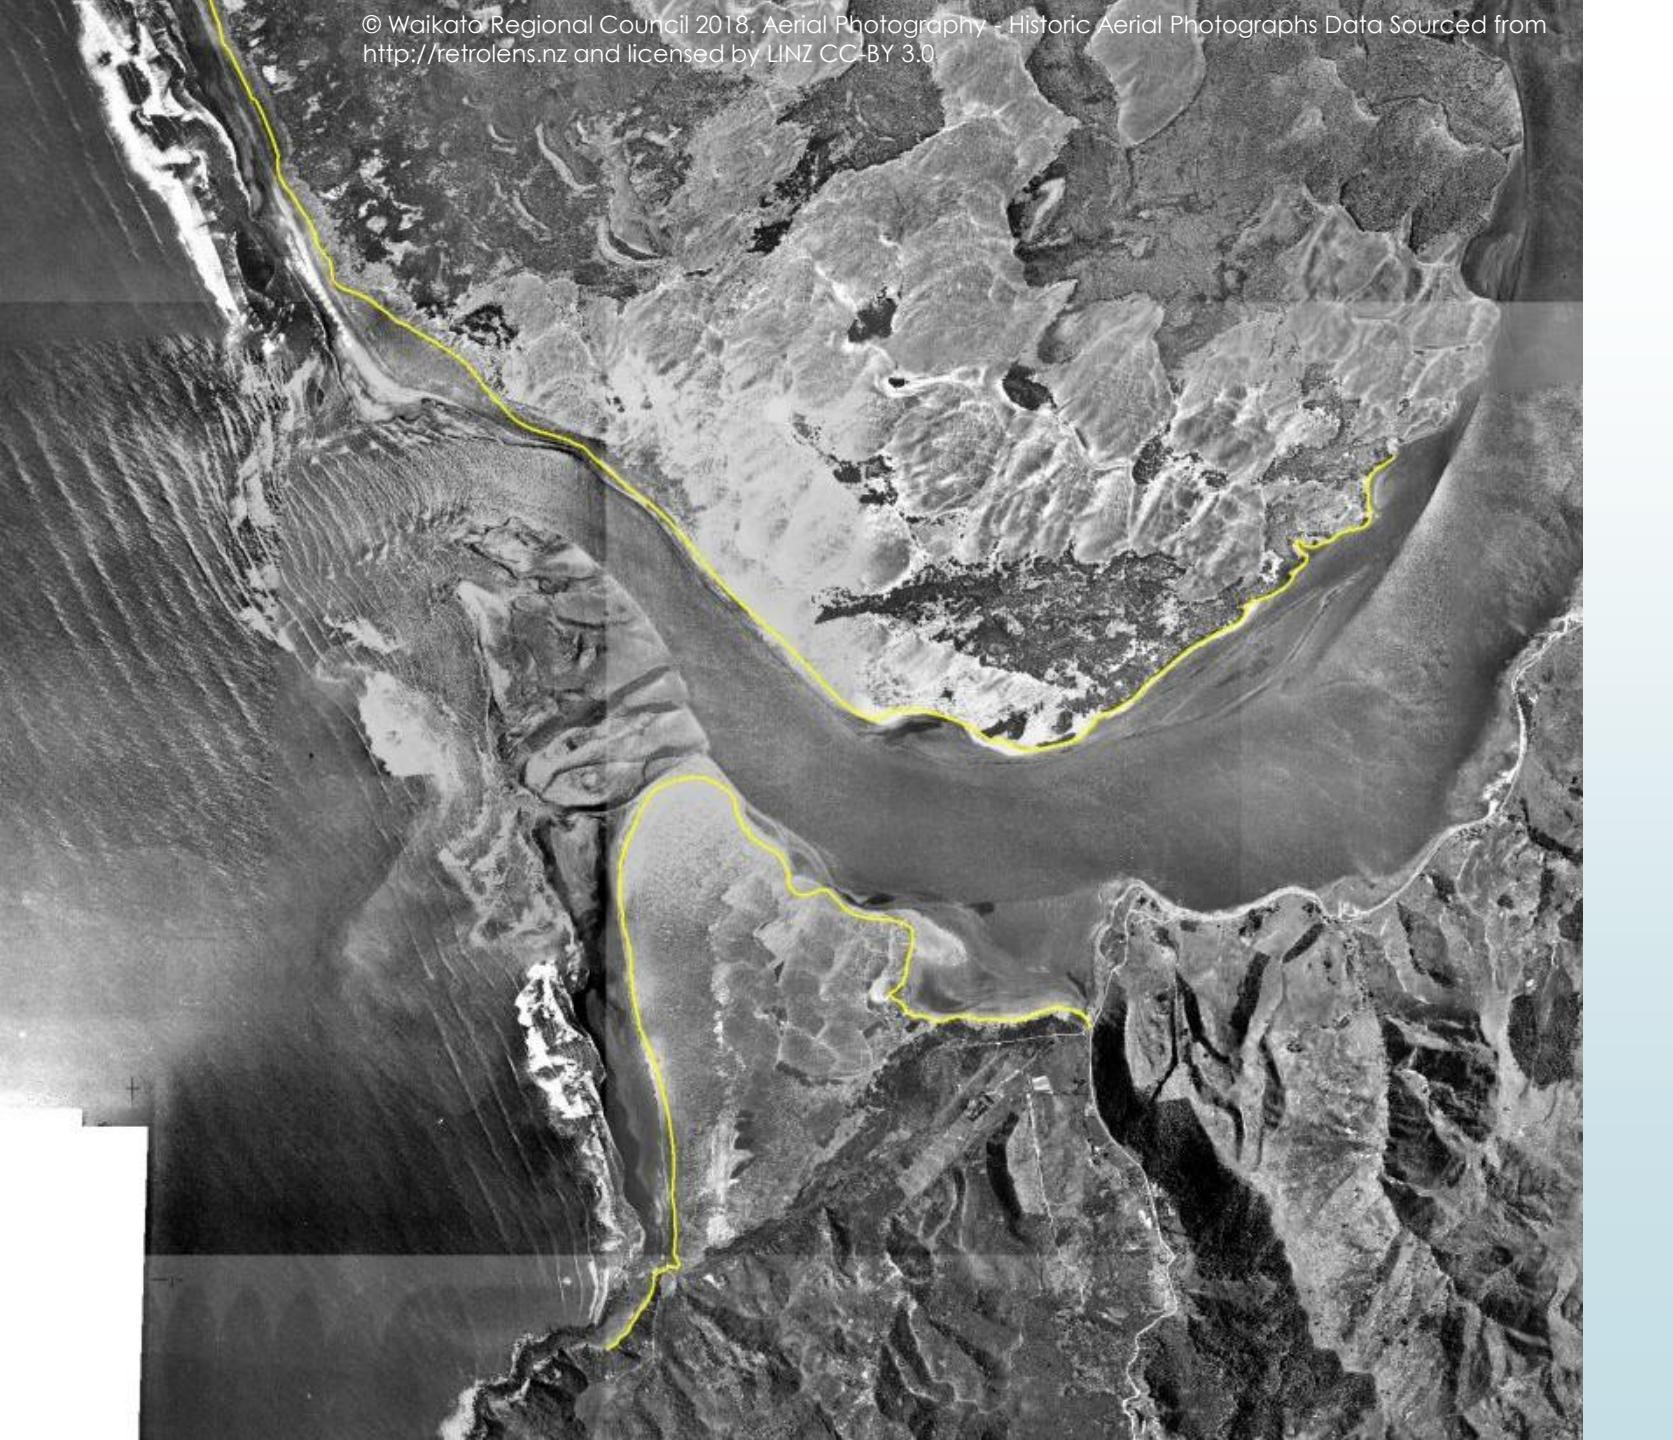
Port Waikato 1940s

- Photograph taken early 1940s
- Spit much shorter than modern day
- Yellow line is digitised shoreline from this photograph

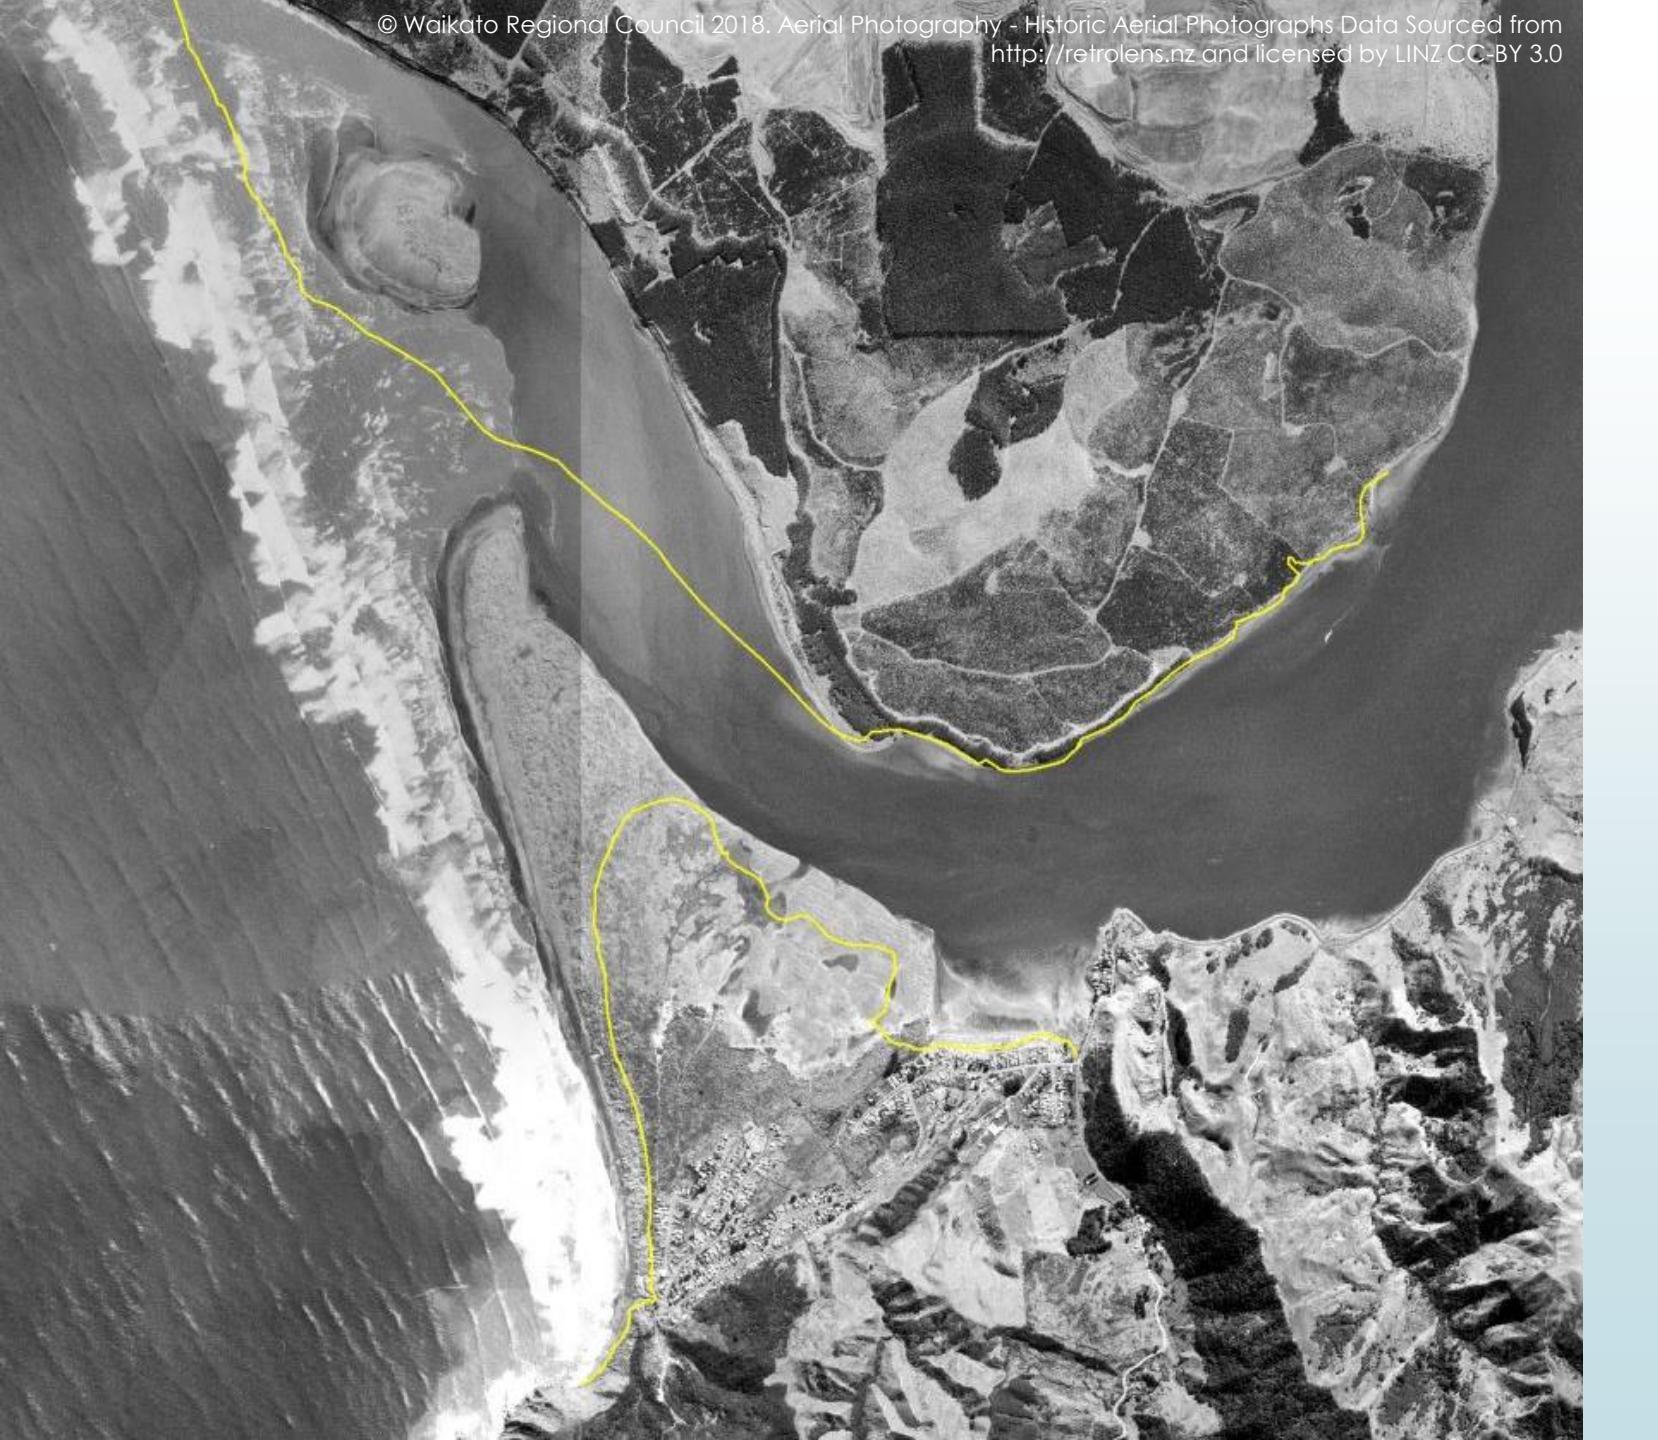
Port Waikato 1970s

- Yellow line is 1940s shoreline
- Significant erosion on northern shore of River entrance
- Spit has extended northwards

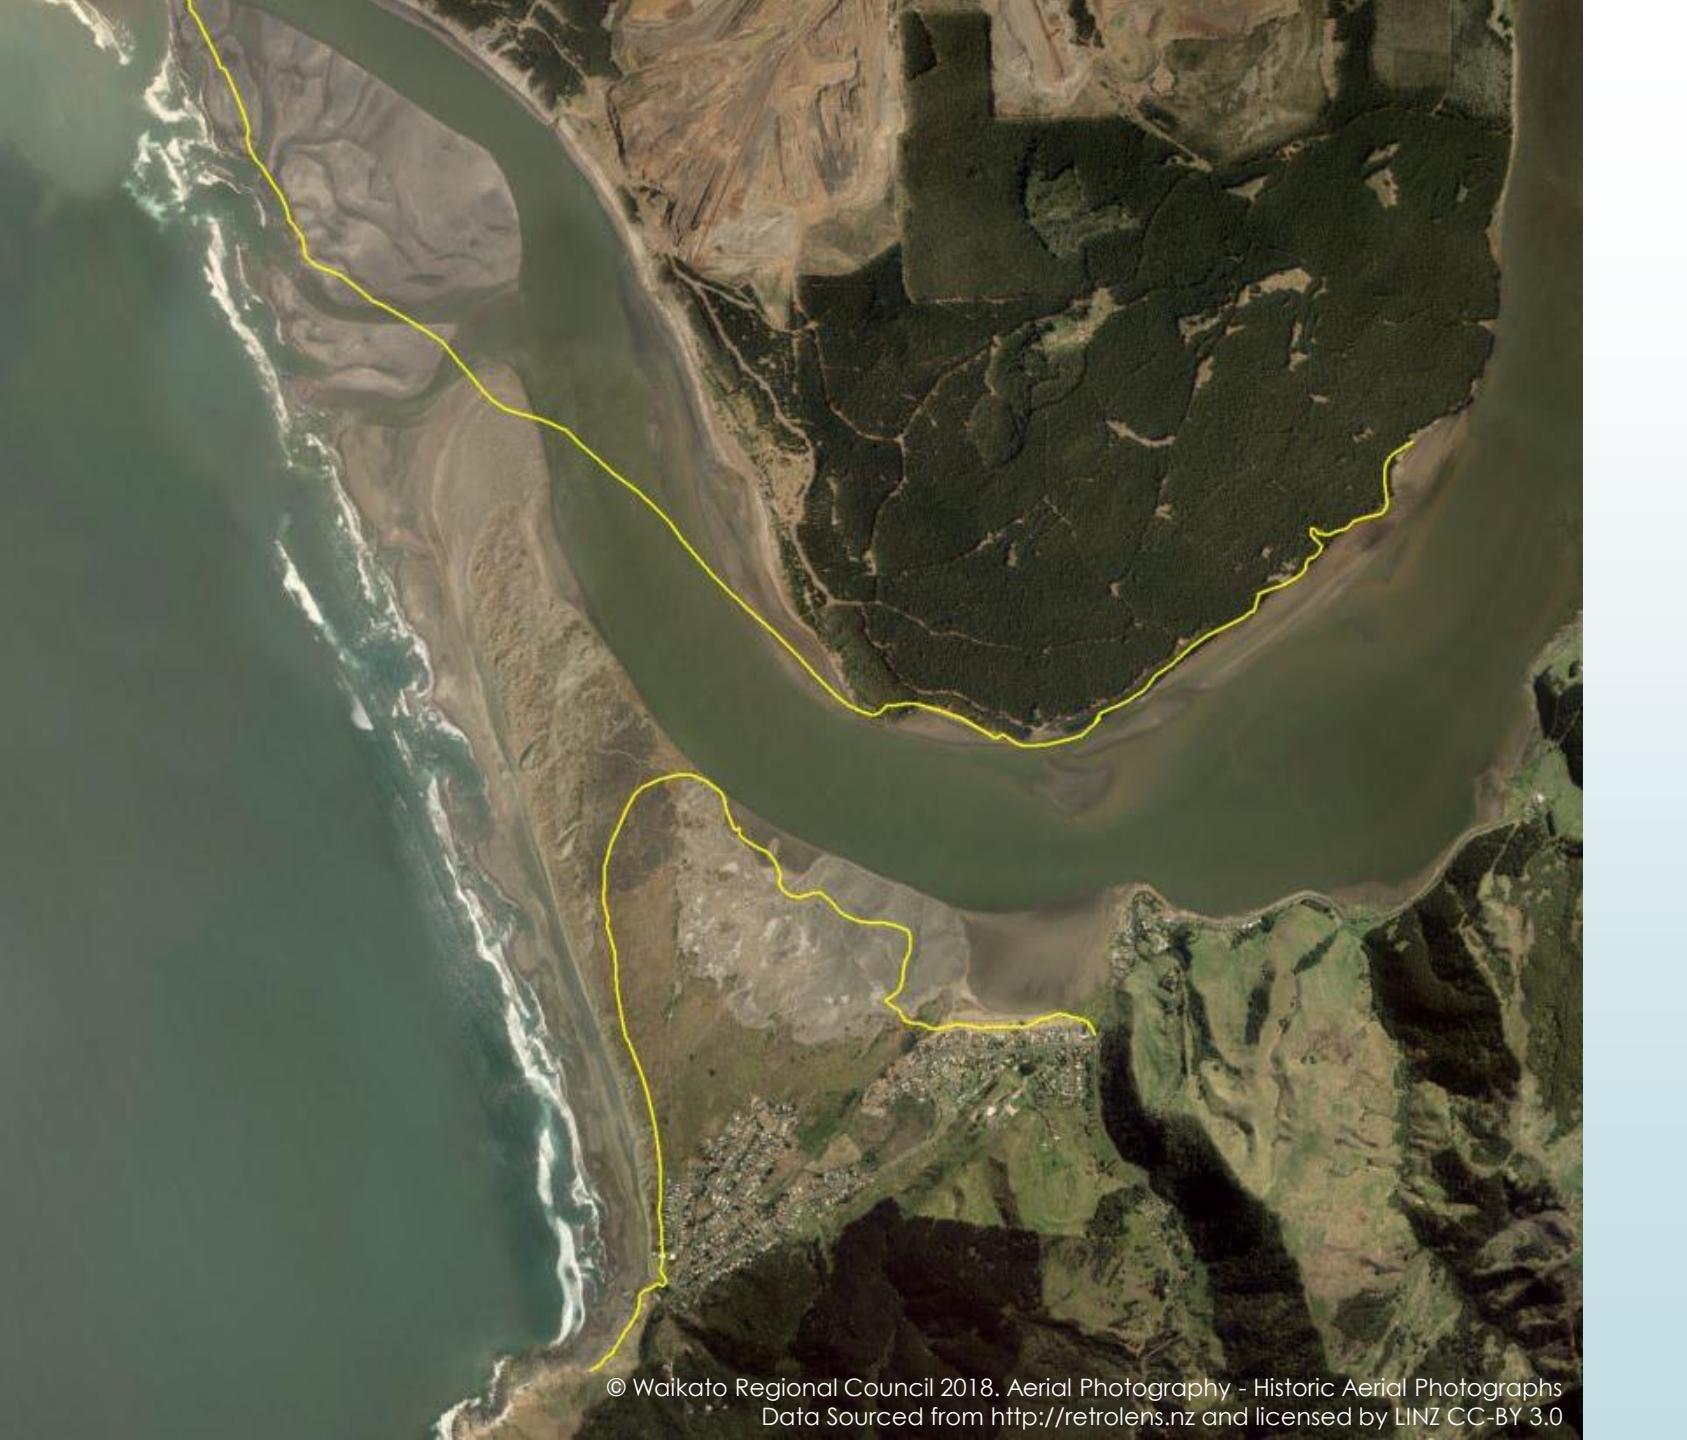
Port Waikato 1990s

- Spit continues to grow northwards and widen at the base
- Yellow line is digitised shoreline from 1940s photograph

- ► 1940s 2002
 - Increased in length by approximately1,200 m
 - Increased in width by approximately 300 m
 - Open coast beach accreted by 70 m at Township.

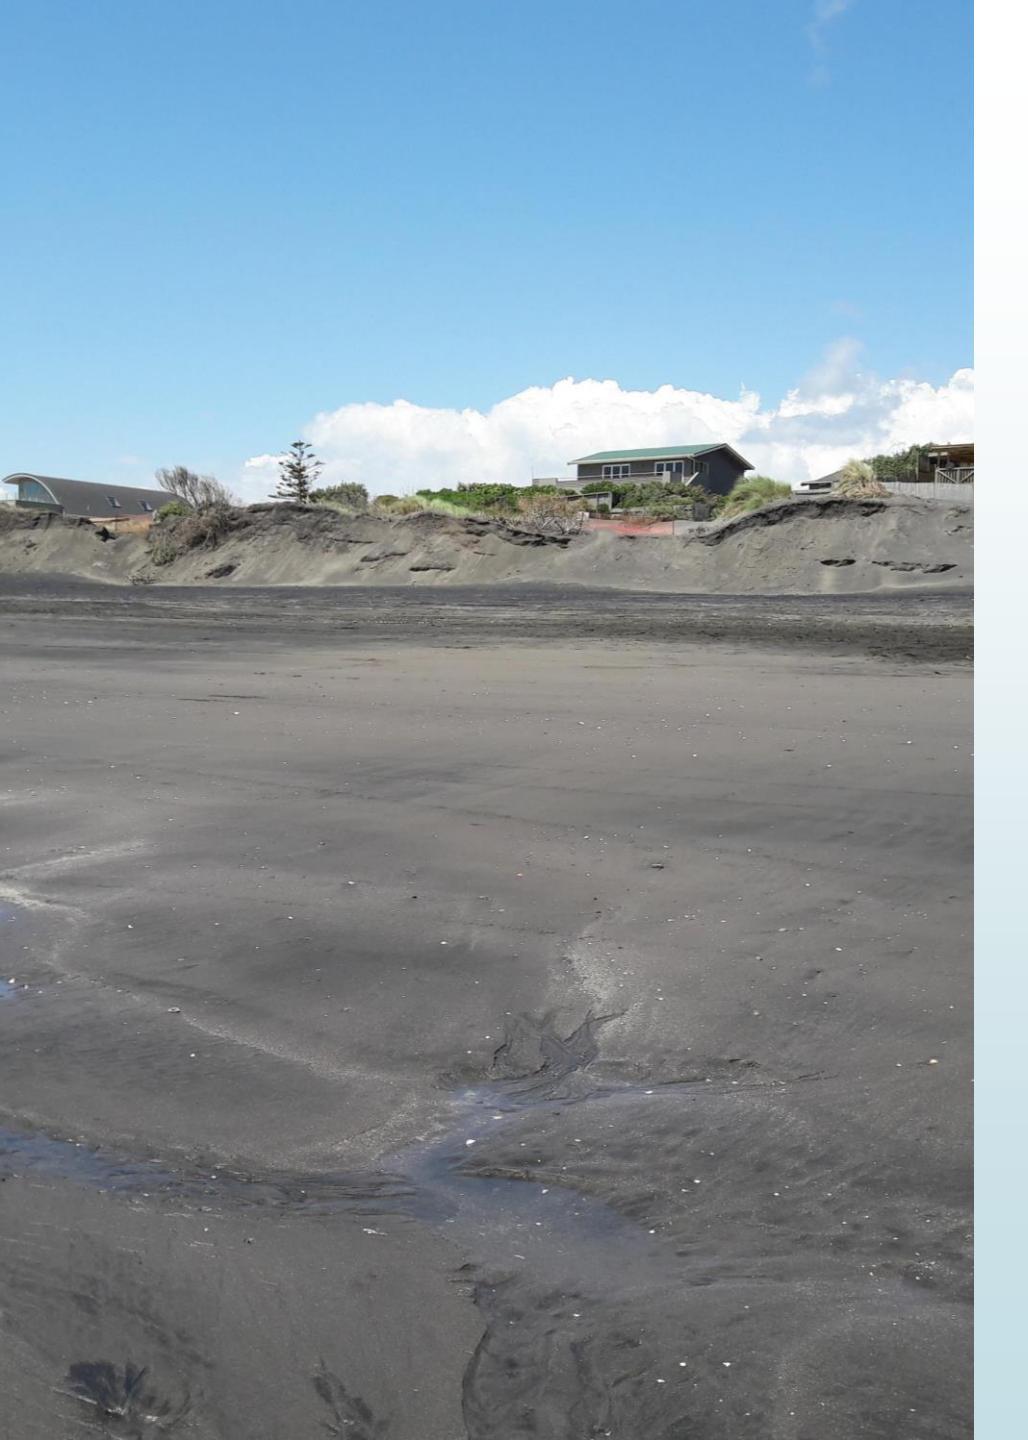
Township Foreshore Looking backwards ... Looking forward...

- Looking backwards (shoreline changes near surf club 1940s to present):
 - 1940s to 2002 advanced by 70-80 m
 - Since 2002 eroded by about 50 m
 - 1997 2002 = relatively stable/minor changes
 - 2000 2012 = eroded at 1-2 m/yr
 - 2012 present = eroded at 5-7 m/yr
 - Average rate of erosion since 2000 = 2.5-3.0 m/yr, but very variable.

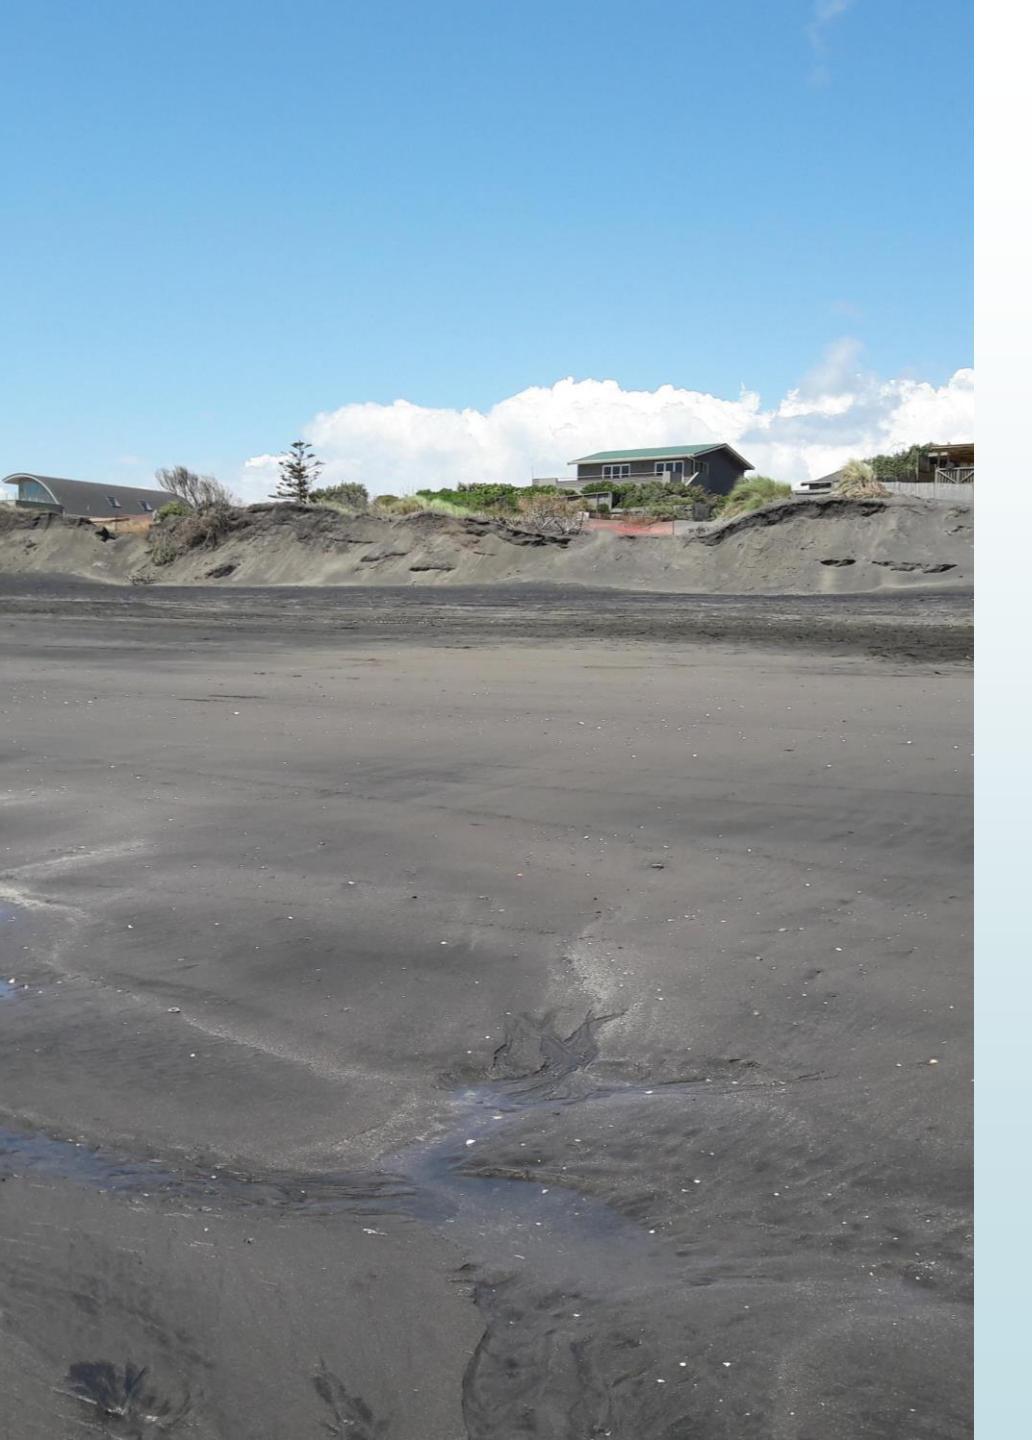
Township Foreshore Looking backwards ... Looking forward...

- Looking forwards Possible future change:
 - Very uncertain
 - Shoreline may just be fluctuating on multi-decadal cycle, not yet back to 1940s position
 - However, could be more complicated than that so erosion might also just continue
 - Erosion likely to be aggravated by future sea-level rise
- IF erosion continues :
 - Private properties could be directly affected within 1-3 years if current high rate of erosion continues.
 - Even at slower rate (i.e. average rate of 1-2 m/yr 2000-2012, entire front row of properties and Surf Club could be severely eroded within 50 years.

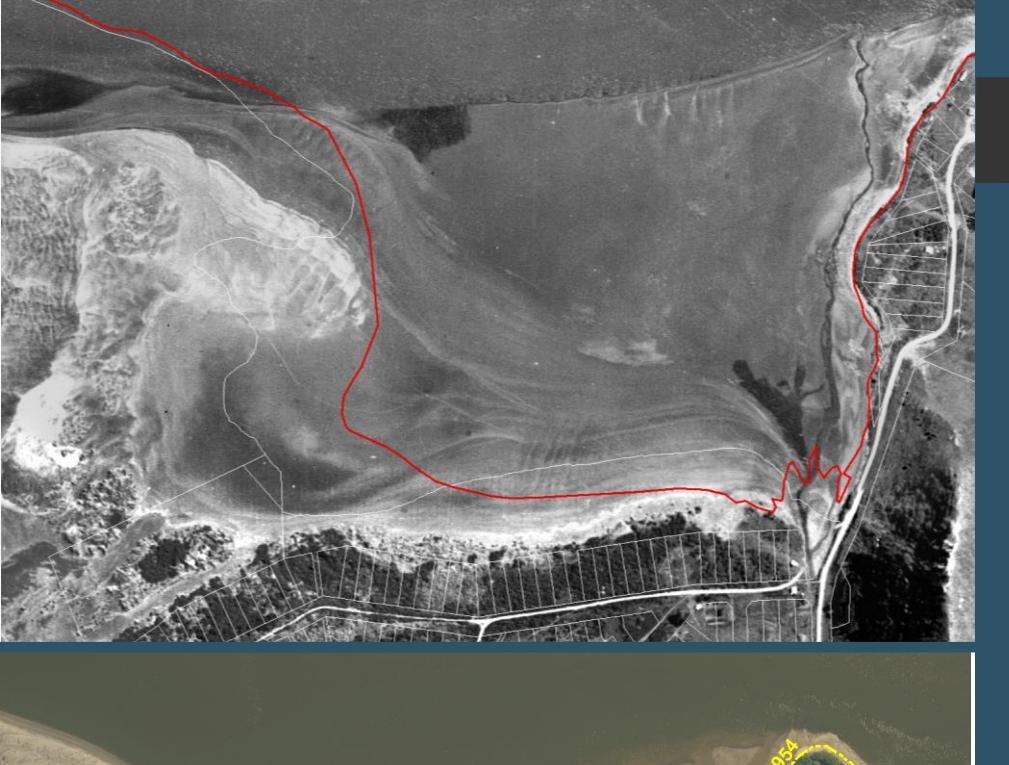
Maraetai Bay

- Small shoreline changes
- Overall trend for accretion since 1940s
- Sea level rise may exacerbate erosion

Red line – 2012 shoreline Yellow line – 1940s shoreline Waikato Regional Council Coastal Inundation Tool http://coastalinundation.waikatoregion.govt.nz/

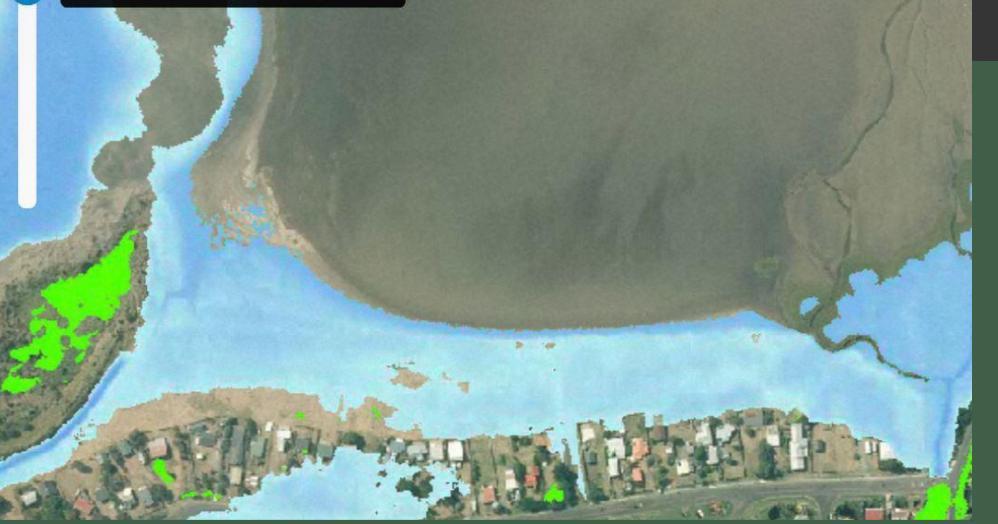
Water Level RL(MVD-53): 3.2 m

Top: approximate current extreme storm level Bottom: extreme storm level with 0.5 m sea level rise

- Low lying potentially vulnerable to increased inundation with sea level rise
- <u>Minimum floor levels</u> likely to be the main requirement
